1-8-92

TEAM W/ SERGIO PITONED AND REQUESTED
MY PRESENCE FOR LOADING OF 2000 GAL
TANK. THE TANK WAS REMOVED 1-7-92 DUE
TO INSTABILITY OF EXCAVATION. HOLE FILLED
BACK W/ GRAVEL TO LEVEL OF THE FIRST
TANK BOTTOM, SHOWN IN PHOTOS.

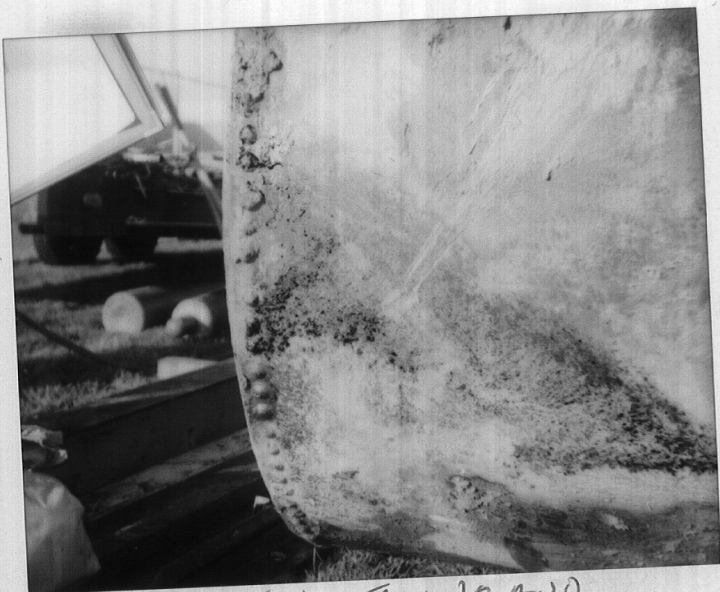
PICTURE SHOWS STAINING AND
SEEPAGE OF HEAVY OIL CONSTITUENTS
2200 CENTRAL 1-8-92 (PW) (2ND TANK)

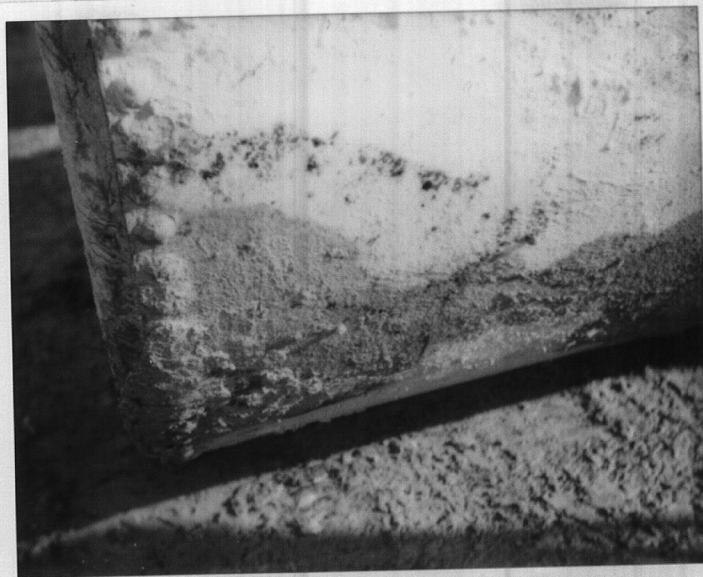
AREA OF STAINING AT BOTTOM
OF 2000 GAL TANK.
2200 CENTRAL 1-8-92 (PW)

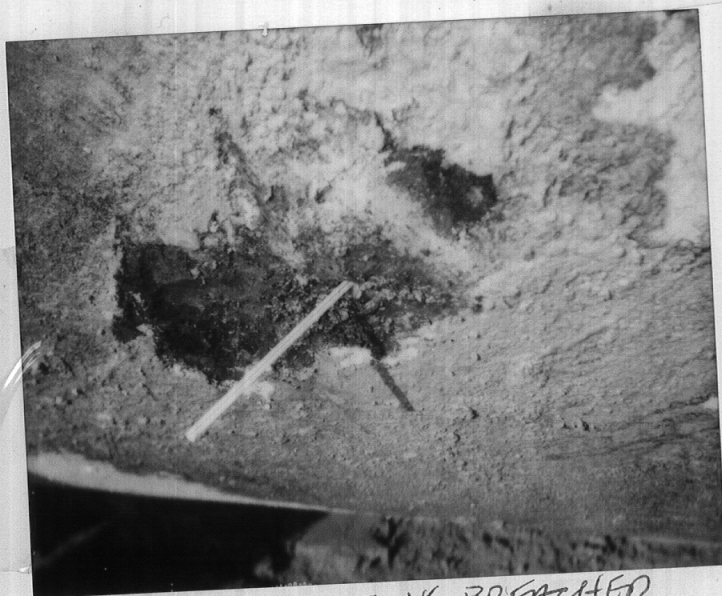
UPON INSPECTION THE TANK WAS FOUND TO
HAVE A HOLE AT 4 O'CLOCK POSITION
SEE PHOTOS. OTHER STAINS AND PRESENCE OF
PRODUCT ON SEAMS IN PHOTOS.

PICTURE SHOWS TANK BREACHED
Q 2200 CENTRAL, SECOND TANK
1-8-92 (PW)

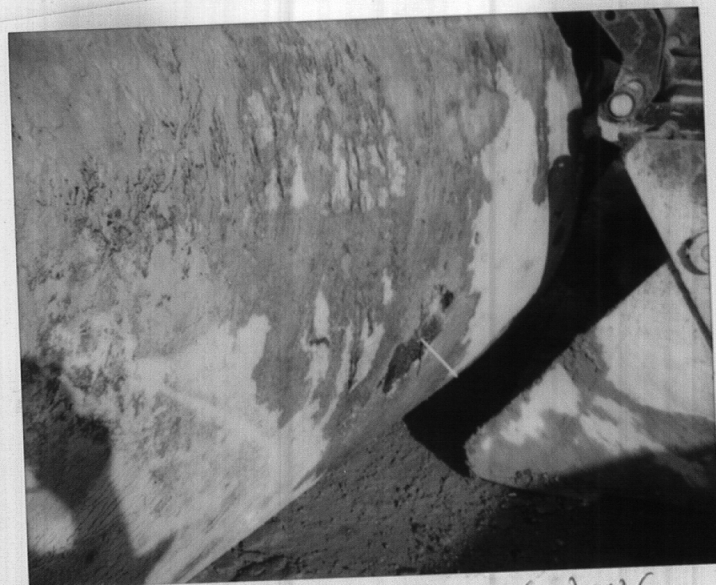
ENLARGED AREA PHOTO, SHOWING
HOLE IN 2000 GAL TANK, 2ND TANK
2200 CENTRAL, 1-8-92 (PW)

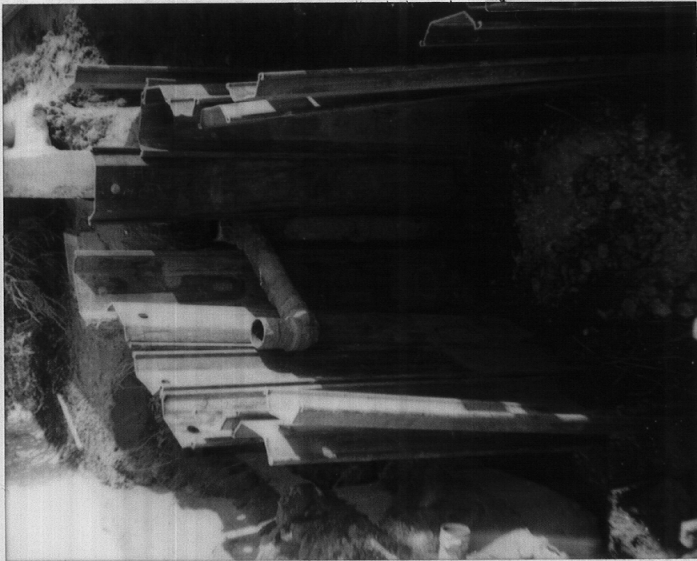
2200 CENTRAL AVE ALAMEDA
SEMCO JOB 1-3-92 W/ EDDY SO
SECOND TANK REMOVAL W/ SHORING

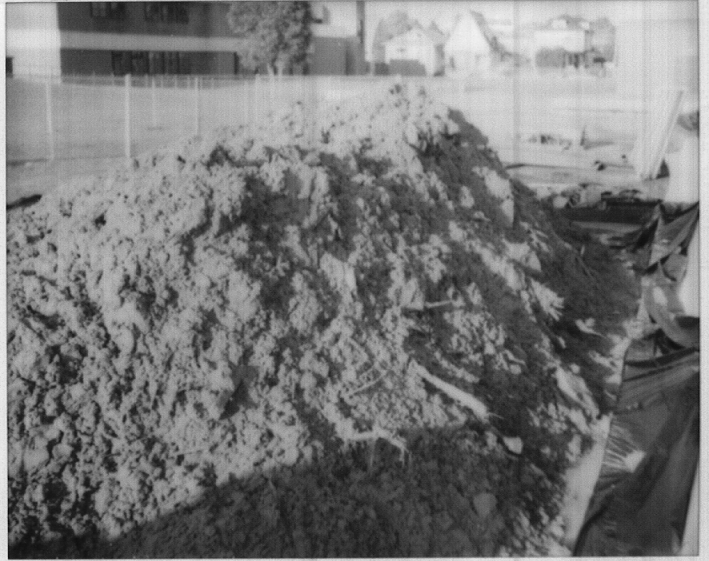
STOCKPILED SOIL ON PLASTIC SHEETING
2200 CENTRAL
1-8-92 RW

THE SITE WILL BE STABILIZED WITH
PEA GRAVEL BACKFILL. ALL EXCAVATED
MATERIAL TO BE CONTAINED ON PLASTIC
FOR SAMPLING.

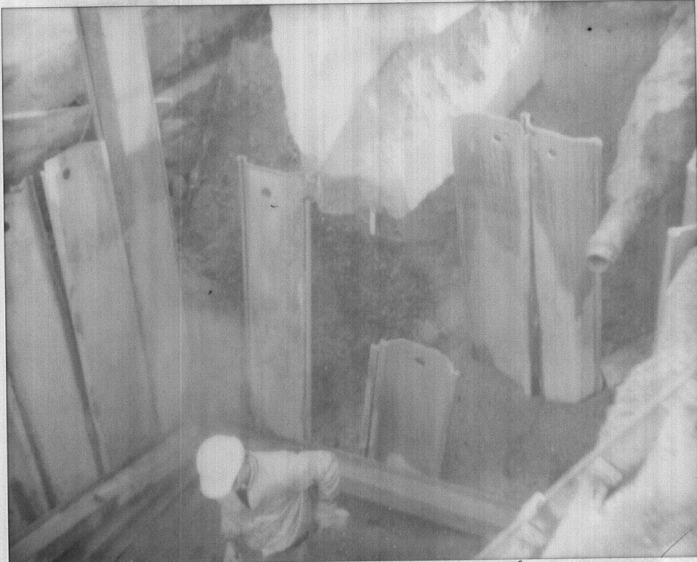
PIT AFTER REMOVAL OF SECOND
2000 GAL TANK
2200 CENTRAL 1-8-92 RW

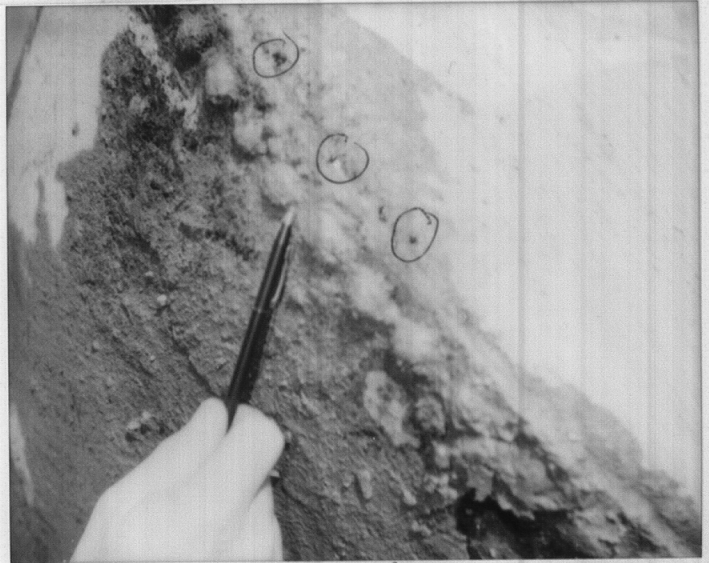
PICTURE SHOWS APPARENT SEEBAGE
AT SEAM, SECOND TANK
1-8-92 RW 2200 CENTRAL AVE

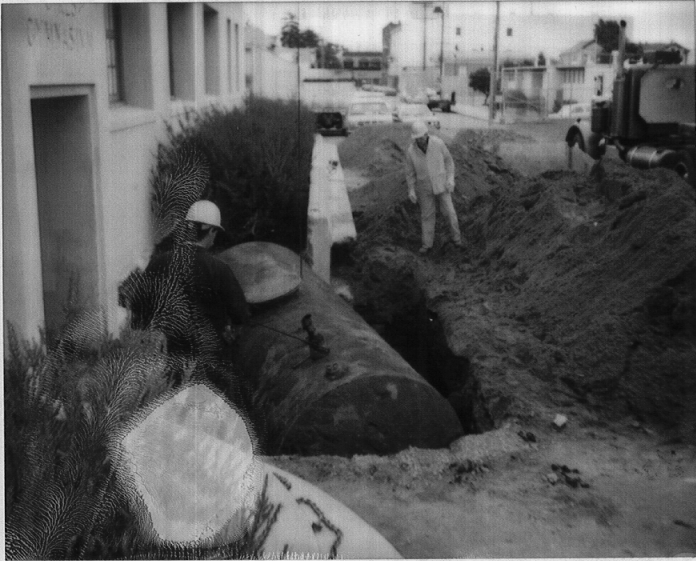
1

2200 CENTRAL ALAMEDA
12/27/91 TANK REMOVAL

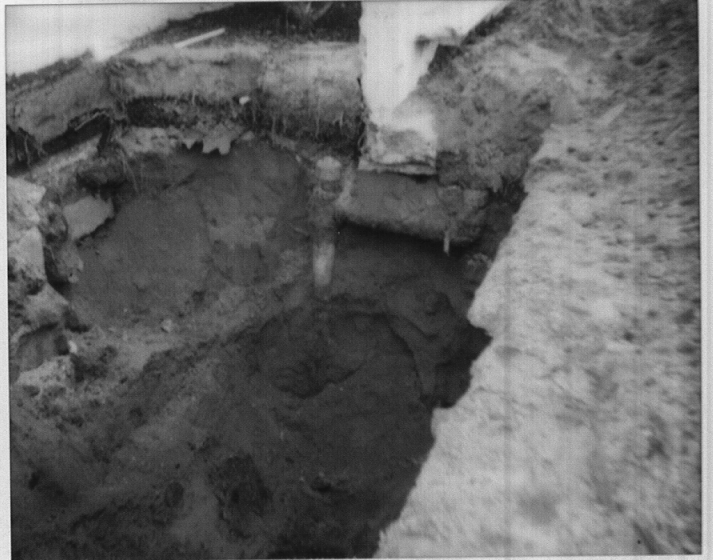
2

2200 CENTRAL AVE ALAMEDA
TANK PIT W/ FALL LINE TO
LOWER TANK

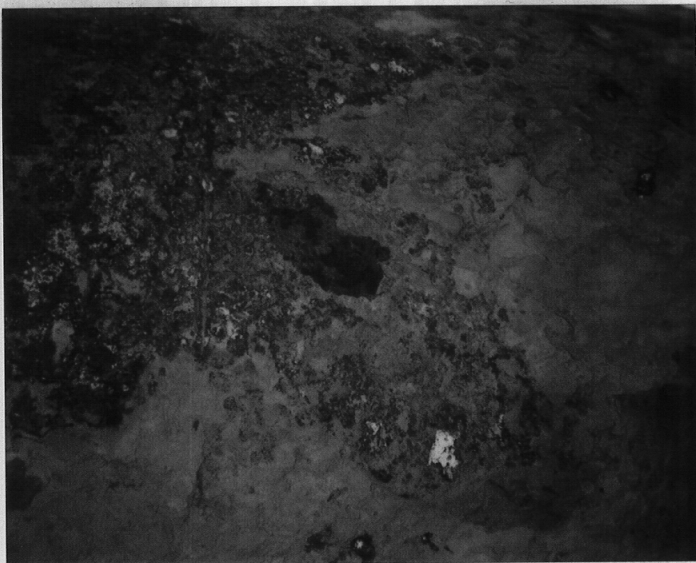
3

2200 CENTRAL ALAMEDA
REMOVED TANK EXTERIOR
SHOWING PITTING

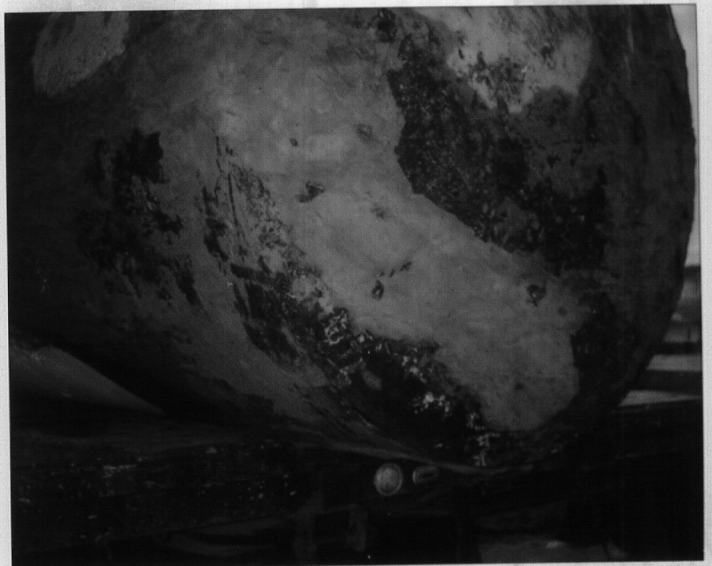
4

TANK ON TRUCK BED
END VIEW, TANK SCRAPPED OF SOIL
