REPORT  
SOIL SAMPLING/TESTING AND  
PRELIMINARY SITE ASSESSMENT  
FIRE STATION No. 1 RELOCATION SITE  
SOUTH LOT ADJOINING  
7494 DONOHUE DRIVE  
DUBLIN, CALIFORNIA

June 1991

SUBJECT: Report  
Soil Sampling/Testing and  
Preliminary Site Assessment  
Fire Station No. 1 Relocation Site  
South Lot Adjoining 7494 Donohue Drive  
Dublin, California  
for Dougherty Regional Fire Authority

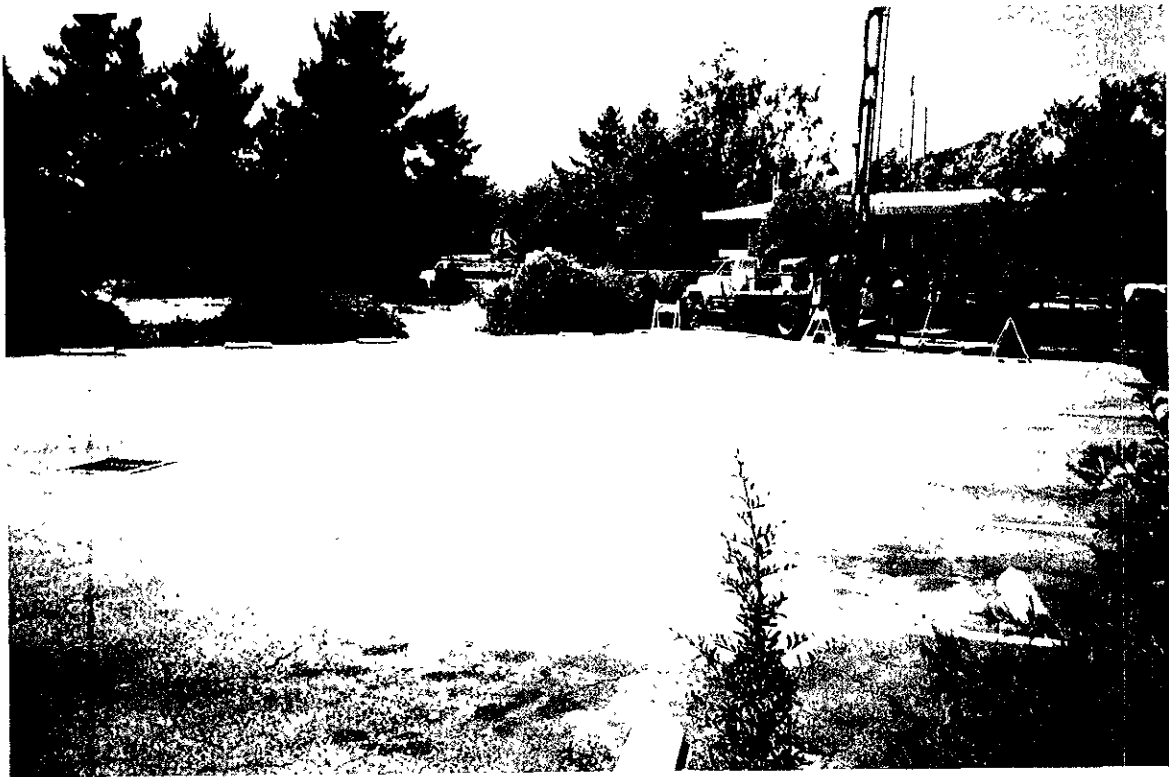
1. Photograph shows most of site, looking northwest, note storm drain to left, light vehicle oil-staining. Shows drilling of 50' deep geotechnical boring.

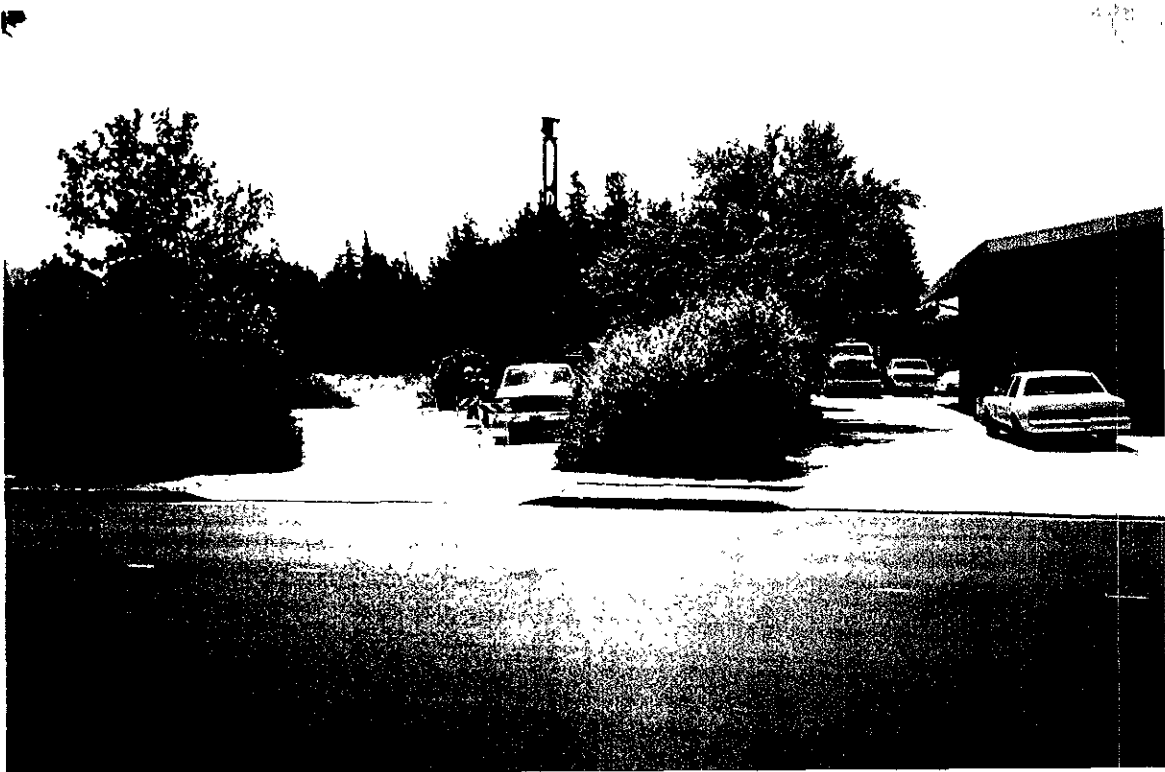
2. Looking west across Donohue Drive, showing north property line separating site and Fire Station No. 1.

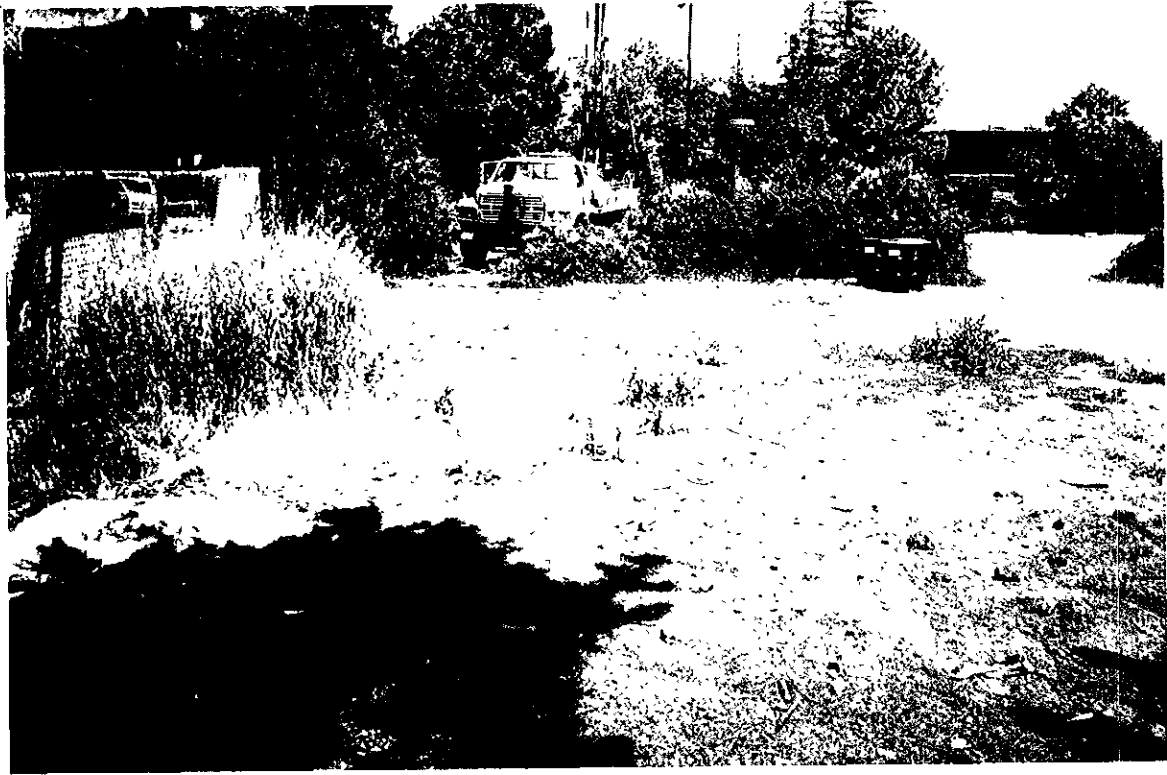
3. Looking east down north property line. Shows EB-2 (foreground) and EB-3 (near drums) locations. Drums contain boring spoils. Shows typical surface condition in west lot half.

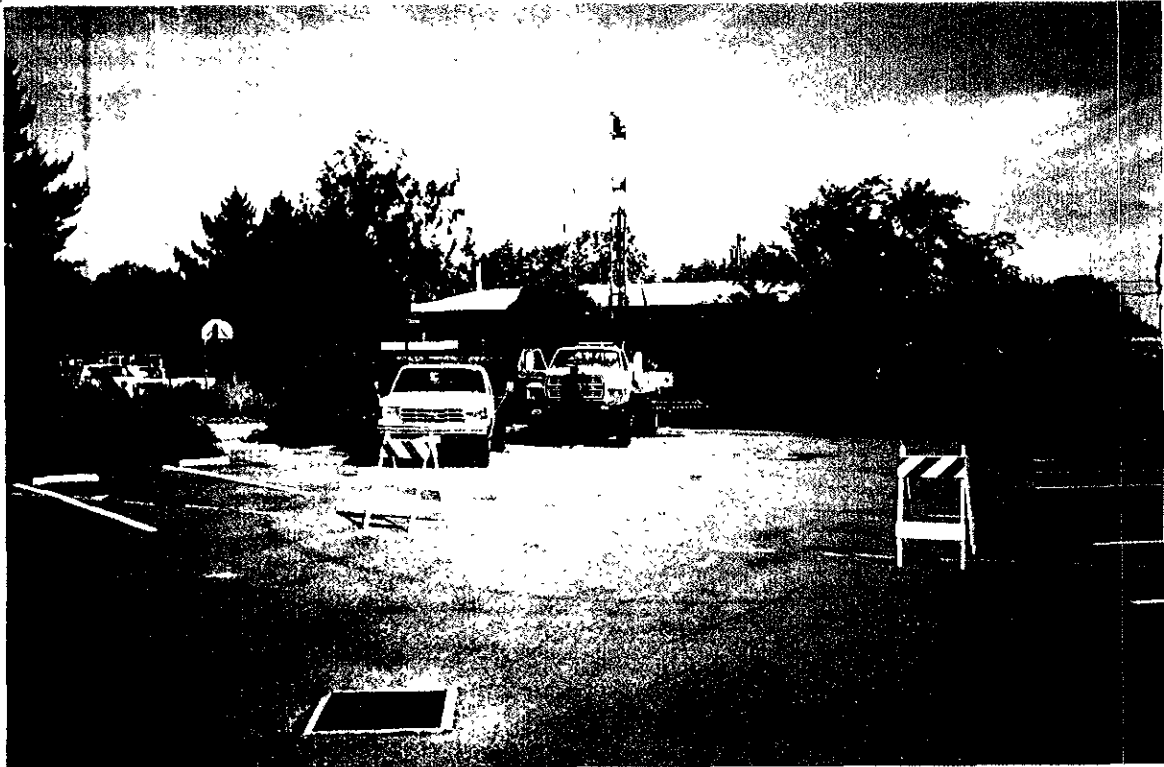
4. Shows east lot parking area. Barricades mark approximate south lot boundary. Storm drain inlets shown in foreground and to the right of drill rig. Fire Station No. 1 in background. Undeveloped west lot shown at left center.

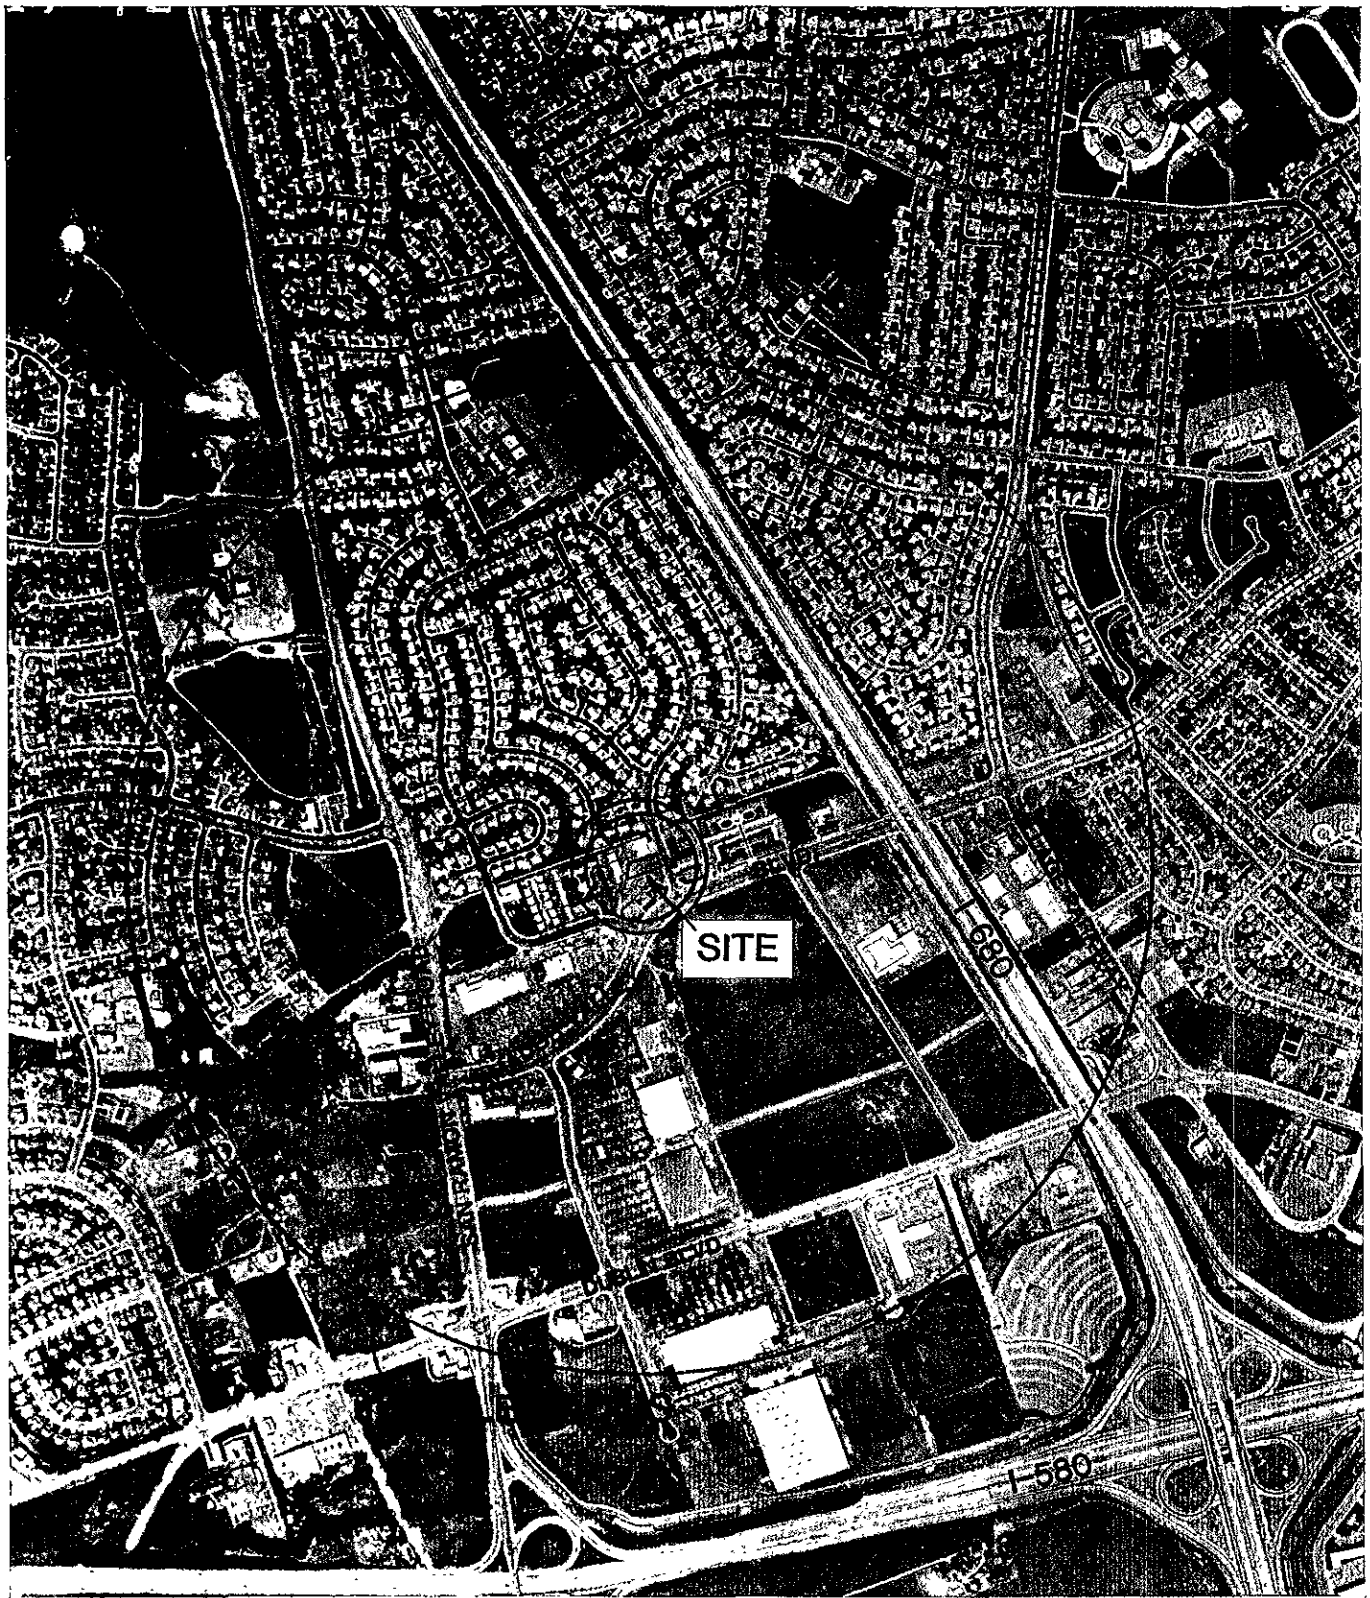
An aerial stereo-pair dated April 1972 indicates that the property is vacant. A dirt path crosses the lot from northeast to southwest. A vehicle (pick-up truck) is observed in the southeast corner of the lot. The site vicinity comprises residential development, with Regional and Amador Plaza Roads newly constructed, but only Mervyn's, Payless, and Albertson's retail stores existing. A portion of the 1972 photograph is presented in the Photo Summary section of this report.

1972 Aerial Photograph (AC 8-15-46) showing vacant site, adjoining Fire Station No. 1, principal streets and highways, and site vicinity covered by investigation.

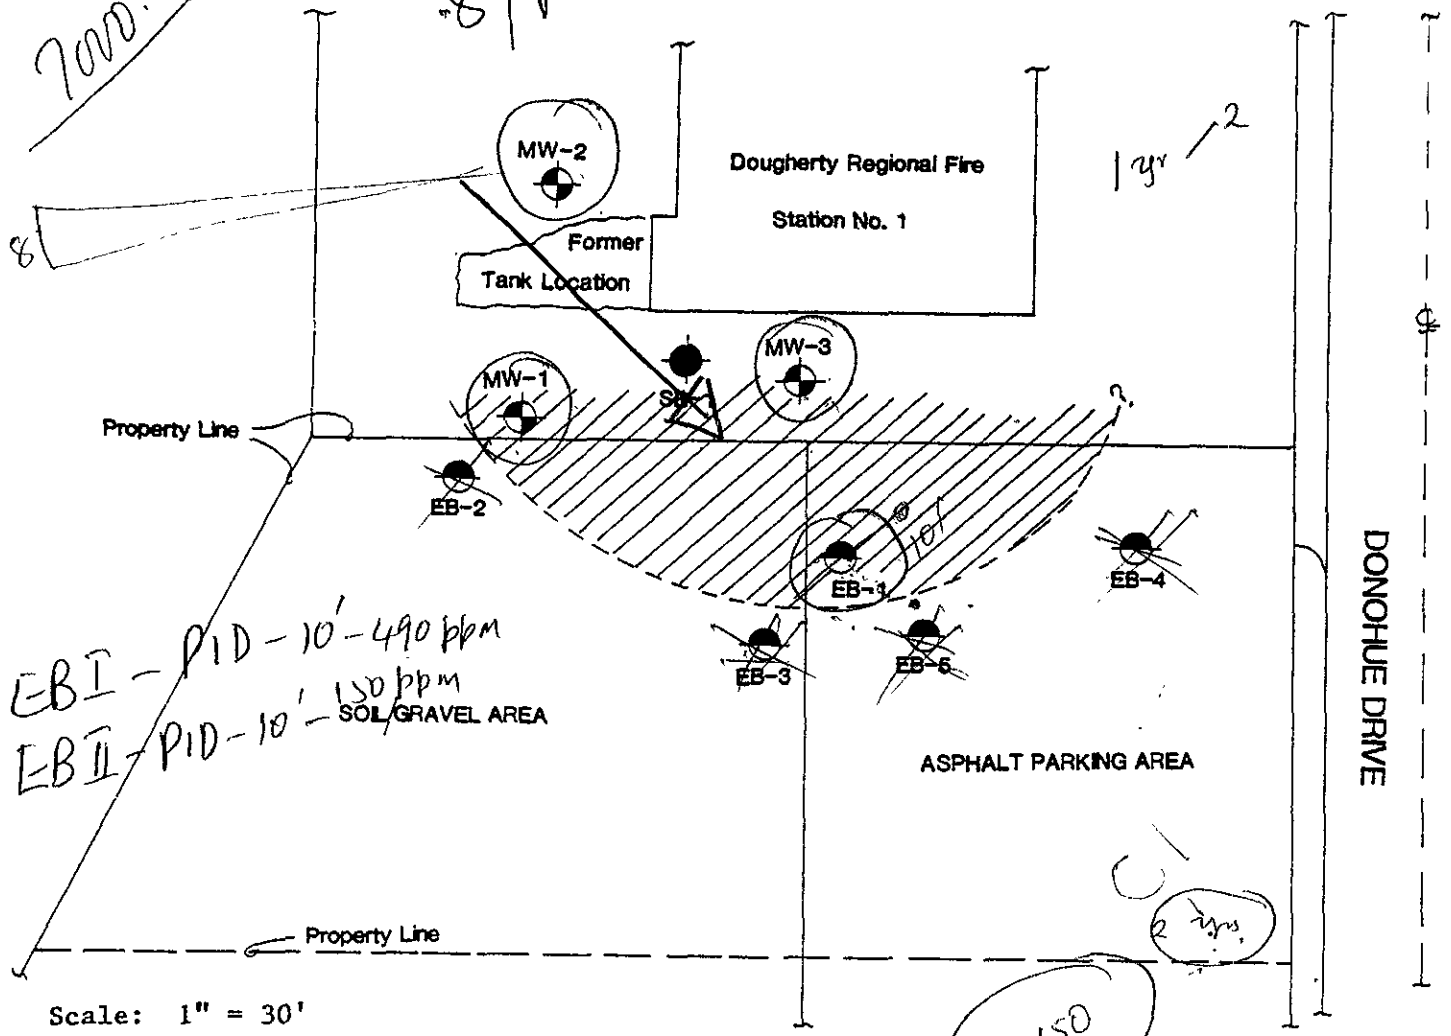
Investigation of the site subsurface revealed motor fuel soil contamination, originating from Fire Station No. 1, in excess of recommended allowable limits along approximately 90 feet of the north property line, and extending approximately 30 feet into the property. Field indications of soil contamination were encountered at depths of 5 to 12 feet, with the greatest concentration observed between 8 and 11 feet. Groundwater was not investigated within the site. Groundwater monitoring of the adjacent motor fuel release area by BSK, for the past year, has revealed no detectable quantities of hydrocarbon constituents. The subject property is down-gradient and cross-gradient from the release area at the existing Fire Station.

EB I - PID - 10' - 490 ppm  
 EB II - PID - 10' - 150 ppm  
 SOL/GRAVEL AREA

With respect to this investigation, and the conclusions presented herein, BSK recommends that the contaminated site soils be remediated. Remedial effort would likely include excavation and treatment of contaminated soil either on- or off-site. A Remedial Action Plan (RAP) addressing site soil contamination would have to be prepared for regulatory agency review and approval. RAP preparation is beyond the scope of our investigation.
