October 25, 1989

Job No. 203 175 3286.01

Subject: Additional Soil Coring and Well Point Investigation  
Chevron Service Station No. 9-0191,  
900 Otis Drive, Alameda, California

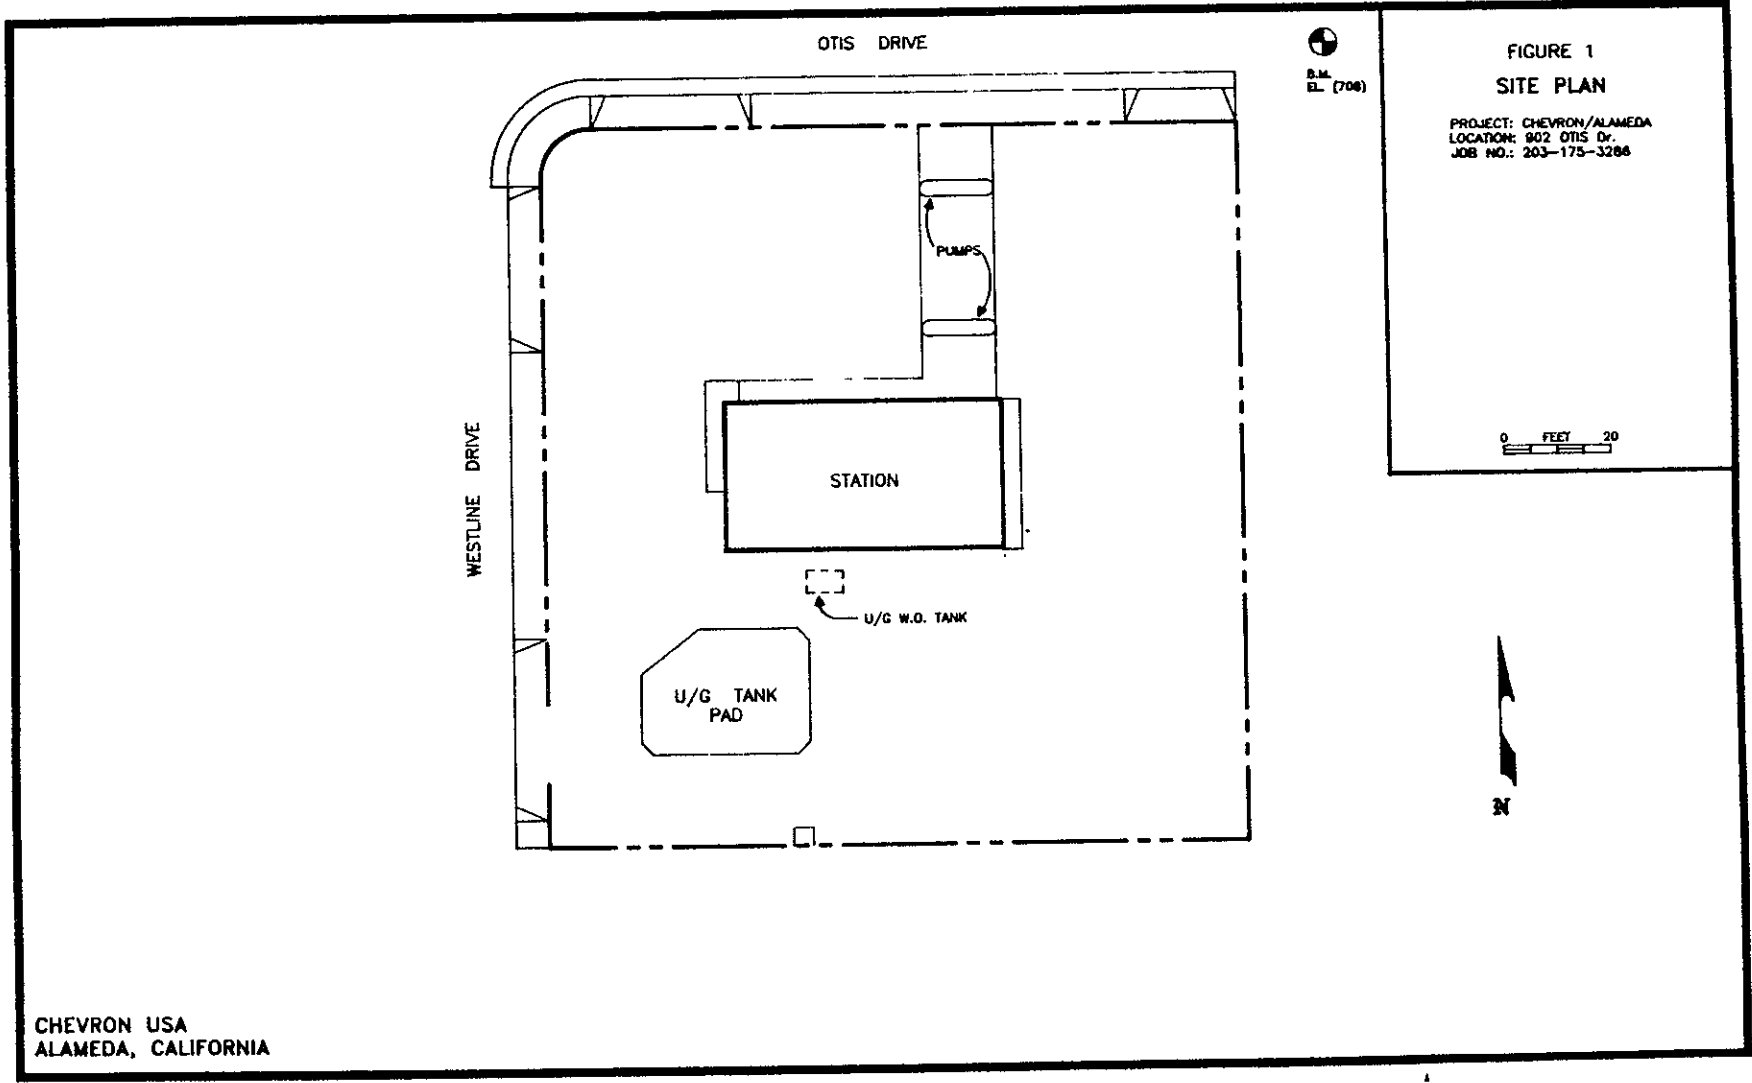
FIGURE 1  
SITE PLAN

along the western edge of the tank pit (see attached Site Plan). Due to collapse of the boreholes during the first round of soil coring, groundwater samples from beneath the site could not be collected. Analyses of the gathered data suggested that hydrocarbons in the soil extended off-site to the west. Based on these results, a second phase of soil investigation was recommended at that time to assess the possible extent of off-site hydrocarbons in the soils. To quantitatively assess the off-site water quality, it was also recommended that groundwater samples be collected at the same time for laboratory analyses.

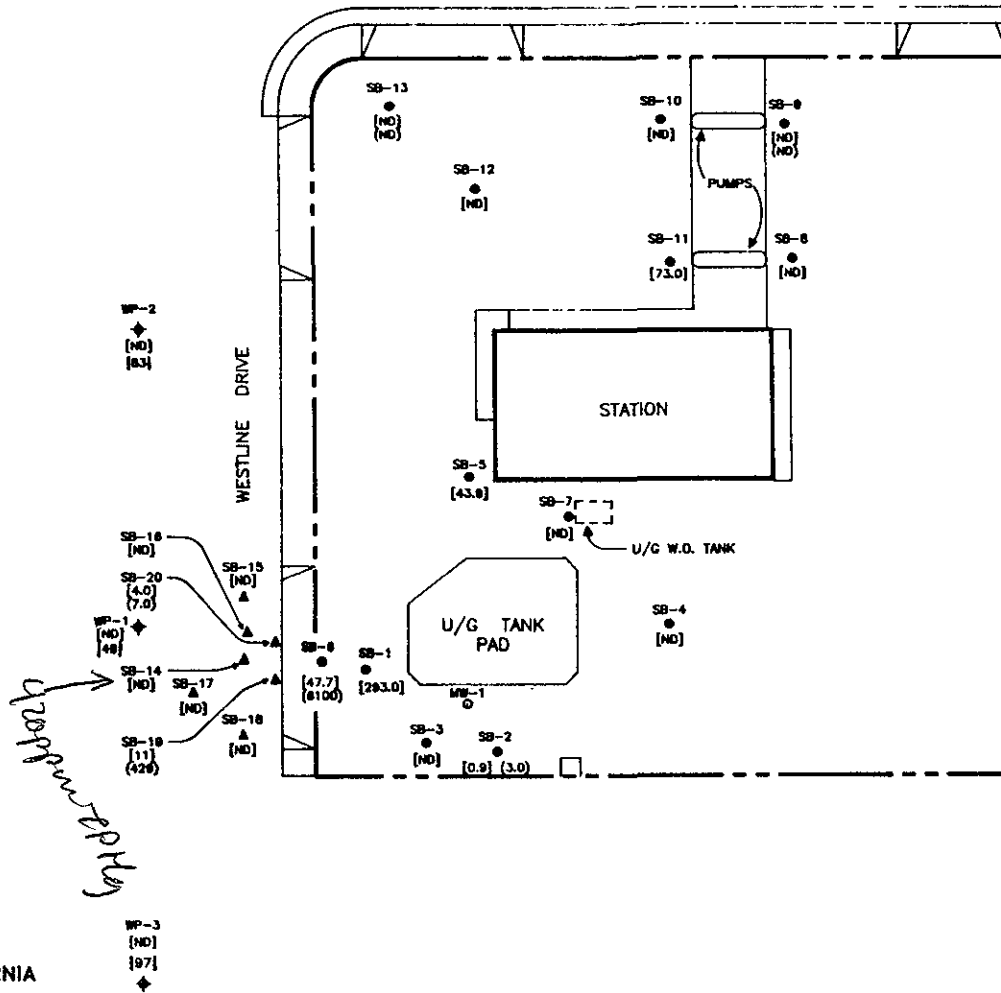
FIGURE 2  
SAMPLE LOCATIONS

Seven samples were collected from the east side of Westline Drive. All borings showed saturated conditions at between 2- and 3-feet below grade. The encountered soils were predominantly fine- to medium-grained sands with minor amounts of silts and clays. Figure 2 shows the locations of all samples collected to date.

*In soil?*  
→ Laboratory analyses of the three selected soil samples indicated measurable concentrations of BTEX and/or TPH-as-gasoline compounds in two samples. The SB-14 sample showed 1 part per million (ppm) each of benzene and toluene, 4 ppm ethylbenzene, 20 ppm xylenes and 420 ppm TPH-as-gasoline. The SB-20 samples showed no BTEX compounds and 7 ppm TPH-as-gasoline. The SB-14 sample showed no detectable concentrations of BTEX and TPH-as-gasoline.

The results of the laboratory analyses of well-point water samples indicate that a plume of dissolved hydrocarbon extends off site to the west. The full extent of this plume is not defined.
