at 4:55 p.m. I arrived at Depot Rd, Metal Masters
+ observed a oily/liquid stain across the driveway that
appeared to have originated

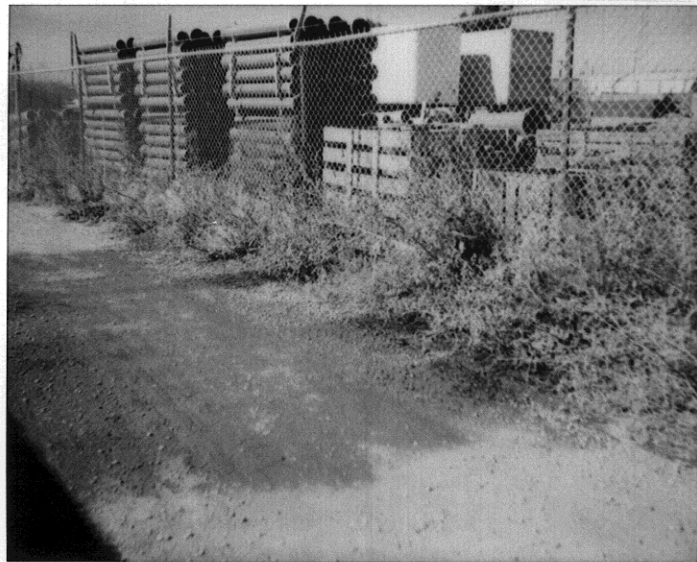
6-29-90 West of 3826 Depot Rd.
Rear of lot. Mix of water + oily liquid
staining neighboring lot.

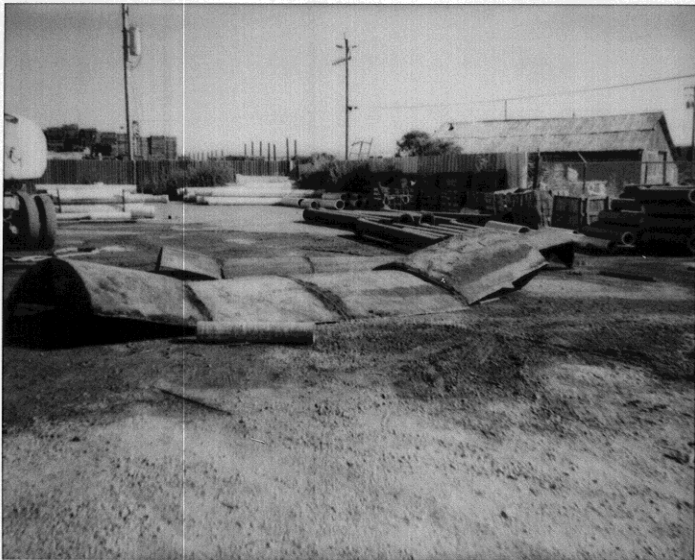
6-29-90. Top section of larger
cut tank at 3826 Depot Rd.
Tank rinse water. Rear of lot.

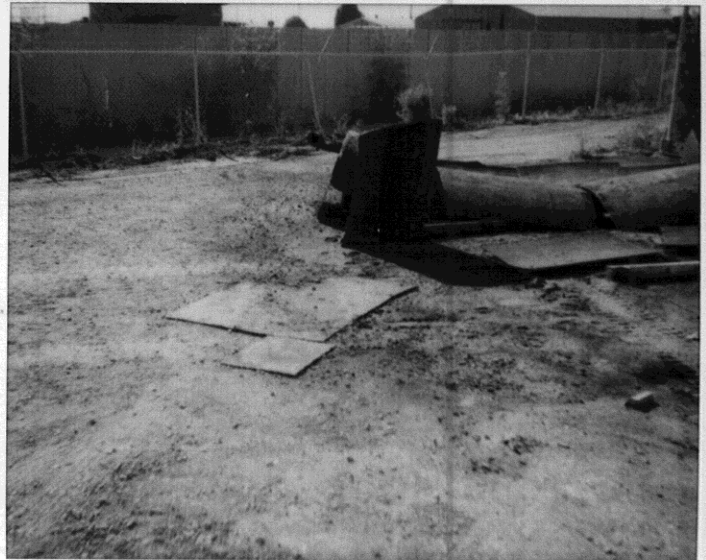
Smaller of 2 cut tanks at 3862
Depot Rd.

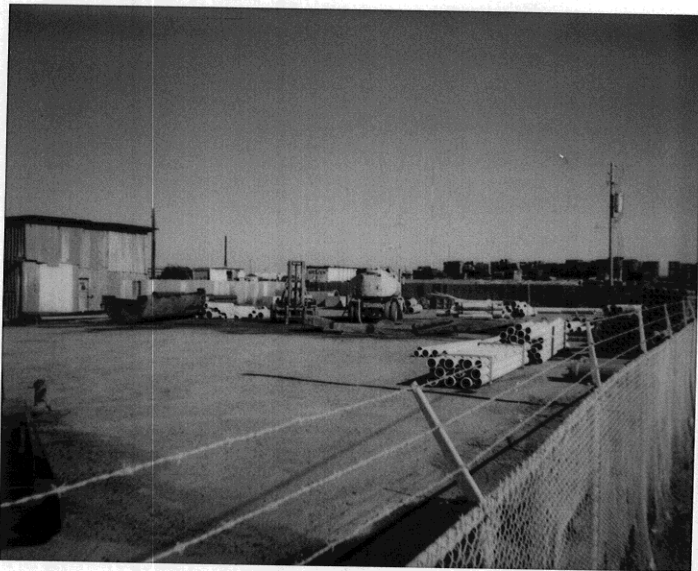
6-29-90. View from west of 3826 Depot Rd.

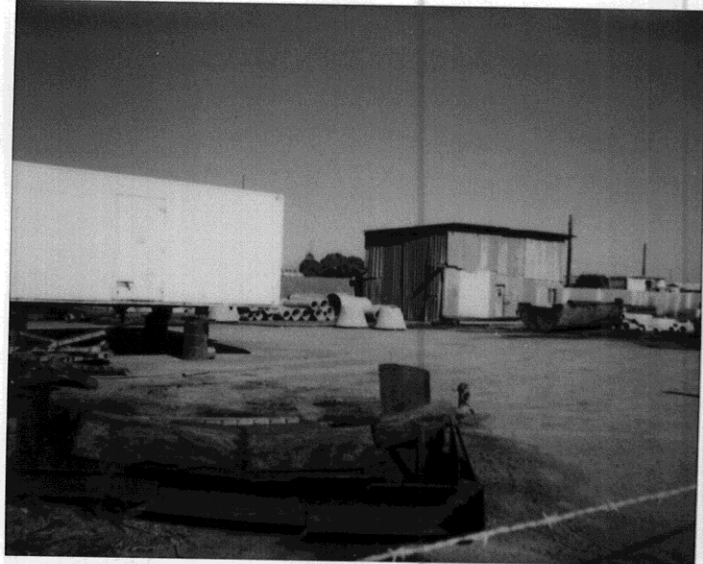
6-29-90. View from west of 3826 Depot Rd. Two tanks cut in pieces + rinsed.

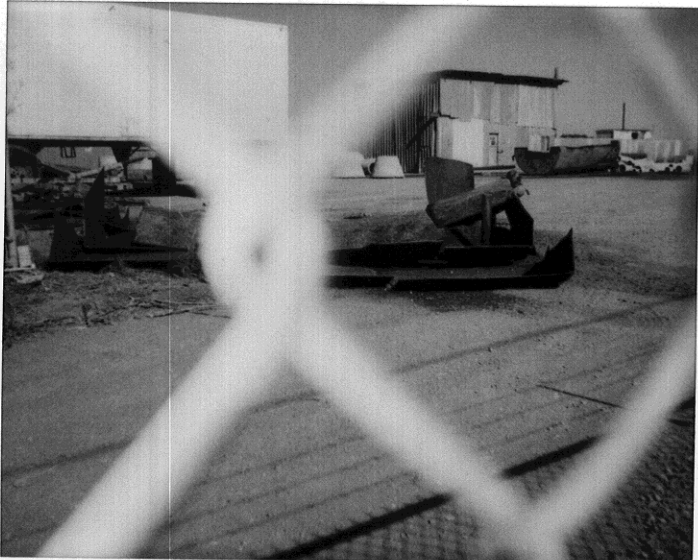
6-29-90 - View from west of 3826 Depot Rd. Two tanks cut in pieces and rinsed.

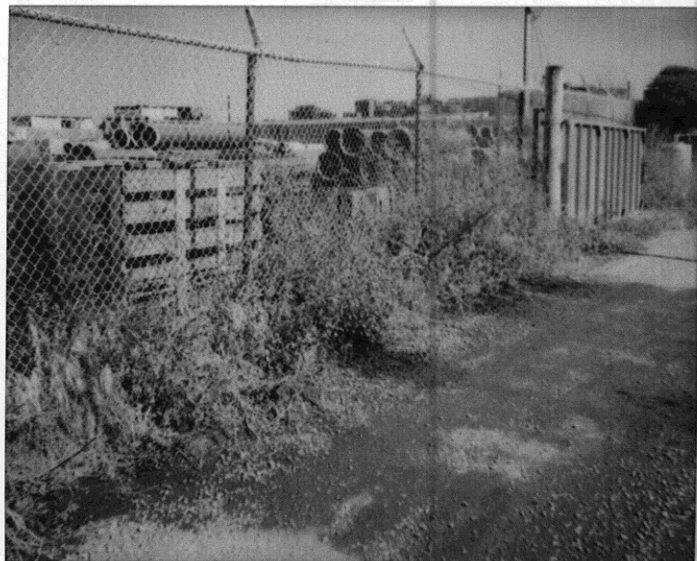
6-29-90 West of 3826 Depot Rd. Rear of lot. Mixture of water + oily liquid staining neighboring lot

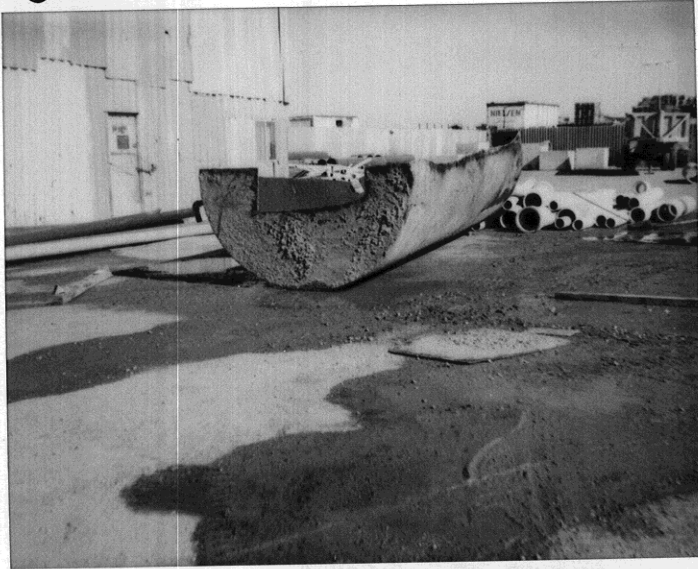
6-29-90. Larger of 2 cut tanks
+ rinse water at 3862 Depot Rd.
Rear of lot.

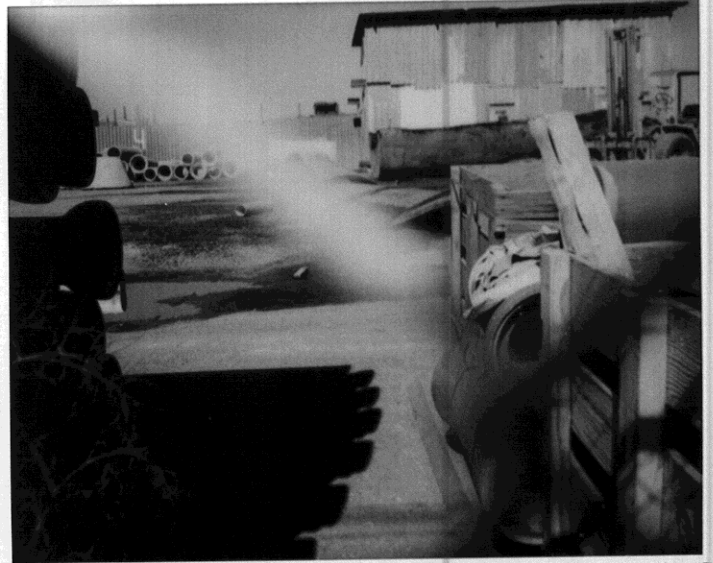
View from West of 3826 Depot Rd
Cut tank + rinse water
6-29-90

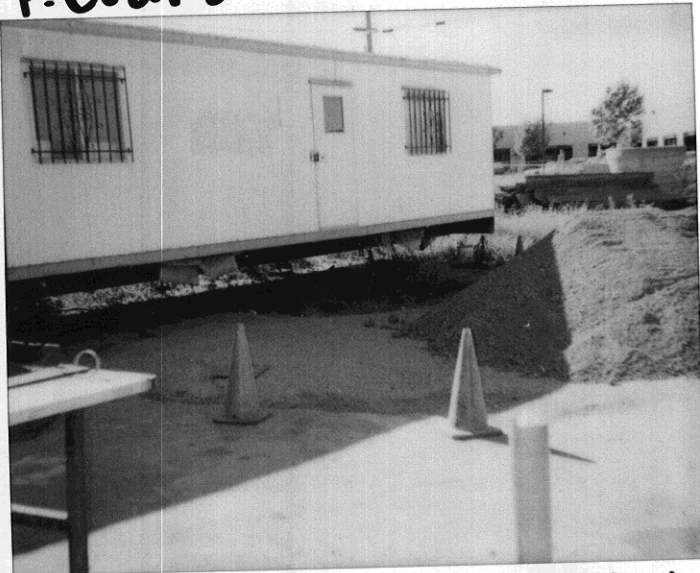
6-29-90. Excavation, refilled,
at 3826 Depot Rd. Front of
lot, across from office

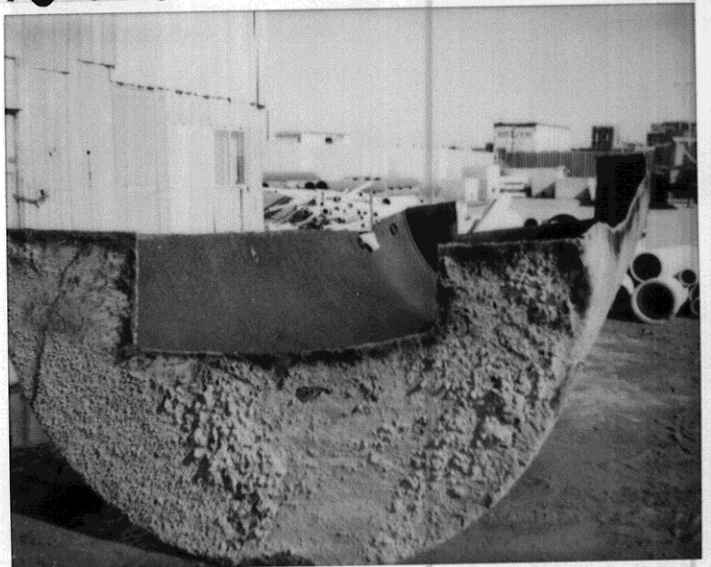
6-29-90. Cut tank at rear of
3826 Depot Rd.
