**REPORT**  
**SITE ASSESSMENT**  
**BROADWAY AND LAWTON AVENUE**  
**OAKLAND, CALIFORNIA**

**RES Project No. 4205-9001**  
**February 1, 1990**

**ENVIRONMENTAL HAZARD ASSESSMENT REPORT**

Report Number 89-1214

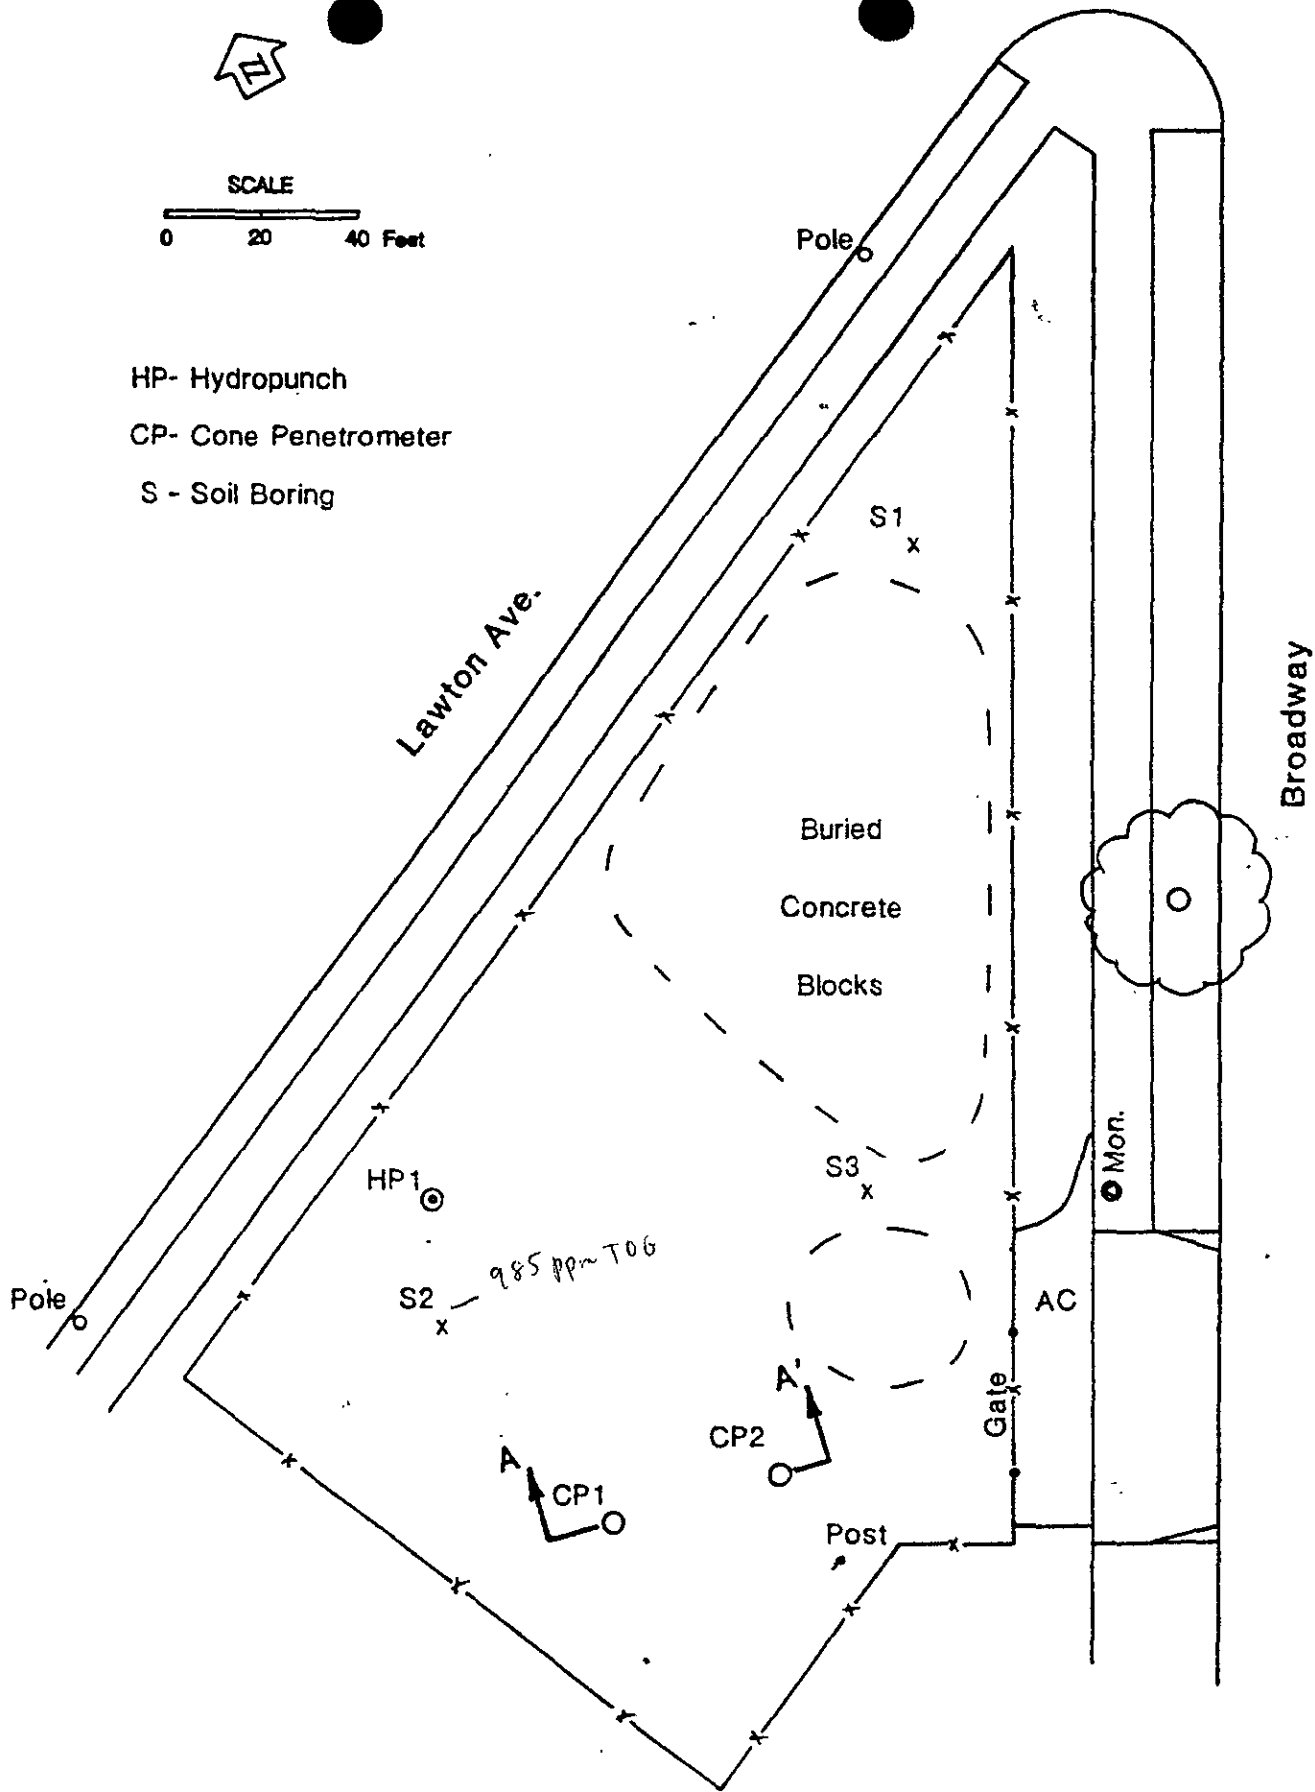
FIGURE 1

The Hydropunch and CPT were utilized on January 16, 1990 at the locations shown in Figure 1. Prior to commencement of this work, RES personnel conducted a site survey to locate underground and overhead utilities in the area of investigation. The groundwater sample was collected with the Hydropunch as described in RES' proposal, dated December 20, 1989. Subsurface hydrogeological data was collected with a CPT probe. The CPT probe is a 1.5 inch diameter rod with a conical point. Sensors at the tip and sides of the probe measure penetration resistance and side friction of the soils, respectively. Prior to each use, the Hydropunch and CPT were cleaned with a non-phosphate detergent followed by a tap water and distilled water rinse to prevent cross-contamination between probe locations.

On January 19, 1990, three soil samples were collected at a depth of approximately 5 feet. The sample locations are shown in Figure 1. These samples were collected using a hand-operated soil auger and sealed into brass sleeves with aluminum foil and end caps. All sampling equipment was decontaminated as previously described. Samples were placed on ice to maintain a maximum temperature of 4°C and delivered directly to a State-certified hazardous materials testing laboratory. Chain of custody procedures were observed.

The original scope of work called for the collection of groundwater samples with the Hydropunch probe. Attempts to collect samples with the Hydropunch in the eastern portion of the site were unsuccessful due to unexpected buried concrete blocks. At a point near the north fence (see Figure 1), the Hydropunch reached the bedrock at 17 feet. Once the Hydropunch was removed, the remaining hole filled with water to approximately 4 inches from the surface. The collection chamber, however, was empty. It is apparent that the containment pit for the former tanks collects perched water and that the Hydropunch collection port was below this localized, perched groundwater. Since the water level in the hole rose to within 4 inches of the surface, water samples were collected as previously described.

Due to damage to the Hydropunch that occurred during the 17 foot punch, the CPT was then used to explore the subsurface hydrogeology. The CPT was pushed to depths of 12 and 18 feet at probe locations CP1 and CP2, respectively. Groundwater was not observed to collect in either hole. The CPT encountered interbedded clays, silts and weathered rock layers underlain by bedrock at the total depths explored. Figure 2 presents a geologic cross section based on the CPT results.

Table 1 summarizes the analytical results. Soil sample S2 contained 985 milligrams per kilogram (mg/kg) of oil and grease. This is above the 100 mg/kg level recommended by the Regional Water Quality Control Board's (RWQCB) Leaking Underground Fuel Tank (LUFT) Field Manual (April 1989). Xylene is below the 1.0 mg/kg LUFT Manual level in all three soil samples. The 25 milligrams per liter (mg/l) of dissolved oil and grease in the water sample HP1 is probably due to the residual soil contamination found in sample S2. The RWQCB sets action levels for TPH contamination of groundwater on a site-specific basis. Copies of the analytical results, along with the chain of custody documentation, are presented in Appendix A.

The results of this assessment indicate the presence of old residual petroleum product contamination from the former underground fuel tank leaks. The higher concentration of xylene with respect to benzene, toluene, and ethylbenzene indicates an aged petroleum fuel contamination source. The high levels of oil and grease in samples S2 and HP1 will generally require soil remediation.

1. Excavate the soil in a 30 foot long by 10 foot wide by 12 foot deep area centered on the HP1 and S2 sample locations. This will remove the known contaminated soil to the typical depth of underground storage tanks.
2. Dispose of the soil at a Class II licensed landfill or biotreat the soil on-site if time and space limitations permit.
3. Sample and analyze soil from two locations at the bottom of the excavation to determine if sufficient excavation has been performed.

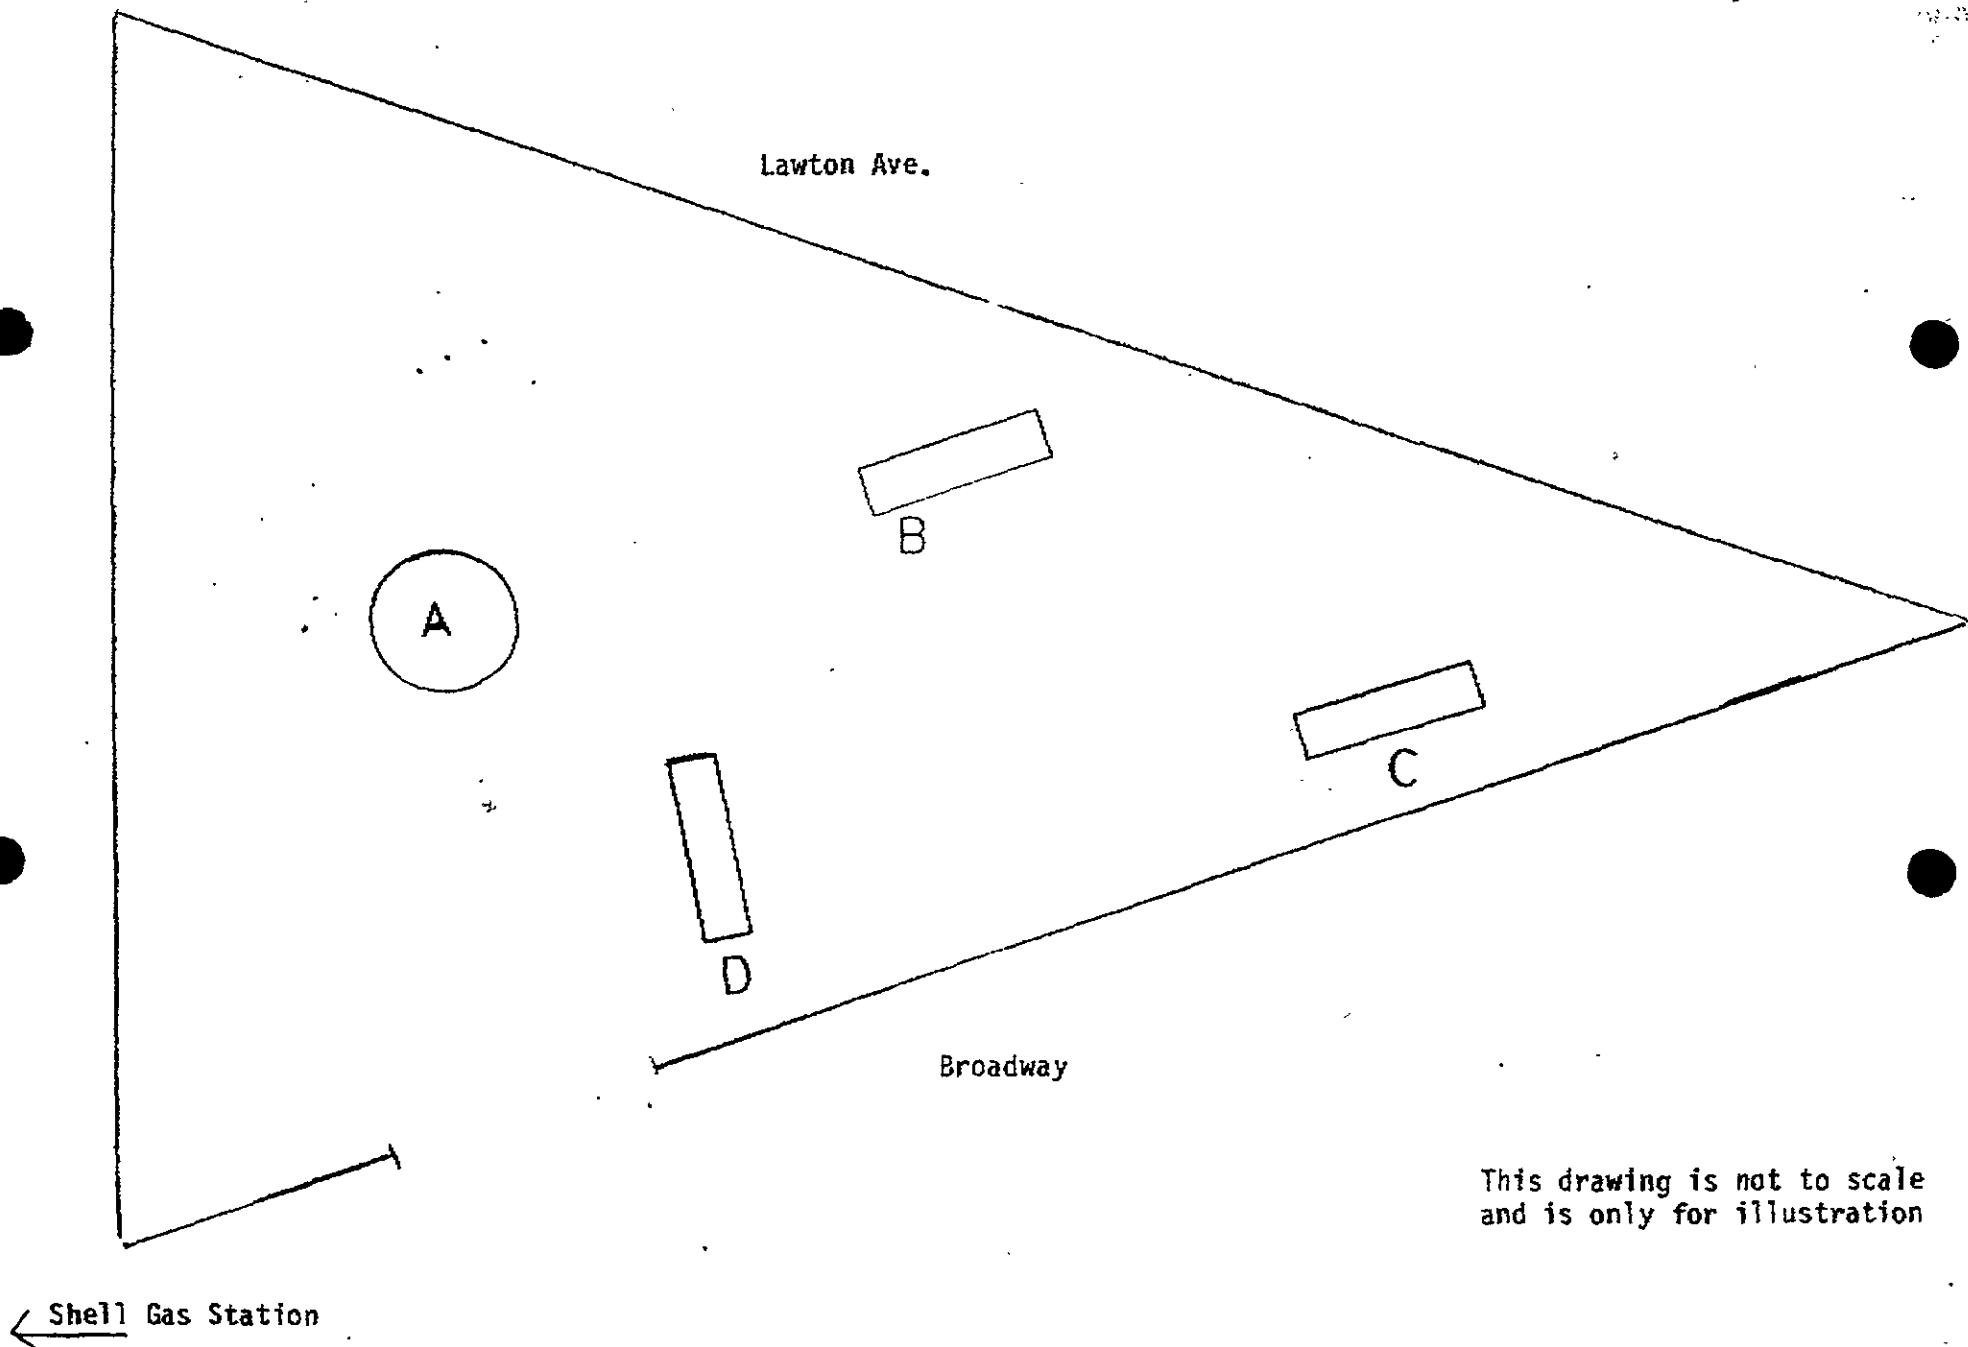
5775 Broadway & Lawton  
Oakland, Calif.

One shallow hole (A) was dug straight in from the gate, near the middle, this turned up conduit with wires in it. Hole (B) was dug next to the fence on the Lawton Ave. side. Hole (C) was dug near the junction of Broadway & Lawton. Hole (D) was dug on the Broadway side, near the gate at a 90 degree angle to Broadway. No excavation was done on the West end of the lot near the buildings as there were cars parked there and the area was mostly covered with asphalt, with no indication of any tanks having been there.

All trenches, except (A) were dug to an approximate depth of 7-8 feet, at this point hard packed, dry earth was encountered that appeared to have been original. The earth excavated was visually inspected and smelled for any indication or odor of gasoline or oil. There was none. All the soil was dry. A sample of dirt from each trench was mixed in a glass jar and a petroleum test strip was placed in jar and left for seven days, no petroleum was indicated on the test strips. Several feet of pipe was found in hole B but had no odor of gasoline in it.
