SITE ASSESSMENT REPORT  
FOR THE PACIFIC DRY DOCK AND  
REPAIR YARDS 1 AND 2  
OAKLAND, CALIFORNIA

Versar Job No. 6695.09

October 2, 1990

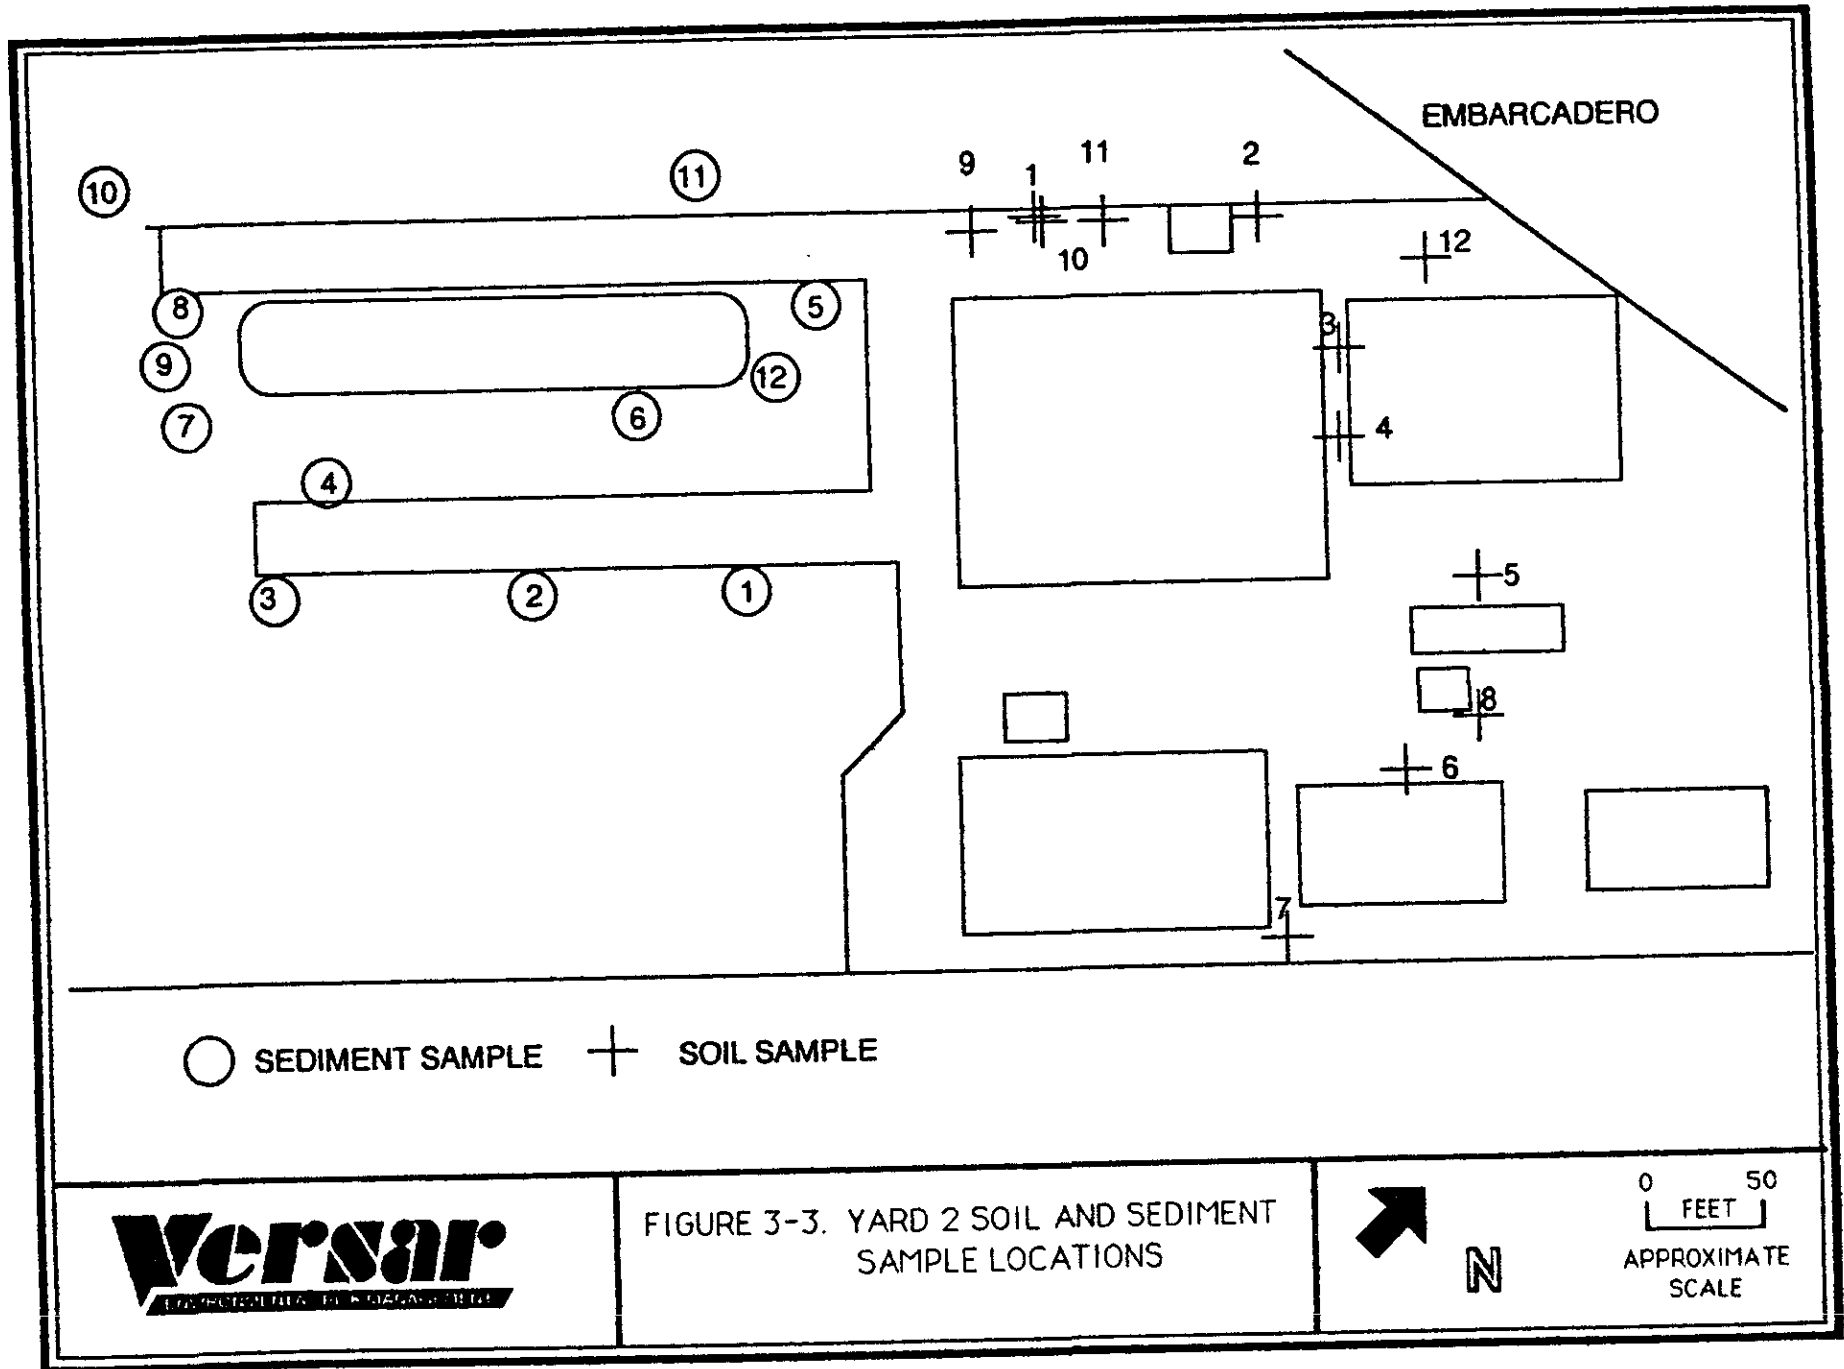
FIGURE 3-3. YARD 2 SOIL AND SEDIMENT SAMPLE LOCATIONS

PDDI-1-0.5/2.5: The samples were collected at depths of 0.5 feet and 2.5 feet, on the northwestern edge of the property on the edge of the estuary, to provide a background for the yard (see Photo 12, Appendix B).

PDDII-2-0.5/2.5: The samples were collected at depths of 0.5 feet and 2.5 feet, adjacent to an oil storage shed and in a run-off channel from a machine shop (see Photos 13 and 14, Appendix B).

PDDII-3-0.5/2.5/5.0: The samples were collected at depths of 0.5 feet, 2.5 feet, and 5.0 feet, at the northern door to the power pack shop, beside the wash tank (see Photo 15, Appendix B). The October, 1989, earthquake raised the concrete slab on which the wash tank is situated (see Photo 16, Appendix B) and the wash tank does not have any spill containment (see Photo 17, Appendix B).

PDDII-4-0.5: The sample was collected at 5.0 feet at the northwest end of a known underground storage tank (UST). Fill debris prevented deeper sampling (see Photo 18, Appendix B).

PDDII-5-0.5: The sample was collected at 0.5 feet at the northeast side of the sales office (see Photo 19, Appendix B). A second layer of asphalt was encountered at 0.75 feet. This sample was taken in an attempt to establish a background level for Yard 2.

PDDII-6-0.5/2.5/5.0: The samples were collected at depths of 0.5 feet, 2.5 feet, and 5.0 feet adjacent to the northern containment walls of above-ground storage tanks. Dark staining at the bottom of the containment walls indicate that the walls are no longer impermeable (see Photo 20, Appendix B). The sample had a silver sheen and oily texture (see Photo 21, Appendix B).

PDDII-7-0.5/2.5: The samples were collected at depths of 0.5 feet and 2.5 feet at the southern edge of an above-ground storage tank. Heavy surface staining is evident in the area (see Photo 22, Appendix B).

PDDII-8-0.5/5.0: The samples were collected at depths of 0.5 feet and 5.0 feet adjacent to the septic tank northeast of the guard house. These samples were taken in order to establish a background for the yard (see Photo 23, Appendix B).
