SITE: FORMER MOBIL STATION 04-H6J  
1024 MAIN STREET  
PLEASANTON, CALIFORNIA

RE: REQUEST FOR REIMBURSEMENT OF WELL REPAIR COSTS

**04-H6J - 1024 Main Street, Pleasanton:  
WELL BOX REPAIRS**

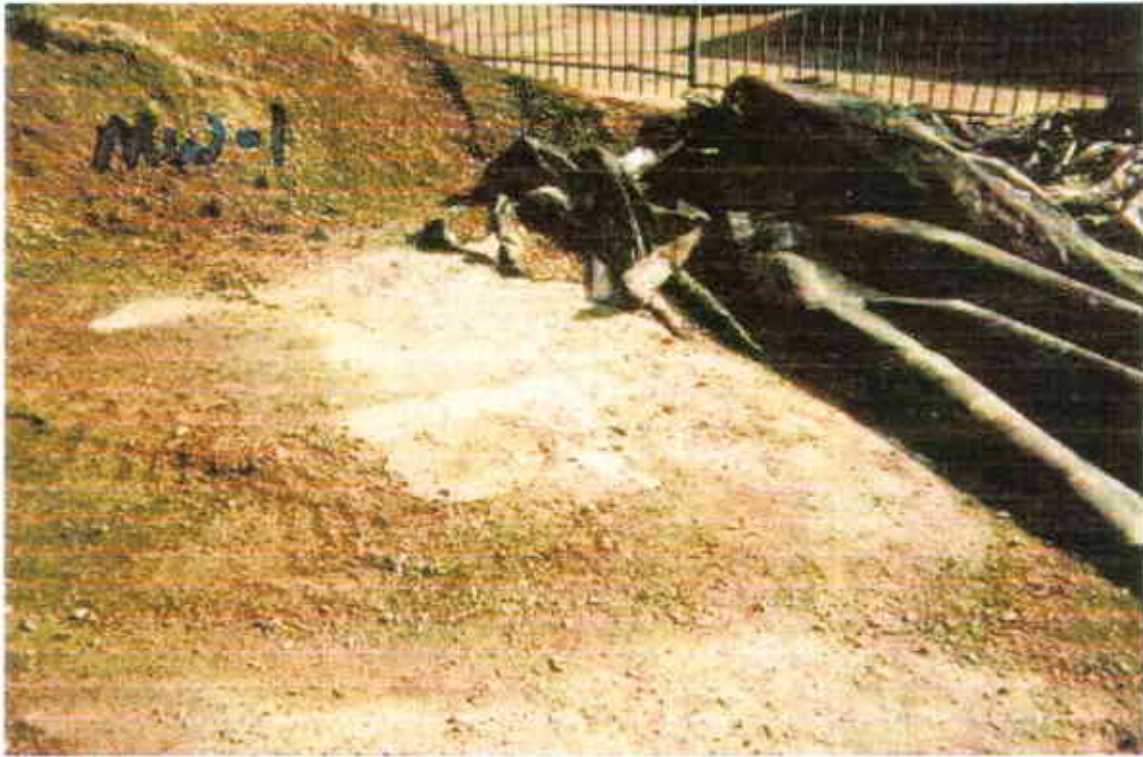
MW-1

- Well VMW-3. The well cover and well-box are broken. The well-box must be removed and replaced.
- Well MW-1. All of the well cover flanges of well-box are broken off. New well-box installation needed.

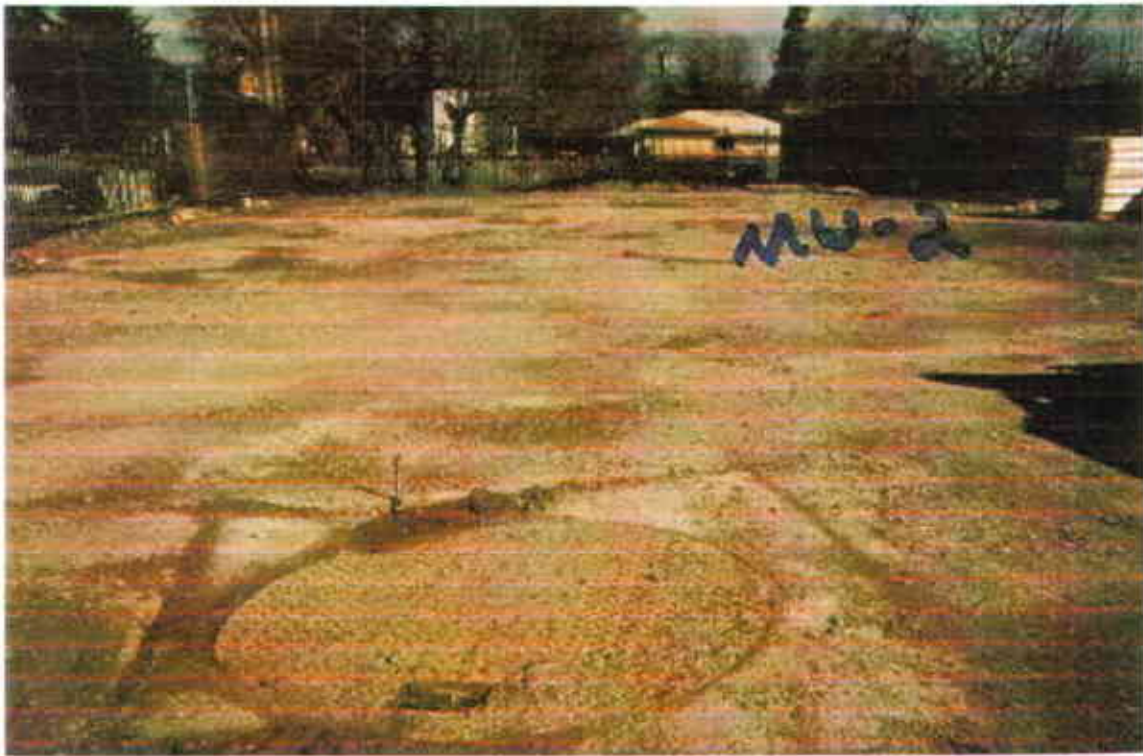
MW-2

- Well MW-4. The well cover and well-box are broken. The well-box must be removed and replaced.
- Well MW-2. Concrete surrounding the three-foot diameter well cover has broken and dropped roughly four inches on one side. A new well-box and possibly repairs to the PVC piping are required. The PVC piping extends from the well to the remedial system as a vapor extraction line.

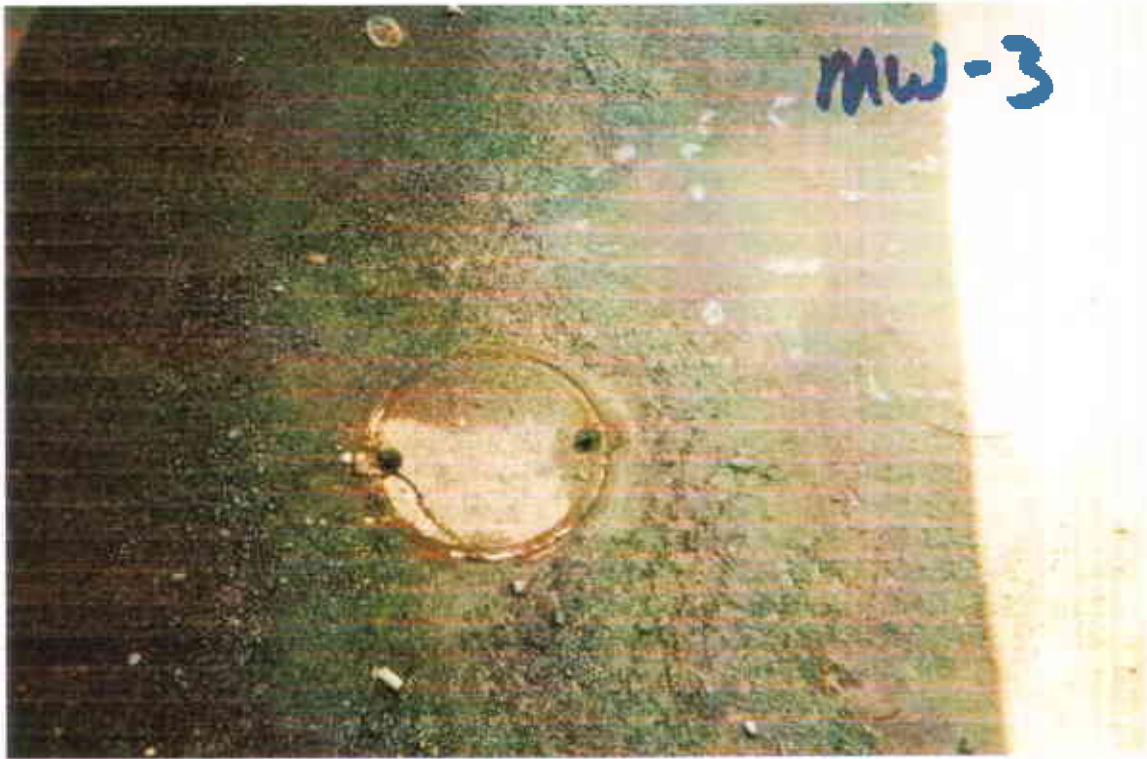
MW-3

- Well MW-5. The well cover bolts are sheared off at the surface. The sheared bolts need to be drilled out and new bolts installed.
- Well MW-3. The well cover and well-box is broken. The well-box must be removed and replaced.

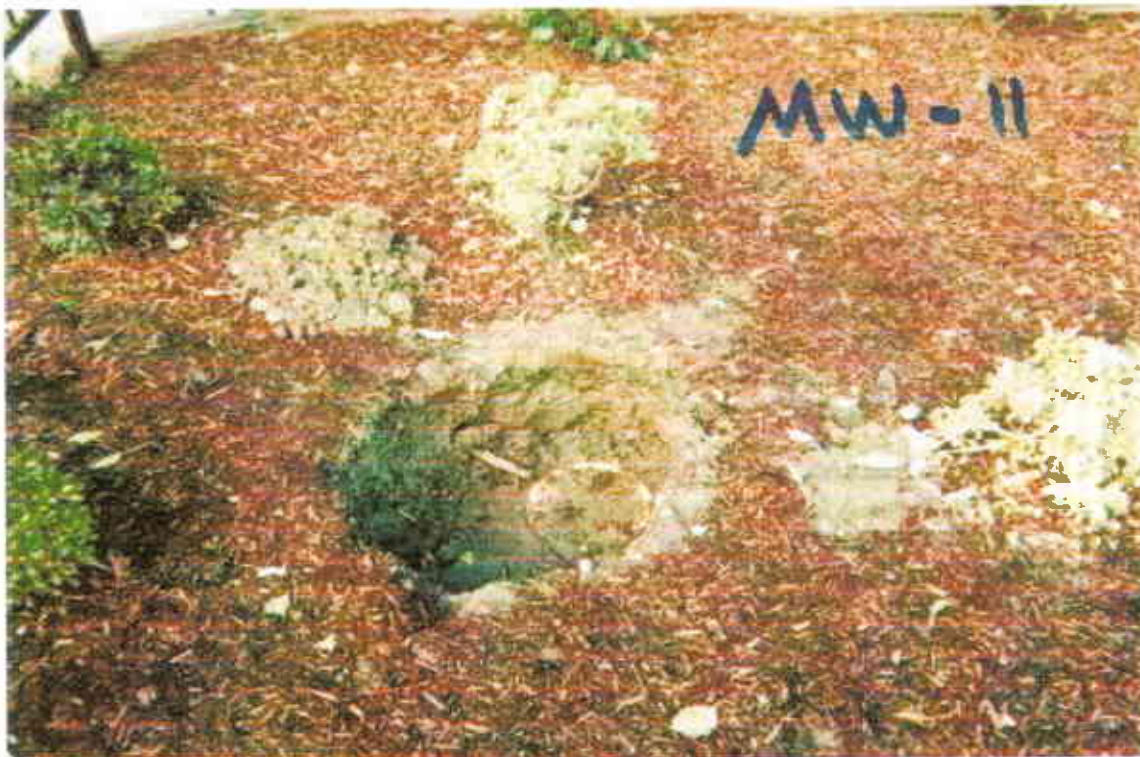
MW-11

- Well MW-11. The well-box is now approximately 1.5 feet below grade (fbg) because a planter area was constructed around the well. The well-box now serves as an accumulation point for liquids and trash, and therefore, needs to be extended to grade, resurveyed, and a new well-box installed.

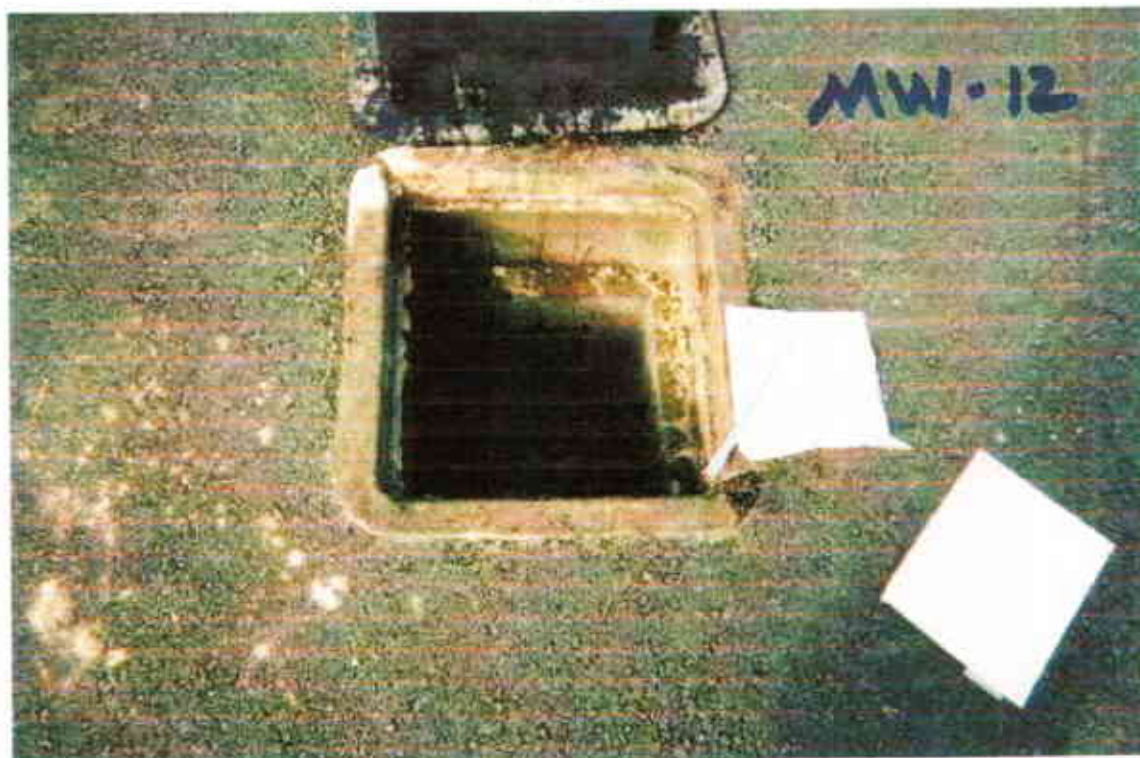
MW-12

- Well MW-12. The well-box is now approximately 2.5 fbg in a parking lot. The well-box now serves as an accumulation point for liquids and trash, and therefore, needs to be extended to grade, resurveyed, and a new well-box installed.
