## RISK MANAGEMENT PLAN

Former Chevron Station #21-0208  
6006 International Boulevard  
Oakland, California

Project No. DG20208G.5C01

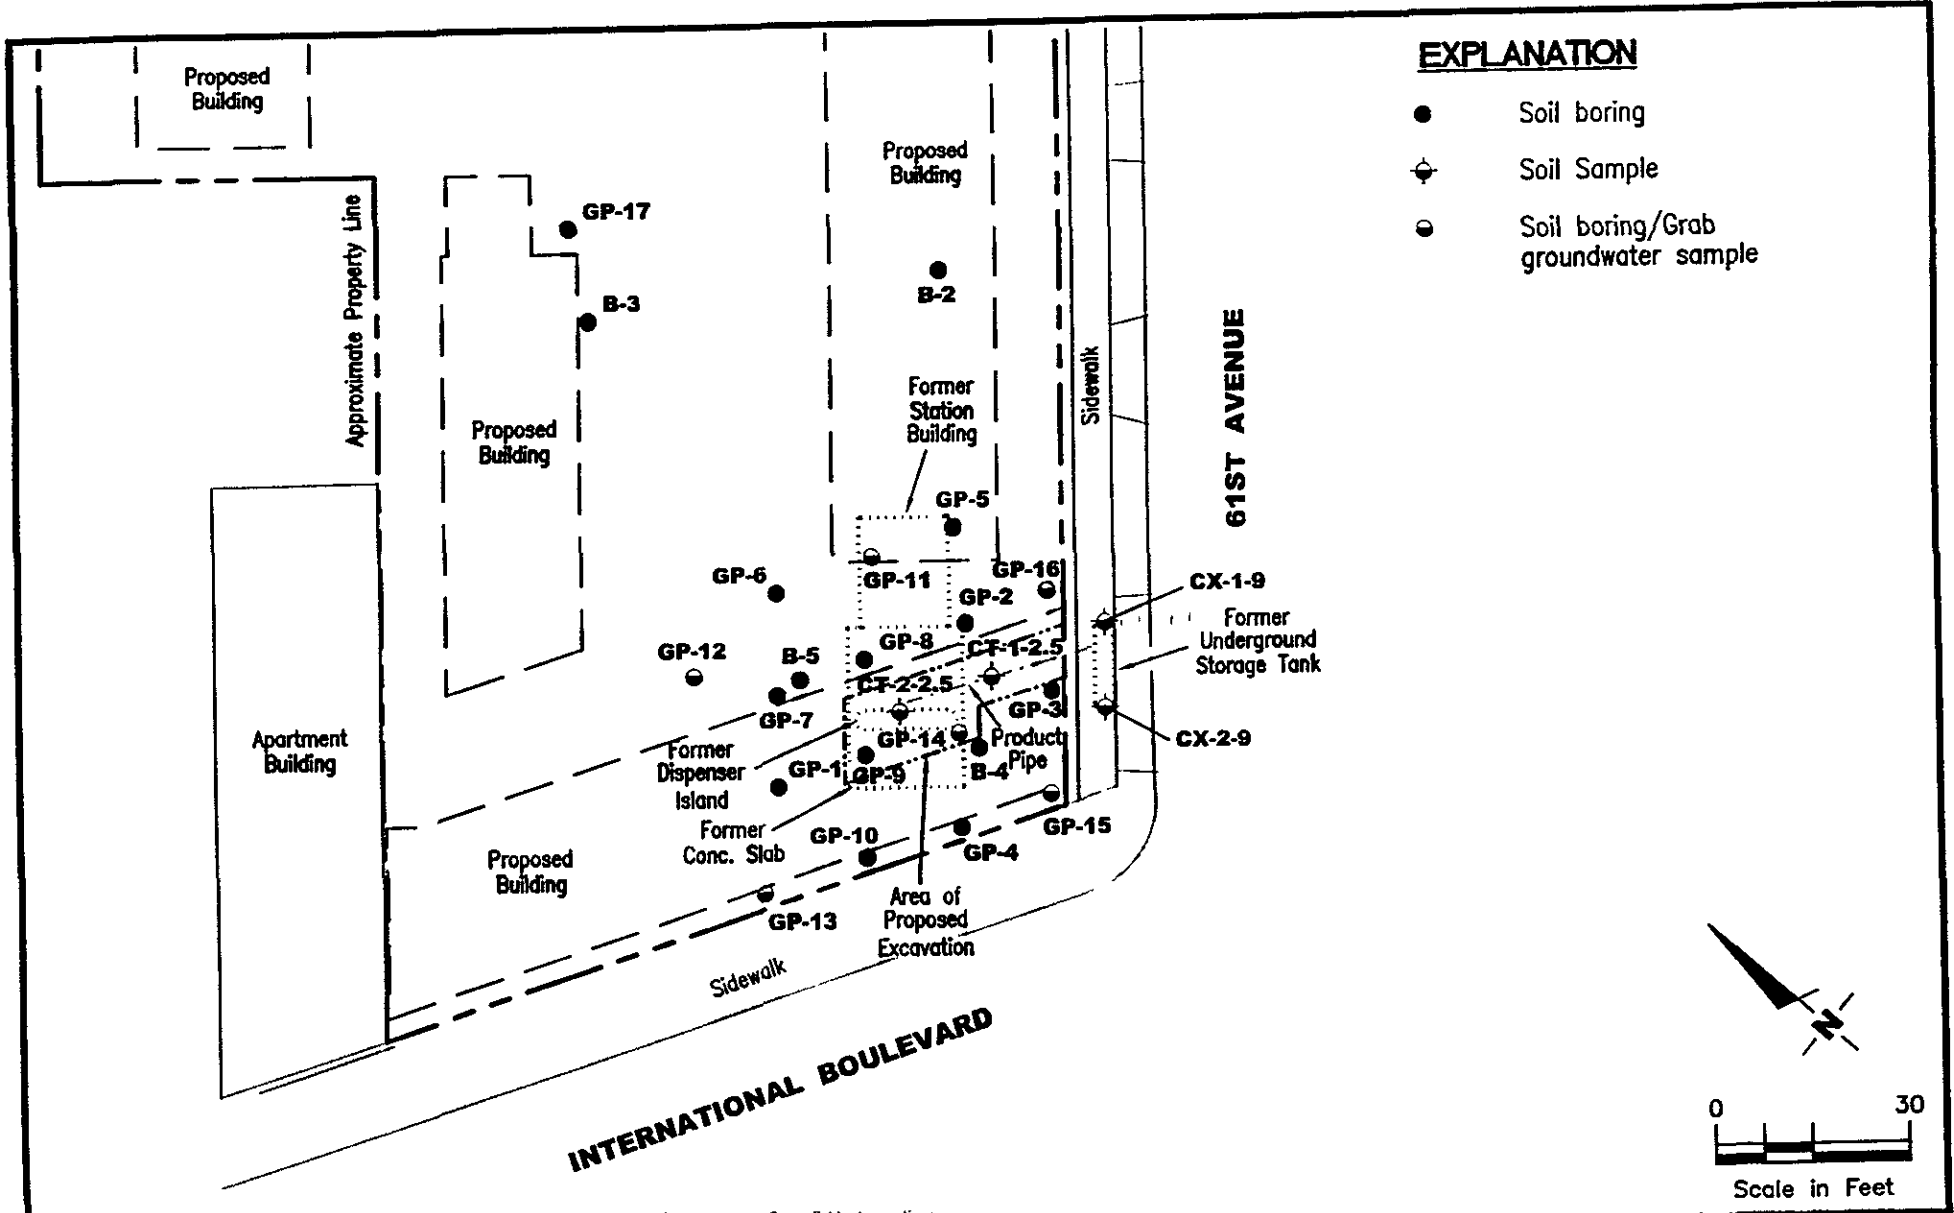
**SOIL BORING LOCATION MAP**  
 Former Chevron Service Station No. 21-0208  
 6006 International Boulevard  
 Oakland, California

A total of 17 GeoProbe borings (GP-1 through GP-17) were advanced at the site up to depths of 10 feet bgs in July 2001 to assess the lateral extent of soil impact. Soil samples were collected at 2.5 and 5.5 feet bgs. Grab groundwater samples were collected from seven of the borings. Analytical data from the soil samples indicated that soil impact is limited to the immediate vicinity of the former product line and dispenser island.

- The highest hydrocarbon concentrations were detected in soil samples collected from the base of the product line trench. The two soil samples contained 560 and 860 parts per million (ppm) of Total Petroleum Hydrocarbons as gasoline (TPHg).

- The lateral extent of hydrocarbons in unsaturated soil has been well defined by soil samples collected from the 17 GeoProbe borings advanced in the vicinity of the former UST, dispenser island, and dispenser island.

Based on these findings, approximately 150 cubic yards of soil was excavated and removed from the site in early August, 2001. At the direction of Alameda County Environmental Health Division soil samples were not collected from the walls of excavation (Analytical results of the soil samples from the GeoProbe borings were used to define the limits of the excavation).
