**Subject: Phase One Tunnel Remediation Investigation and Phase Two Work Plan,
Intake and Discharge Tunnels, Former Seabreeze Yacht Center, Oakland**

Phase One Tunnel Remediation Investigation and Phase Two Work Plan

FORMER SEABREEZE YACHT CENTER
Oakland, California

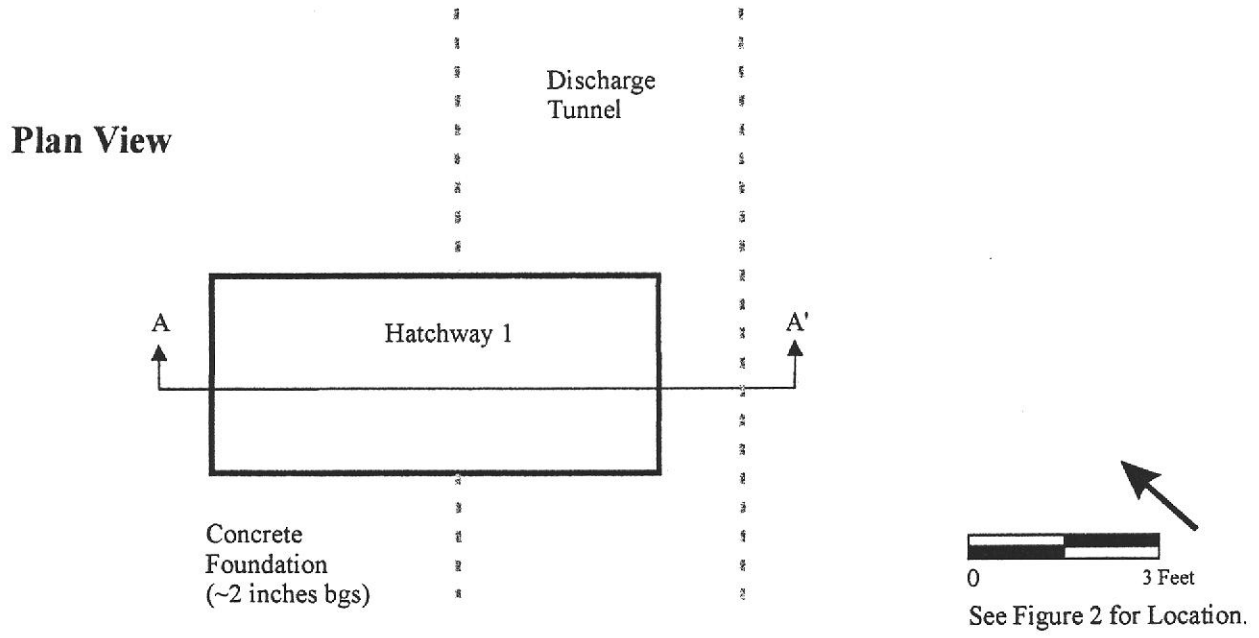
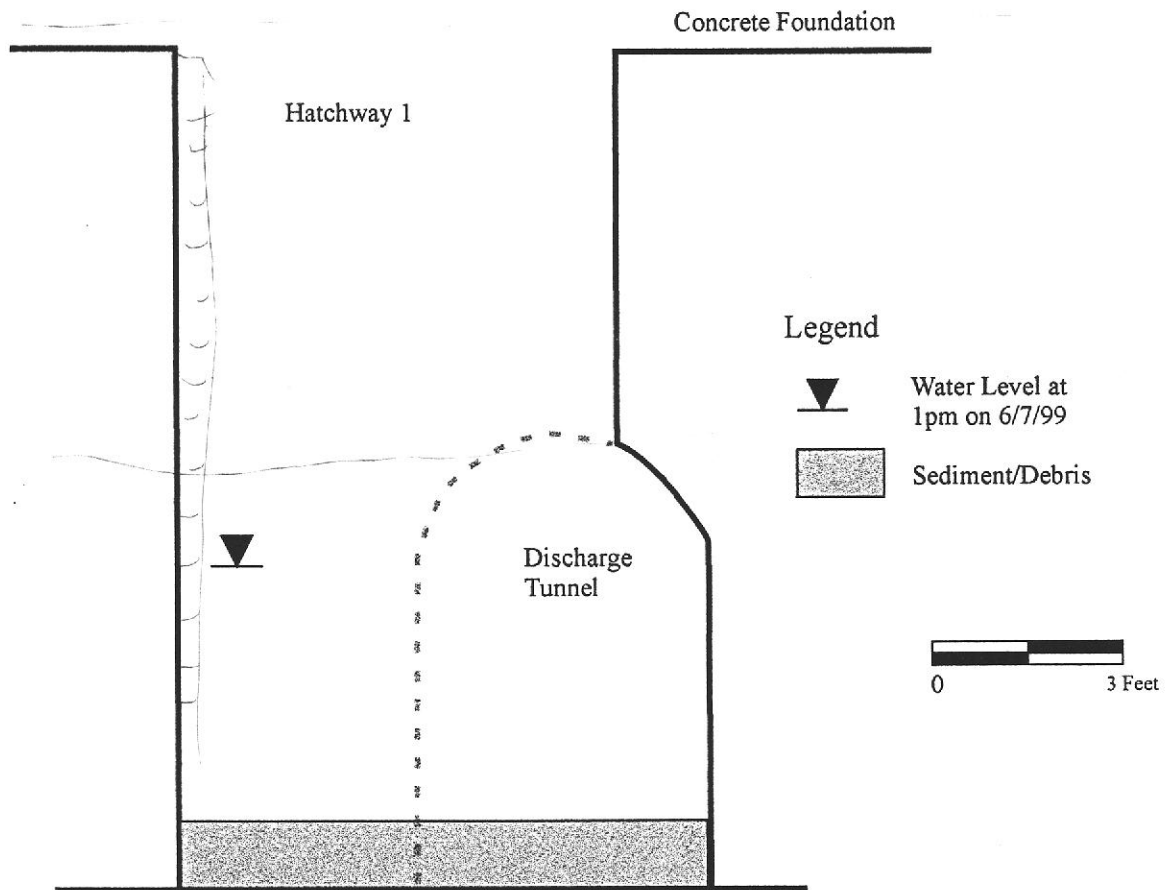
Figure 3

Hatchway 1 was located and exposed during the 1995 investigation. On 7 June 1999, the hatchway steel cover was lifted with a backhoe to access the hatchway interior. The eastern half of the hatchway provided access to the discharge tunnel. The top of the discharge tunnel was observed in the hatchway at approximately six feet bgs. The tunnel was approximately seven feet high and 4.5 five feet wide and consisted of an arched top (Figure 3). The hatchway was off center from the tunnel alignment; the hatchway bottom appeared to be flush with the tunnel bottom.

Water was encountered in the hatchway at approximately eight feet bgs. Water levels were collected at all exposed hatchways at 1 pm (about low water tidal condition). The water level appeared to fluctuate with rising and falling tide during field activities; an oily sheen was observed at the water surface. Approximately one foot of debris/sediments was present at the tunnel bottom in the hatchway. The tunnel appeared to continue both north and south of the hatchway and was free of major obstructions.

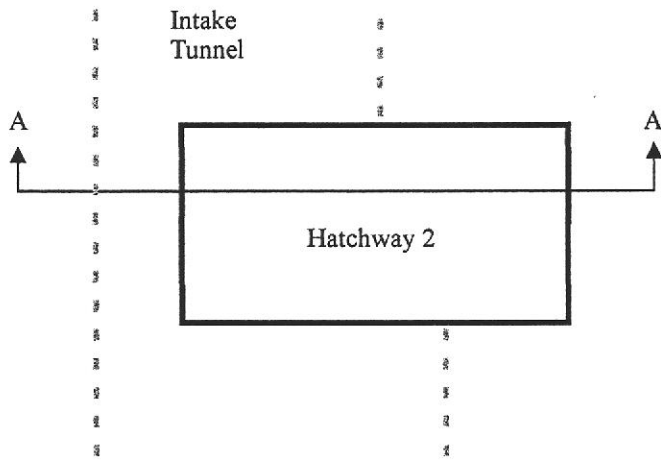
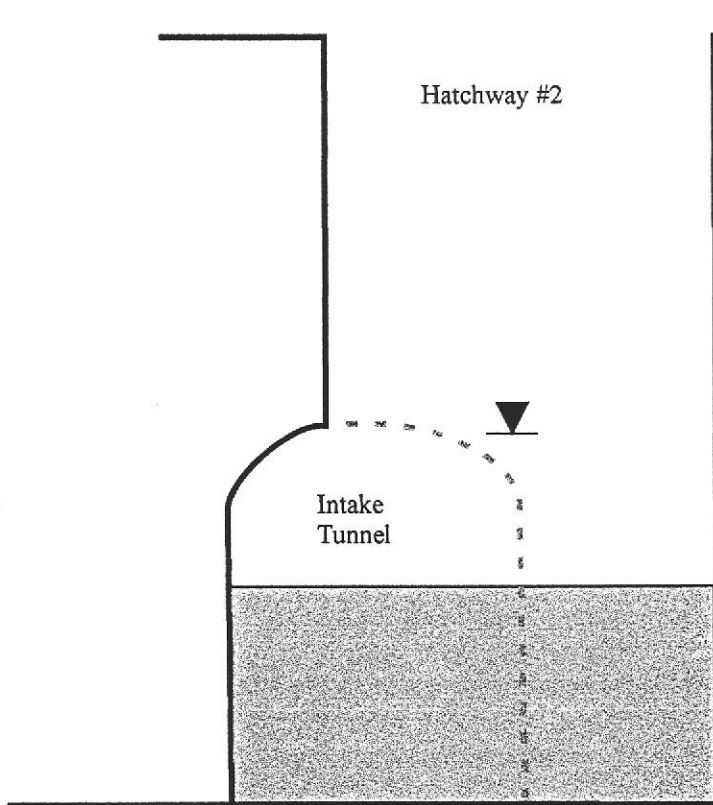
Figure 4

Hatchway 2. Available historic drawings of the former power plant identified the presence of Hatchway 2 within the footprint of the concrete plant foundation (Figure 2). During 1999 field activities, the hatchway surface was exposed at approximately two inches bgs (Figure 4). The hatchway was approximately three feet wide, six feet long, and extended to 12 feet bgs. Gravelly soil, debris (e.g., old ceramic materials possibly associated with former power generating activities), concrete rubble, and broken steel pipelines filled the inside of the hatchway; these materials were removed using a backhoe. During removal, an oily sheen was observed on the soil and debris surfaces.

The western half of the hatchway provided access to the intake tunnel. The intake tunnel top was approximately six feet bgs and was designed with an arched top. Along the north wall of the hatchway, the intake tunnel was approximately 4.5 feet wide and six feet high; along the south wall of the hatchway, the intake tunnel was approximately 5.5 feet wide and six feet high (Figure 4). The intake tunnel appeared to continue north and south of the hatchway and was free of major obstructions

Approximately 3.5 feet of debris/sediments were present in the tunnel bottom. Water was encountered in the hatchway at approximately six feet bgs at 1 pm; similar to Hatchway 1, the water level in Hatchway 2 appeared to fluctuate with rising and falling tide. An oily sheen was observed on the water surface.

Barricades and caution tape were placed around the excavation and a temporary wooden cover was placed over the hatchway for safety purposes.

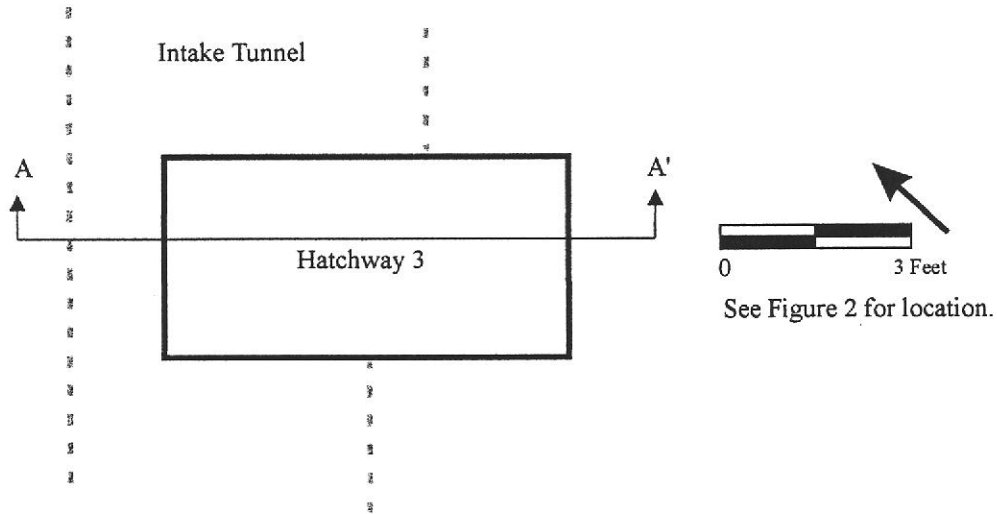
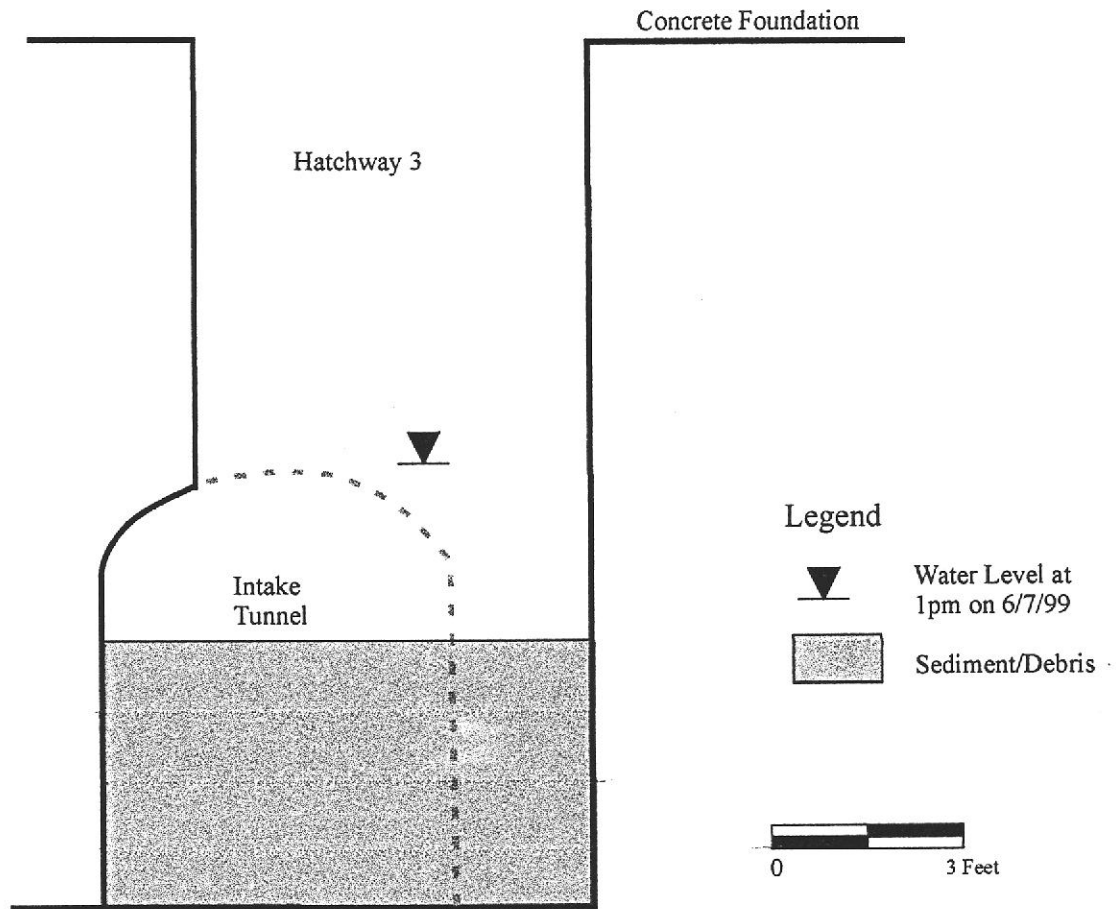
Figure 5

Hatchway 3. Available historic drawings of the former power plant identified the presence of Hatchway 3 within the footprint of the concrete plant foundation (Figure 2). During field activities, the hatchway surface was exposed at approximately two inches bgs. The hatchway was approximately three feet wide, six feet long, and extended to approximately 13.5 feet bgs. Gravelly

soil and a minor amount of debris filled the inside of the hatchway; these materials were removed using a backhoe; similar to Hatchway 2, an oily sheen was identified on the soils and debris during removal.

The western half of the hatchway provided access to the intake tunnel. The top of the intake tunnel in the hatchway was at approximately 6.5 feet bgs and was designed with an arched top. Along the north wall of the hatchway, the intake tunnel was approximately 5.5 feet wide and seven feet high; along the south wall of the hatchway, the intake tunnel was approximately 4.5 feet wide and seven feet high (Figure 4). The intake tunnel appeared to continue north and south of Hatchway 3 and was free of major obstructions.

Between four to six feet of debris/sediments were present in the tunnel bottom. Water was encountered in the hatchway at approximately 6.5 feet bgs at 1 pm (approximate depth to top of tunnel); similar to the conditions in the other hatchways, the water level in Hatchway 3 appeared to fluctuate with rising and falling tide. An oily sheen was encountered at the water surface.

Barricades and caution tape were placed around the excavation and a temporary wooden cover was placed over the hatchway for safety purposes.
