PRIVILEGED AND CONFIDENTIAL MEMORANDUM

Subject: 901 Embarcadero, Oakland

Liquid Carbonic a.k.a. Alliance Gas Products Spill Report July 25, 1999

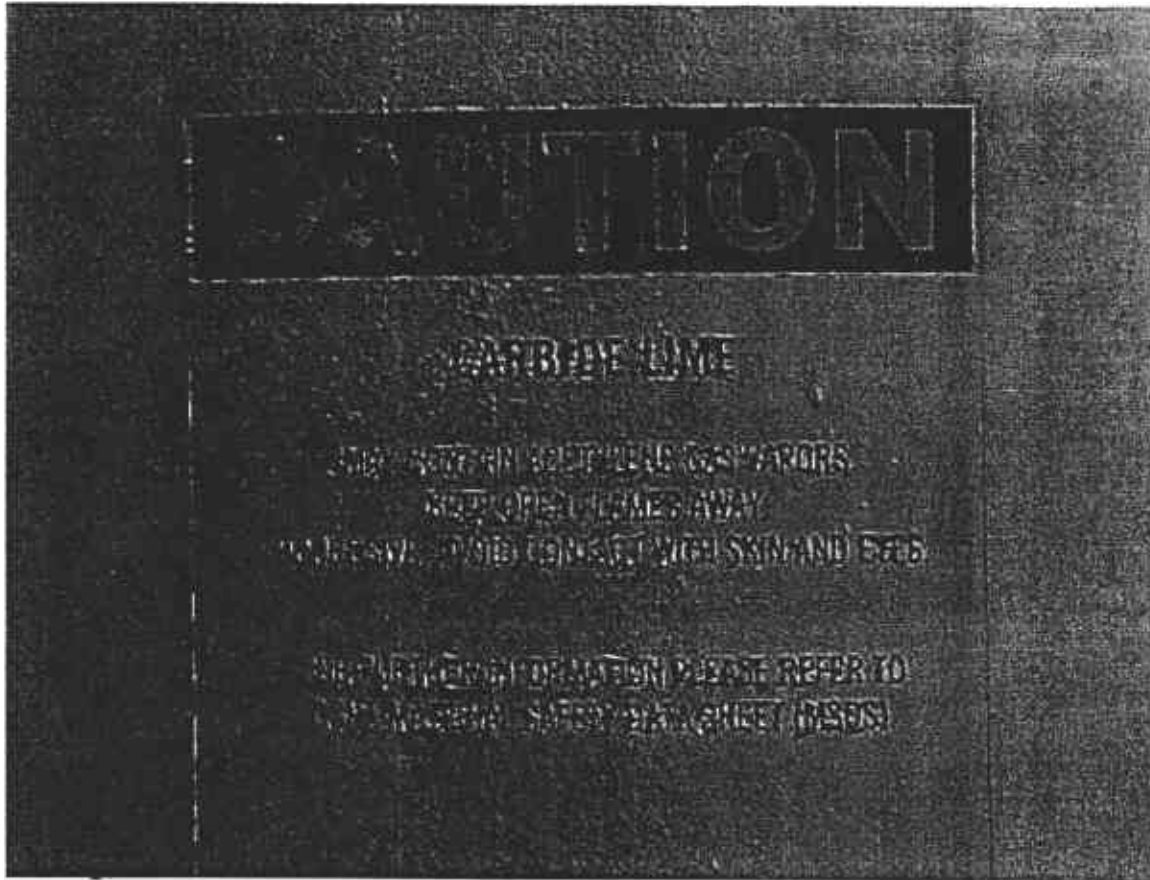
Figure 1

Later Thursday afternoon, the Harbormaster reported that the milky substance spill was occurring again and the Hazmat Unit of the Oakland Fire Department was on scene as was the Environmental Investigation officer, Sergeant Ken Whitman, of the Oakland Police Department. The source of the white substance was determined to be the gas manufacturing plant, commonly referred to as Liquid Carbonic. The operator admitted to spilling carbide lime sludge, a by-product of acetylene manufacture, on Thursday morning, but

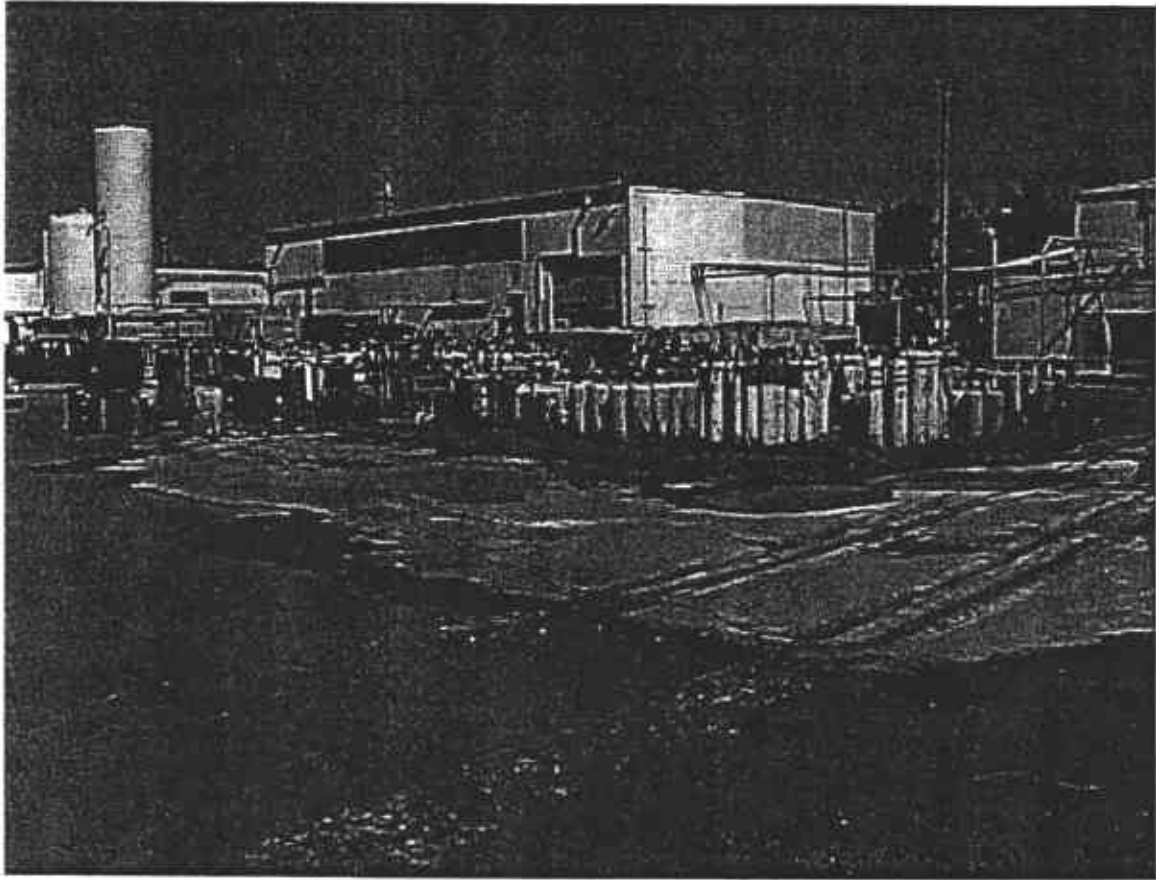
Figure 3

The property on which the spill occurred (Figure 3) is Port owned and leased to the gas plant operator (Alliance Gas Products). Apparently, no structures on the Liquid Carbonic property are owned by the Port.

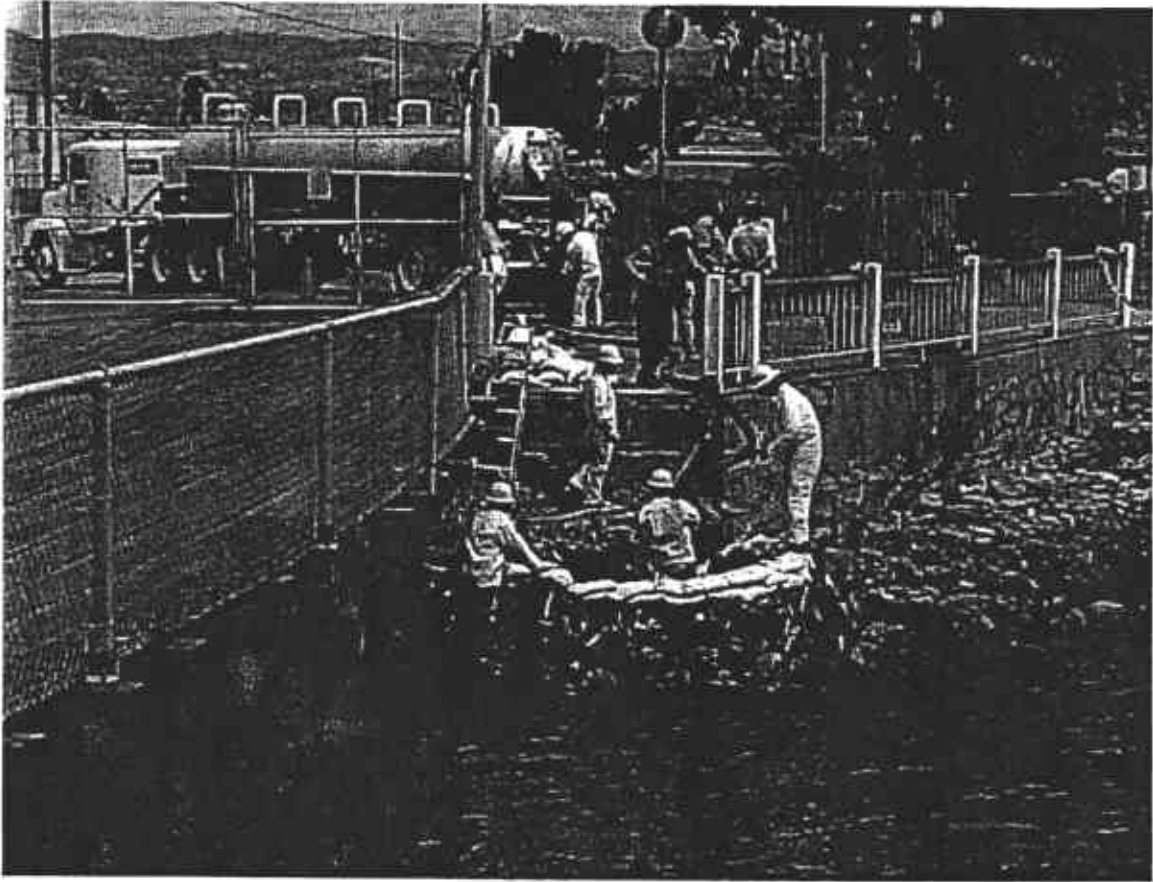
Figure 4

On Friday morning, Morgan Environmental had constructed a temporary catchment structure (Figure 4) at the outfall and had a vacuum truck ready to suck up material flushed from the storm drain. Cal Fish and Game (Warden Danny Reno, telephone 916-445-0045) was present at the scene. Samples of the sludge, the milky bay water, and biological organisms were obtained. The OFD also has samples of the sludge and water. George Leyva and Rich Hiett of the Regional Water Quality Control were on scene. Leroy Griffin of the Oakland Fire Services Agency (CUPA) was also present.
