AGRICULTURE INDUSTRIES INC.
SCHROPP RANCH NUMBER 1
3880 MOUNTAIN HOUSE ROAD, BYRON
ALAMEDA COUNTY, CALIFORNIA

Final Site Assessment Report
Describing the Nature and Extent of
Hydrocarbon Contaminated Soil and
Results of Ground Water Investigation

November 1994

Prepared by:
WZI Inc.
4700 Stockdale Highway, Suite 120
Bakersfield, California 93309

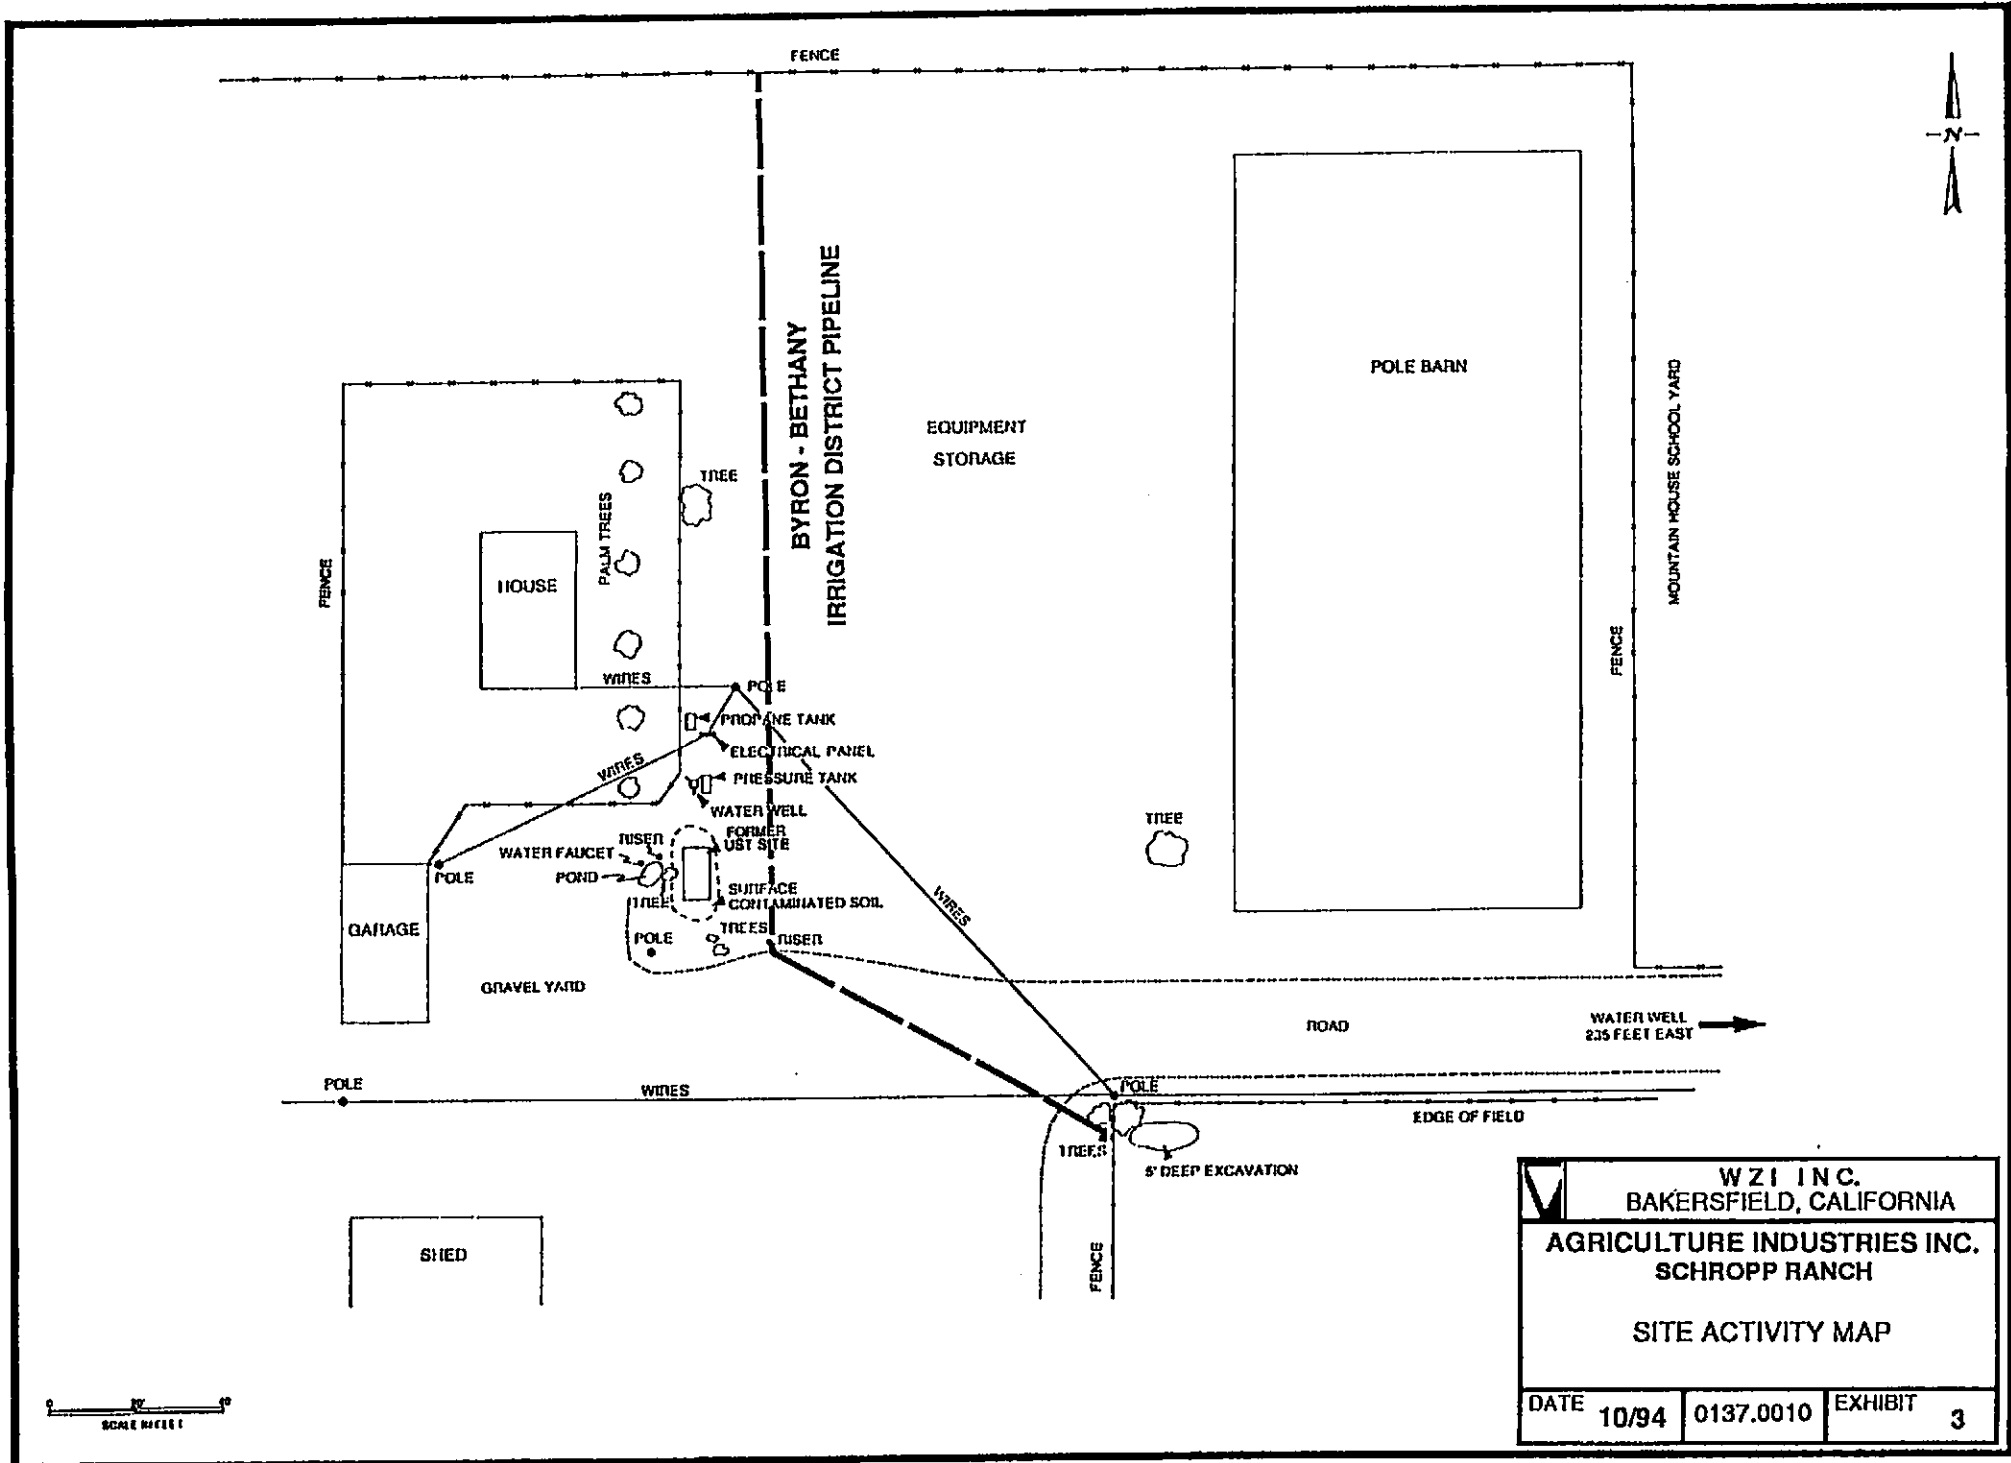
WZI INC. BAKERSFIELD, CALIFORNIA		
AGRICULTURE INDUSTRIES INC. SCHROPP RANCH		
SITE ACTIVITY MAP		
DATE	0137.0010	EXHIBIT
10/94		3

During January of 1992, the underground storage tank depicted in Exhibit 3 was removed from the subsurface along with associated piping by the lessor, Mr. Don Holck and hydrocarbon stained soil was reported to be present immediately around and below the former tank location. Mr. Holck reportedly removed the tank from the subsurface along with associated piping. The tank, piping, and surface dispenser were all stockpiled within the main yard area after removal. Mr. Holck did not have any comment on the condition of the tank, piping and dispenser after removal from the surface. No fuel is currently stored on the property and all vehicles are fueled from off-property sources. In addition to noticing the hydrocarbon stained soil, the employee of the lessor who occupied the adjacent farm house reported a strong gasoline smell from domestic water lines in the house. Water well 2S/3E-6F1, which supplied the house with water for an unknown period of time, possibly as long as 40 years, was located immediately adjacent to the former underground tank location.

After submission of the Problem Assessment Report, WZI conducted a reconnaissance of the shallow subsurface in the equipment yard with hand auger borings (Exhibit 3). These borings were drilled during July, 1992. Exhibit 4 depicts the locations of these auger borings and the analytical results are tabulated in Table 1 and Appendix II-1. The results of this limited drilling indicated the presence of hydrocarbon contaminated soil was restricted to the main portion of the yard area at shallow depths to a maximum of 15 feet below ground surface. Based on the hand auger data, a final excavation plan was developed for the shop yard.

Prior to initiating the excavation, the Byron-Bethany Irrigation District concrete irrigation line was removed (Exhibit 3). During the excavation, all work was conducted under the oversight of a California Certified Engineering Geologist. Sample locations and direction of excavation control were controlled by the engineering geologist. All sidewalls and cuts were kept in accordance with OSHA requirements for excavations and confined space entry.

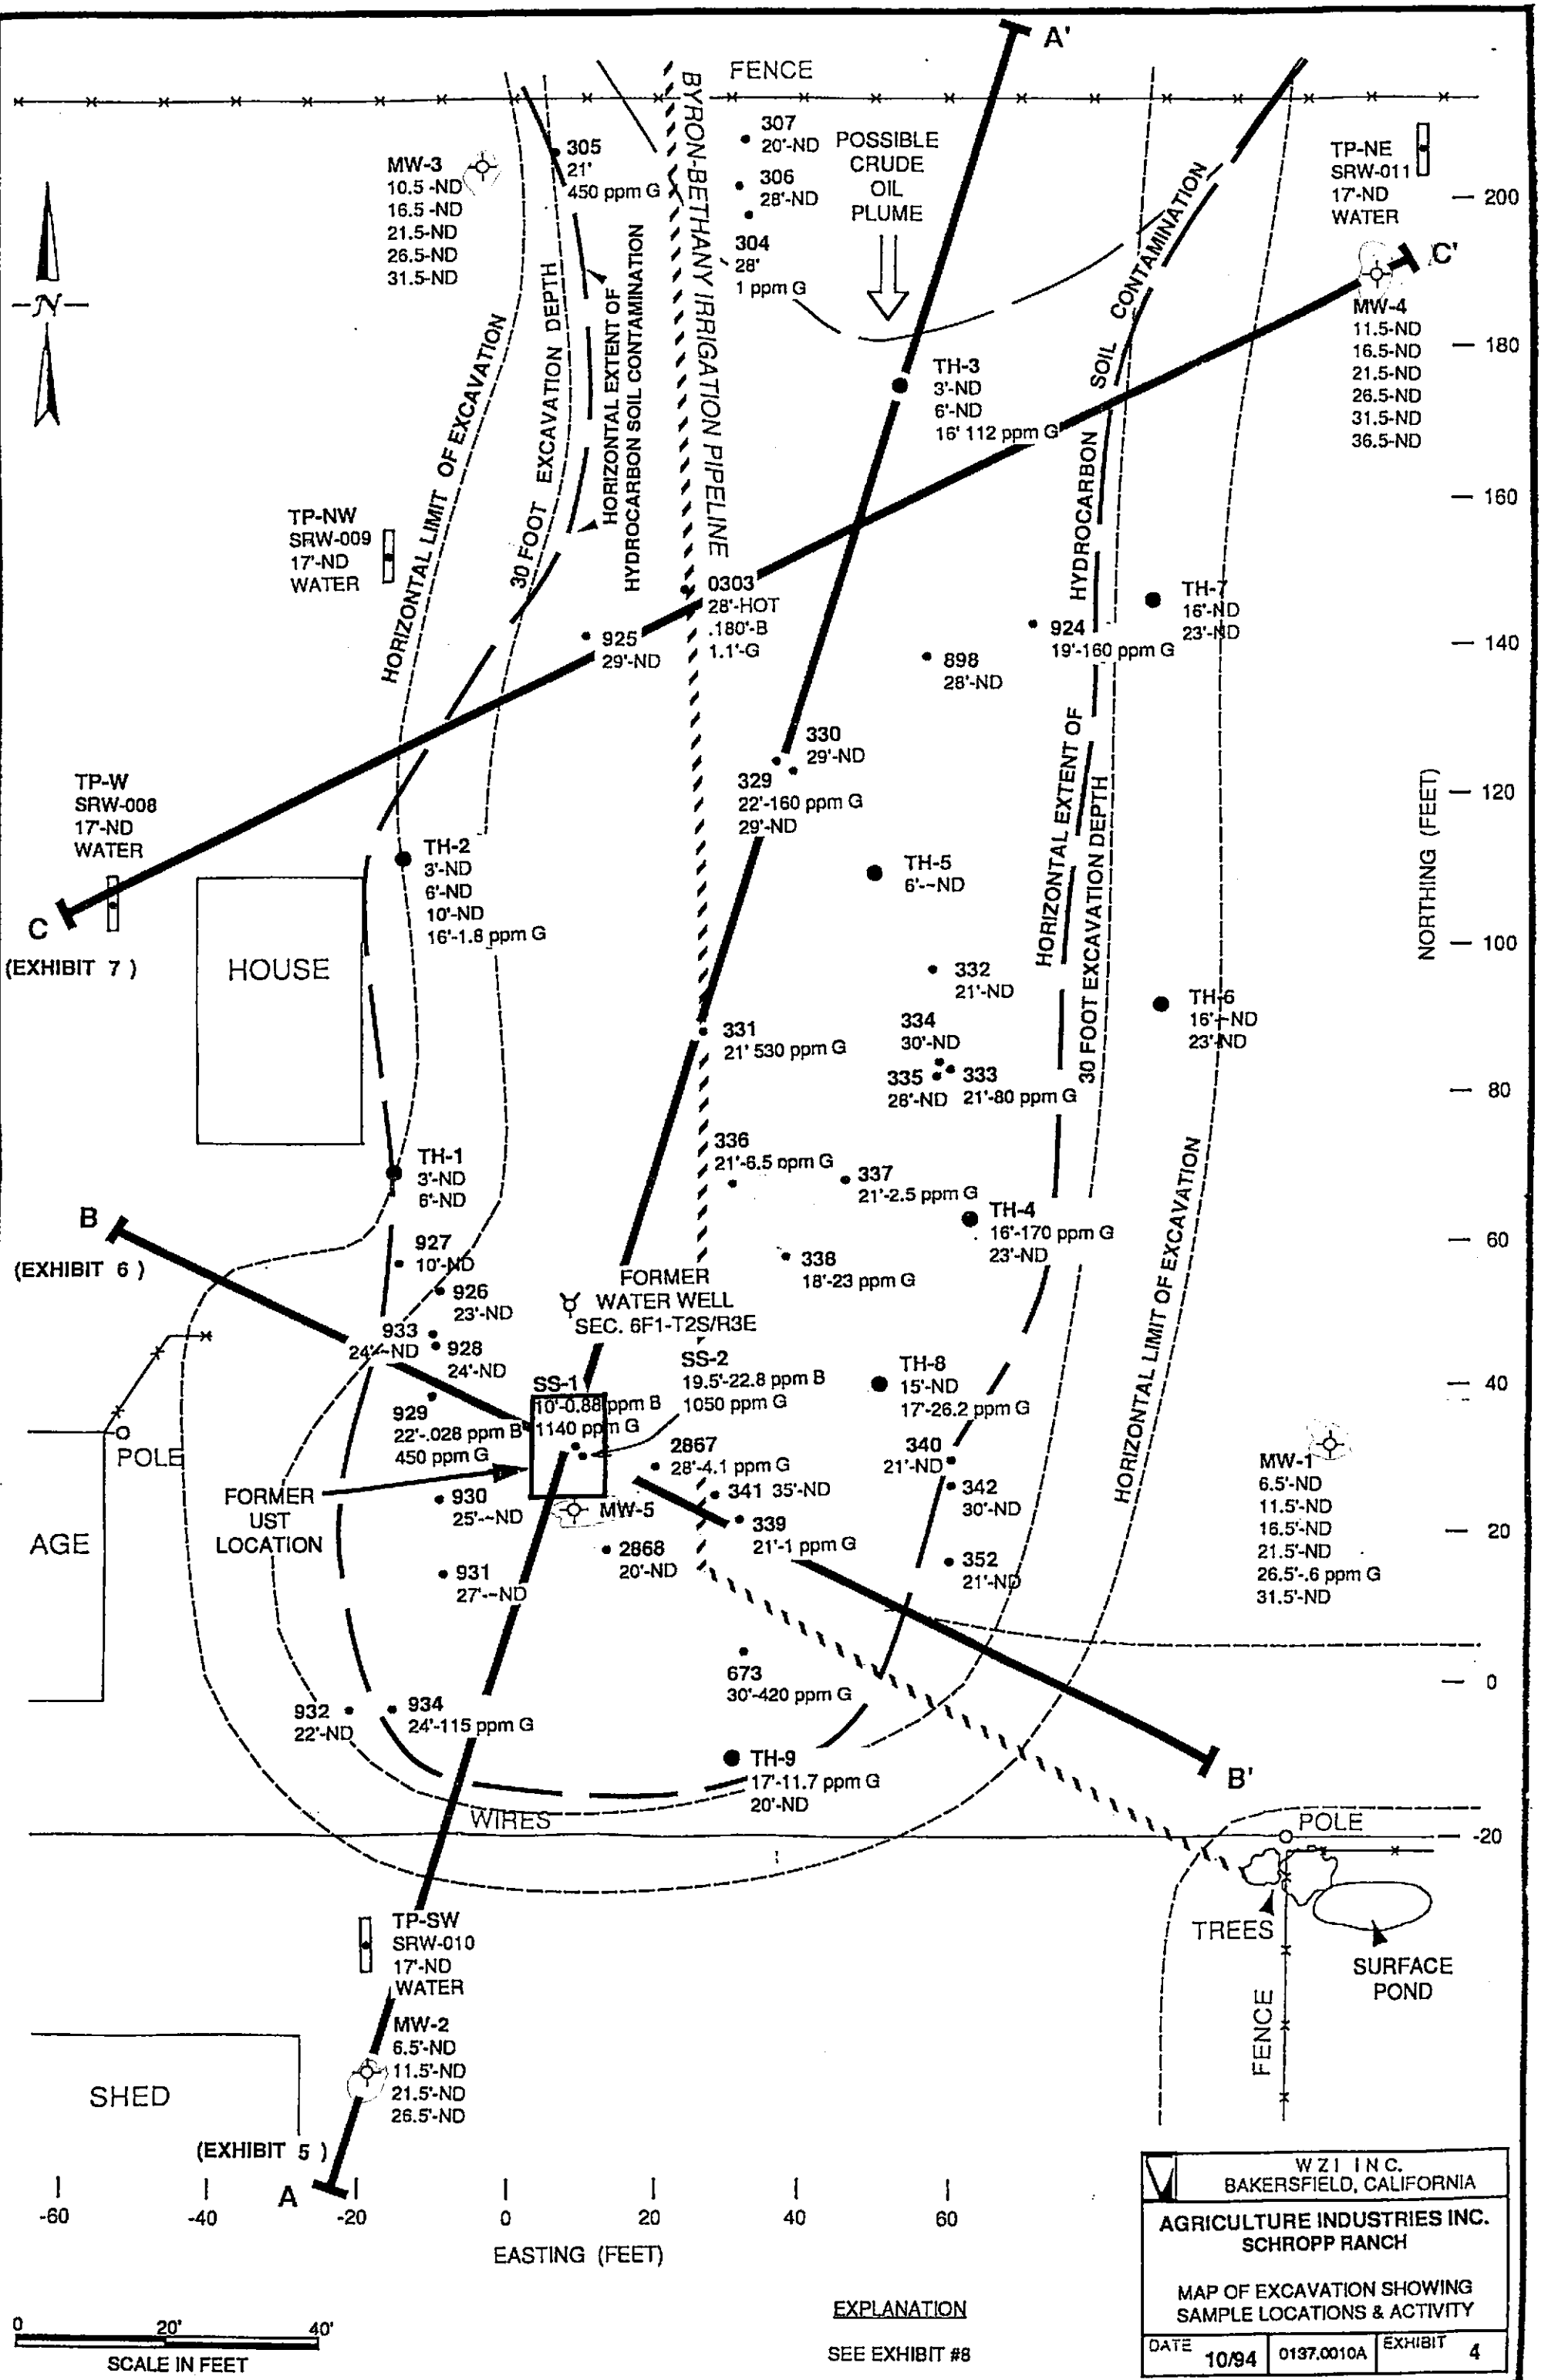
WZ1 INC. BAKERSFIELD, CALIFORNIA		
AGRICULTURE INDUSTRIES INC. SCHROPP RANCH		
MAP OF EXCAVATION SHOWING SAMPLE LOCATIONS & ACTIVITY		
DATE	0137.0010A	EXHIBIT 4

Exhibit 4 is a map which depicts the final excavation limits on the property. A total of 24,863 cubic yards of contaminated and clean soil was excavated in order to remove all accessible hydrocarbon contaminated soil and to stabilize the walls of the excavation. Identification of hydrocarbon contaminated soil was made using a photo ionization device (PID), color, and odor as described in the WZI workplan contained in Appendix I.

A minor volume of gasoline contaminated soil was left below the farm house and immediately adjacent to it for engineering safety. The westward extent of the hydrocarbon contaminated soil beneath the house was bracketed by a series of exploration trenches where uncontaminated soil was found to be present (Exhibit 4). The volume of hydrocarbon contaminated soil left in place is estimated to be approximately 100 cubic yards and is believed to be immediately below and on the east side of the farm house (Exhibit 4).

- The base of the excavation has been presented in Exhibit 4. The excavation was elongate in the north-south direction and most of the excavation is about 32 feet deep. The south end of the excavation, in the vicinity of the water well, was excavated to 35 feet.

soil appears to be present only in the northern portion of the excavation at a depth of approximately 22 to 25 feet below ground surface. This soil contamination appears to discontinue southward approximately 20 feet south of the property line (Exhibit 4).
