**ENVIRONMENTAL SITE ASSESSMENT  
AND SAMPLING PLAN  
768 46TH AVENUE  
OAKLAND, CALIFORNIA**

**June 3, 1988  
Job No. 17212-001-043**

Environmental Site Assessment  
and Sampling Plan  
768 46th Avenue  
Oakland, California

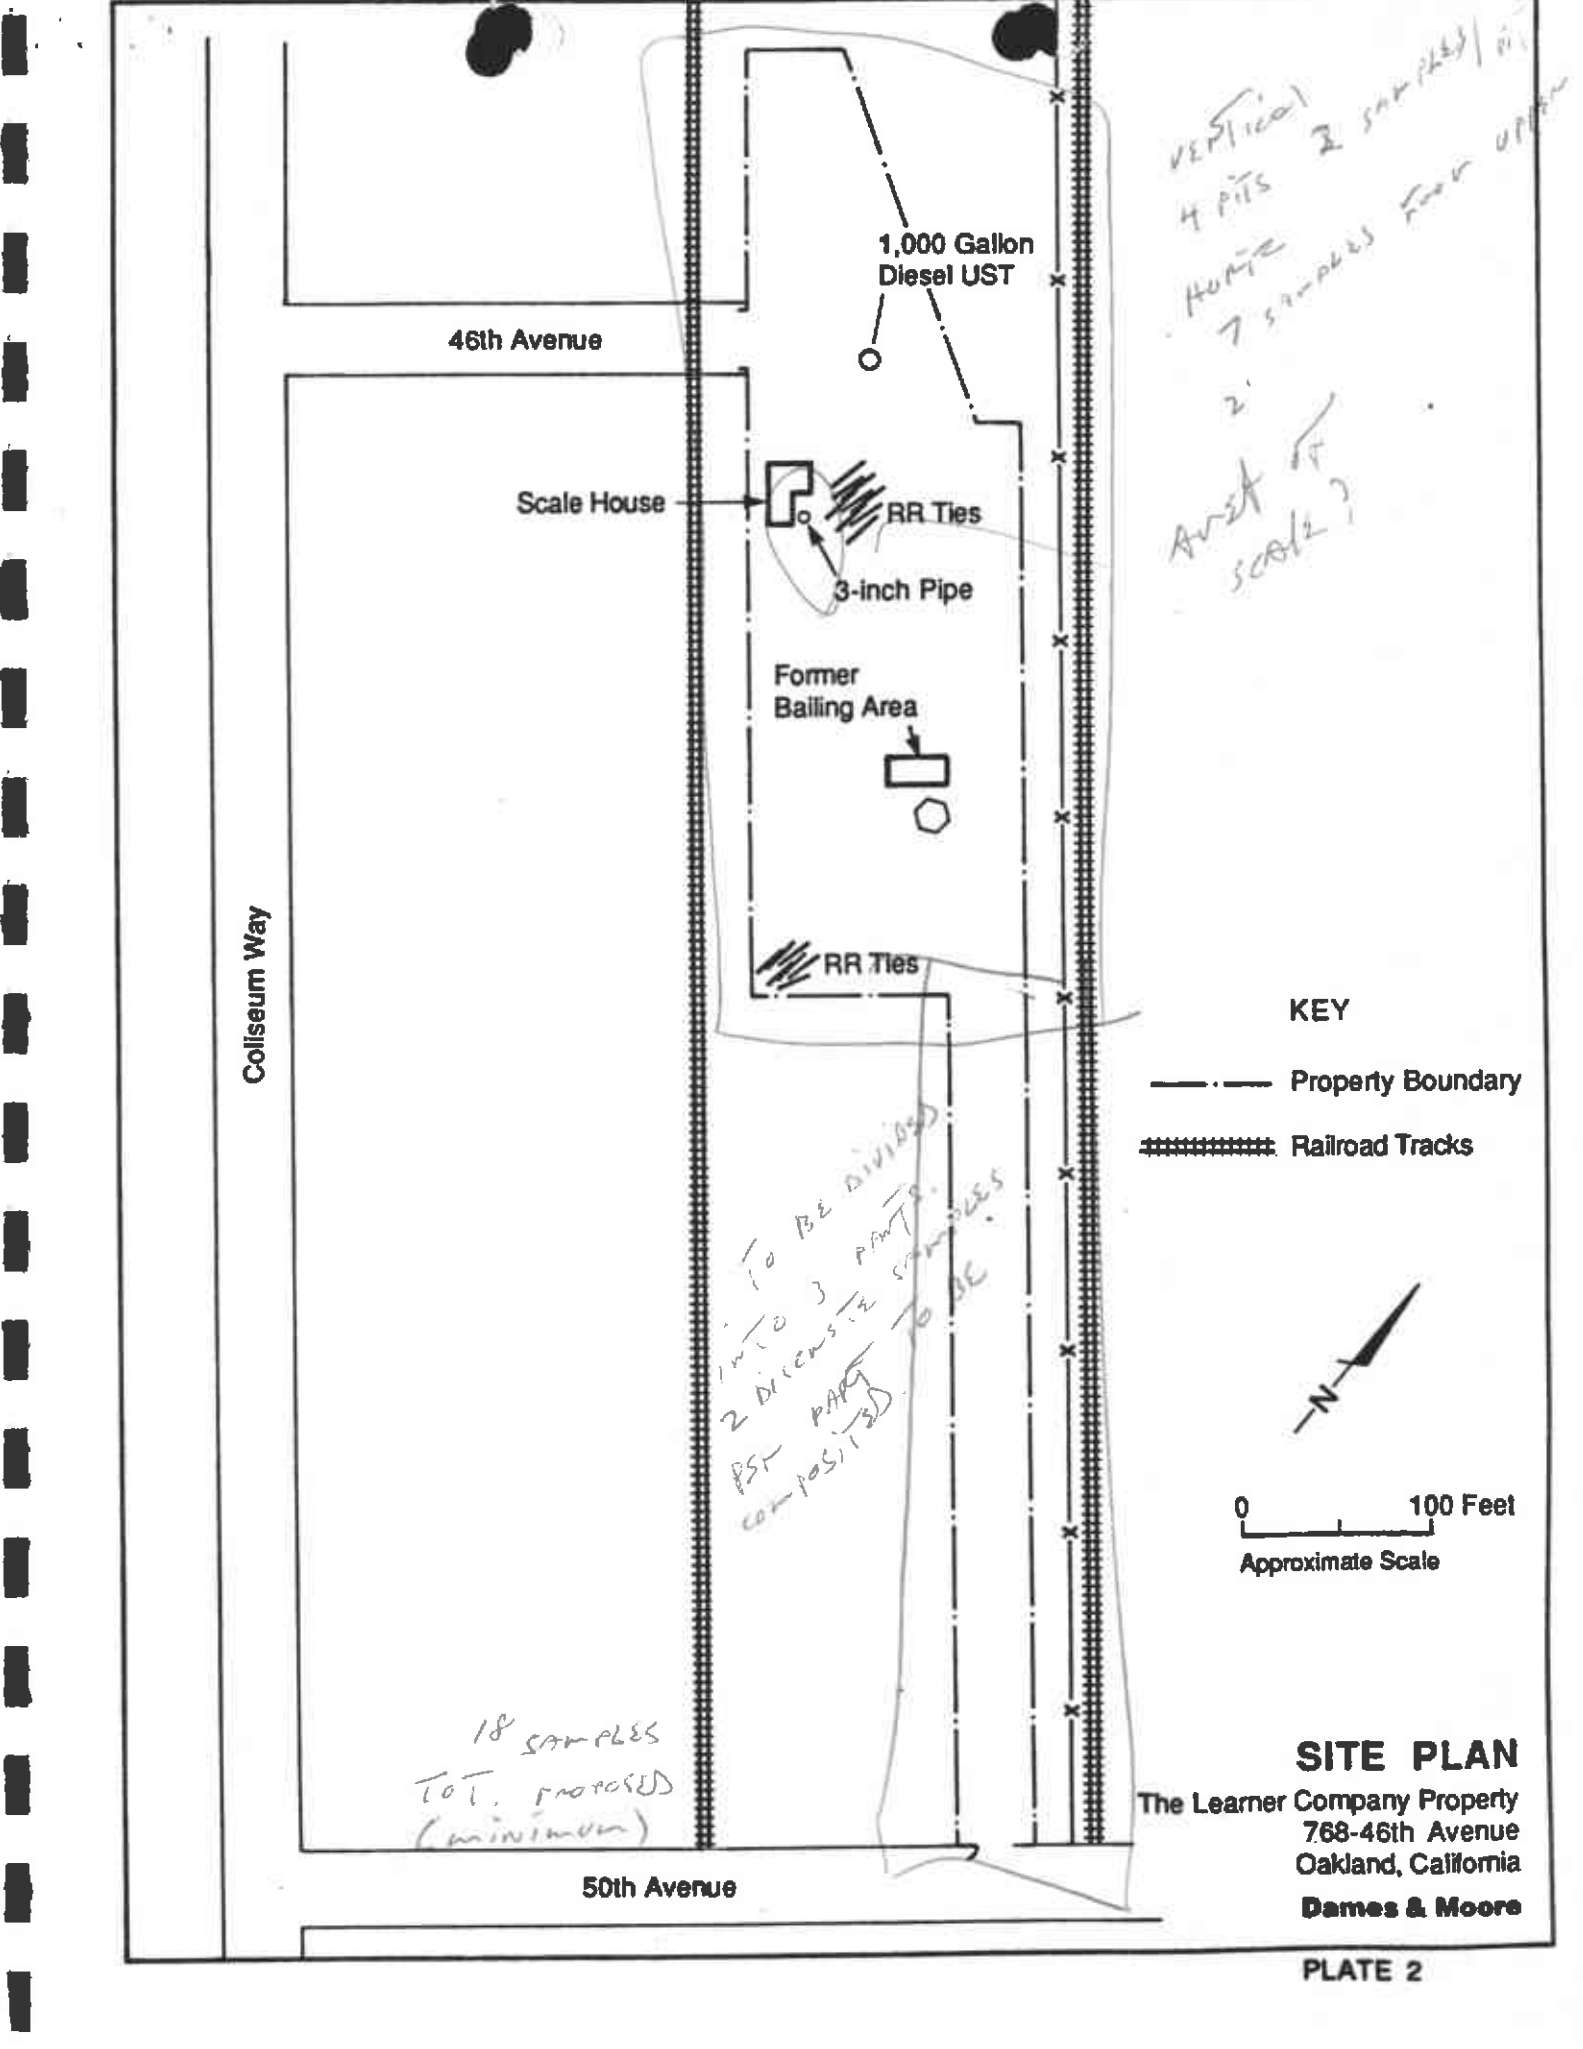
**SITE PLAN**

At the time of the site inspection, the railroad tracks had been completely disassembled and most of the railroad ties piled up at various locations around the site (Figure 2). The remaining ties were scattered along the former track location. Although the bailing equipment had been largely disassembled, two large pieces of the bailer were remaining. According to Mr. Jack Hecht of the Learner Company, some disassembled pieces of the bailing equipment had been removed from the property while the rest had been placed in various locations around the property.

*(OKS)* The railroad ties currently stockpiled at the site could be picked up and removed from the site by a railroad tie recycler. Dames & Moore contacted A&K Railroad Ties (A&K) of Oakland with regard to accepting the ties. A&K inspected the ties on May 19, 1988 and indicated that they would be willing to pick up the ties at no cost.

*OK* The piles of soil and metal scrap not contaminated with oil present at the site may be disposed of at a Class III sanitary landfill. The sanitary landfill may require testing of the soil for PCB's prior to accepting the material.

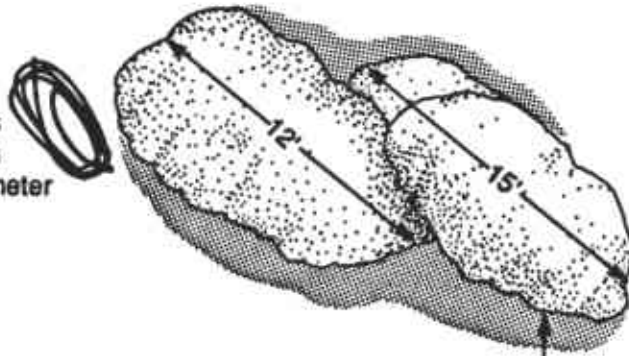
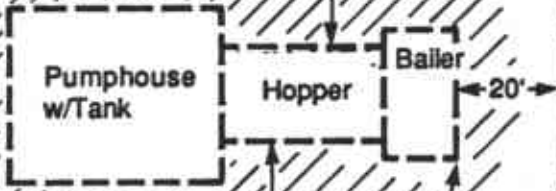
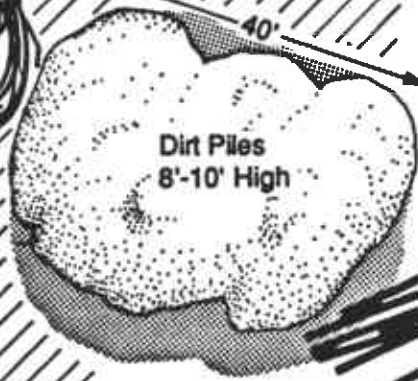
**FORMER BAILING AREA**

The site topography is relatively flat. Excavations and piles of soil remain where activities have recently occurred to remove the railroad tracks and disassemble the bailing equipment. Two large piles of soil (6-8 feet high) are located about 50 feet north of the bailing area (Figure 3). According to Nelson Linendoll, onsite foreman for the Learner Company, these piles were formed following removal of the railroad bed material and consist primarily of soil with some gravel, small wood pieces and metal scrap. There are several other large piles (8-10 feet high) located south of the bailer that consist of soil and metal scrap. These piles were from material accumulating over the years from onsite operations (Linendoll, 1988). A pile about 12 feet high and 15 feet in diameter, consisting of metal cables with some piping and scrap metal, was also noted in this area (Figure 3).

During our reconnaissance-level site inspection on May 17, 1988, dark-stained soils were noted in a large area around the former bailer location (Figure 3). Mr. Linendoll reported that since operations ceased in 1982, vandalism has been a problem at the site. He reported that the

brass valves from the above-ground storage tank and associated piping for the bailer were stolen. The removal of these valves apparently resulted in the release of Tellus 68 hydraulic fluid onto the ground in the vicinity of the bailer. The amount of hydraulic fluid released is unknown, although it may have been as much as 300 to 500 gallons. The release of the hydraulic fluid was not noticed by Learner Company personnel until activities started on the site in January 1988.

In summary, our Phase I findings indicate that onsite contamination of soils in the vicinity of the former bailer has occurred as a result of reported leakage of hydraulic fluid from an above ground storage tank and associated piping.

A site-specific sampling plan to investigate the extent and nature of hydraulic oil contamination in the vicinity of the former bailer is presented as an attachment to this letter report.

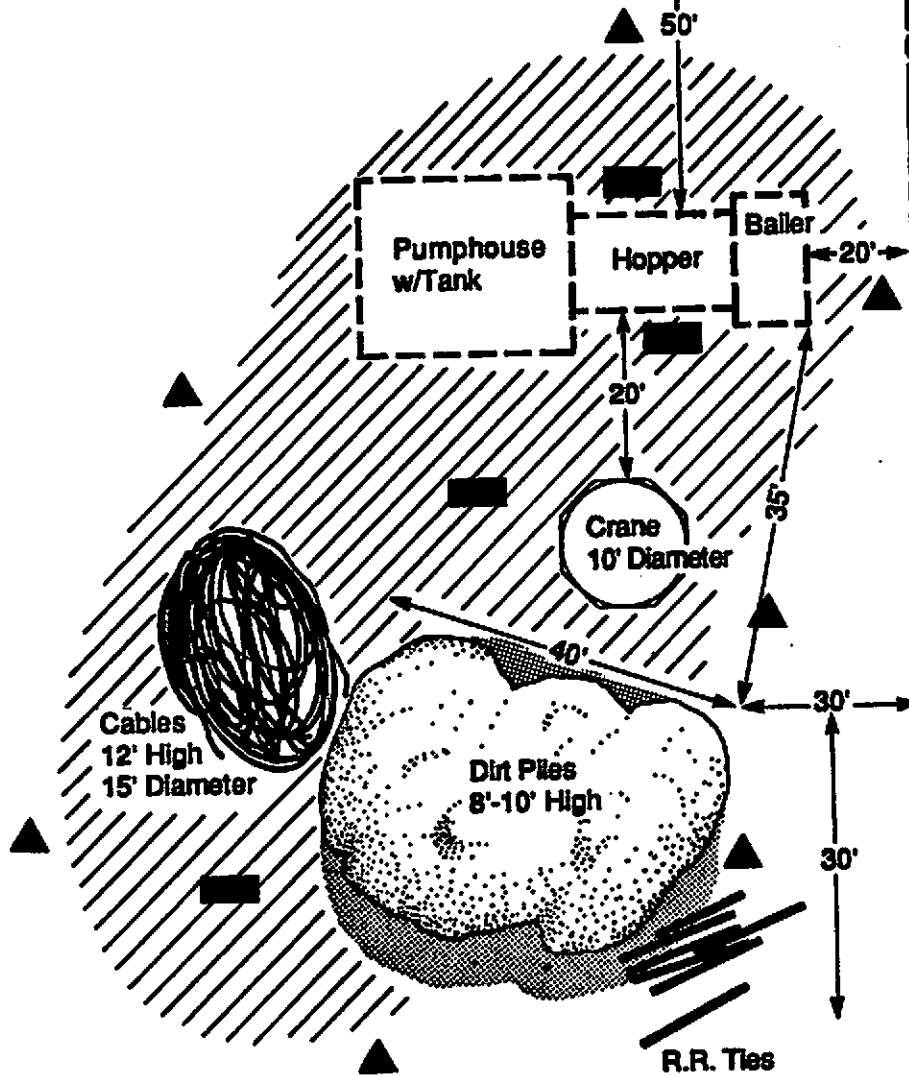
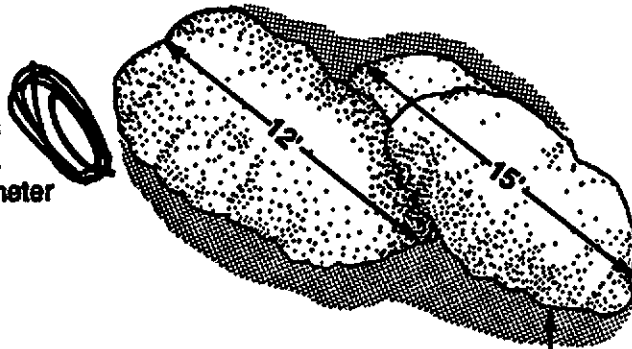
FIGURE 1

**PROPOSED SAMPLING LOCATIONS  
FORMER BAILING AREA**

To investigate the vertical extent of the hydraulic oil contamination in the vicinity of the bailer, approximately four (4) exploratory pits will be excavated utilizing a backhoe within the visibly stained area around the former bailer. The proposed exploratory pit locations are shown on Figure 1, although exact locations for each pit will be determined in the field. The depth of each exploratory pit will be field determined based on visual observations, but will not extend below the groundwater surface. A log of each exploratory pit will be maintained by a Dames & Moore onsite geologist.

To investigate the horizontal extent of the hydraulic oil contamination, a minimum of seven (7) surficial soil samples will be collected using a stainless steel hand auger. The proposed sampling locations are shown on Figure 1, although the exact locations will be field determined. Soil samples collected using the hand auger will be collected from the upper 24 inches of soil.
