CORRECTIVE ACTION REPORT

SNK Andante Project

3992 San Pablo Avenue
Emeryville, California

August 2003

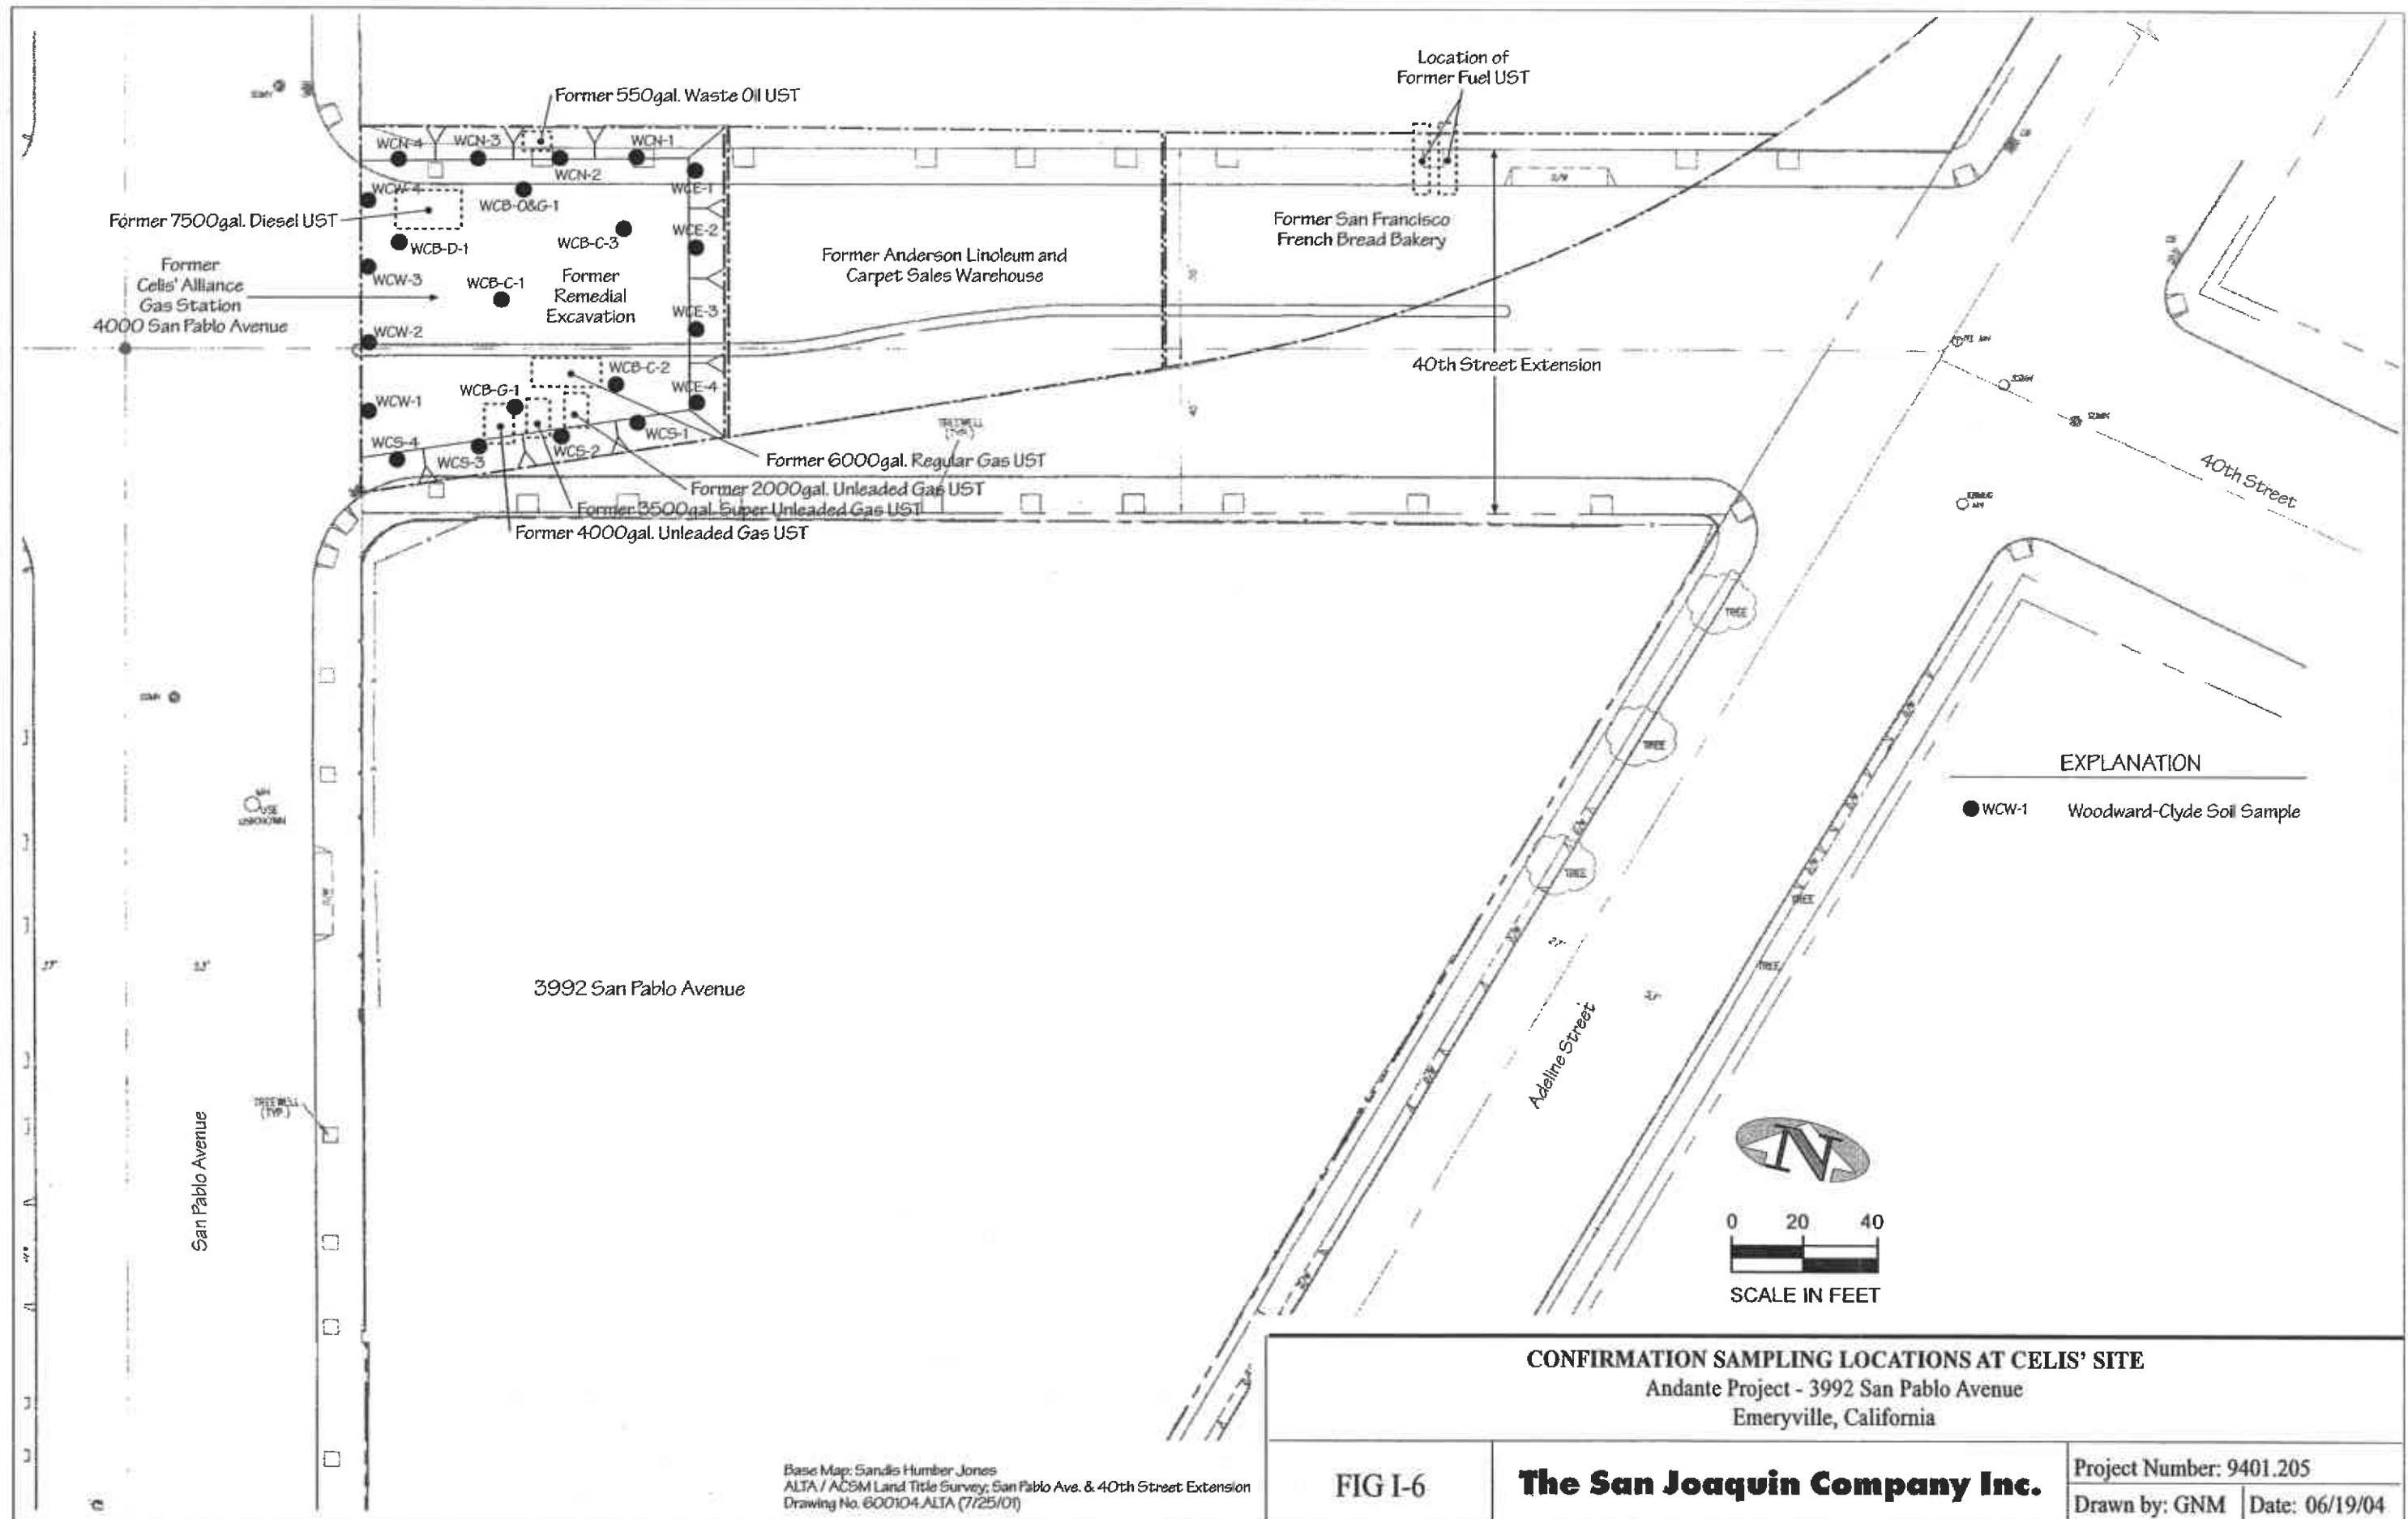
FIG I-6	The San Joaquin Company Inc.	Project Number: 9401.205 Drawn by: GNM Date: 06/19/04
----------------	-------------------------------------	---

CONFIRMATION SAMPLING LOCATIONS AT CELIS' SITE
 Andante Project - 3992 San Pablo Avenue
 Emeryville, California

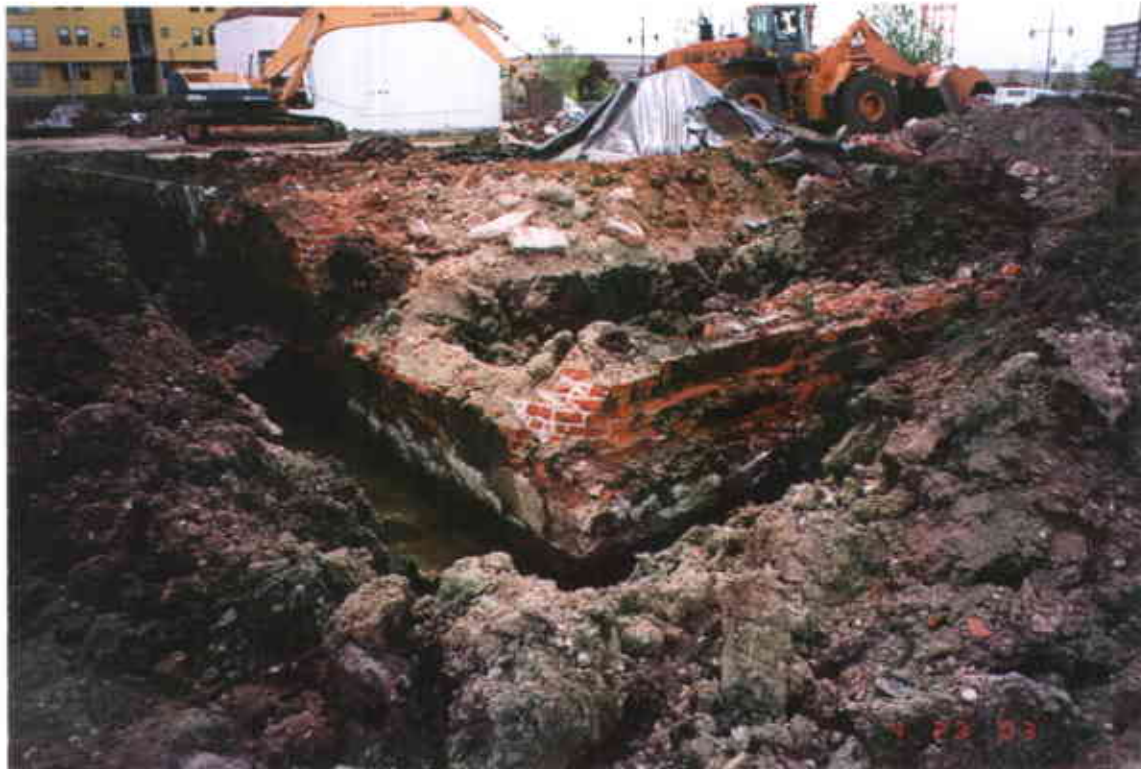
Plate 1: Example of Buried Mass Masonry Foundation Structures

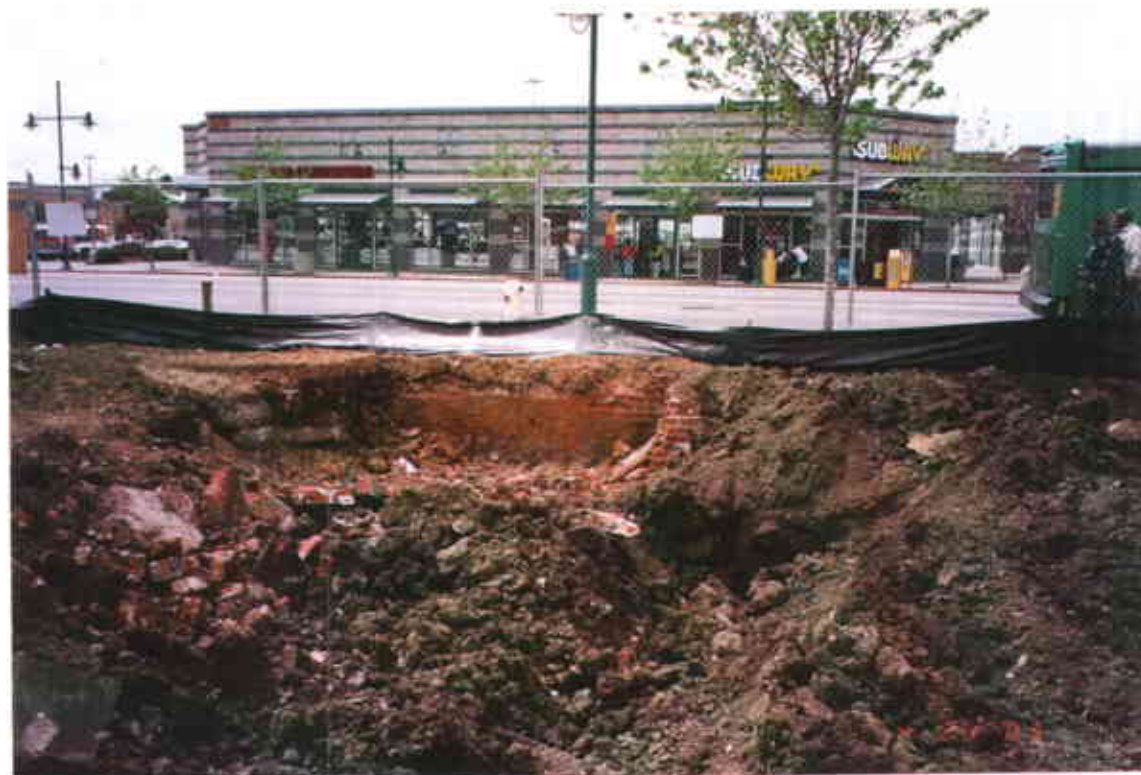
Plate 2: Exposed Basement Retaining Wall Along San Pablo Avenue Frontage

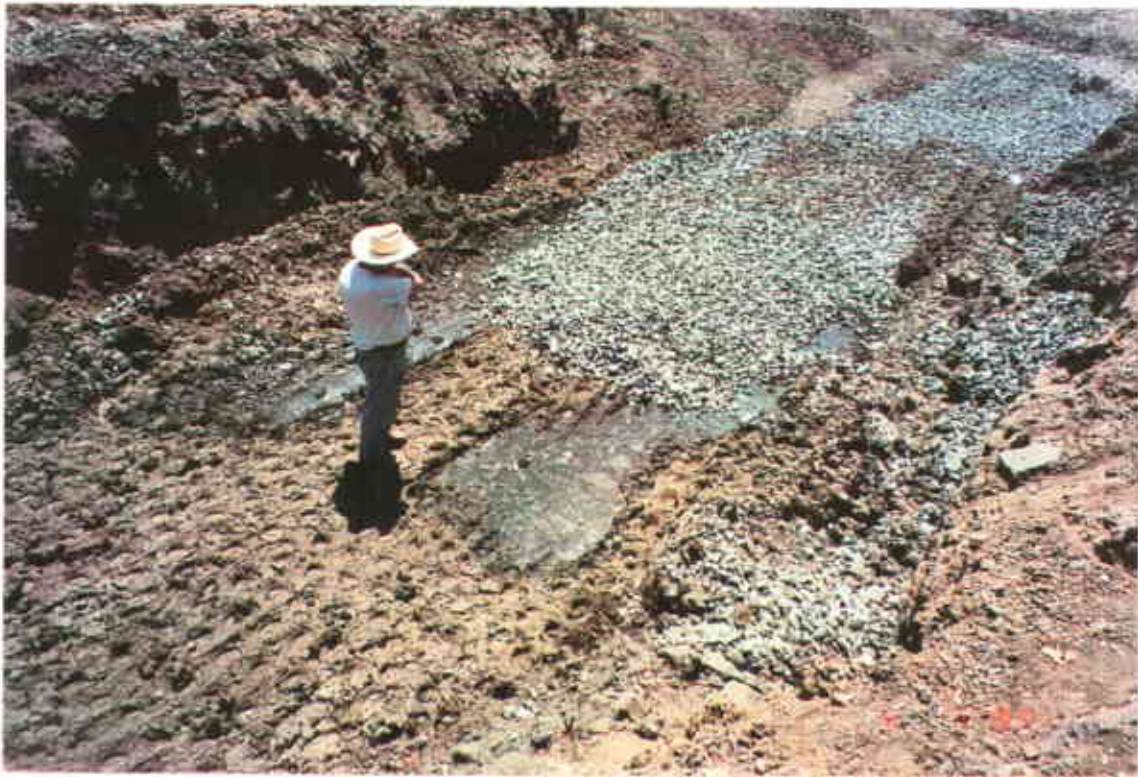
Plate 12: Transition between Backfilled Paleo Stream Channel and Clay Plug
Note: Engineer is standing on clay in plug compacted by vibratory sheep's-foot compactor.
