Re: Site Assessment
4701 San Leandro Street
Oakland, California

Environmental Site Assessment
4701 San Leandro Street
Oakland, California

March 12, 1991

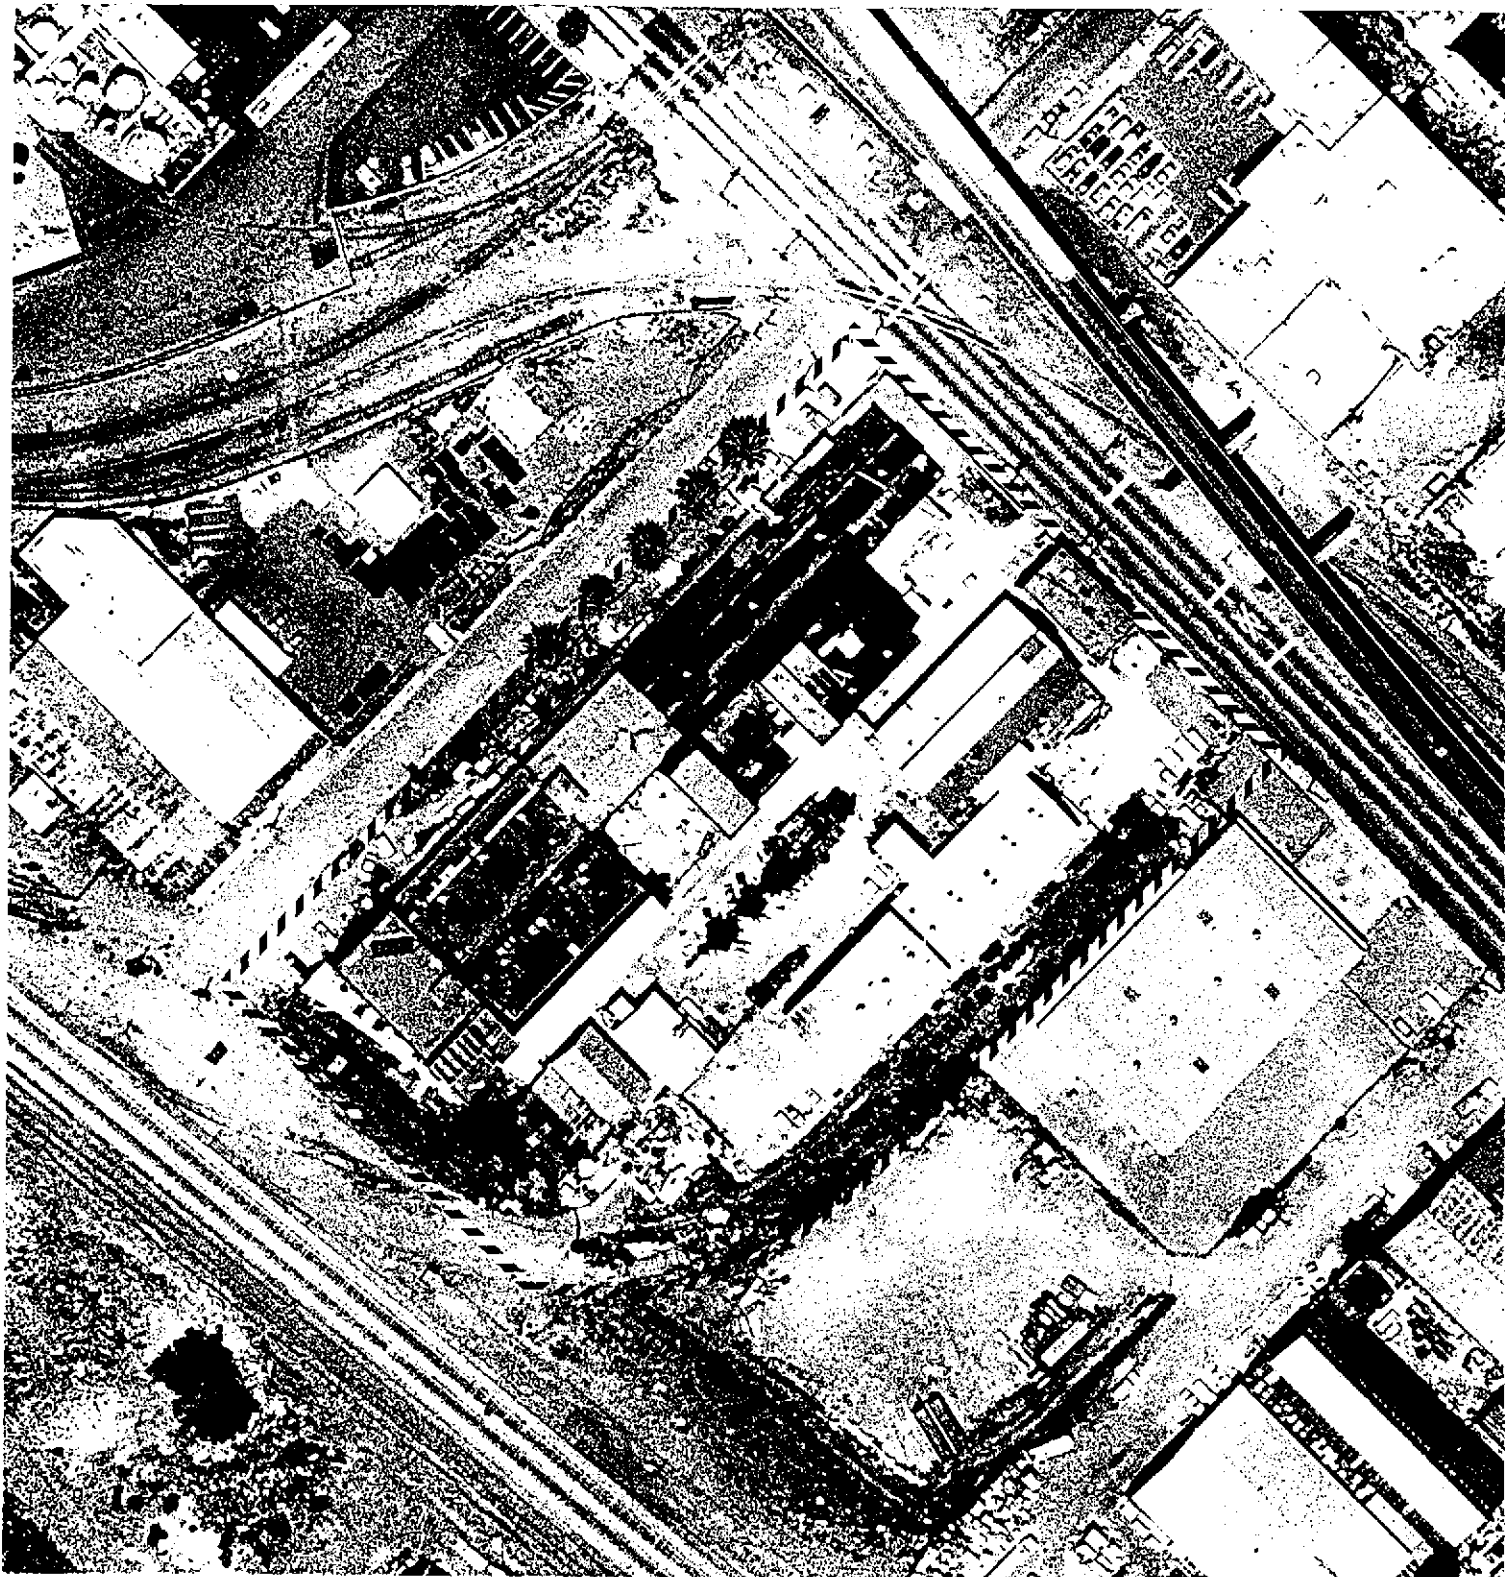
PHOTO DATE: 6-12-90

6. 3-30-88 Photo AV 3268-6-29. Same as previous photo.
7. 6-12-90 Photo AV 3845-10-34. This photo is included with the report. The subject property has the same structures. The east end of building is no longer used as a loading dock. The above ground tank south of the subject property has been removed and more above ground tanks are on the building west of subject property.
