RE: Hydraulic Hoist Removal Report
Grand Auto Store, 2512 107th Avenue, Oakland, California

HYDRAULIC HOIST REMOVAL REPORT

**Former Grand Auto Store
2512 107th Avenue
Oakland, California 94603**

**ALLWEST PROJECT 92198.24
January 11, 1993**

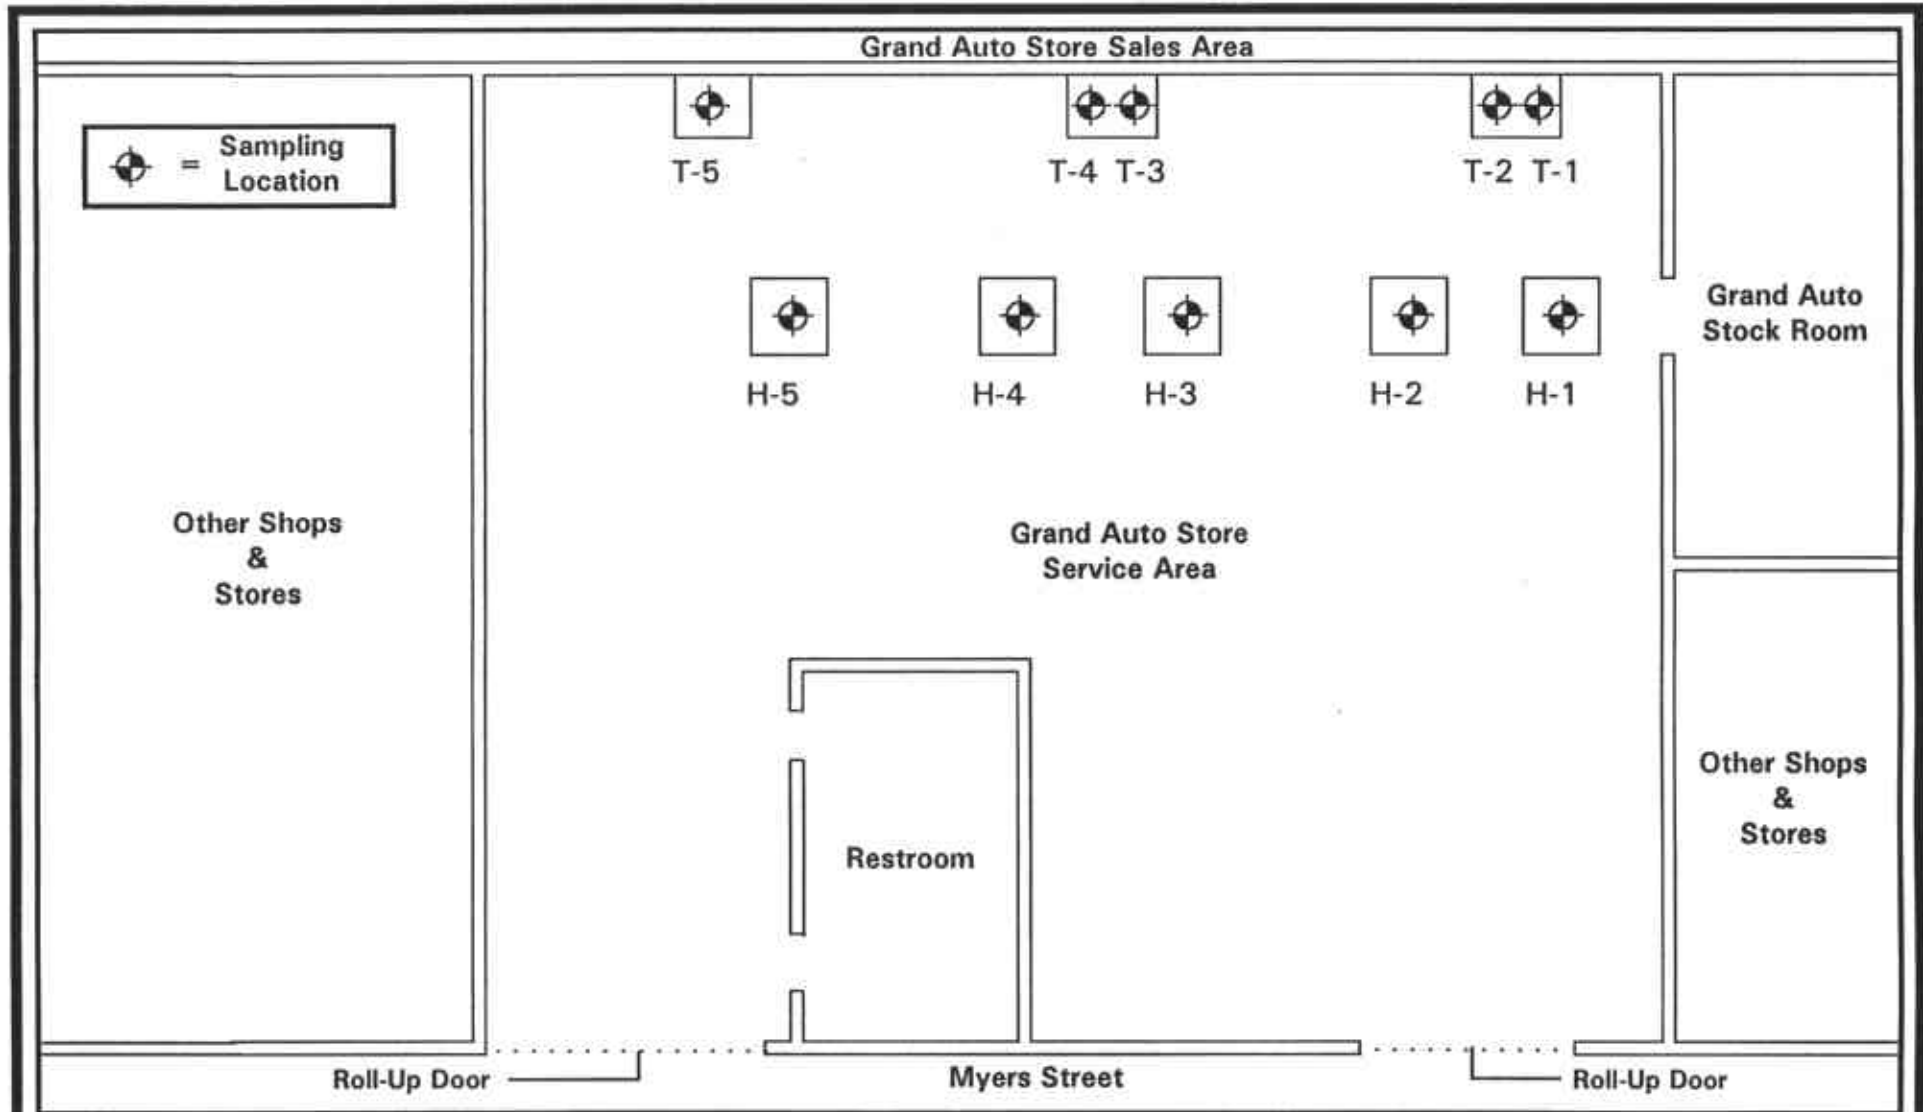
Figure 3

All the samples analyzed contained no detectable concentrations of TPH-d. However, detectable concentrations of petroleum hydrocarbons in the motor oil range were found in all the samples from reservoir pits and one from the hoist pit. The concentration levels varied from 100 parts per million (ppm) at hoist H-5 to 10,000

ppm at reservoir T-3. The following Table 1 summarizes the results of Minimum Verification Analyses for the hoist closure. Certified analytical reports and chain-of-custody documentation are presented in Appendix C.

The hydraulic fluid impacted soils can be readily mitigated by over-excavating the currently open hoist/reservoir pits and removing additional soil from the pit bottom and sidewalls. To demonstrate the effectiveness of remediation, verification sampling and testing should be performed after the completion of over-excavation. It is highly advisable that a work plan outlining the over-excavation objective and procedure be prepared and approved by the local regulatory agency prior to commencing the actual excavation work so that regulatory notification will not be an issue at a later date.

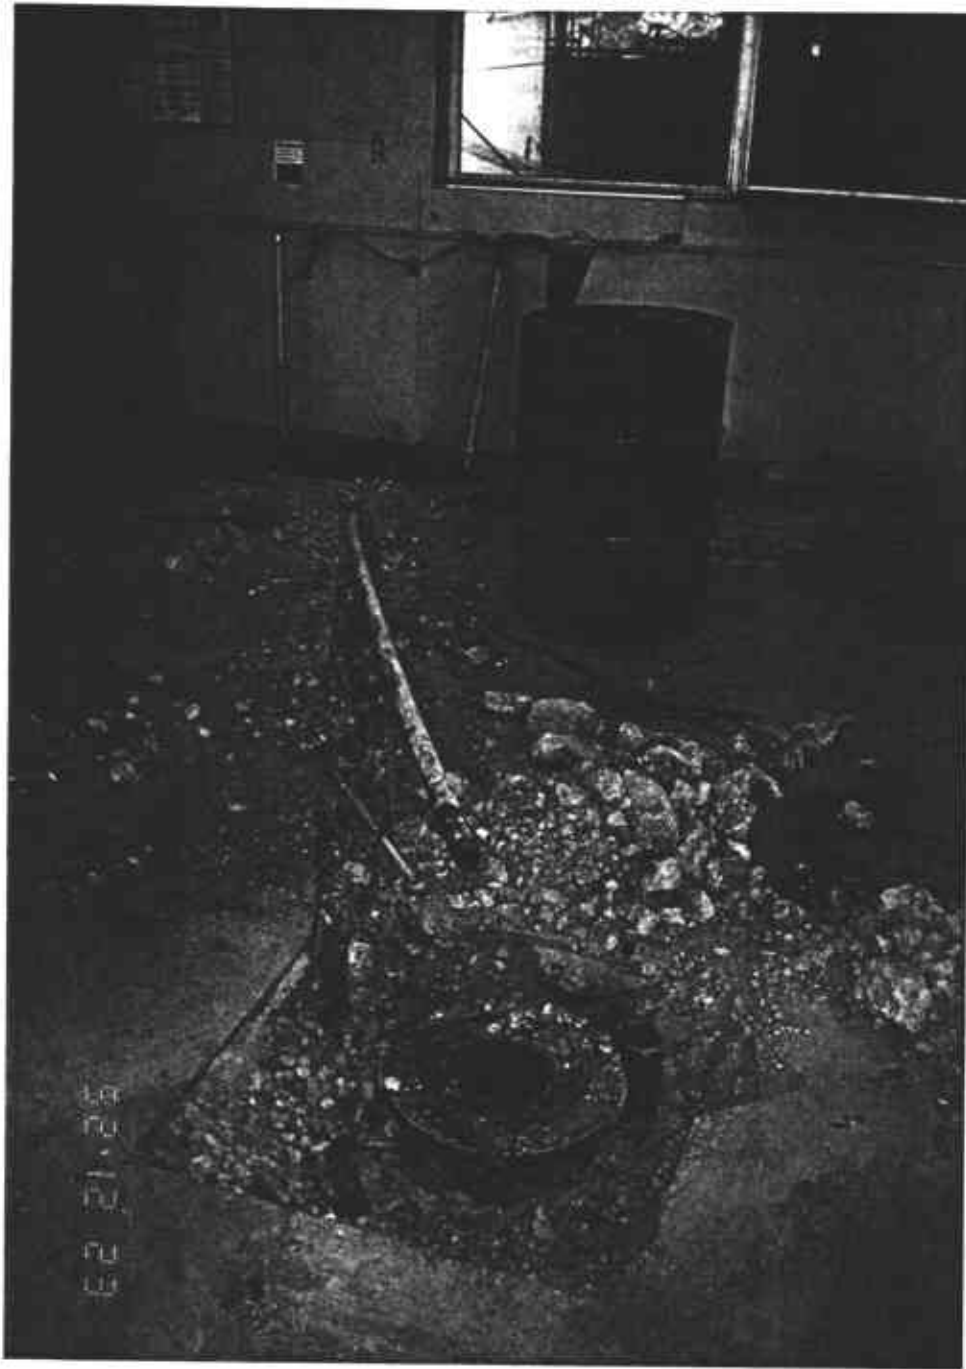
PHOTOGRAPH # 1

View of the site condition prior to hoist removal. The concrete slab around hoist No. H-5 was being excavated to expose the top of hoist. The reservoir pit No. T-5 and associated piping are visible in the background

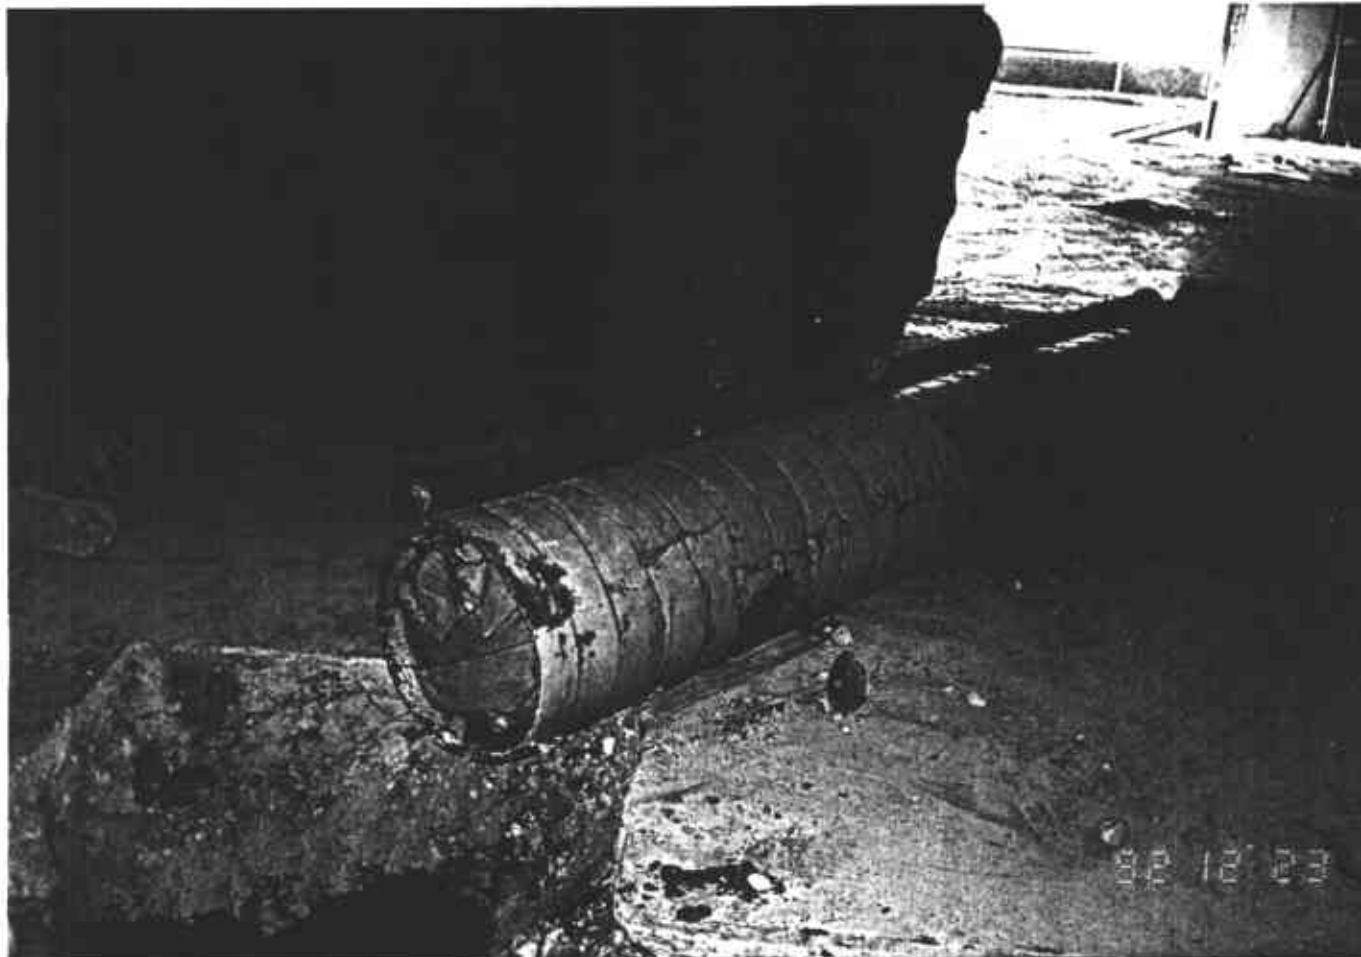
PHOTOGRAPH # 5

View of hoist No. H-2 after removal. Showing the near intact exterior wrapping of hoist No. H-2.

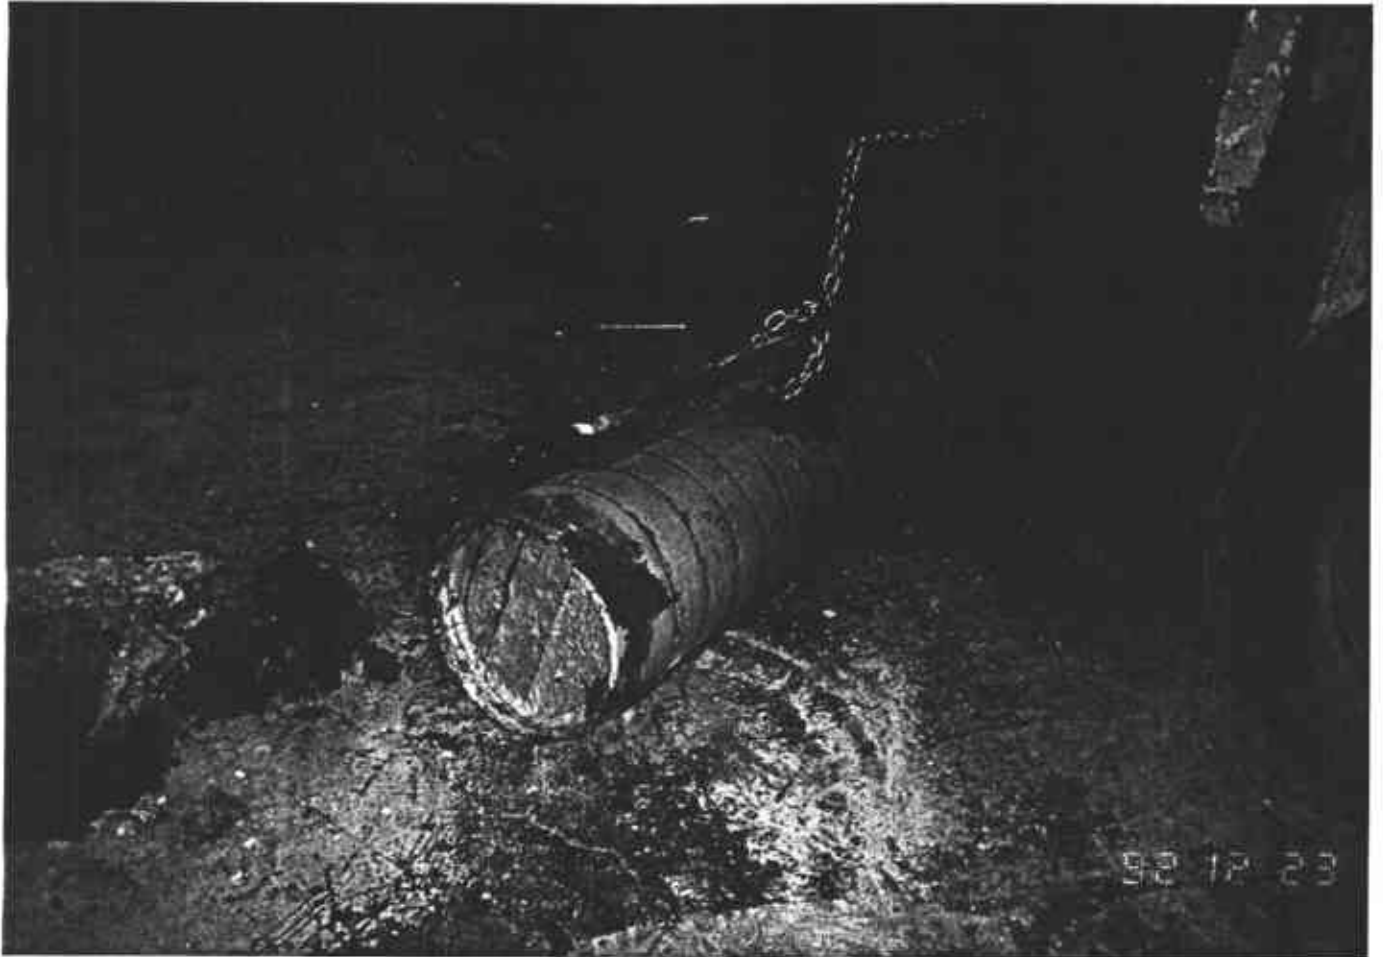
PHOTOGRAPH # 6

View of hoist No. H-3 after being pulled out of the ground.

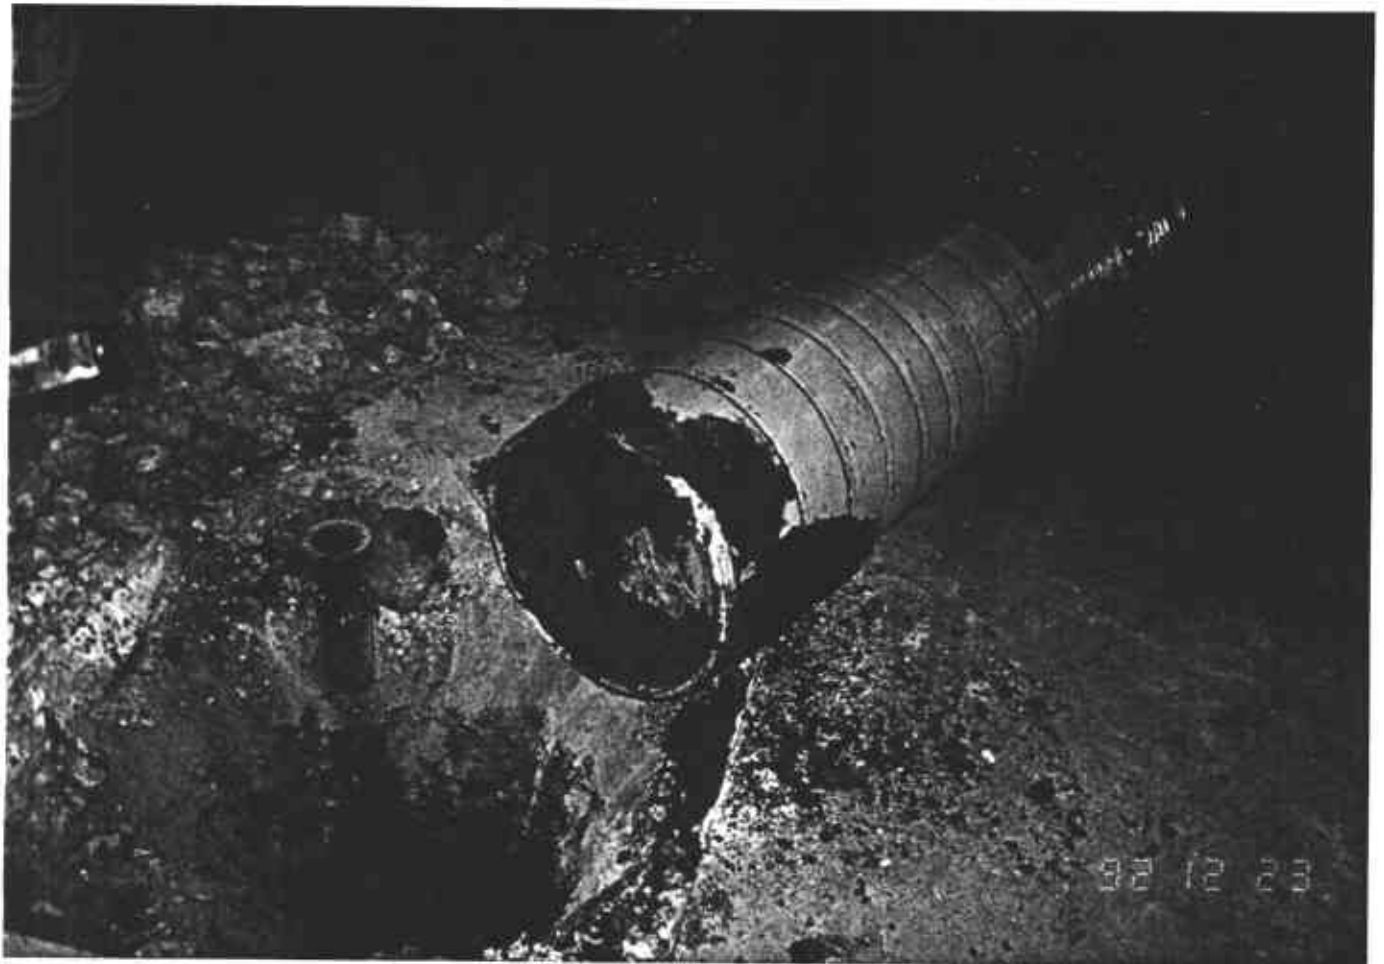
PHOTOGRAPH # 7

Of the five soil samples collected from the hoist pits, four were non-detect and only one (H-5) with 100 ppm concentration. All the hoists were observed well wrapped with no signs of corrosion or puncture. Laboratory data and field observations indicate the hoists were structurally sound with no leakage. The low concentration of hydrocarbon in soil sample from hoist H-5 is most likely from minor piping deterioration. The extent of impact is expected to be very small.

View of hoist No. H-5 after removal. The over-flow pipe of H-5 was separated from the hoist cylinder during removal because the pipe was not properly bolted onto the cylinder.

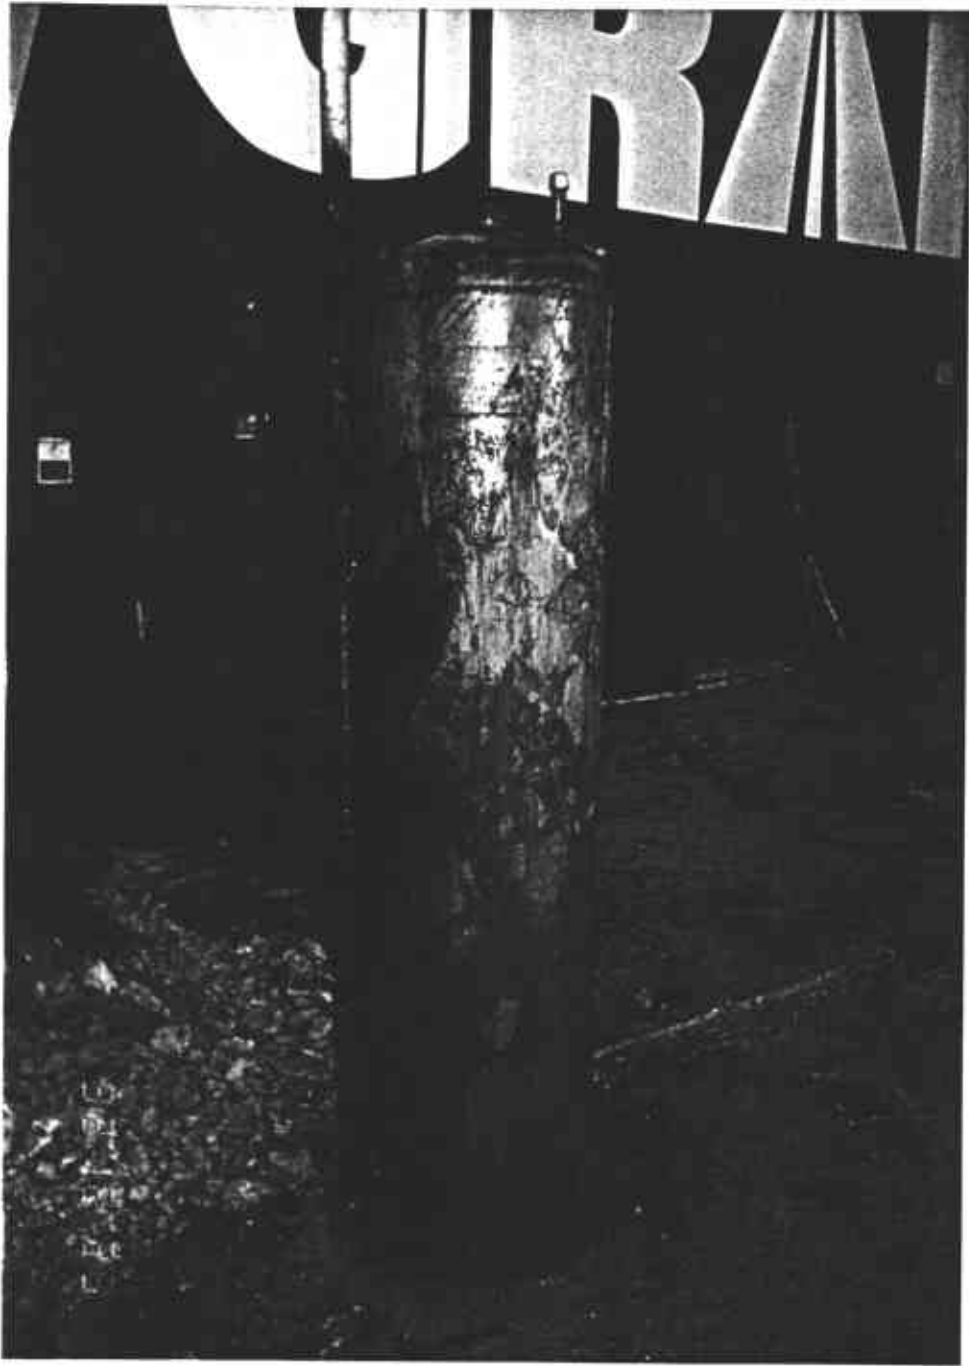
PHOTOGRAPH # 9

View of reservoir No. T-3 after removal.

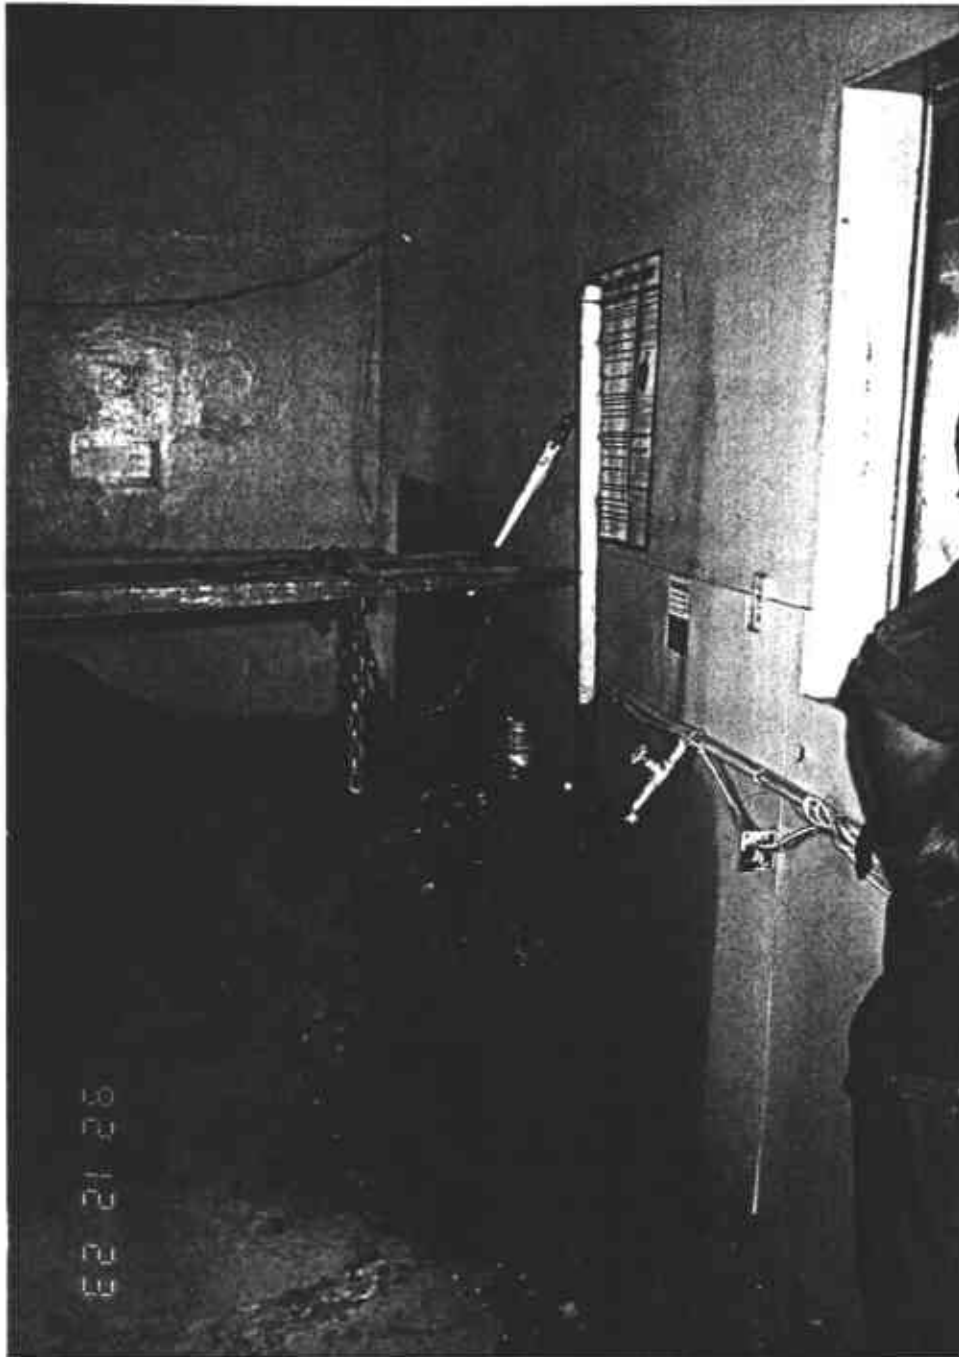
PHOTOGRAPH # 10

View of Reservoir No. T-5 being pulled out of the ground.
