**RE: Soil Remediation Progress Report, Hydraulic Hoist Removal Site,
Former Grand Auto Store, 2512 107th Avenue, Oakland, California**

SOIL REMEDIATION PROGRESS REPORT

**Hydraulic Hoist Removal Site
Former Grand Auto Store
2512 107th Avenue
Oakland, California**

ALLWEST PROJECT 92198.25
April 30, 1993

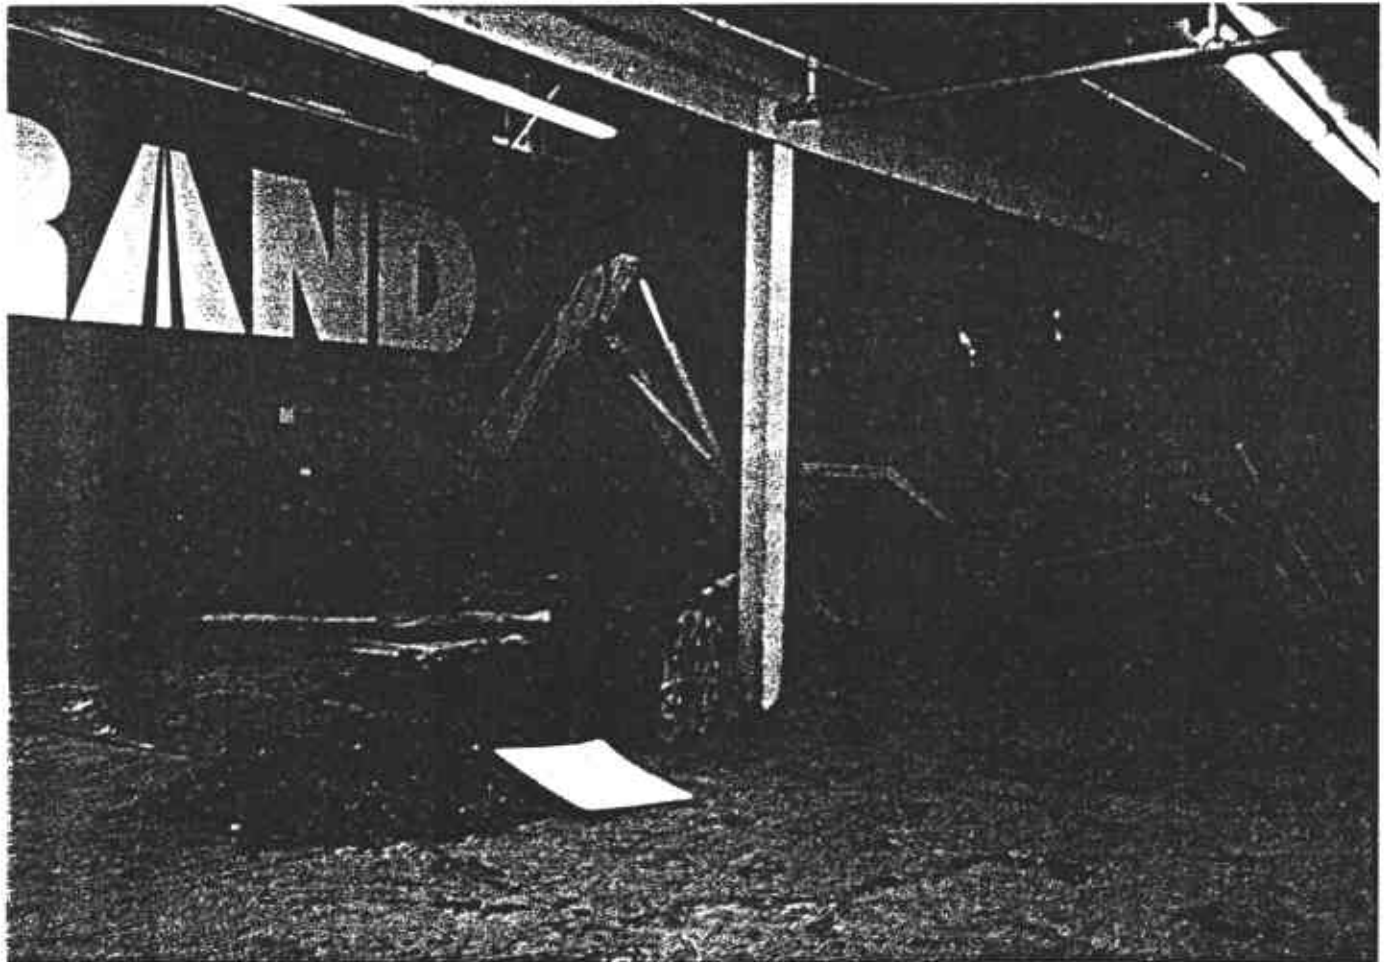
PHOTOGRAPH # 1

View of over-excavation to remove impacted soil from reservoir pit T-1/T-2.

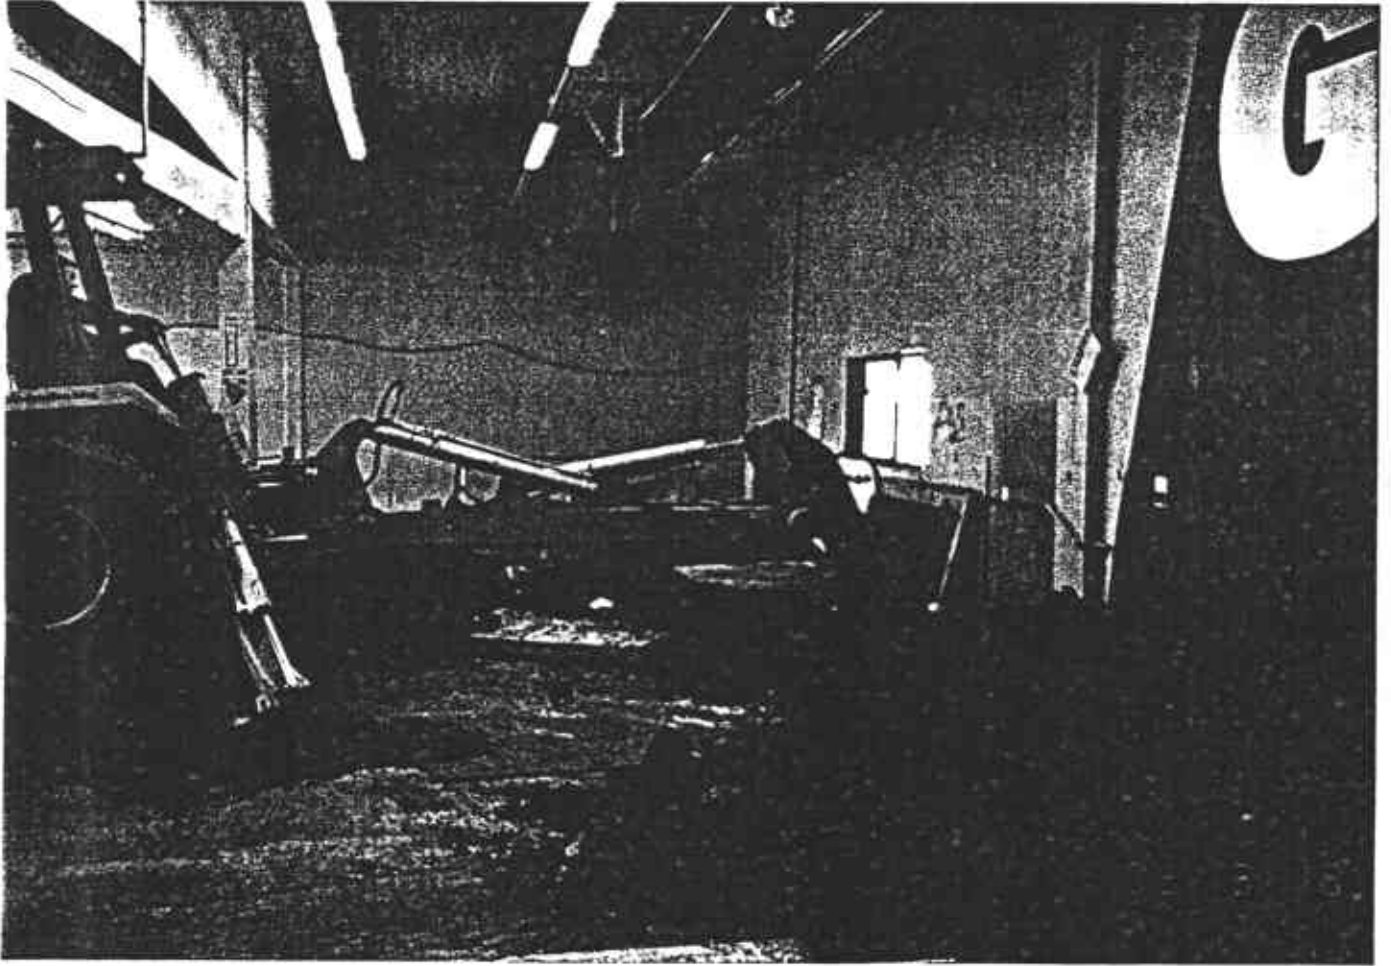
PHOTOGRAPH # 3

Since some stained soils were still visible in pit T-3/T-4 at a depth of 8 feet, additional soil samples below the over-excavation limit of this pit were collected to investigate the possibility that the extent of soil staining only extended to a few feet further below. A 3-inch diameter bore hole in the middle of the pit was hand augured by an engineer from *AllWest* on April 9, 1993. The bore hole extended 5 feet below the bottom of the pit to a depth of 13 feet bgs. A total of two soil samples, one at a depth of 12 feet and the other at 13 feet, were collected from the bore hole during this investigative sampling.

The results of verification analyses demonstrate that the over-excavation has removed all hydraulic oil impacted soils from the former hoist/reservoir pits H-5, T-1/T-2, and T-5. The investigative samples from pit T-3/T-4 indicate hydraulic oil impacted soils extend to a depth of at least 13 feet. However, due to the proximity of building foundations to the former reservoir sites, further excavation to remove the remaining impacted soils would require extensive underpinning and shoring of the foundation system.

View of over-excavation at reservoir pit T-3/T-4.

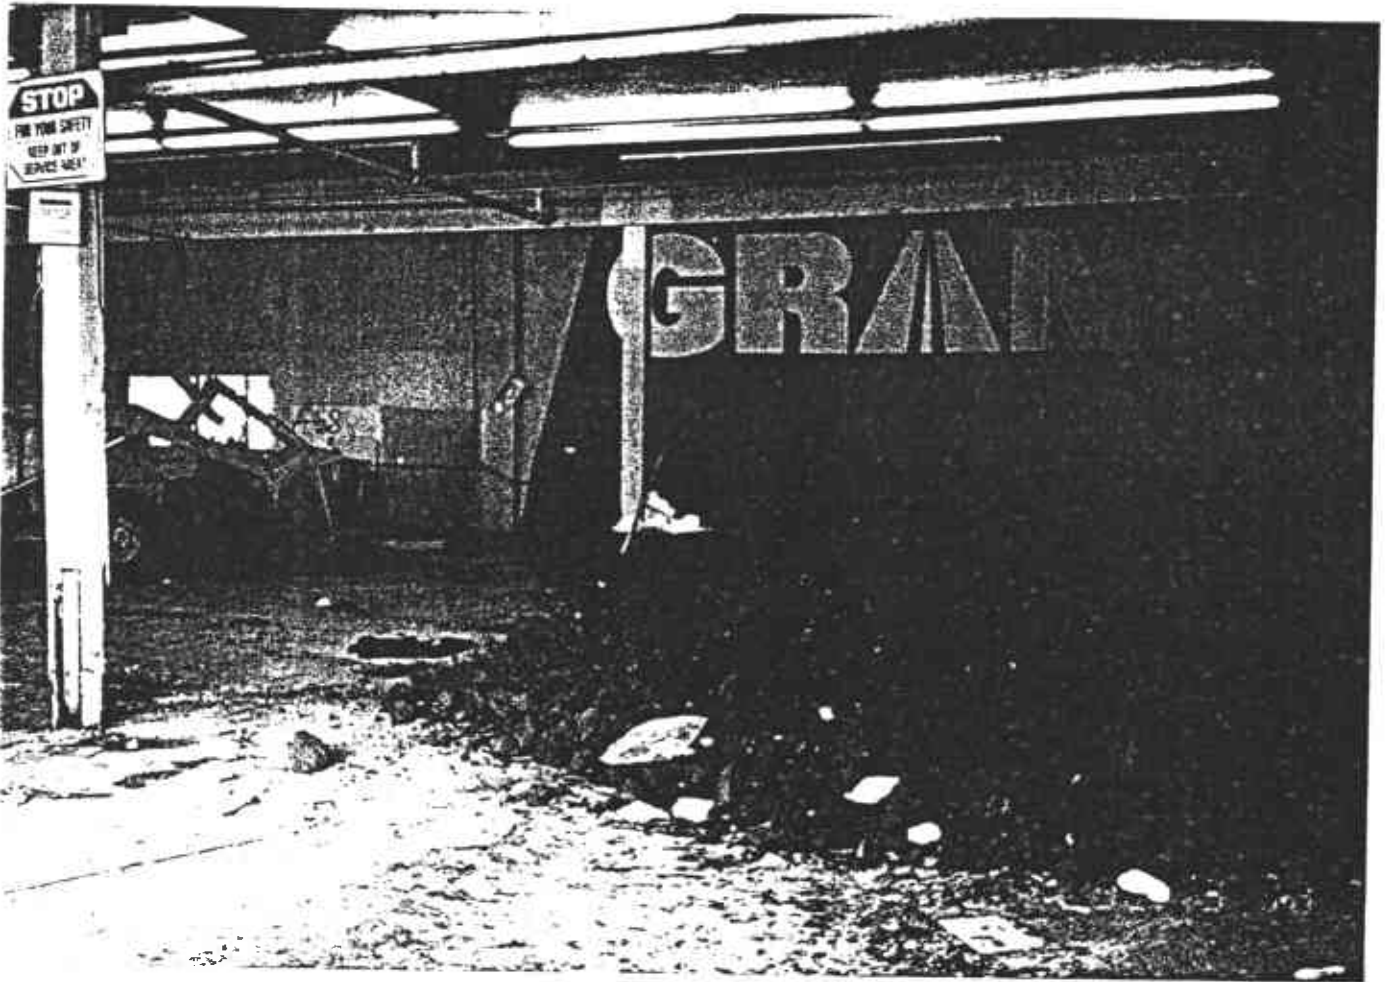
PHOTOGRAPH # 7

View of waste soils from over-excavation temporarily stockpiled inside the building.

3. Direct the remedial contractor, *Stokley Construction*, to dispose waste soils currently stockpiled inside the building. Disposal method should be the previously agreed upon treatment/recycling process, which would relieve *PACCAR Automotive* of all environmental liabilities associated with the disposition of those waste soils.
