March 1, 2000

49600.4

**Anomaly Investigation**  
**9<sup>th</sup> Street and Broadway**  
**Oakland, California**

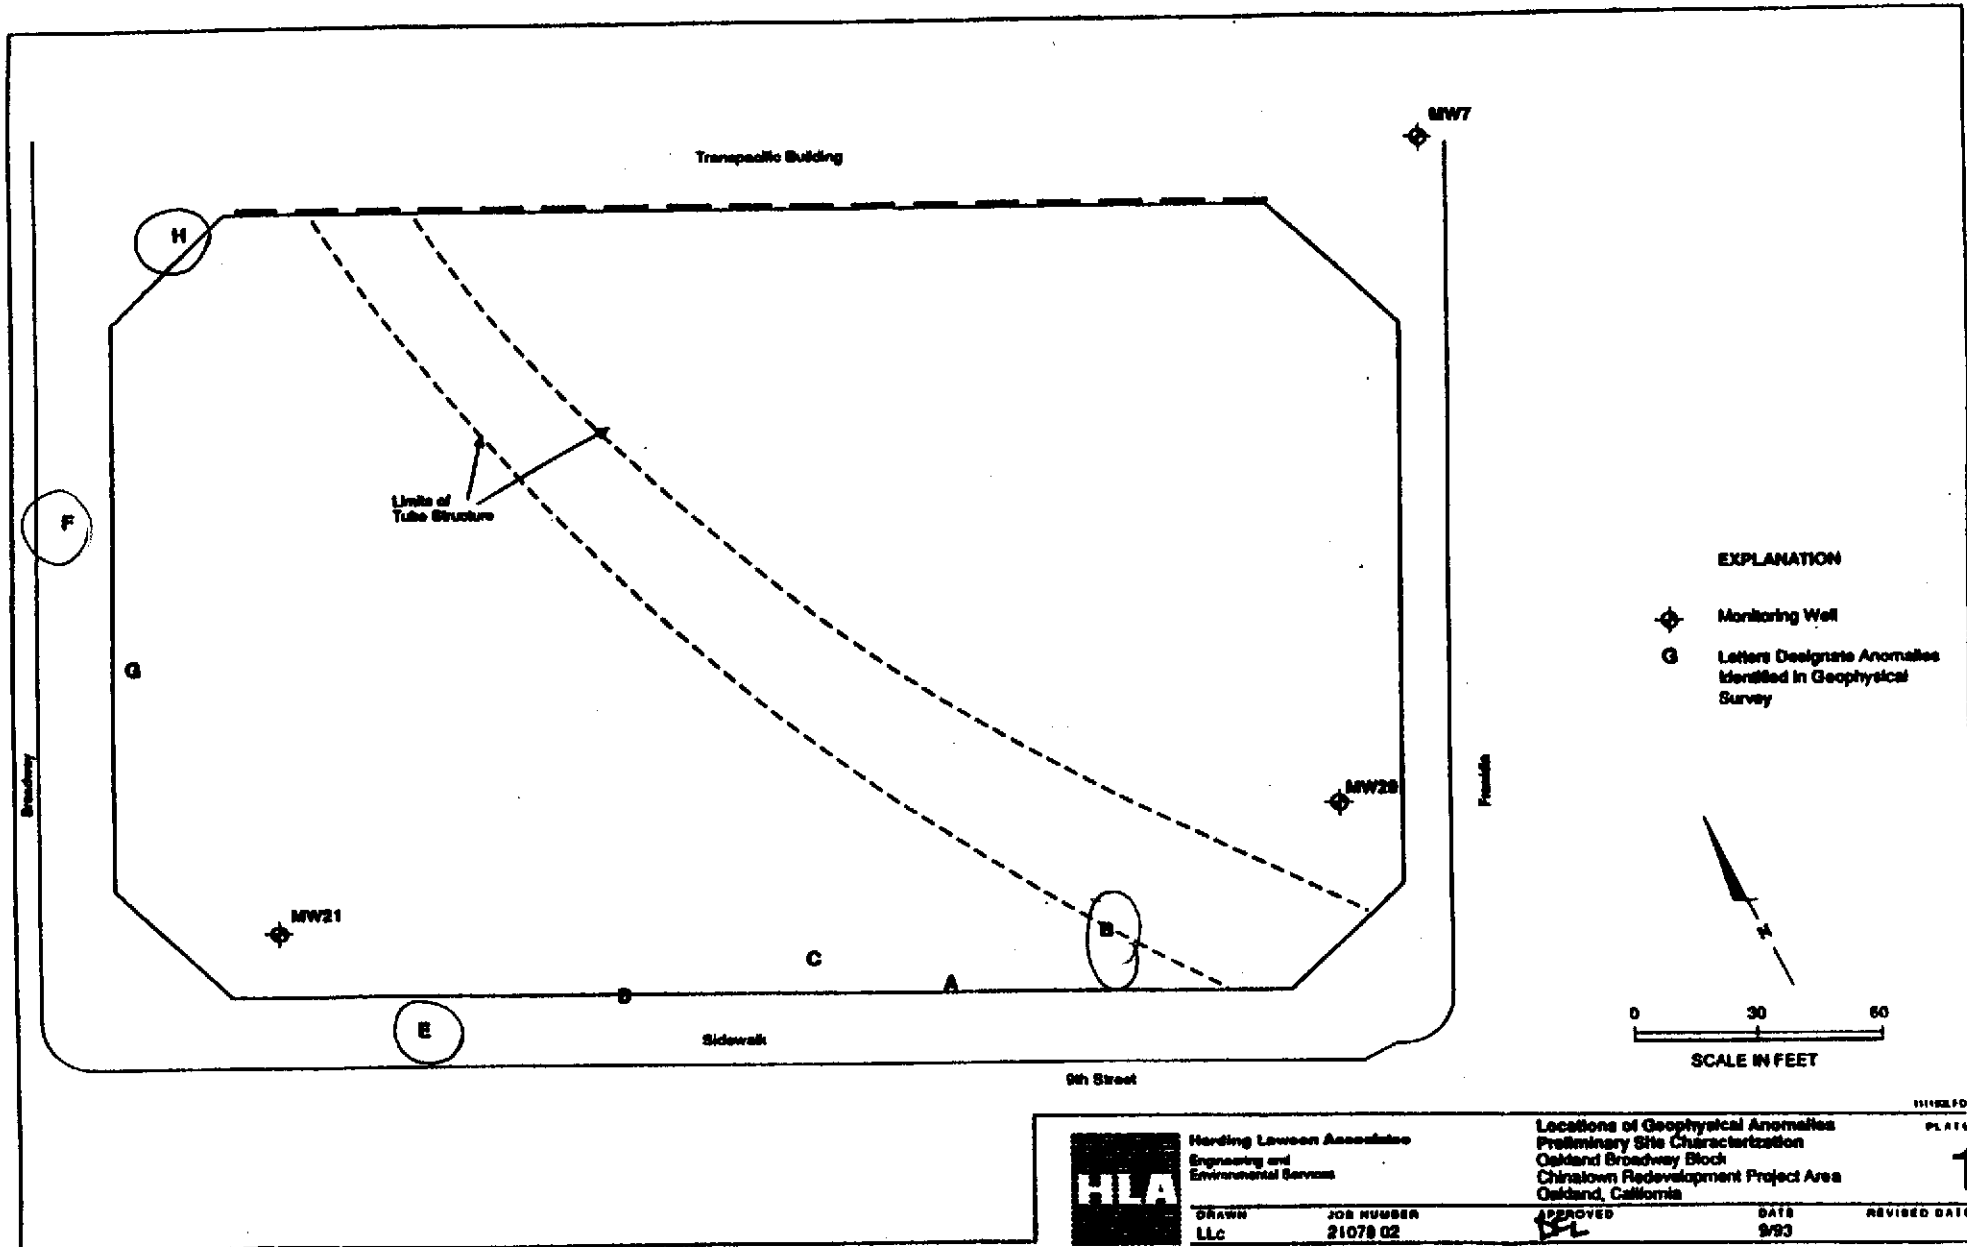
*Broadway, Oakland, California*, dated November 11, 1993. The site location map (Plate C-1 of HLA's 1993 report, see attachment Plate 1) showing the eight locations, designated A through H, provided the starting point for this investigation. These locations were identified in a 1993 geophysical survey as likely to contain buried metal. HLA's 1993 report recommended further investigation of locations A, C, D, E, and G.

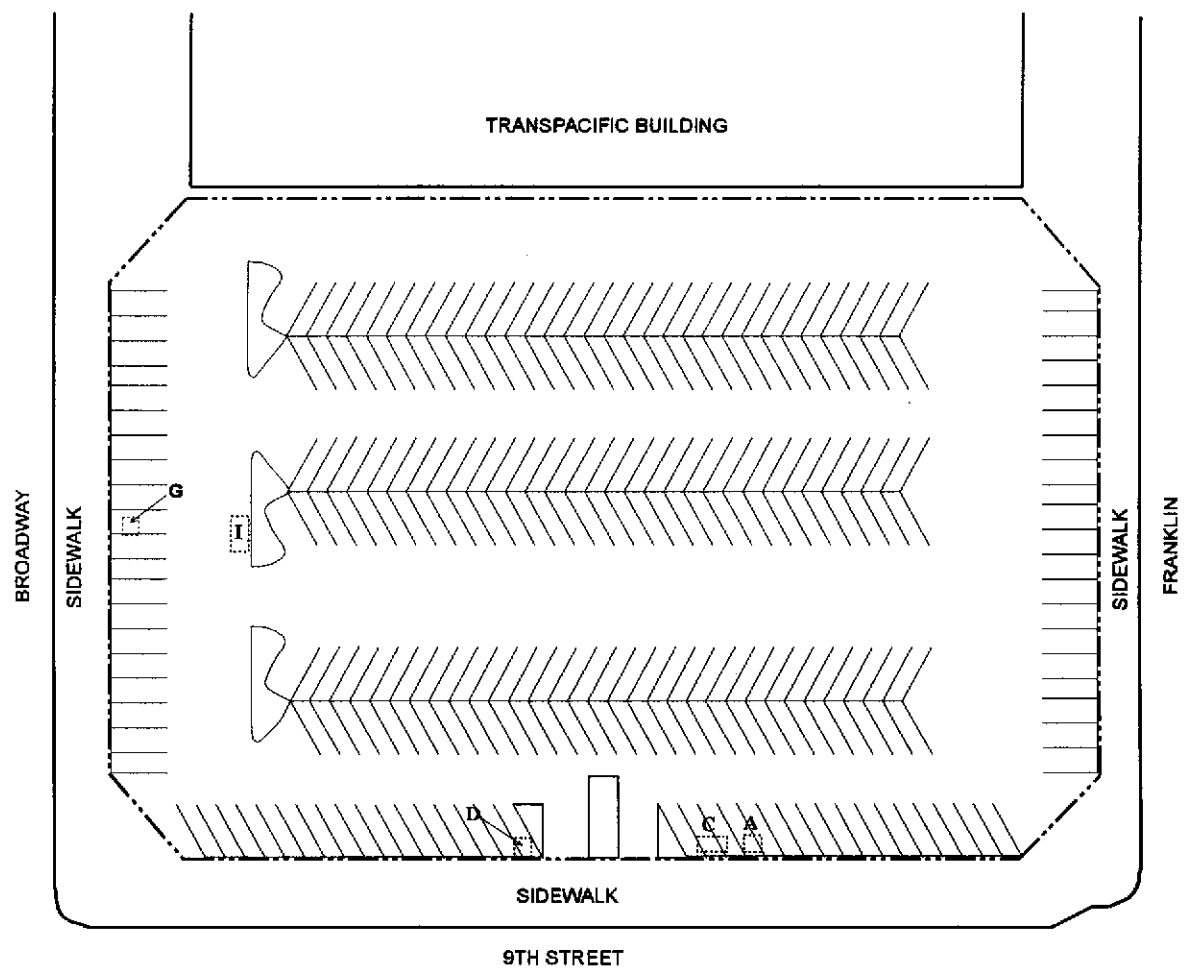
PLATE  
**2**

While surveying location G, HLA detected an additional metallic anomaly not detected in the 1993 geophysical survey. This metallic anomaly was located approximately 30 feet to the east of location G and is designated location I (see Plate 2). 2

- A Possible tank: high amplitude, may extend under wall, wall contains metal reinforcement which interfered with instruments
- B Not likely to be tank: long, thin, and shallow
- C Not likely to be tank: low amplitude
- D Not likely to be tank: too thin
- E Not likely to be tank: shallow, possible utility
- F Not likely to be tank: shallow and small
- G Possible tank: high amplitude but small
- H Not likely to be tank: high amplitude but ~~was~~ location was recently trenched by Developer's geotechnical consultant
- I Possible tank: additional anomaly located when investigating G, high amplitude and broad (see Plate 2)

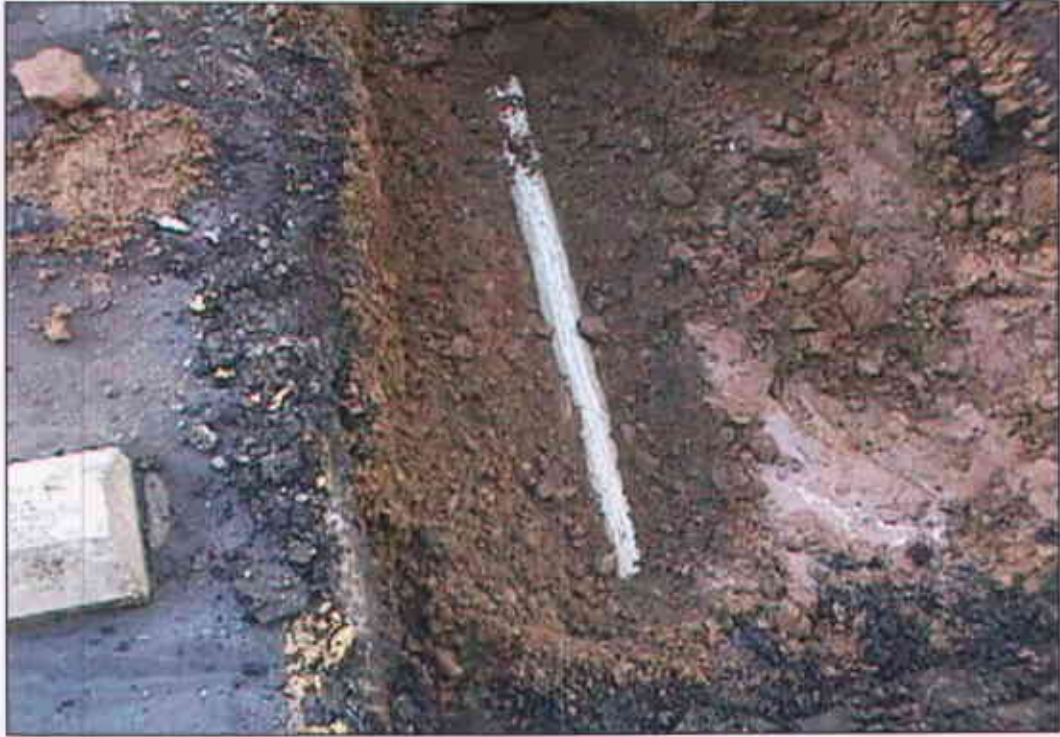
At approximately 1.5 feet bgs, a 2-inch PVC pipe was uncovered (see Photograph 1). The excavation was moved slightly to the north and continued to a final depth of 5 feet bgs. No evidence of a UST or fuel piping was observed.

Photograph 1. Location A - 2-inch PVC pipe

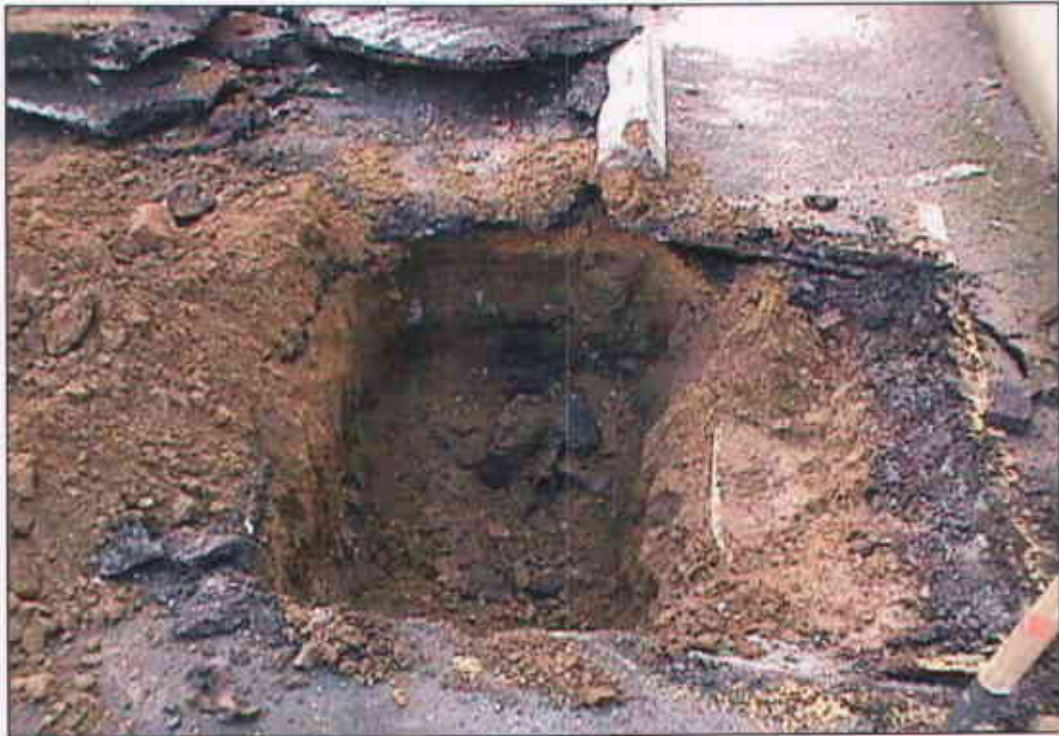
At approximately 1 foot bgs, a 1-inch electrical conduit made of metal was uncovered (see Photograph 2). The excavation was moved slightly to the north and continued to a final depth of 5 feet bgs. No evidence of a UST or fuel piping was observed.

Photograph 2. Location C - metal conduit

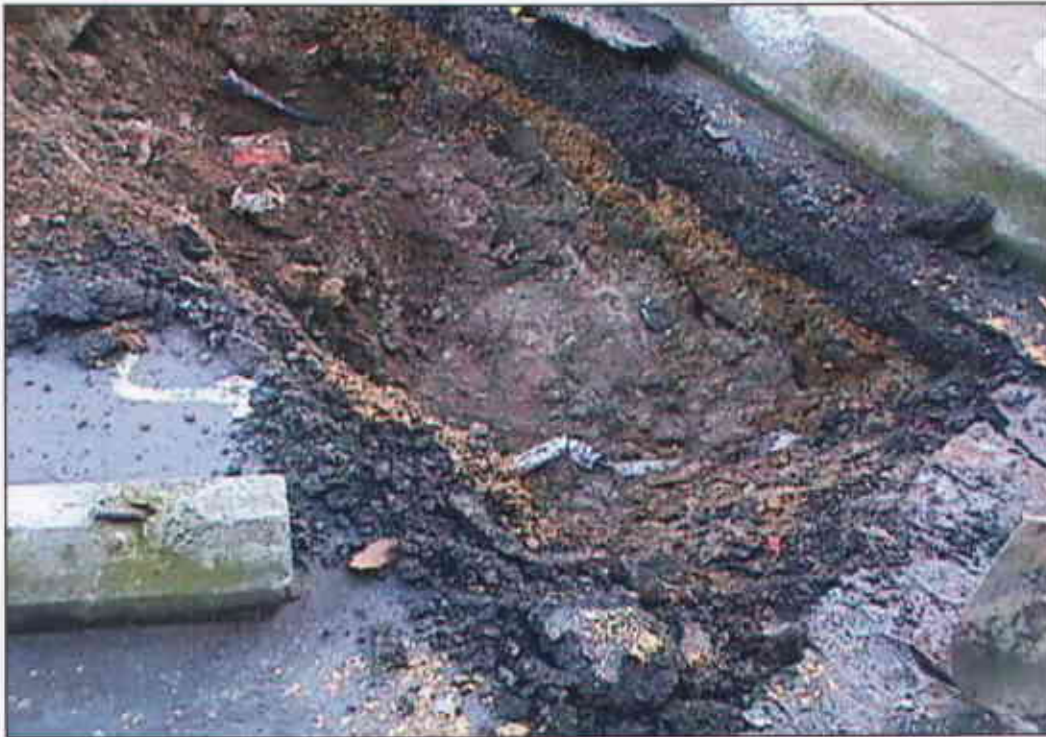
In the upper foot at this location, a 3/4-inch metal pipe, a large metal footing and brick debris were uncovered (see Photographs 3 and 4). The excavation terminated at 2.5 feet bgs due to difficulty digging through the brick materials (see Photograph 5). No evidence of a UST or fuel piping was observed.

Photograph 3. Location D - metal piping

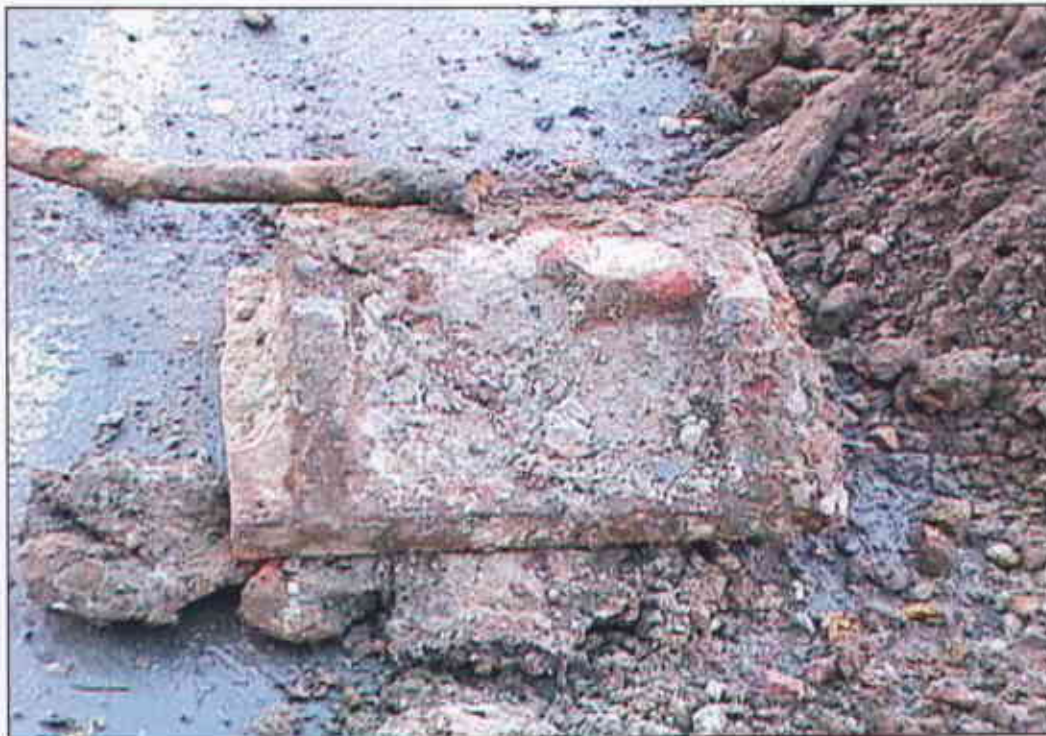
Photograph 4. Location D - metal footing

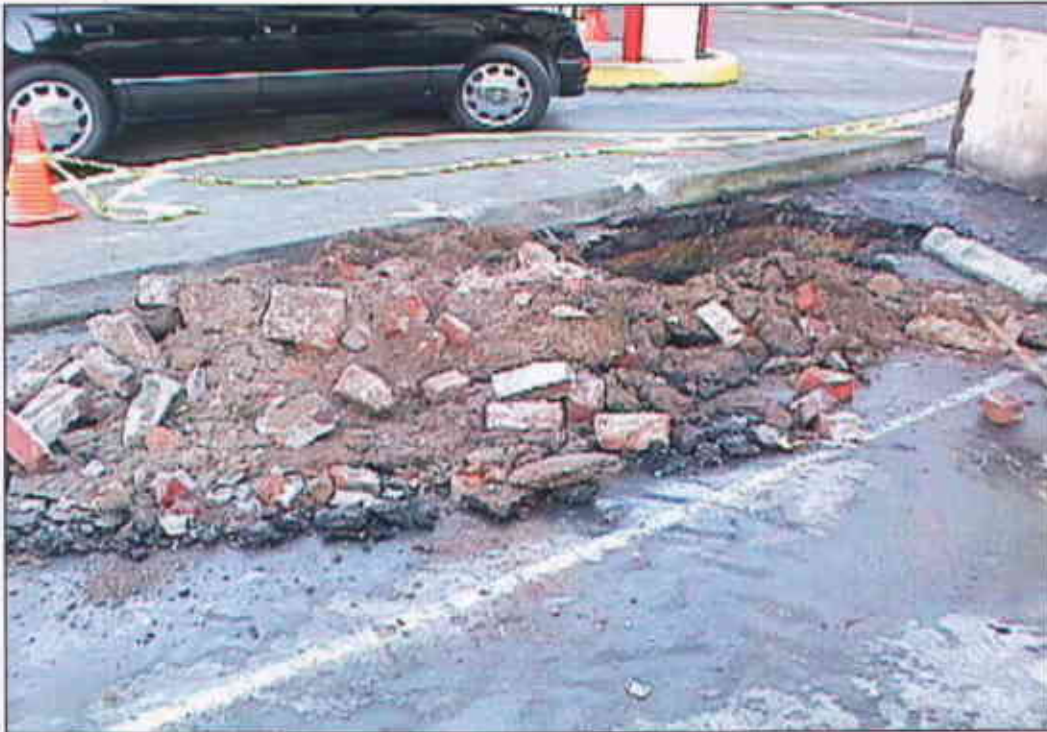
Photograph 5. Location D - brick

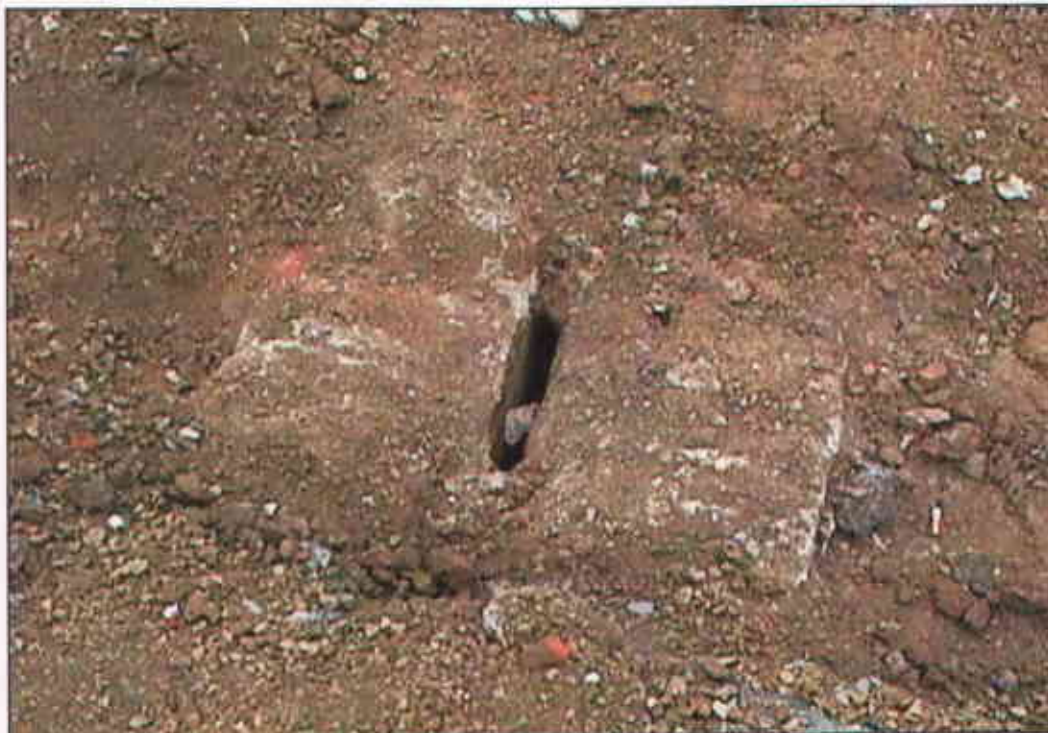
At approximately 1 foot bgs two subterranean concrete walls were uncovered (see Photograph 6). The excavation was moved slightly to the north and continued to a final depth of 5 feet bgs. No evidence of a UST or fuel piping was observed.

Photograph 6. Location G - subterranean structure

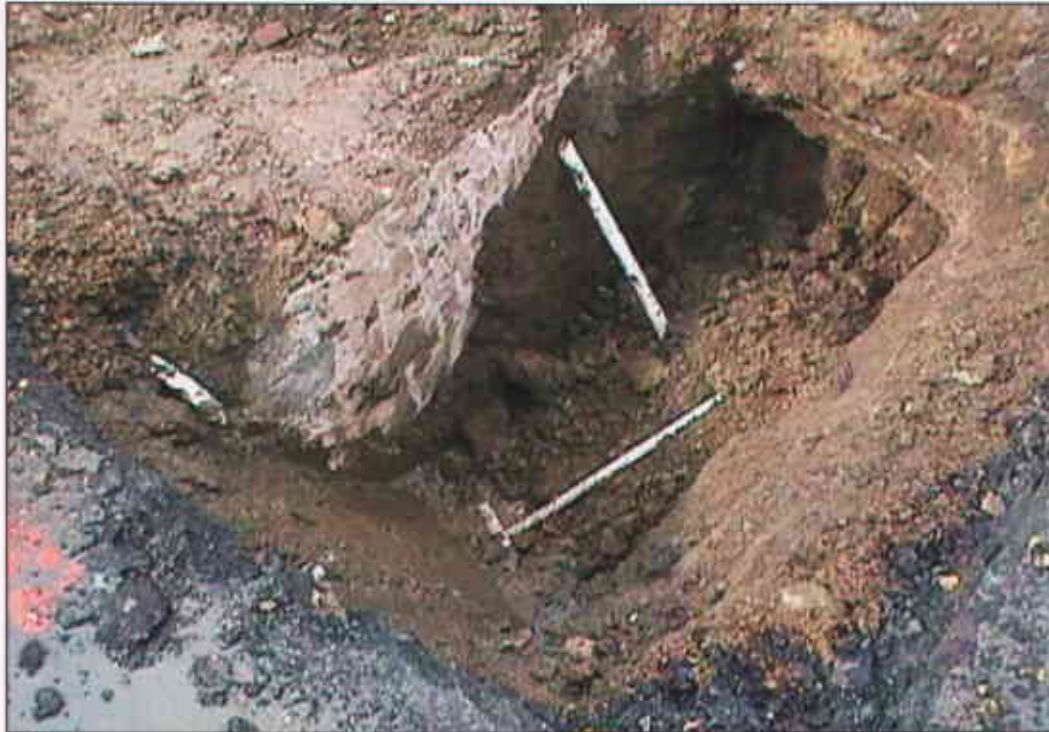
At approximately 1 foot bgs, a 1-inch PVC pipe was uncovered, which appeared to be an abandoned irrigation line. A subterranean concrete structure was also found at this location (see Photograph 7), and it appeared to be an extension of the structure noted at location G. An approximately 18-inch section of metal pipe (see Photograph 8) was also uncovered from this location. We observed no indication that the pipe had been used to convey a fuel product. Because of rust at either end, it appeared to have been in its current state (i.e. a small section) for some time. The excavation was continued to a final depth of 5 feet bgs. No evidence of a UST or fuel piping was observed.

Photograph 7. Location 1 - subterranean structure and pieces of PVC pipe

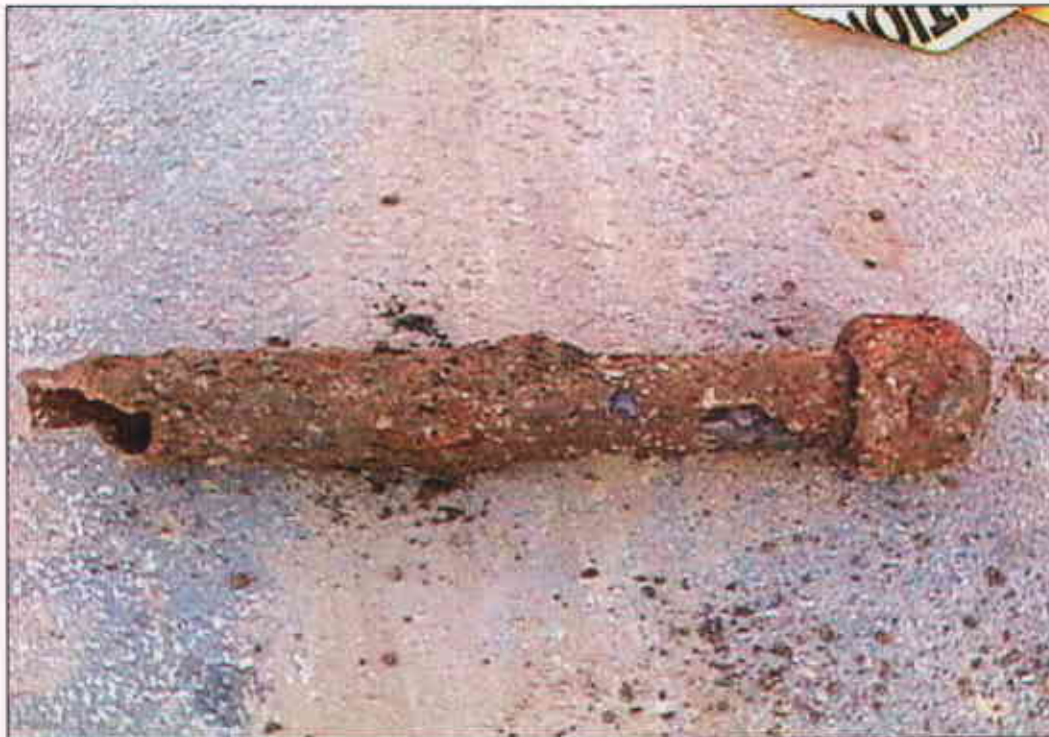
Photograph 8. Location 1 - metal pipe
