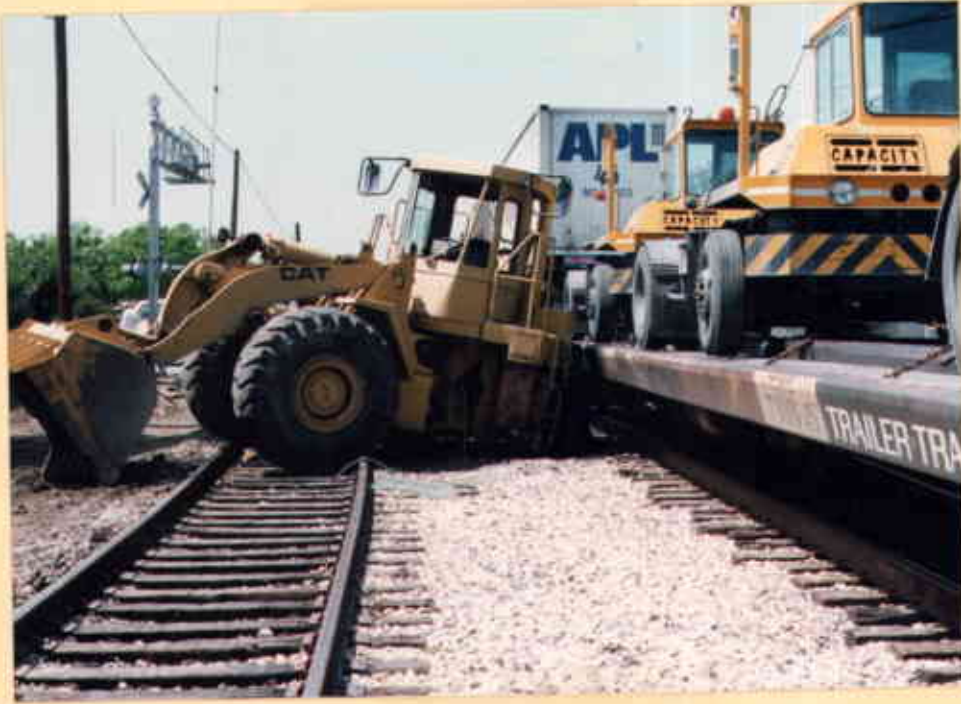
①

Standing between
main & siding
Looking westward
approx. 50' east
of Ave "A".
Loader leaning
against train.

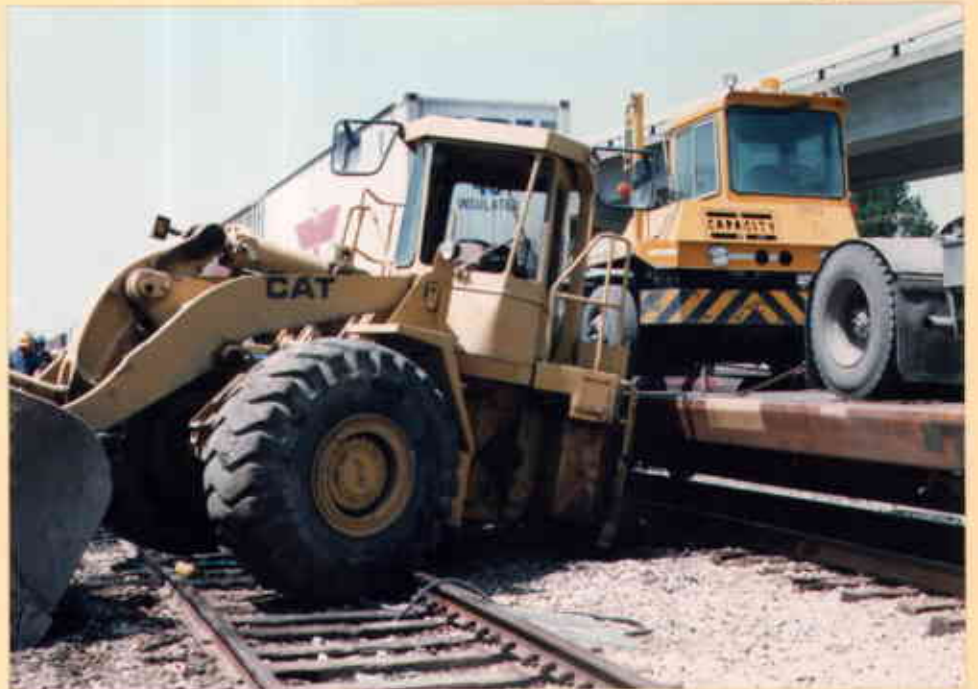
②

Standing between
passing track
& Fence looking
westward.
Loader leaning
against train on
south side of
track.

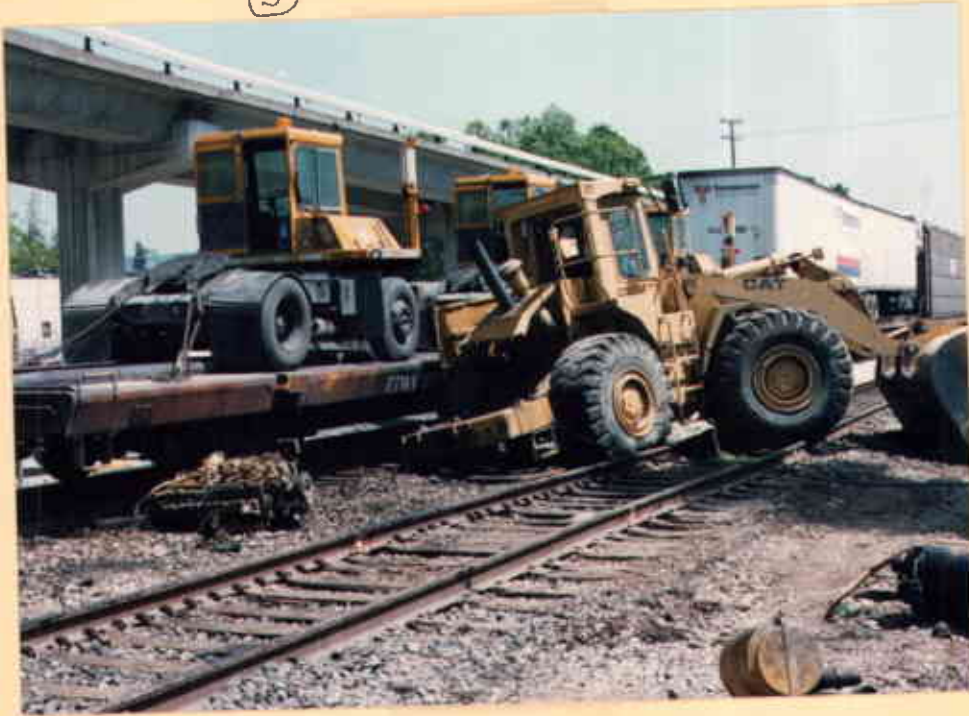
(3)

Standing on South Side of track approx 10' off Ave "A" Looking westward. Loader leaning against train.

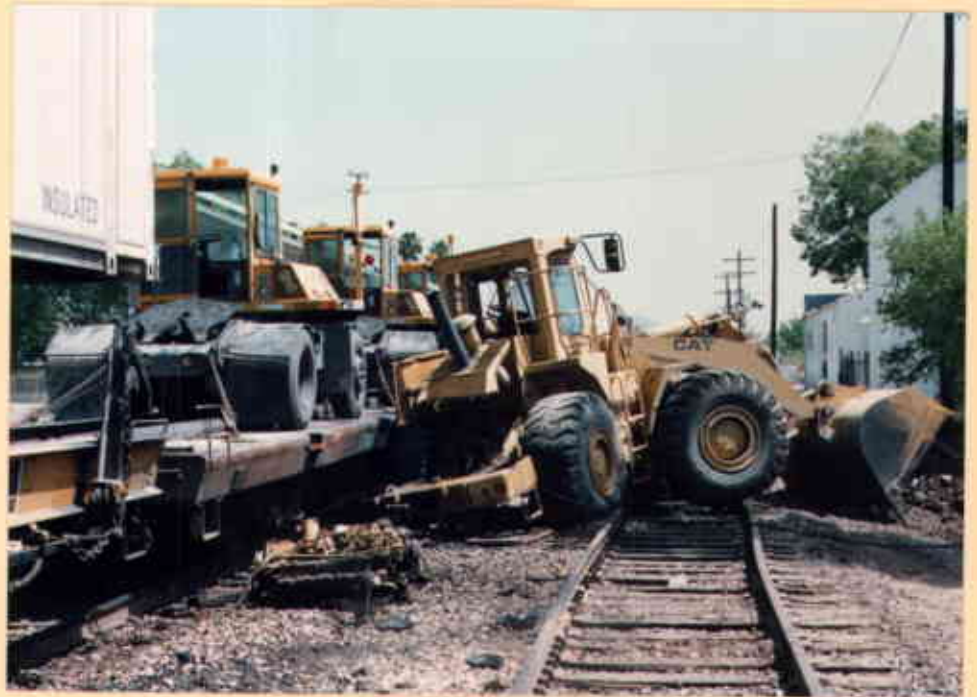
(4)

Standing in the middle of passing track looking westward. Note position of motor.

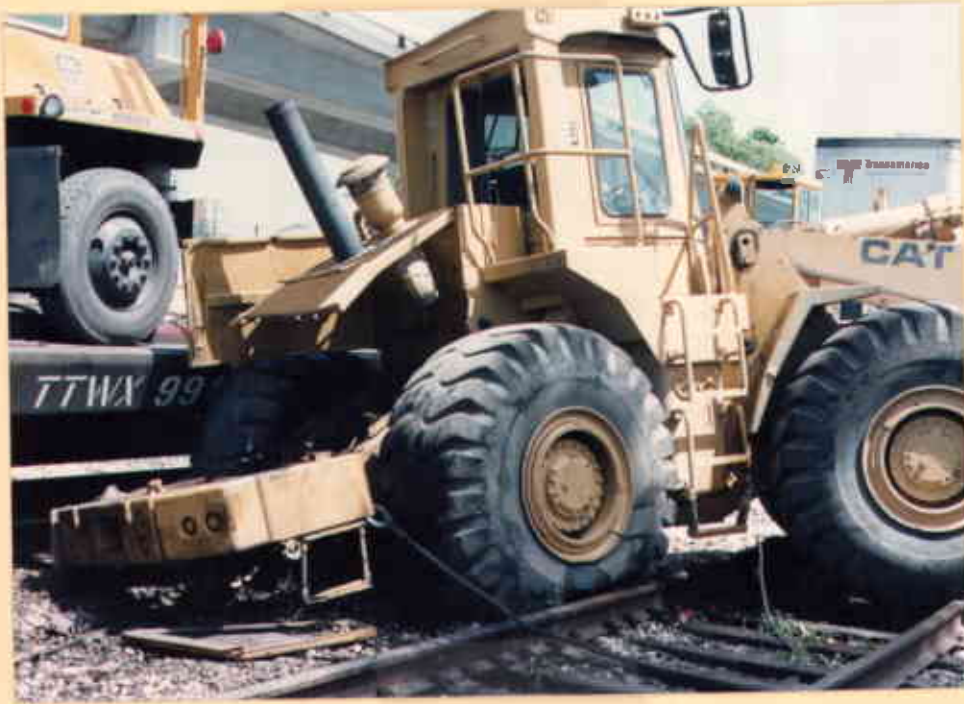
5

Standing on
South Side of
right of way

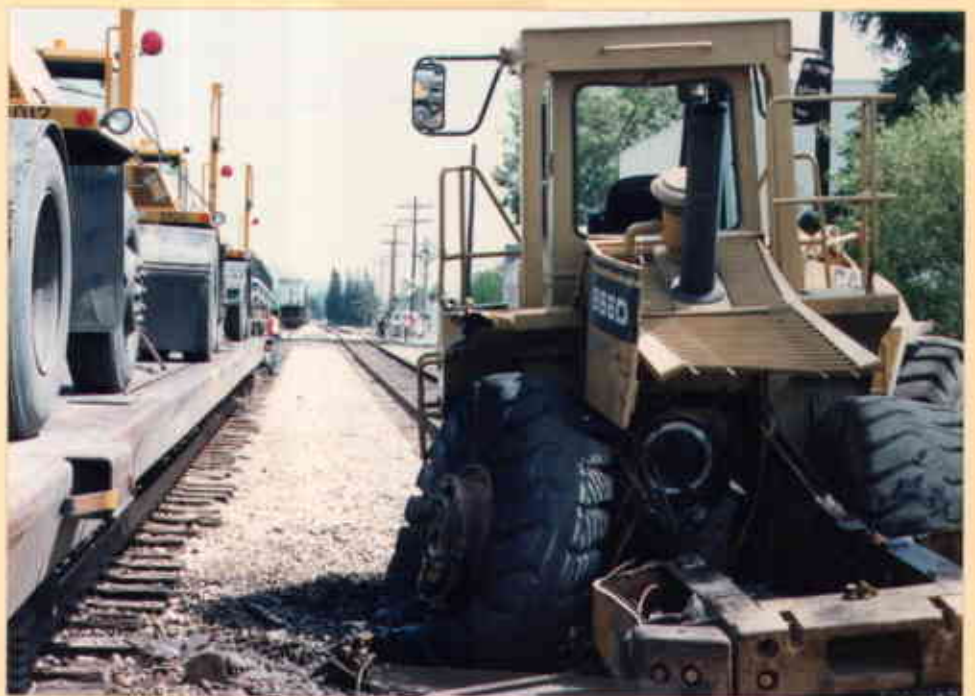
6

Standing approx.
50' east of Ave
"A" between main
+ passing
track, Loader
has been removed
From Fouling main
track - now
sitting directly
on top of
passing track.

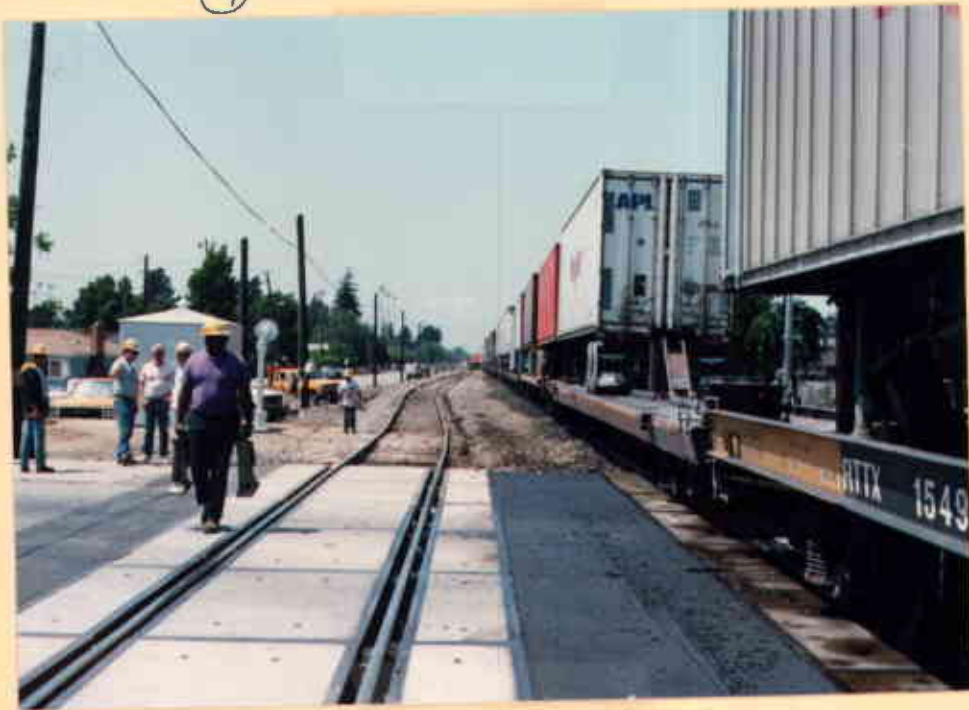
⑨

Standing on the east edge of Avenue "A" looking westward. Note wheel marks on xing + siding misalignment on passing track.

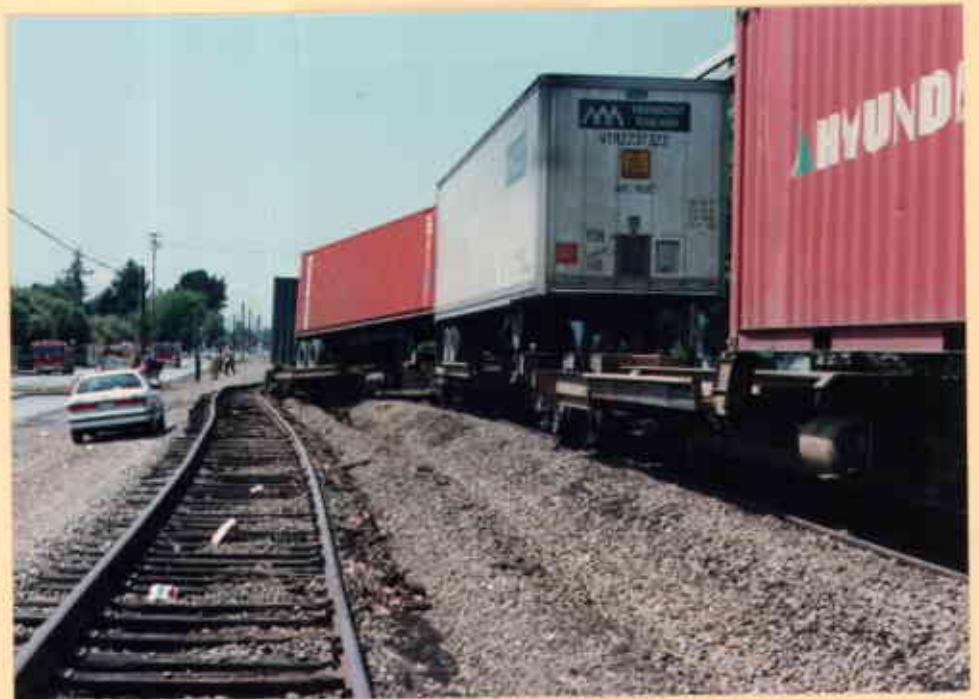
⑧

Standing in middle of passing track looking westward - approx 6 cars from head end of train. Cars 2+3 derailed.

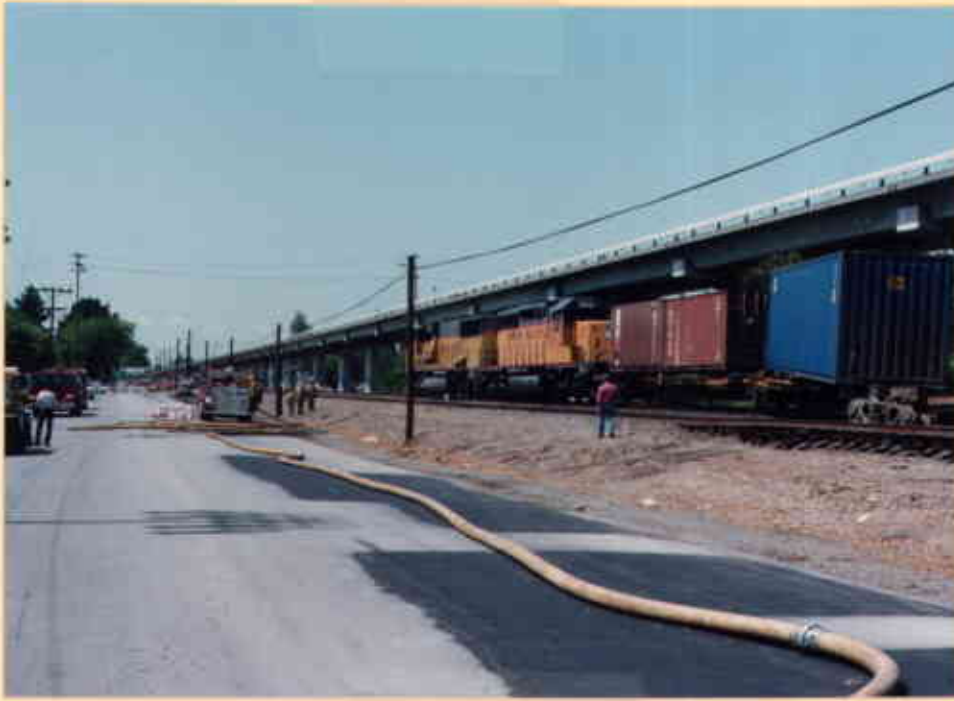
9

Standing in the middle of Adjacent Street, South Side of main track. Note 2nd Container is sitting on 2nd car - articulated car # TTAX 76832. truck #3 derailed.

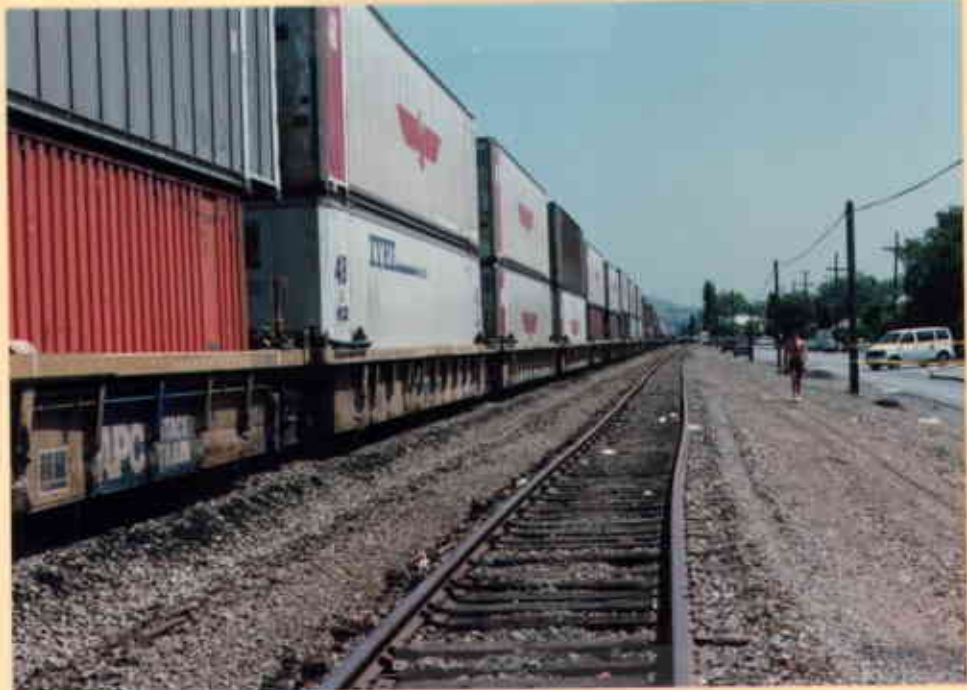
10

Standing in the middle of passing track looking westward - approx 7 poles to Ave "A". Note damage on APC cars

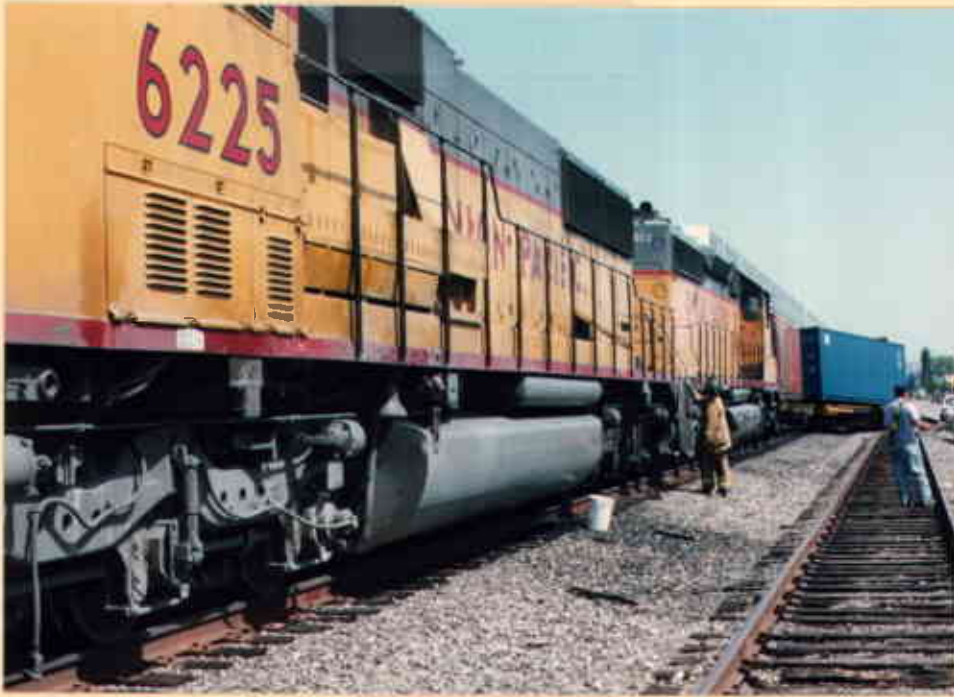
11

Standing beside
lead locomotive
looking westward.
Note damage on
both locomotives
passing track
severely
misaligned.

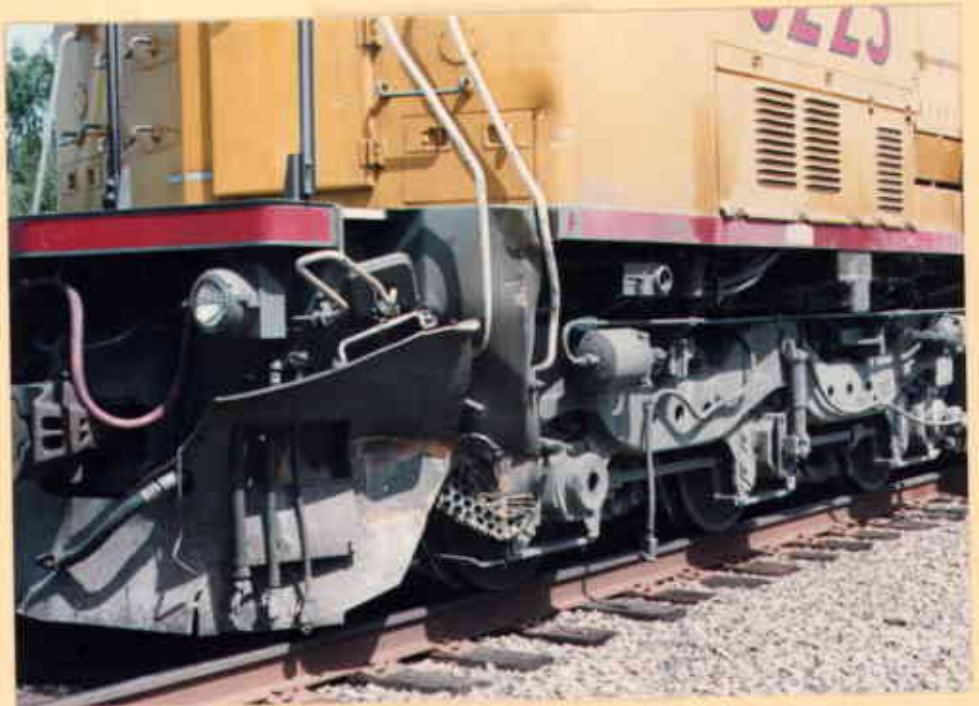
12

Standing between
passing track
& main track
at head end of
train. Note
damage to lead
locomotive 6225.

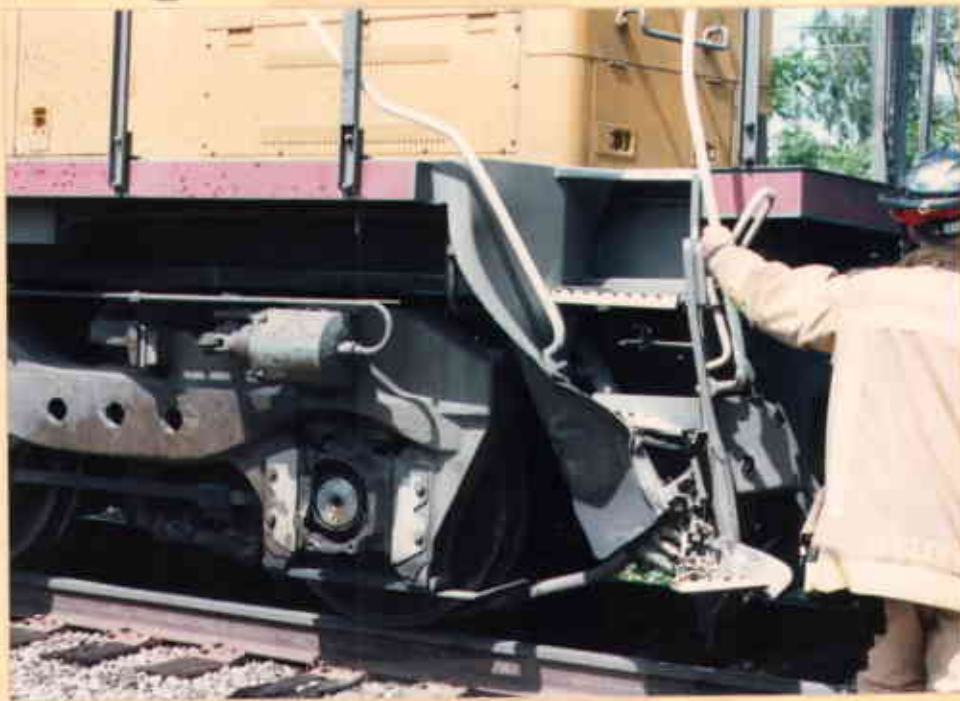
13

Standing between
passing + main
track. picture
taken of rear
end of lead
Locomotive,
Axel # L-6.

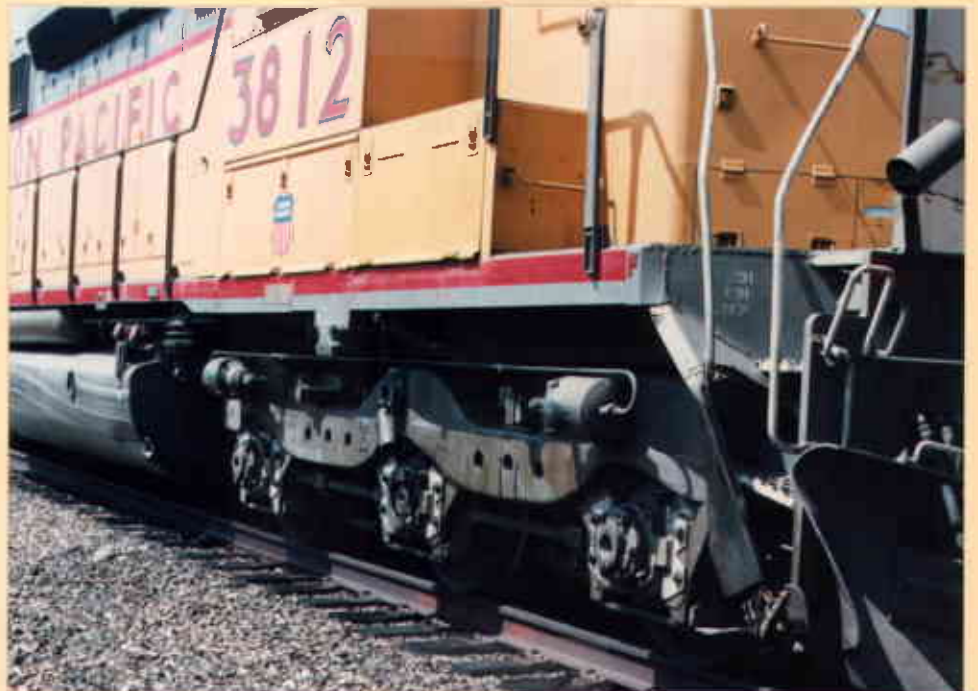
14

Standing between
passing track
+ main track
at rear of 2nd
Locomotive.

note: damage
of R-2 bearing
cap
