## ENVIRONMENTAL SITE CHARACTERIZATION

Oak Walk Redevelopment Site  
Emeryville, California

April 2005

Project No.: 0004.083

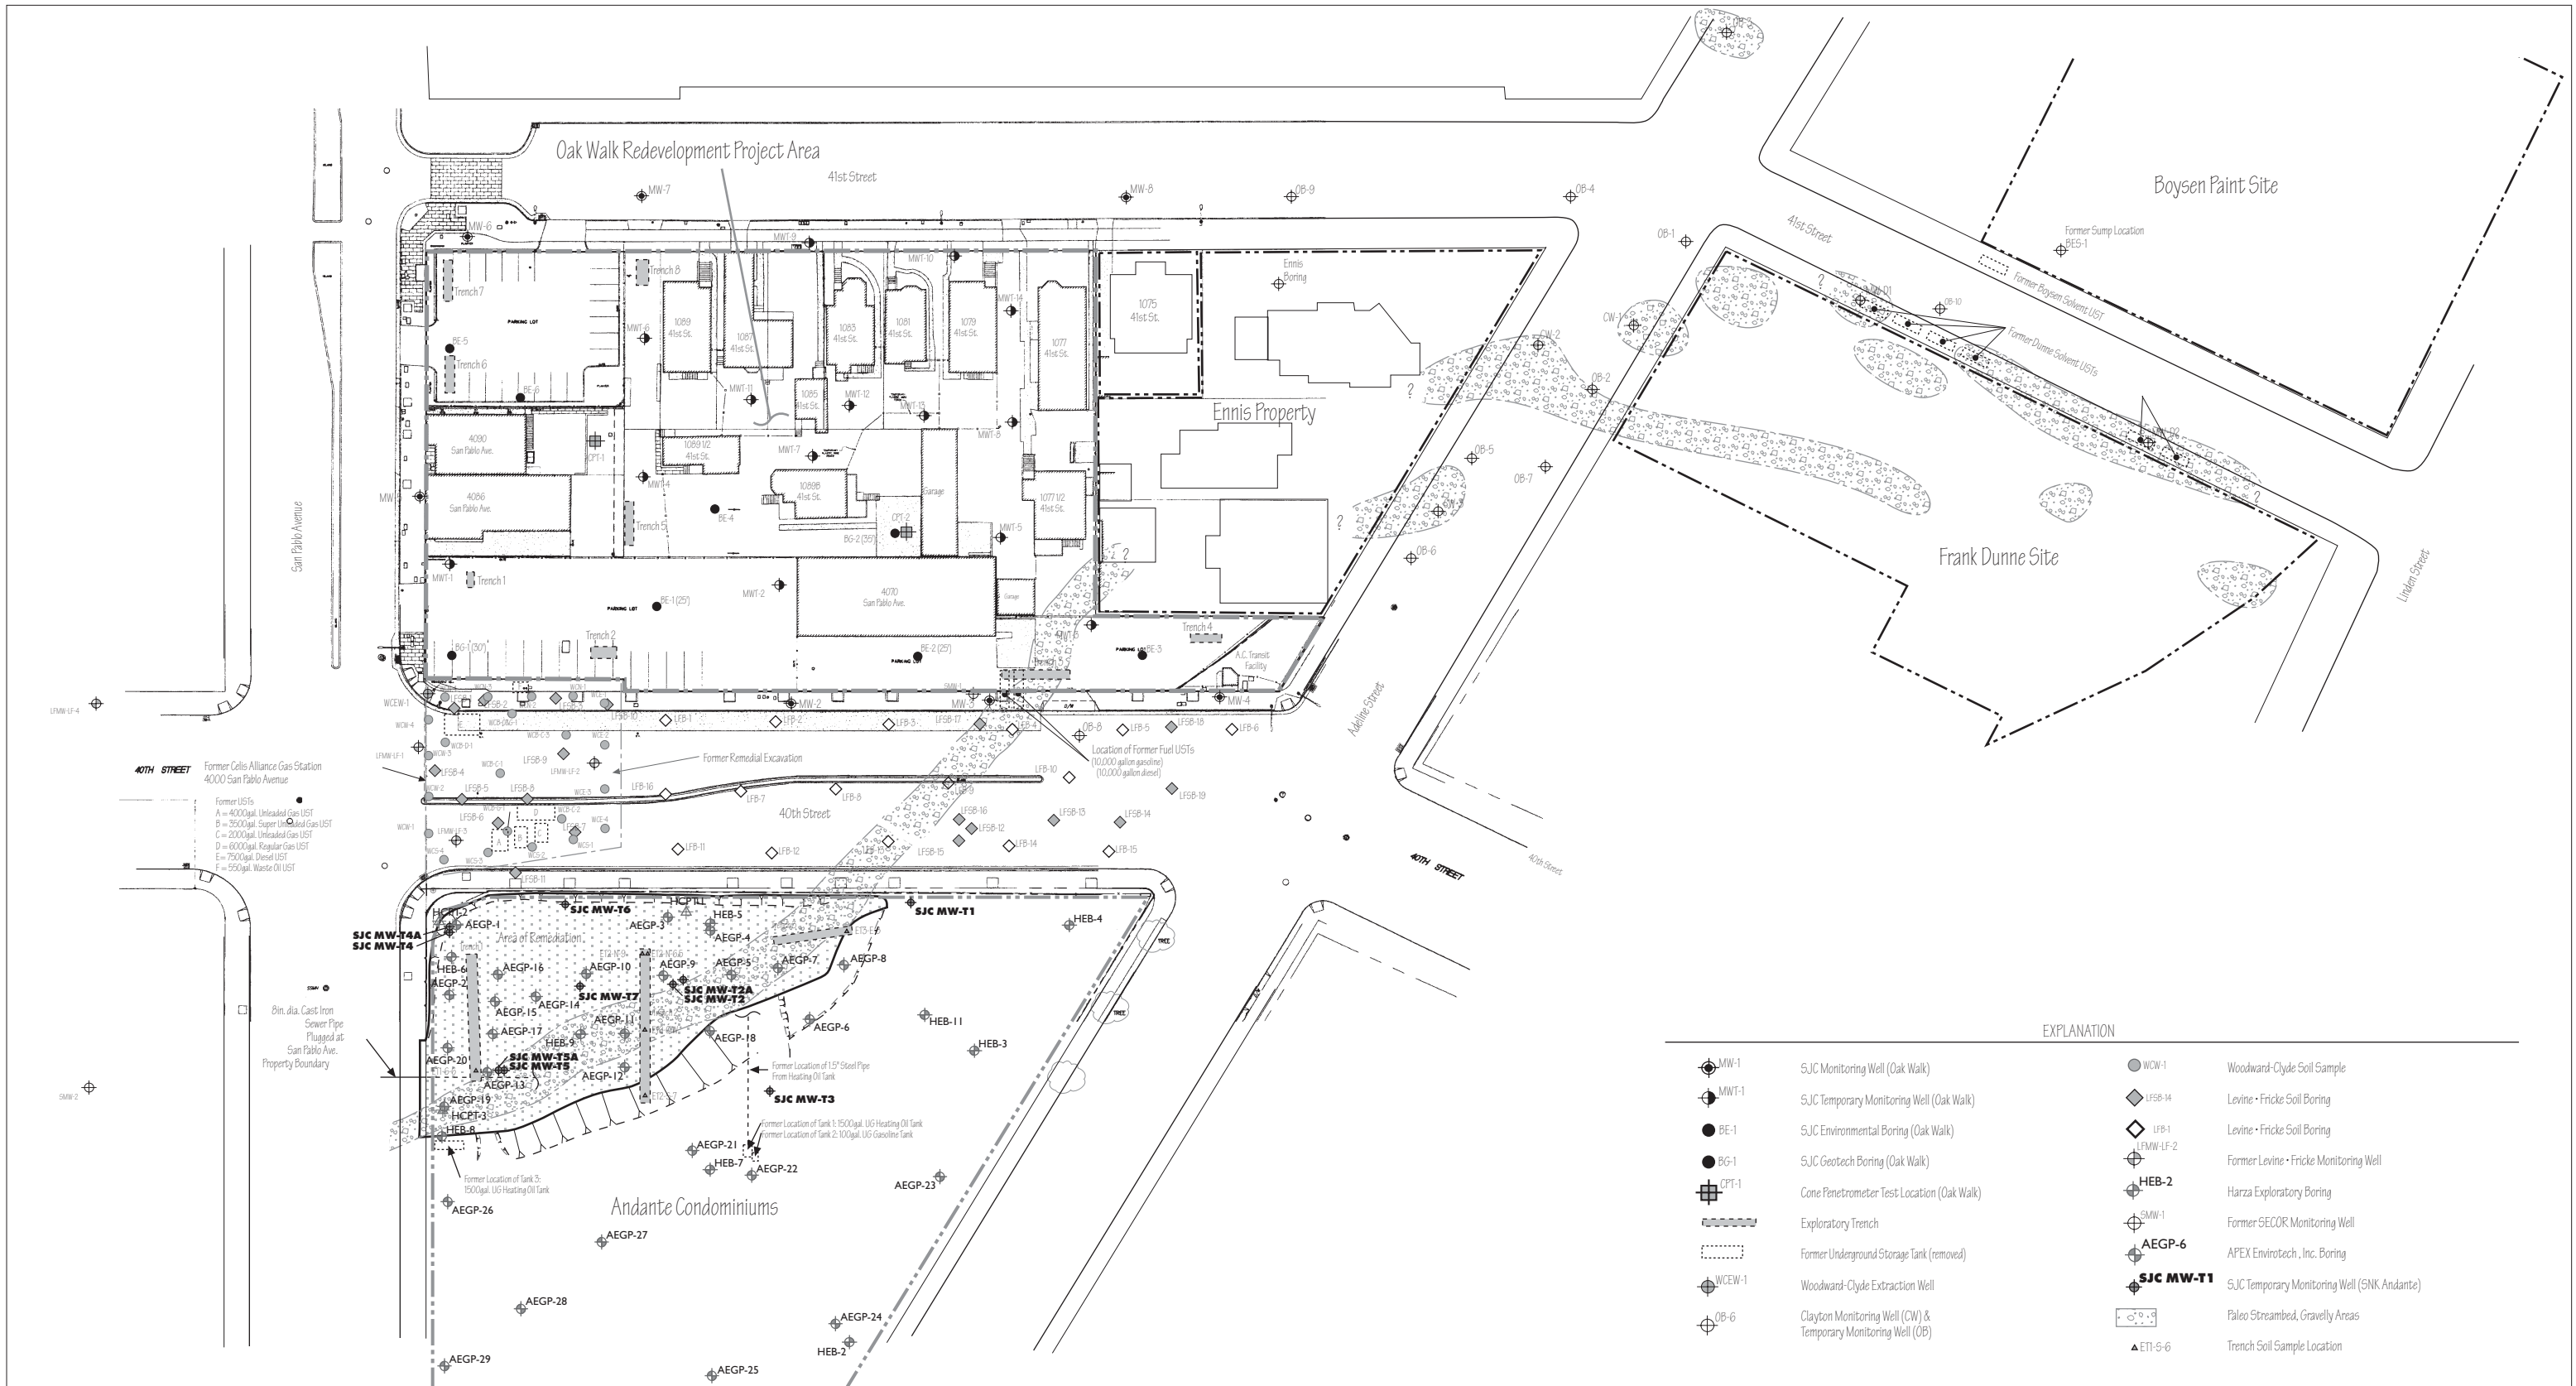
<b>FIG 4</b>	<b>The San Joaquin Company Inc.</b>	Project Number: 0004.083 Drawn by: GNM Date: 04/07/05
--------------	-------------------------------------	--

As can be seen on Figure 4, the major source of the contamination found beneath the 40th Street right-of-way can be attributed to releases that occurred on the Celis Site and, to some degree, to leakage from underground storage tanks that were located on property at the rear of 4070 San Pablo Avenue that was owned by the SFFBC (The San Joaquin Company Inc. 2003). However, analytes of concern were also detected in soil and groundwater beneath 40th Street that, because of their hydrogeological juxtaposition relative to those sites at which underground storage tanks are known to have leaked, are difficult to explain without considering other potential sources of contamination. Such sources also appear to have been located in what is now the 40th Street right-of-way or, if not on that property itself, at hydrogeologically up-gradient locations.

One underground storage tank that contained paint solvents that leaked into the subsurface was present at the former Boysen Paint Site. The location of that tank is also shown on Figure 4, together with the location of a sump on that property where it is believed that solvents and other paint manufacturing wastes were discharged into the subsurface.

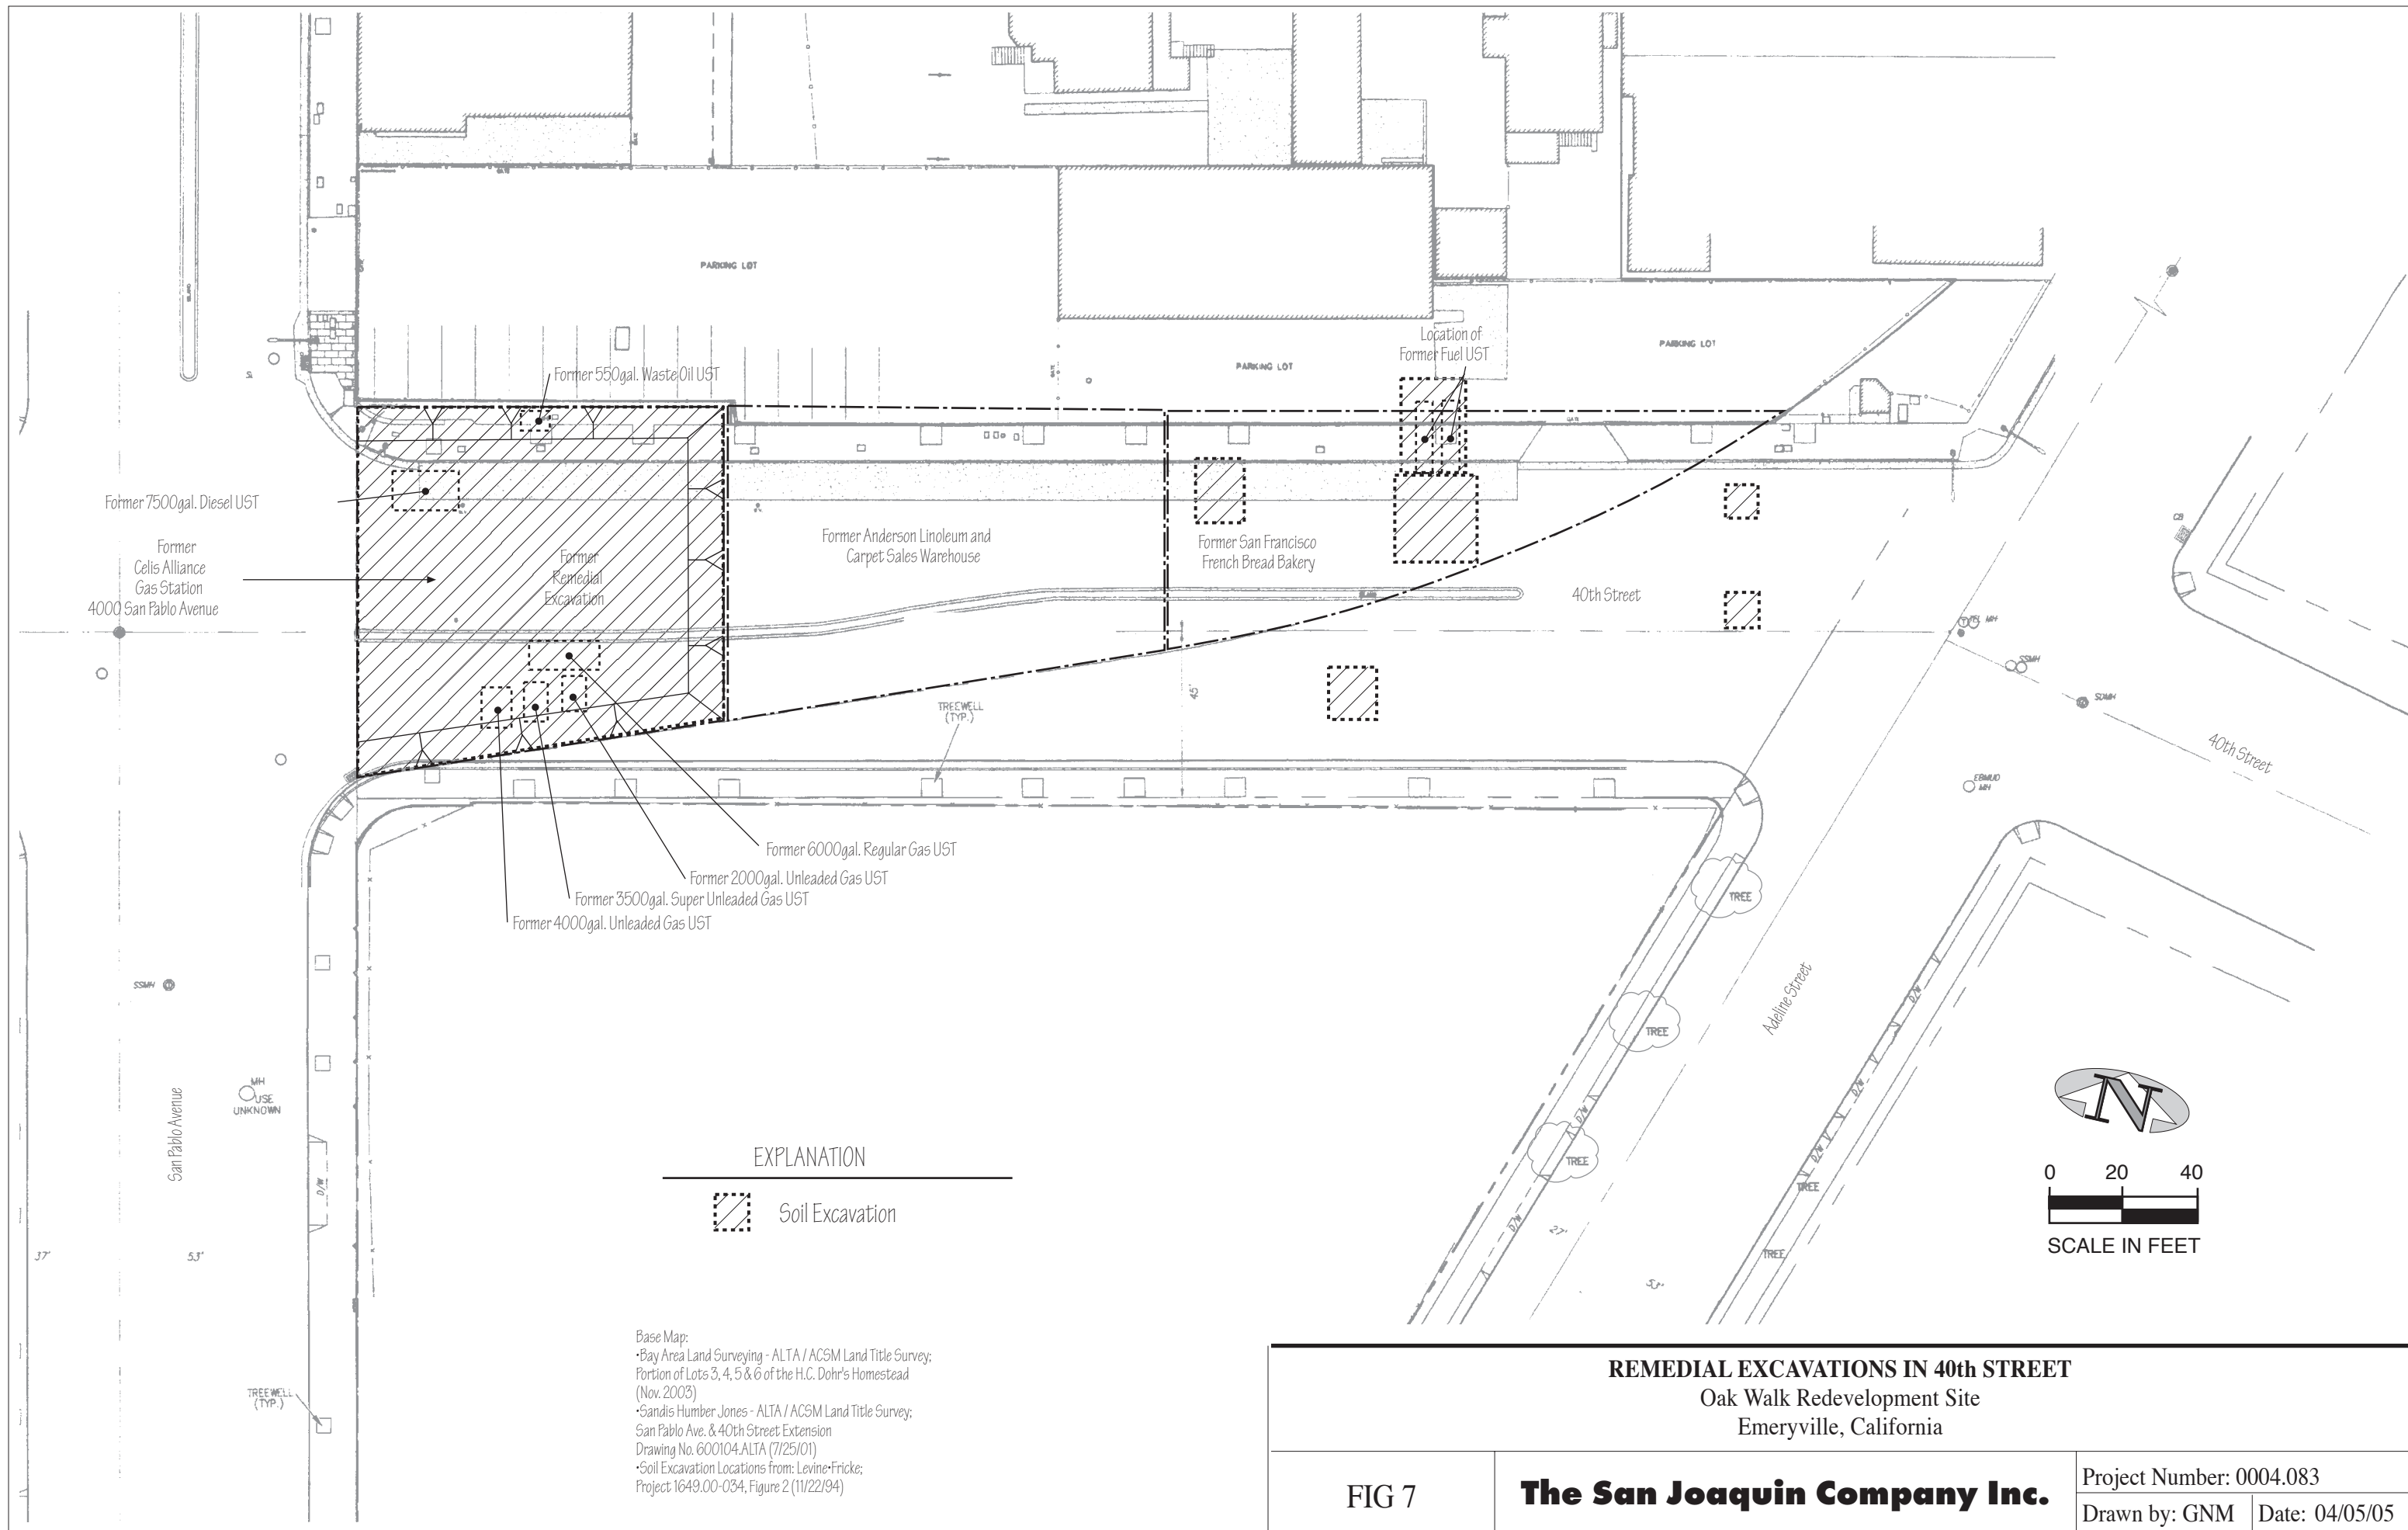
FIG 7

As noted previously, soil affected by high concentrations of fuel hydrocarbons that had leaked from the SFFBC tanks when that company owned the property, and possibly from releases at other locations, was excavated from a 20 x 20 x 10 ft. deep area in the 40th Street right-of-way to the south of, and adjacent to, those underground storage tanks.

**REMEDIAL EXCAVATIONS IN 40th STREET**  
 Oak Walk Redevelopment Site  
 Emeryville, California
