**APPLIED EARTH CONSULTANTS, INC.**

December 30, 1987  
Job No: 607471

Subject: SAMPLING OF STORM SEWER  
Dublin Multilayer, Inc.  
6341 Scarlett Crt.  
Dublin, CA 94568

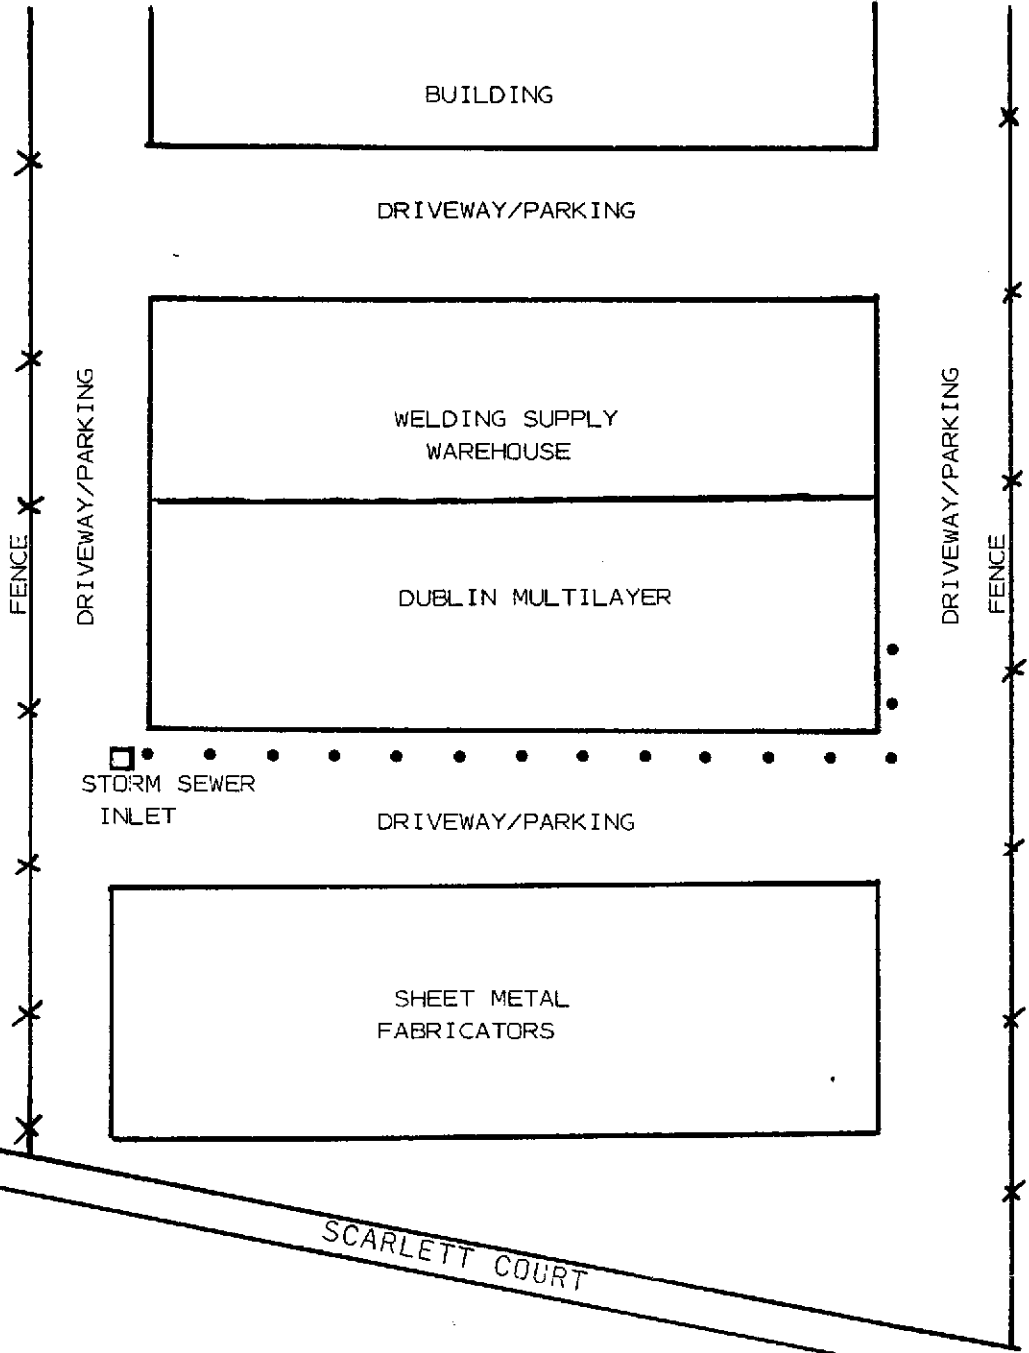
SITE PLAN  
6341 SCARLETT CRT  
DUBLIN, CA

This letter is in reference to the sampling of the storm sewer inlet adjacent to the building currently occupied by Dublin Multilayer, located at 6341 Scarlett Court, Dublin, California (see Plate 1). As per the telephone request of Mr. Lowell Miller (October 20, 1987), of the Alameda County Health Services Agency, Environmental Division (ACHSAED), and yourself (October 26, 1987), a second sampling of the subject site storm sewer was collected, and was to include the liquid and solid phases of the materials found in the sewer. The purpose of this sampling, as well as the previous sampling of the same sewer that occurred on July 19, 1987, (see Appendix B) was to investigate for the presence of chemicals in the sewer from an unauthorized discharge that occurred at the subject site on July 19, 1987.

- APPROX. PATH OF DISCHARGE
- BUILDING WALLS
