Subject: 1396- 5th Street, Oakland, Calif.  
Environmental Closure  
Submission to Alameda County

23 January 2007  
Project 4068.01

Subject: Red Star Yeast Project  
1396 Fifth Street  
Oakland, California

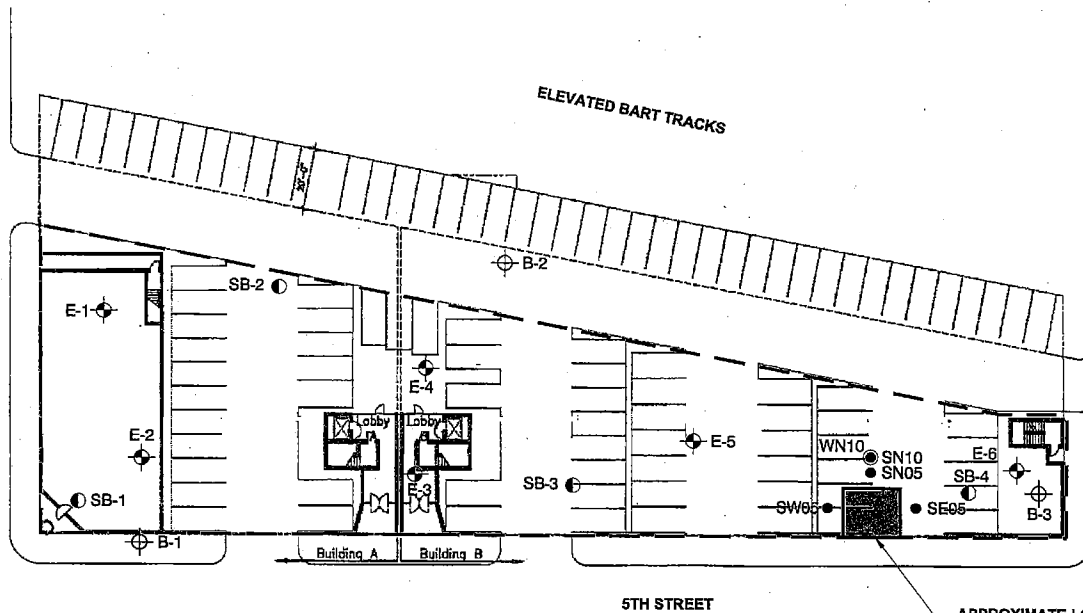
<b>RED STAR YEAST SITE</b> Oakland, California		
<b>SITE PLAN</b>		
Date 12/13/06	Project No. 4068.01	Figure 2
<b>Treadwell&amp;Rollo</b>

On 20 August 2004, Remediation Services Inc performed a subsurface investigation to collect soil and groundwater samples at the Site (Figure 2). A total of four exploratory borings (SB-1 through SB-4) were drilled to depths of approximately 20 feet and four soil and two groundwater samples were collected and analyzed for total petroleum hydrocarbons as diesel (TPHd), total petroleum hydrocarbons as gasoline (TPHg), volatile organic compounds (VOCs), pH, polynuclear aromatic hydrocarbons (PAHs), heavy metals (cadmium, chromium, lead, mercury, nickel, and zinc), and the groundwater samples were also analyzed for total dissolved solids (TDS).

On 14 April 2006, Treadwell & Rollo advanced six exploratory borings (E-1 through E-6) to depths of approximately 6.5 feet to 10 feet below the ground surface at locations shown on Figure 2. A total of twelve soil samples indicated no TPHg, MTBE, BTEX, VOCs, or SVOCs were detected at or above method reporting limits in any of the soil samples analyzed. Low levels of TPHd were detected in six soil samples at concentrations ranging from 1.4 mg/kg to 7.8 mg/kg. TPHmo was detected in six samples at concentrations ranging from 6 mg/kg to 43 mg/kg.

On 14 November 2006, Treadwell & Rollo collected four soil samples and one groundwater sample from the area surrounding the tank excavation (Figure 2). TPHd was detected in the soil samples collected approximately 5 feet east and north of the former excavation area at concentrations of 1.3 and 2.0 mg/kg, respectively. No other constituents were detected at or above method reporting limits from the area surrounding the excavation area or from the excavated soil. TPHg was detected in groundwater at a concentration of 270 µg/L from sample WN10. No other constituents were detected at or above the method reporting limits.

APPROXIMATE LOCATION OF FORMER TANK AND EXCAVATION LIMITS

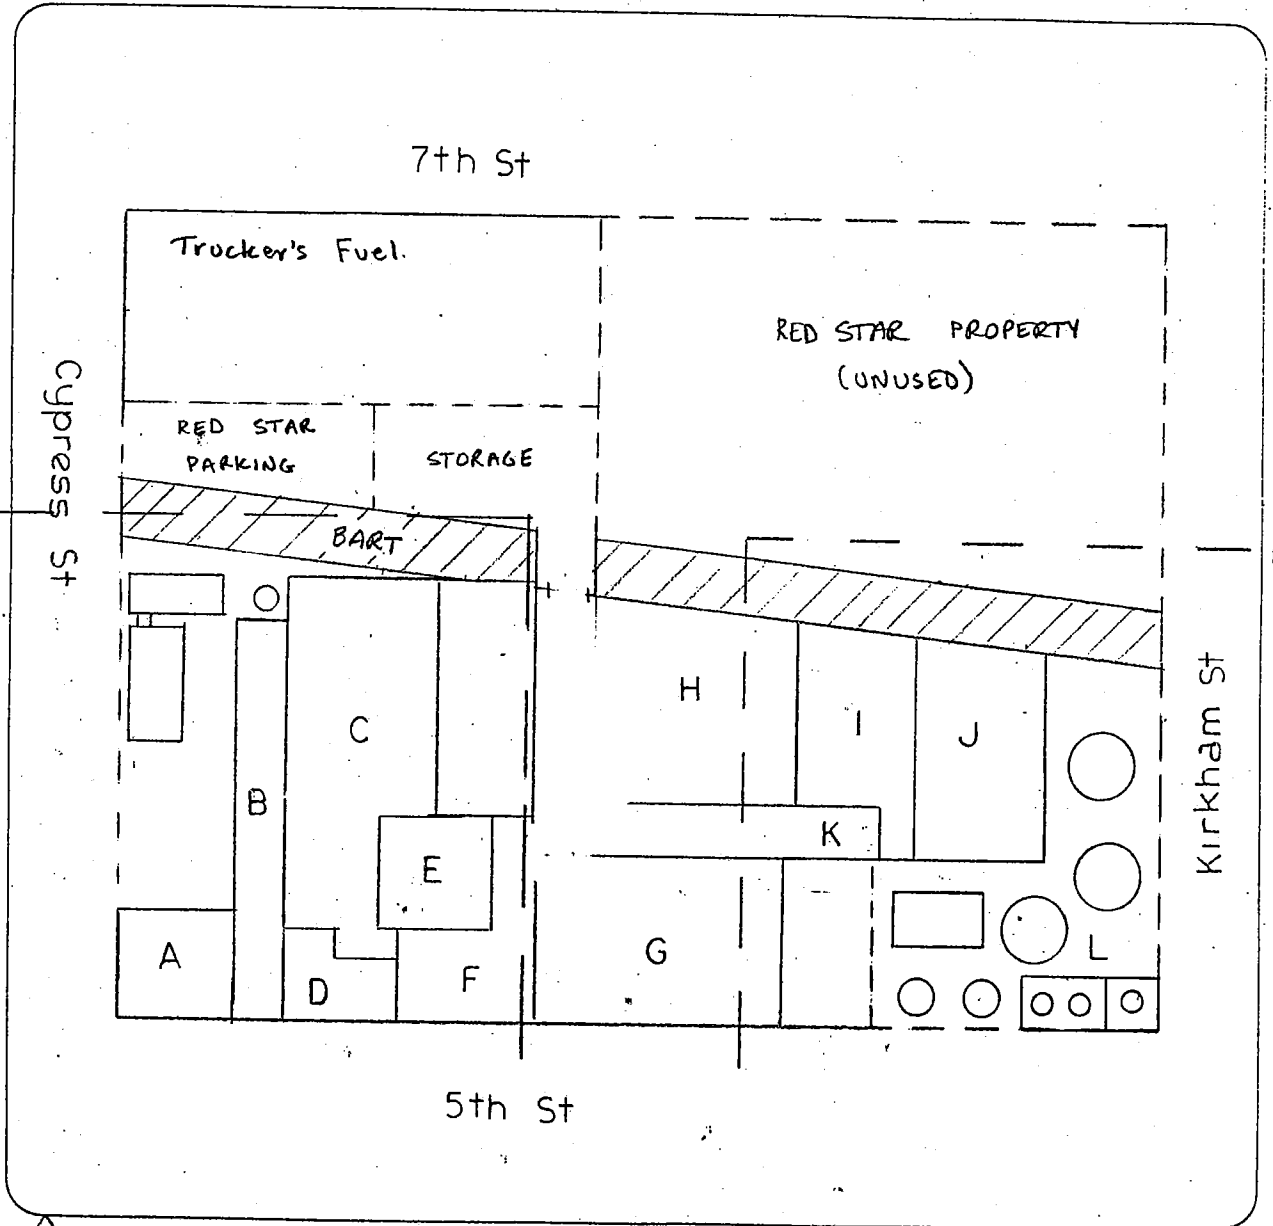
HAZARDOUS MATERIALS MANAGEMENT PLAN  
Facility Map - Site Plan

We have attached figures in Appendix A that shows the layout of the former facility including the locations of the storage areas and above ground tanks. Based on the information that we have obtained, it appears that the information regarding a 16,000-gallon above ground fuel tank is incorrect and the only above ground fuel tank was the 1,600-gallon tank at the southwest corner of the facility.

The areas noted as having oil stains are shown on the Figures within Appendix A. No information was available regarding that these areas were further investigated or if any remediation were performed in these areas. Reportedly, all buildings and equipment at the former facility were located on either concrete foundation system or concrete pads, therefore minimizing the amount of oil to reach the soil beneath. As previously submitted to ACEH, we

If unknown areas of suspected petroleum hydrocarbons or other hazardous materials are discovered during the excavation activities, the following contingency plan will be followed. The impacted area will be excavated, stockpiled on and covered with plastic sheeting, soil samples will be collected and tested for appropriate chemical constituent (petroleum hydrocarbons and metals), and reported to ACEH and City of Oakland. Based on the results of the testing, the soil will be properly disposed.
