**From:** Debbie Patterson [dpatterson@lionstonegroup.com]  
**Sent:** Thursday, October 10, 2013 9:37 AM  
**To:** jrigter@lfire.org  
**Cc:** Wickham, Jerry, Env. Health; vbajsarowicz@haleyaldrich.com; Schwartz, James (JSchwartz@haleyaldrich.com); Sachin Grover; Sebik, Joanna (JSebik@haleyaldrich.com); Doug McKinnon; Debbie Patterson  
**Subject:** Former LeHigh Hanson Facility - Area of Concern 3 (AOC 3)  
**Attachments:** 2013\_1009\_AOC3 Tank.docx

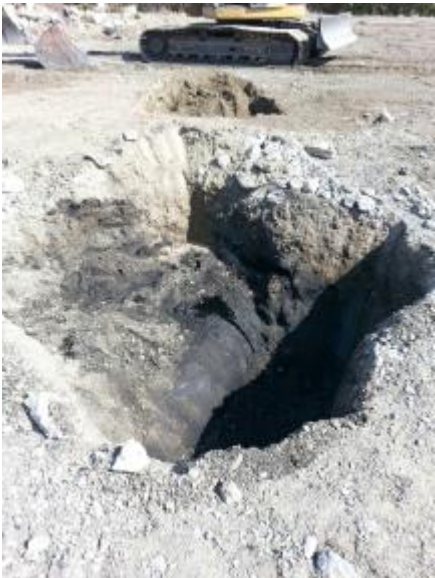
<b>Photo No.</b> 1	<b>Date</b> 10/09/2013

<b>Description</b> Steel tank encountered beneath the wash rack in AOC 3. The excavation is 5 ft by 5 ft. the tank is located at 4 ft bgs.

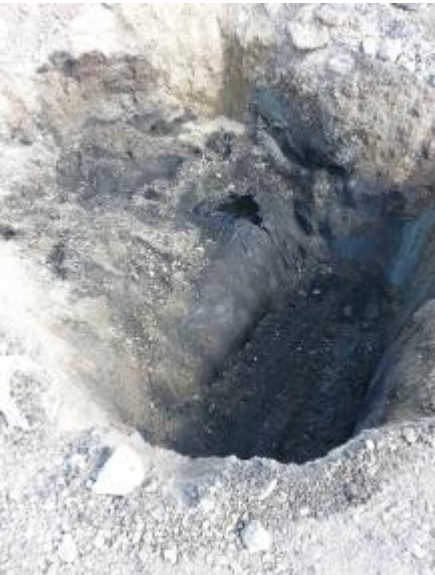
<b>Photo No.</b> 2	<b>Date</b> 10/09/2013

According to field observations no rivets were observed on the exterior of the tank. The dimensions and contents of the tank are not know at this time. An oozing black material was observed at the top of the tank; however the source of the material could not be identified. Sorbent material was used to prevent further contamination of the surrounding soil.

<b>Description</b> Steel tank encountered beneath the wash rack in AOC 3. Note oozing black material on the top of the tank. Note stained soil surrounding the tank.
