**Subject:** Phase I Environmental Site Assessment Report  
1160-1168 36<sup>th</sup> Street and 3601 & 3623 Adeline Street  
Emeryville, California 94608

Phase I Environmental Site Assessment

**1160-1168 36<sup>th</sup> Street and  
3601 & 3623 Adeline Street  
Emeryville, California**

Clayton Project No. 70-03661.00  
May 28, 2003

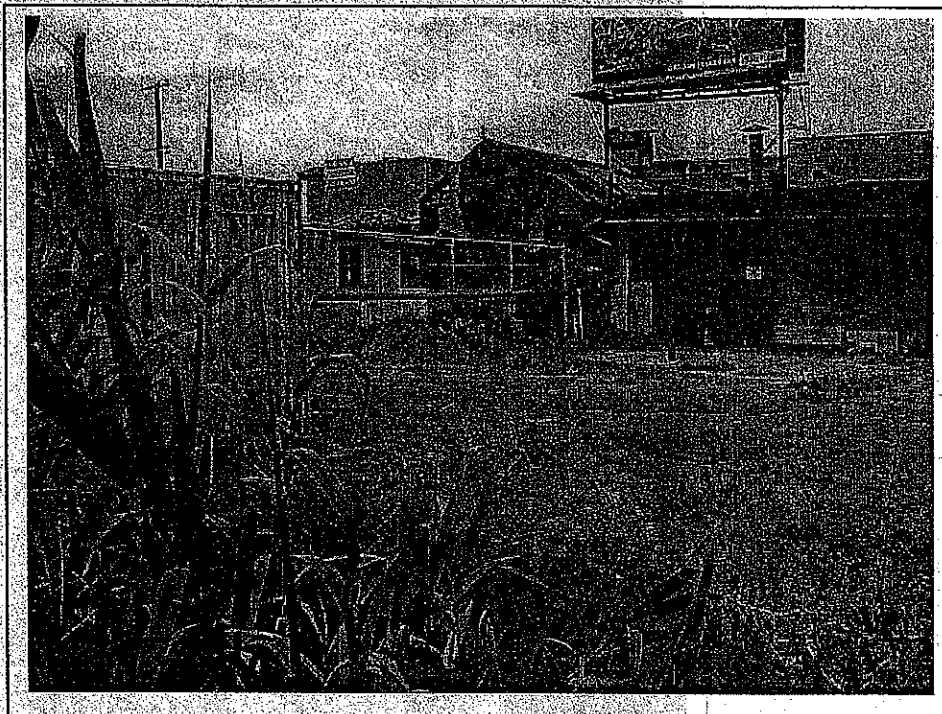
<b>Clayton Project No.</b> 70-03661:00	<b>Description</b>	View of yard to the southwest with storage container at left in area of reported former gasoline UST	<b>7</b>
	<b>Site Name</b>	1160-1168 36 <sup>th</sup> Avenue, 3601 and 3623 Adeline Street, Emeryville, California	<b>Photo Date</b> April 23, 2003

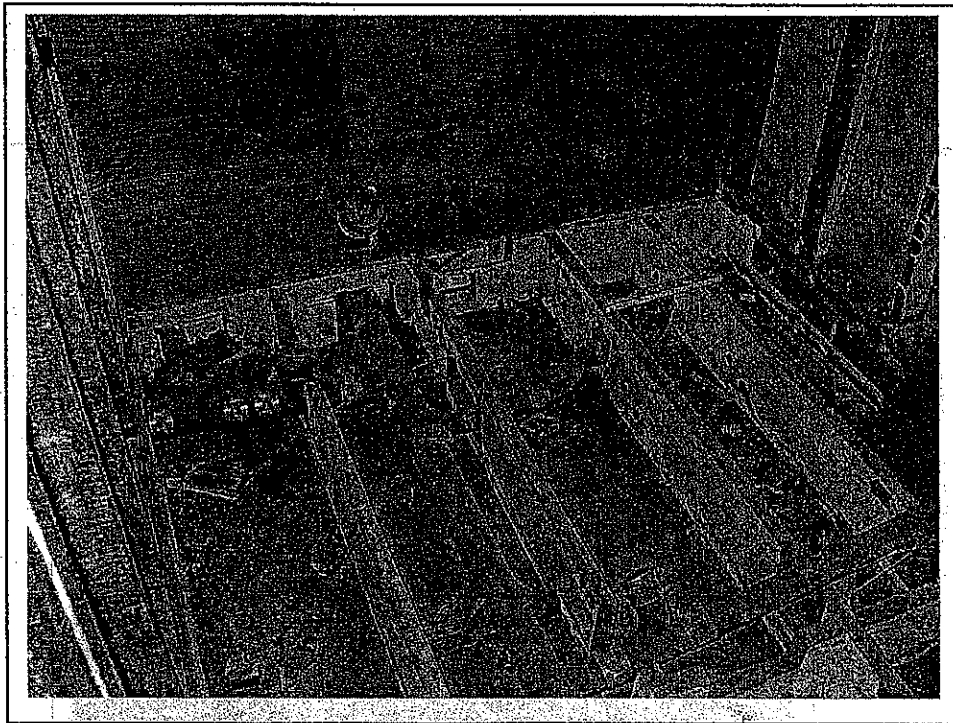
<b>Clayton Project No.</b> 70-03661.00	<b>Description</b>	View of small room with multiple sewer pipe connections in the northwest corner of the main building	<b>9</b>
	<b>Site Name</b>	1160-1168 36 <sup>th</sup> Avenue, 3601 and 3623 Adeline Street, Emeryville, California	<b>Photo Date</b> April 17, 2003

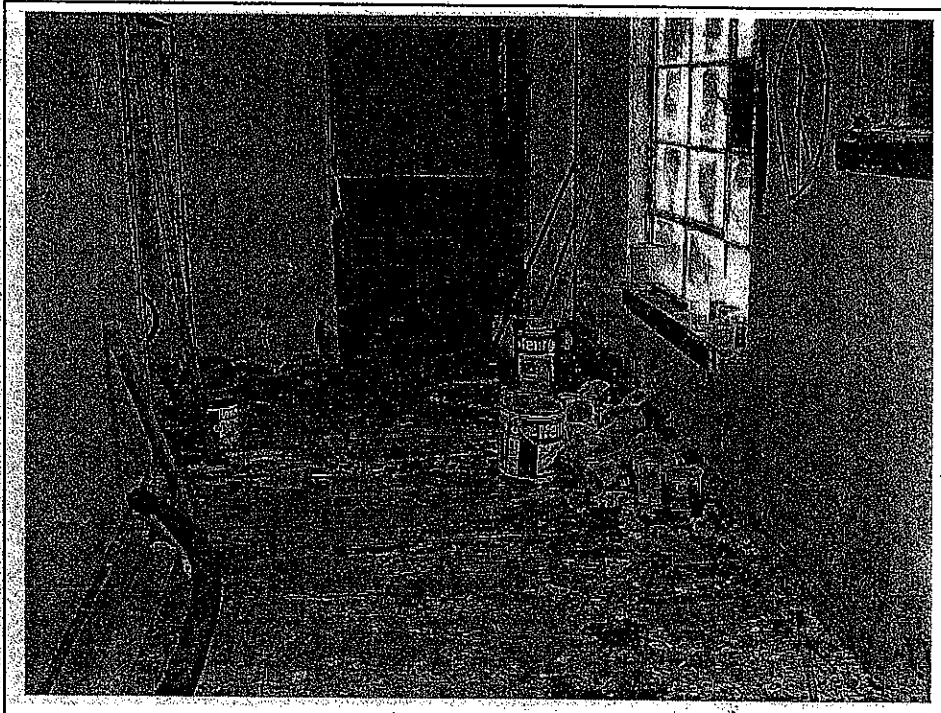
<b>Clayton Project No. 70-03661.00</b>	<b>Description</b>	View of stairs and hallway on 2 <sup>nd</sup> floor in north main building with maintenance supplies, debris, and water damaged flooring	<b>16</b>
	<b>Site Name</b>	1160-1168 36 <sup>th</sup> Avenue, 3601 and 3623 Adeline Street, Emeryville, California	<b>Photo Date</b> April 17, 2003

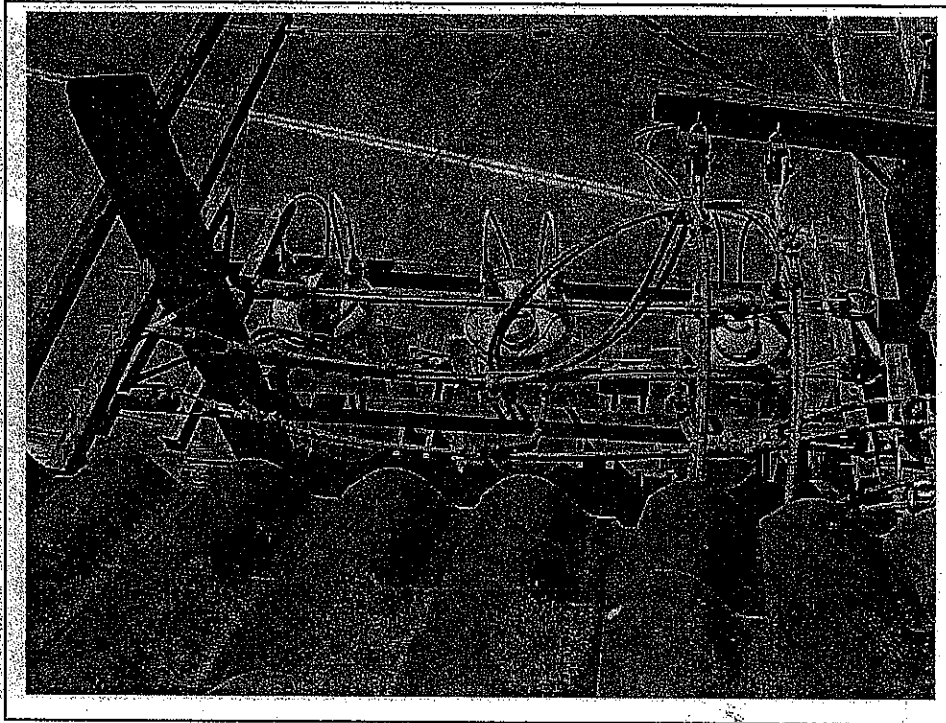
<b>Clayton Project No. 70-03661.00</b>	<b>Description</b>	View of three transformers at the northwest corner of subject property	<b>23</b>
	<b>Site Name</b>	1160-1168 36 <sup>th</sup> Avenue, 3601 and 3623 Adeline Street, Emeryville, California	<b>Photo Date</b> April 17, 2003

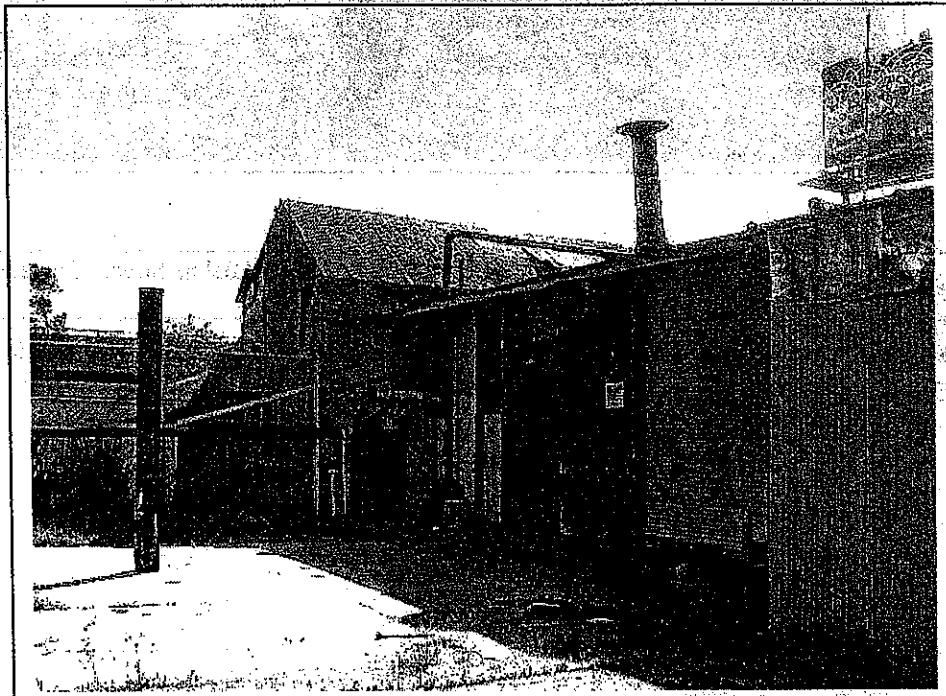
- Evidence of a discharge source was observed at the subject property by the south shop at the 3623 Adeline site. A small concrete sump covered with a loose metal sheet exists near the door to the south shop. The sump was reported to be impacted with oily sludge, which was sampled, cleaned, and the waste sludge was disposed of as hazardous waste. This activity was documented in the PES Environmental Inc., Phase I and II 1999 report (See Section 3.6 for details). No discharges of regulated materials are currently occurring.

<b>Clayton Project No. 70-03661.00</b>	<b>Description</b>	View to the southwest of yard area and front of south garage. Sump in back corner of yard by building. Large pipe is water service. Vent on roof assumed to be from former bronze kiln.	<b>32</b>
	<b>Site Name</b>	1160-1168 36 <sup>th</sup> Avenue, 3601 and 3623 Adeline Street, Emeryville, California	<b>Photo Date</b> April 17, 2003

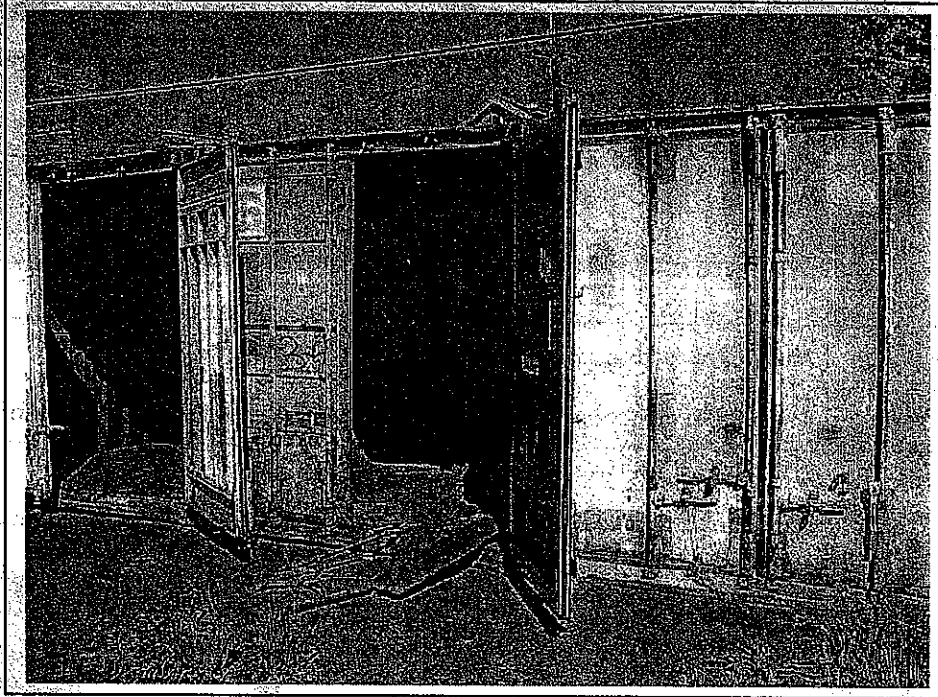
<b>Clayton Project No.</b> 70-03661.00	<b>Description</b>	View to the east of containers in yard area at 3623 Adeline Street. Container on right was locked and inaccessible	<b>33</b>
	<b>Site Name</b>	1160-1168 36 <sup>th</sup> Avenue, 3601 and 3623 Adeline Street, Emeryville, California	<b>Photo Date</b> April 17, 2003
