**Preliminary Site Assessment Phase
Workplan**

for
Diesel Fuel Release
located at:

FCI DUBLIN
Federal Correctional Institution
5701 8th st - Camp Parks
Dublin, CA

RO# 2977

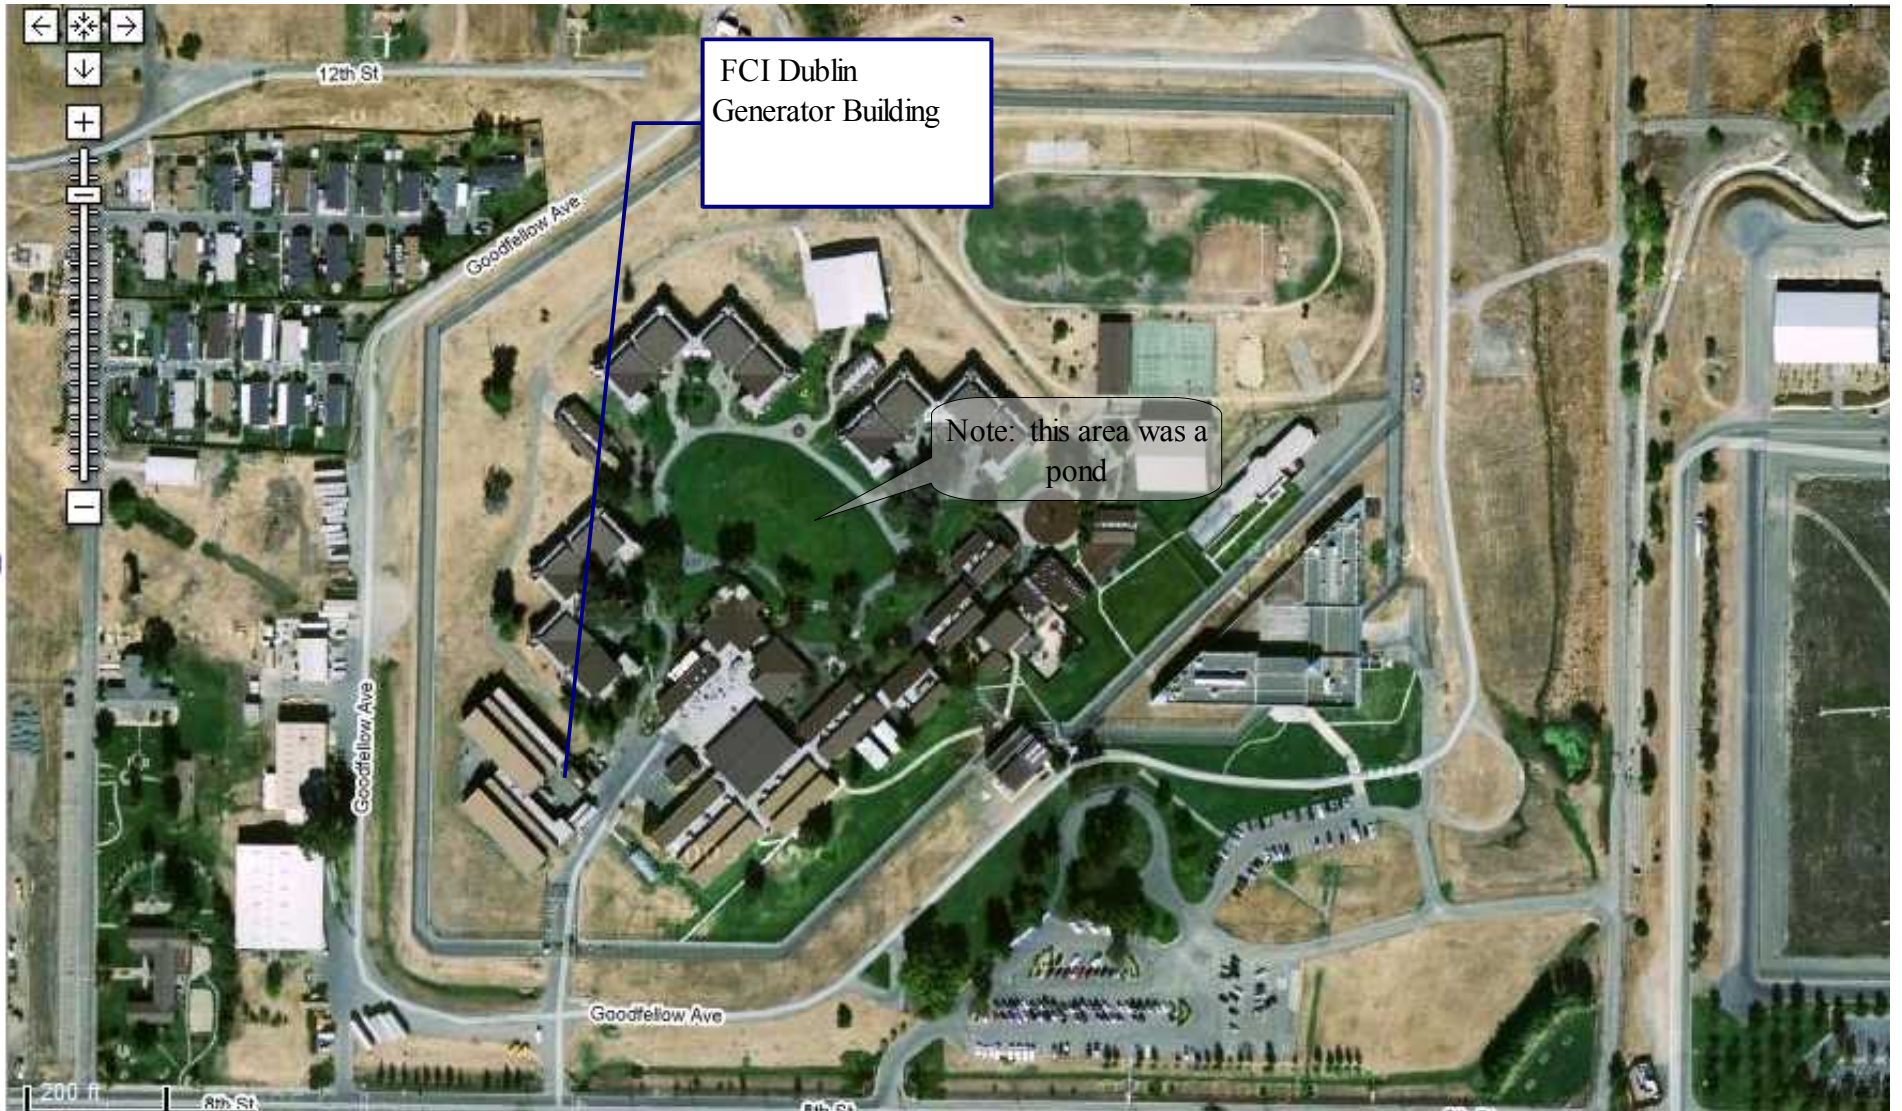
Figure 2: Facility Map, FCI Dublin

- Figure 2 and the text included a note indicating that the open field north and east of the generator on the property is a pond. This has been corrected to indicate that this area *was* a pond.
- The site was stated to be 13° cross gradient from the direction of the groundwater gradient at the Bay Petroleum site in Dublin. The actual magnitude is 36°. Please see Figure 7 in Tab 2.
- Figure 4 did not show the location of the spill site or the Bay Petroleum site. The call outs for these locations are now visible.

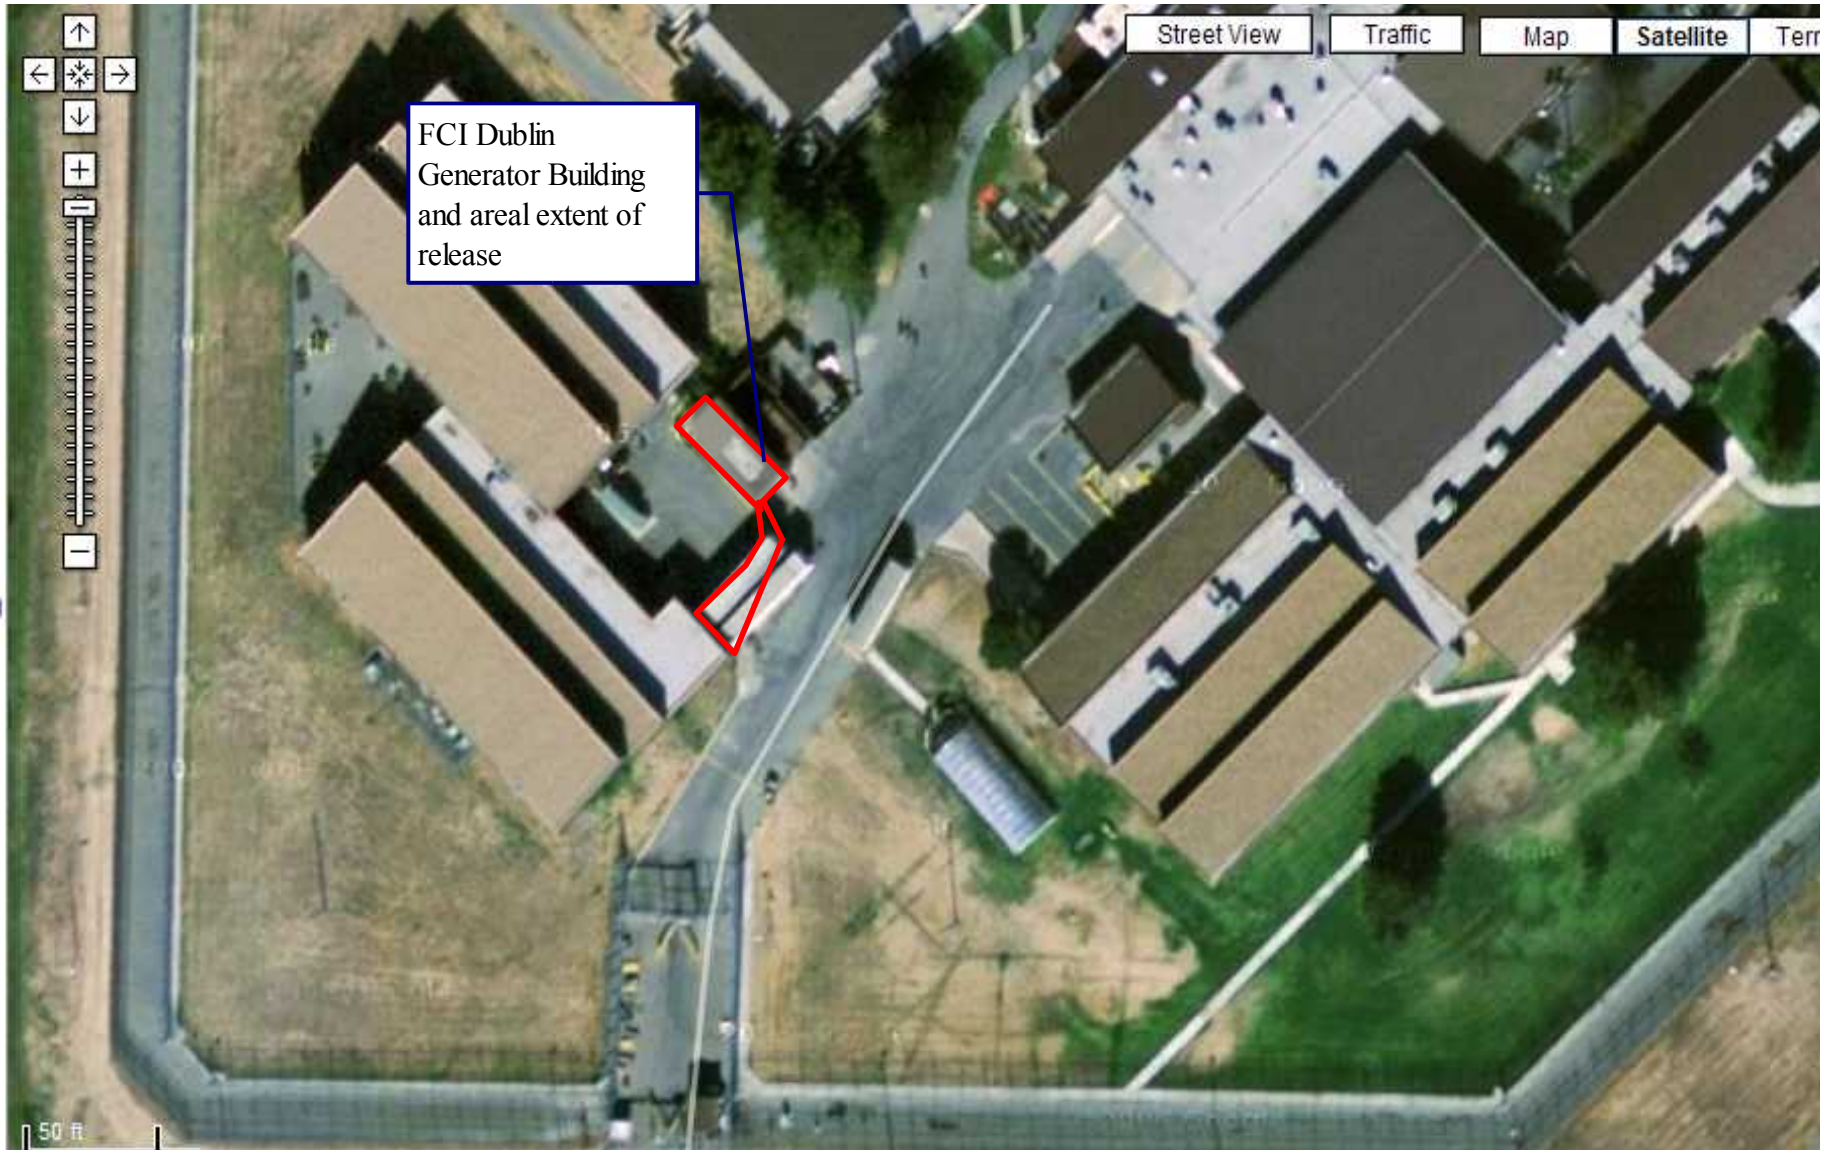
Figure 3: Site of Release, Generator Building, FCI Dublin

The generator building is a concrete block wall building set on a concrete slab-on-grade, located on the south west side of the facility. Figures 1 through 3 provide the general area and site detail.

Approximately 100 bank (in place) cubic yards of soil and asphalt cover have been removed in the interim remedial action. Residual contamination exists along the north and west sides of the generator building. Based on observation (appearance and odor only, no analytical), the area south of the building extending to the loading dock well show no residual diesel contamination. This area was not as severely affected as the walkway area on the north and west sides of the building, where free product collected until absorbed with spill clean-up materials (Pig brand Lite Dri.)

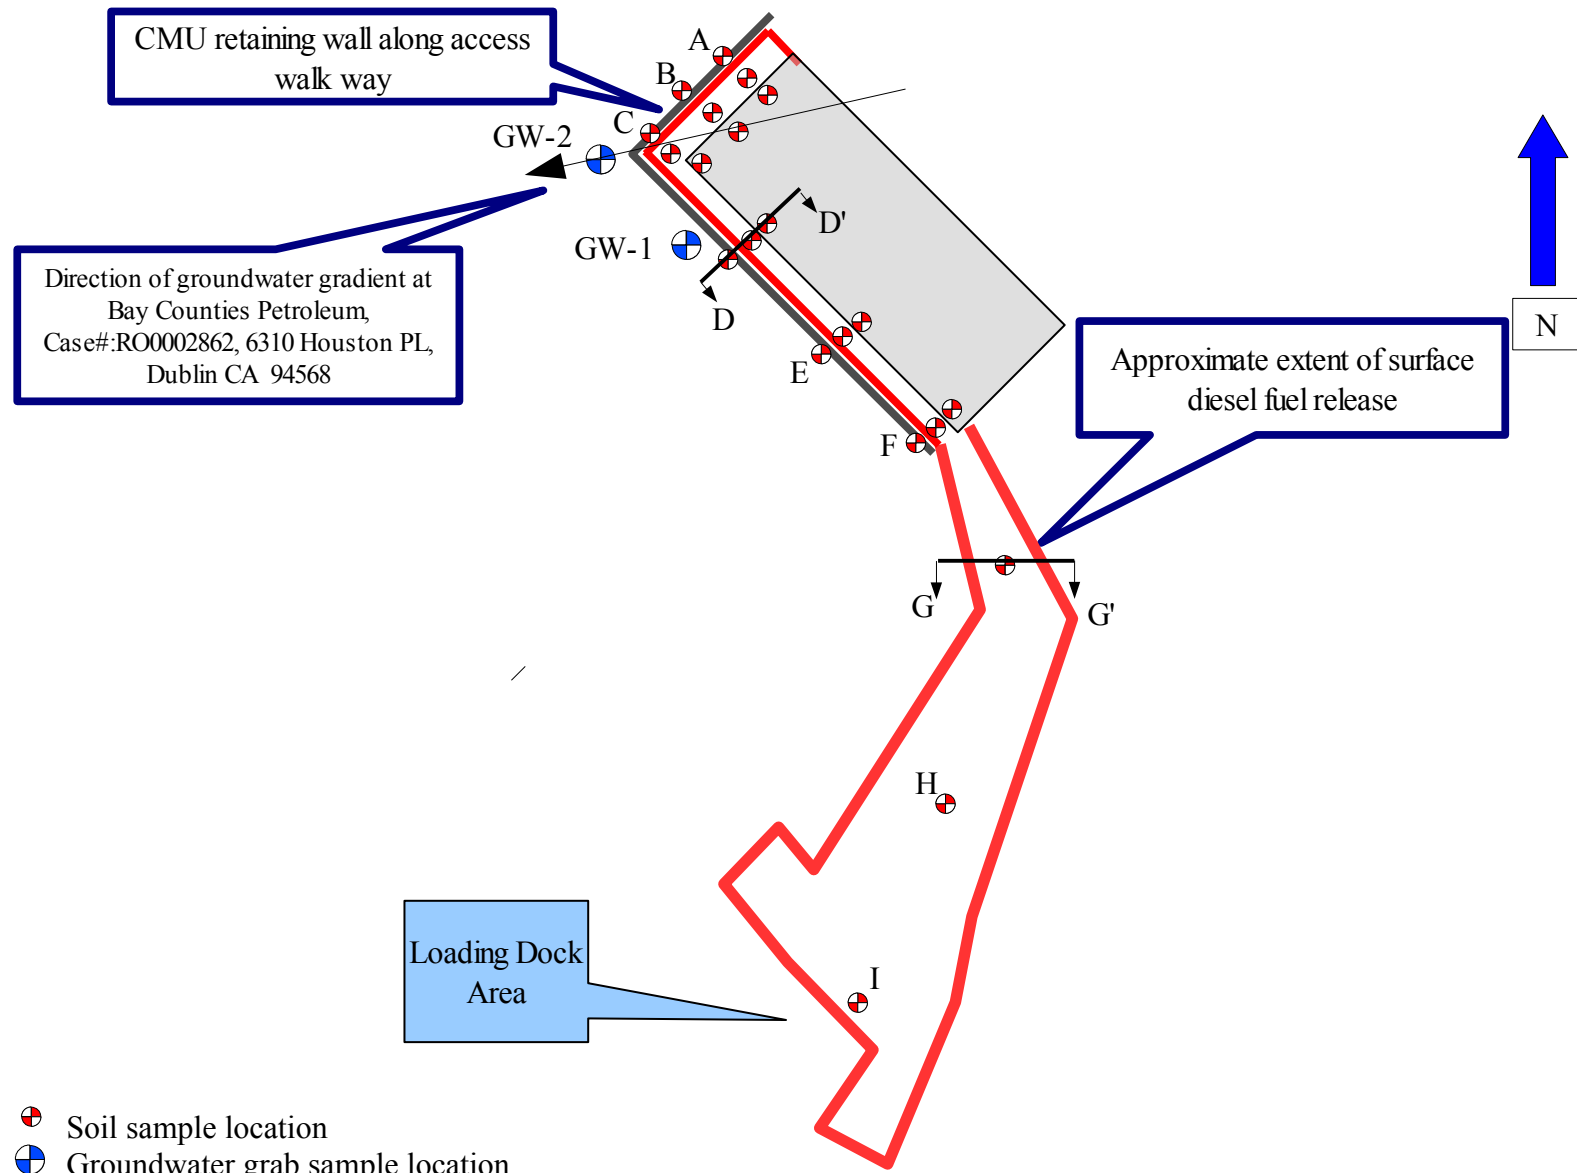
Figure 5: Detail sketch of area of release – Rev. 1. Generator building (including storage tank) is 26 ft wide by 40 ft long
 Approximate Scale: 1" = 20'

The proposed Scope of Work for this investigation consists of 30 soil samples and two groundwater grab samples. The sample locations are detailed on Figures 5 and 6. The contaminants of concern are total petroleum hydrocarbons as diesel (TPH-d) and the potential toxic constituents of diesel fuel, benzene, toluene, ethyl benzene, and xylenes (BTEX) and Naphthalene. The sample locations, sample points, and lab analyses are summarized in the table below:

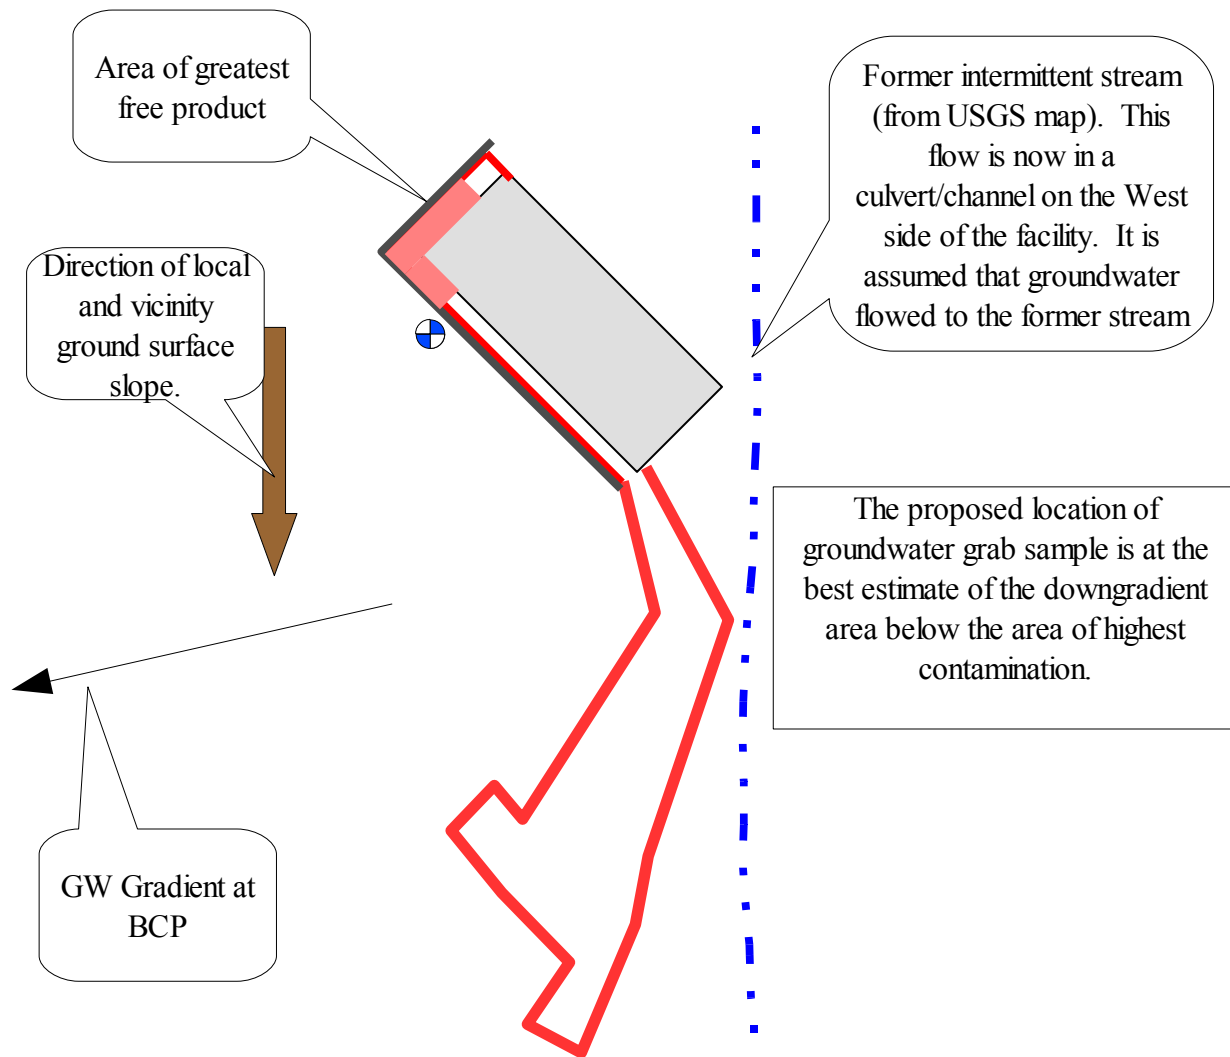
Figure 7 – Primary contamination area and groundwater sample location logic

The area most severely affected by the release was the north west corner of the walkway. Please see Figure 7.

Nearest site with groundwater data is (LOP Findings) [BAY COUNTIES PETROLEUM](#) , Case#:RO0002862
 6310 HOUSTON PL, DUBLIN CA 94568
 Ground surface at 335
 GW at 327

FCI Dublin at 360 ft amsl, 25 ft higher (ground surface elevation)

4,907 ft away to the northeast, Groundwater flow direction is N 102.7°W, backsite from FCI Dublin to BCP is N139°W, cross gradient is then 36°.

Local gradient is 0.0024 ft/ft gradient (at Bay Counties Petroleum site), if constant between sites would put ground water elevation 11.8 ft higher, or about 339 ft. Estimated depth to gw is then 360-339 = 21 ft
