### Summary of Utility and Topographic Surveys 6235 College Avenue Oakland, California

September 28, 2017  
Fugro Project No. 04.72160042

### Summary of Utility and Topographic Survey Services, 6235 College Avenue, Oakland, California

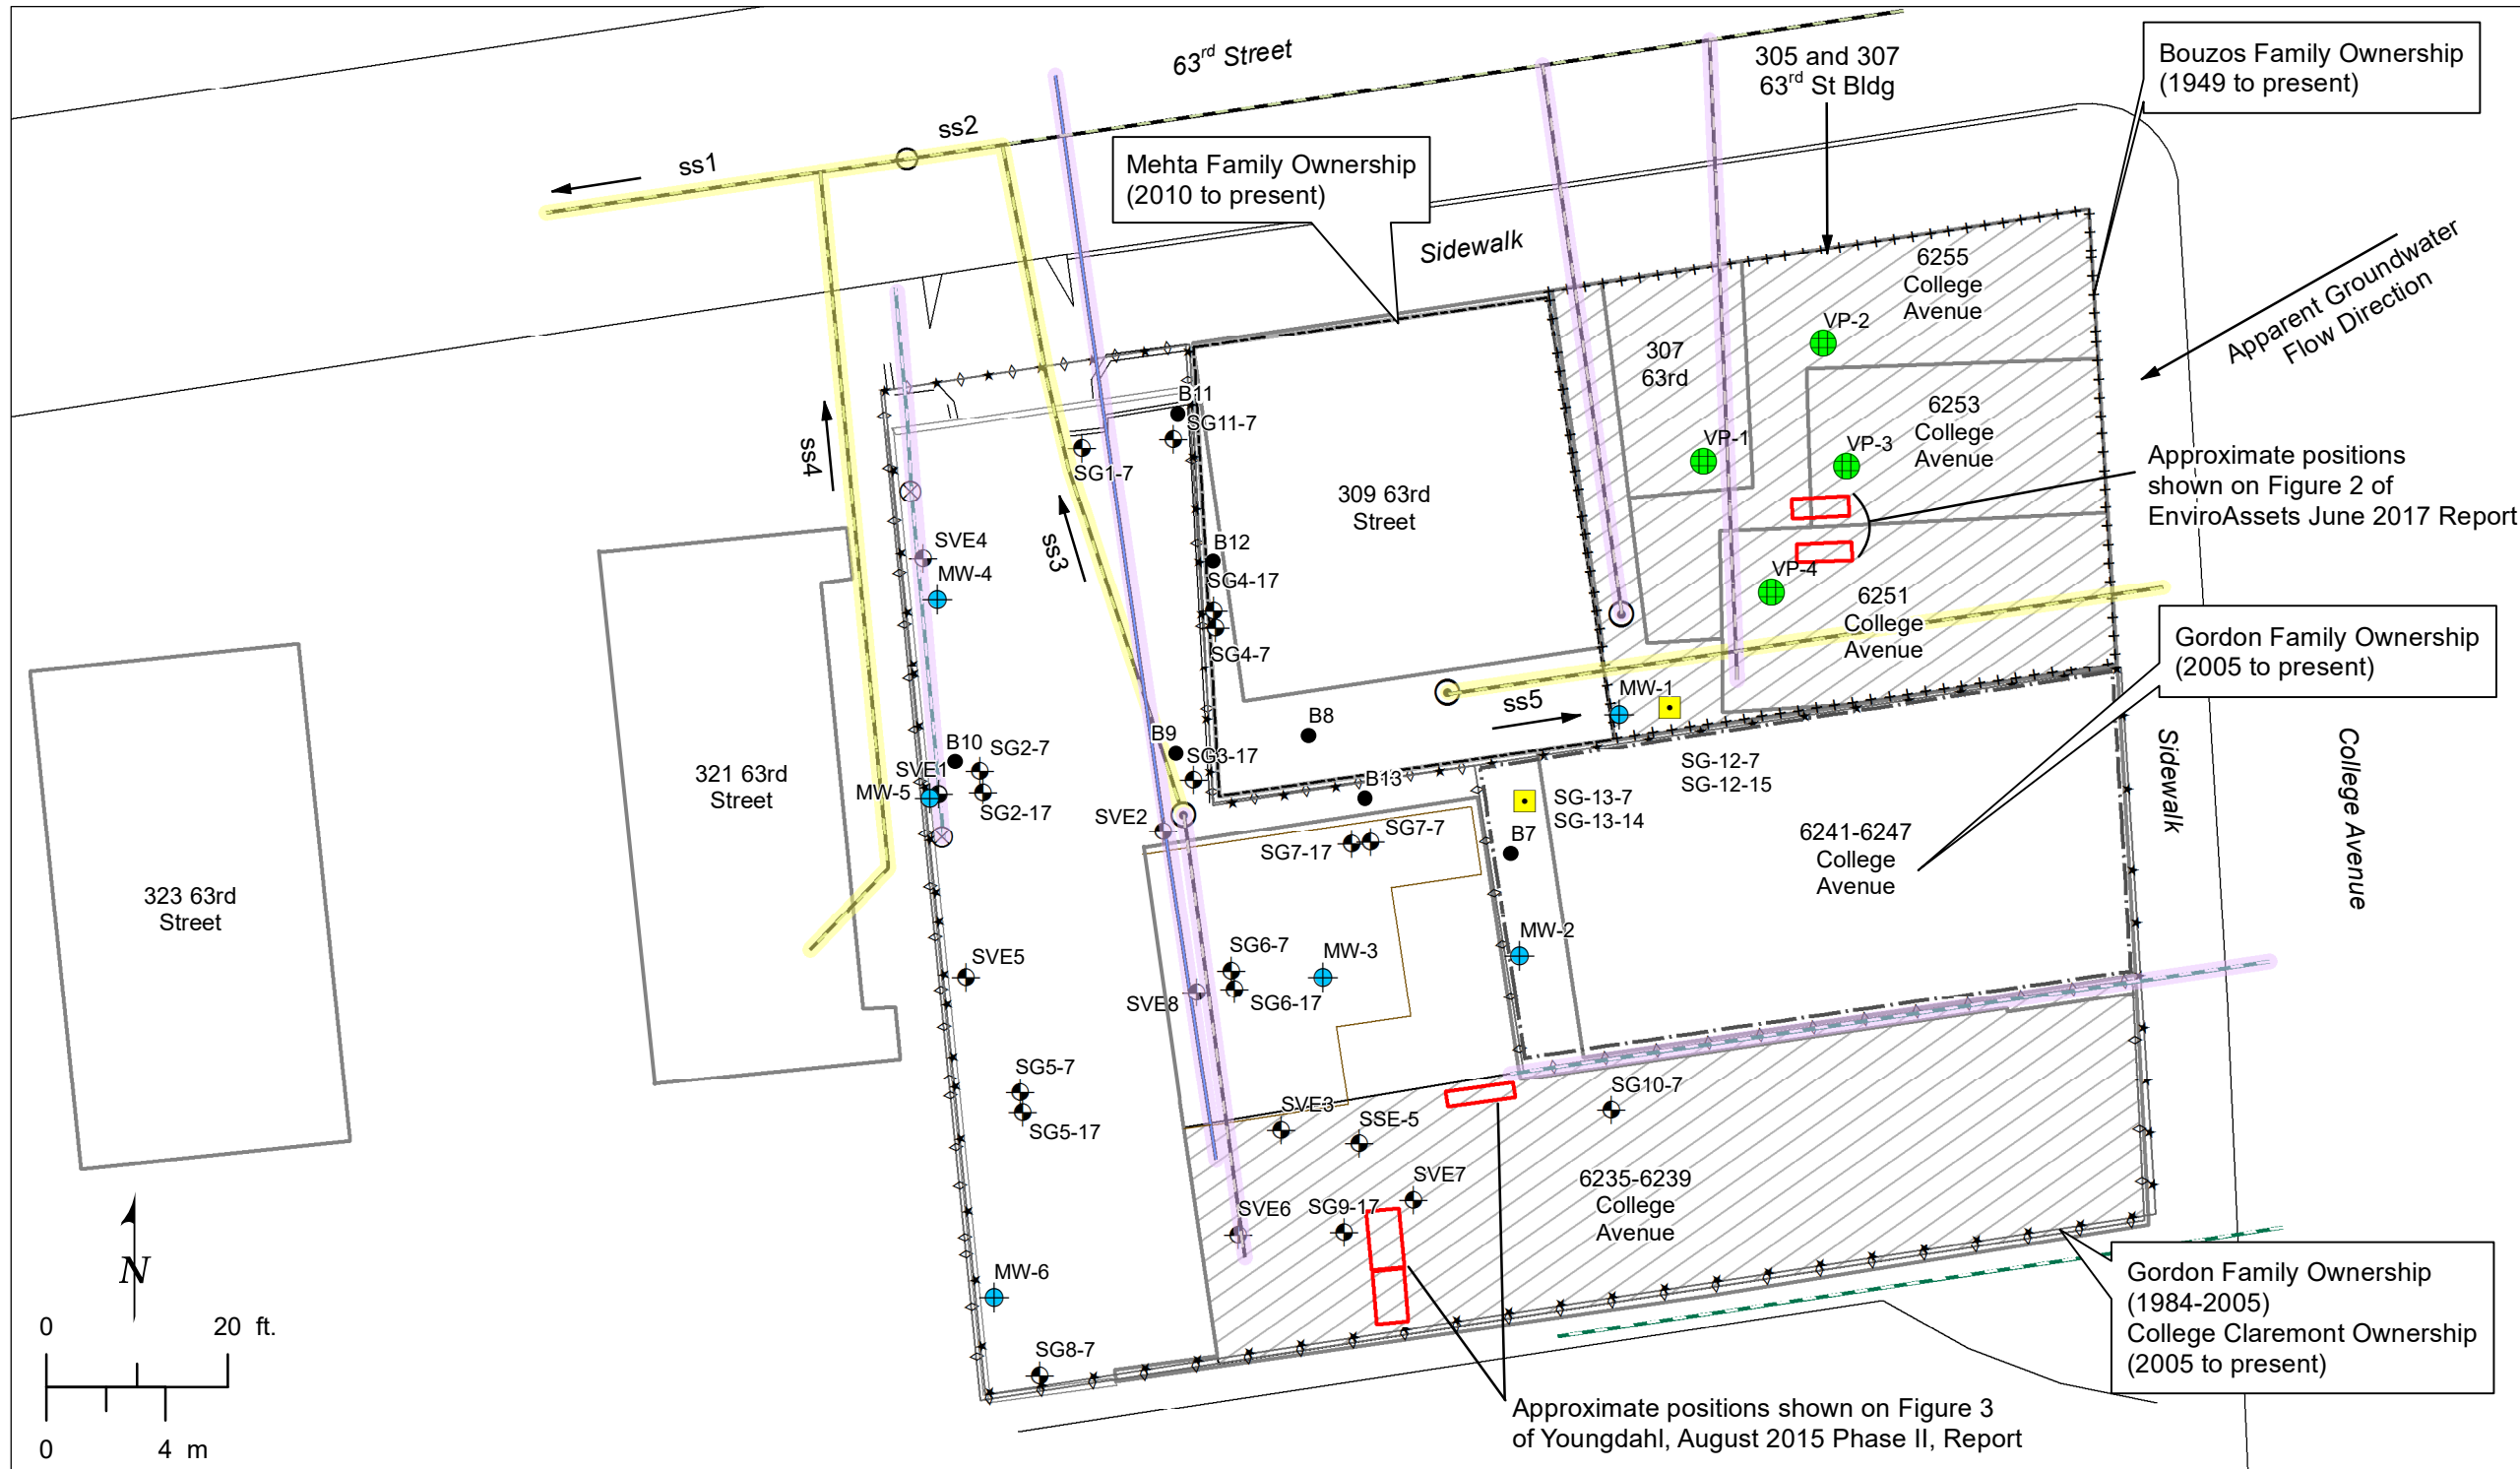
**POINTS OF INVESTIGATION**

- Identification of sewer lateral tie-ins and taps (closed tie-ins) at the mainline within 63<sup>rd</sup> Street was not feasible due to existing construction details and manhole entry obstructions. Tracing of all existing laterals within the local area was also not feasible due to the lack of access to private properties to complete the survey. Laterals and the portion of the mainline below 63<sup>rd</sup> Street which were surveyed on January 12, 2017 are shown on Plate 1.

It is unclear what methods were used by others to document the location of the utility lines shown on the various investigation report maps and development maps. Other line orientations and the location of the suspected dry cleaning machine locations, as presented by various other investigators are shown on Plate 1.

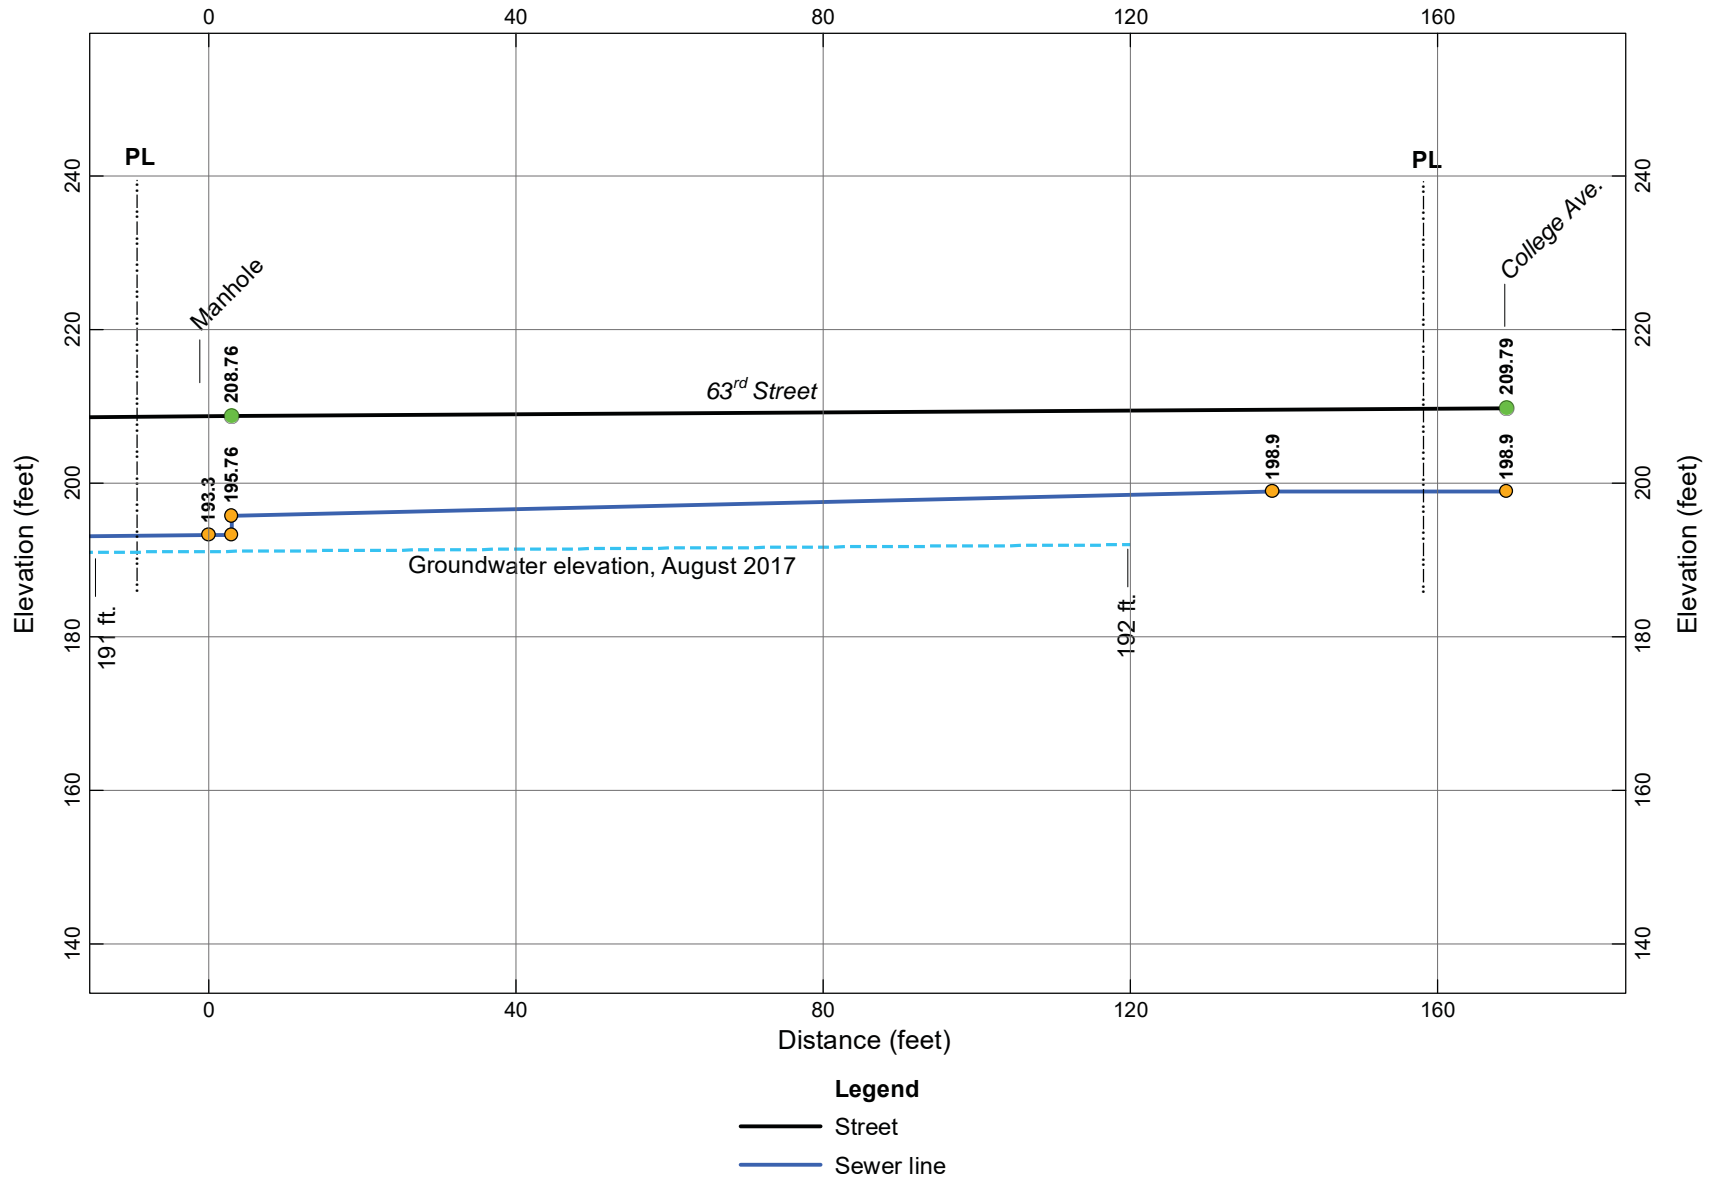
63<sup>RD</sup> STREET MAINLINE SEWER PROFILE

Using the flowline elevations shown on the City maps and the topographic survey data for the Site, Fugro developed an approximate profile of the mainline located below 63<sup>rd</sup> Street, to better depict the construction of this line. It is the change in elevation of the line and the paving over of the former manhole near College Avenue which hamper any further camera surveying of the 63<sup>rd</sup> Street mainline without extensive and intrusive excavation activities. The profile is presented on Plate 2.

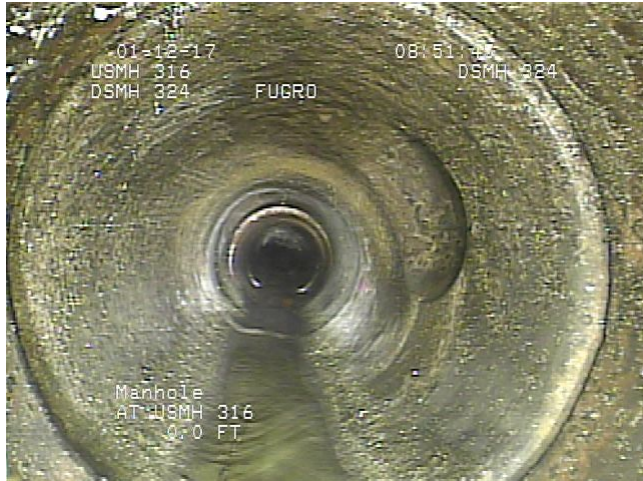
AMH - Manhole  
Distance: 0  
Severity: None

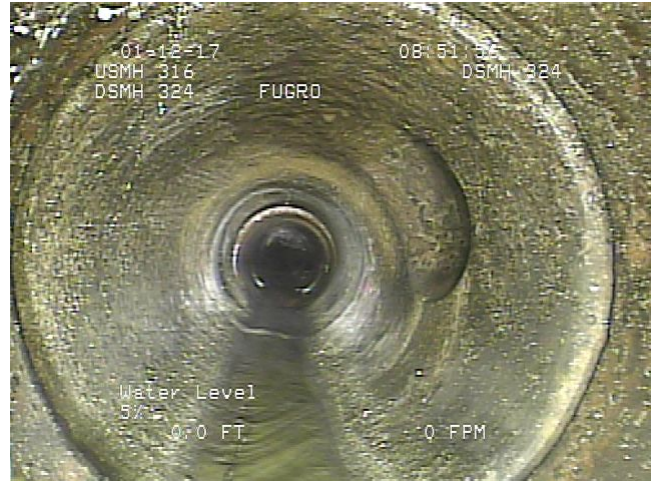
MWL - Water Level  
Distance: 0  
Severity: None

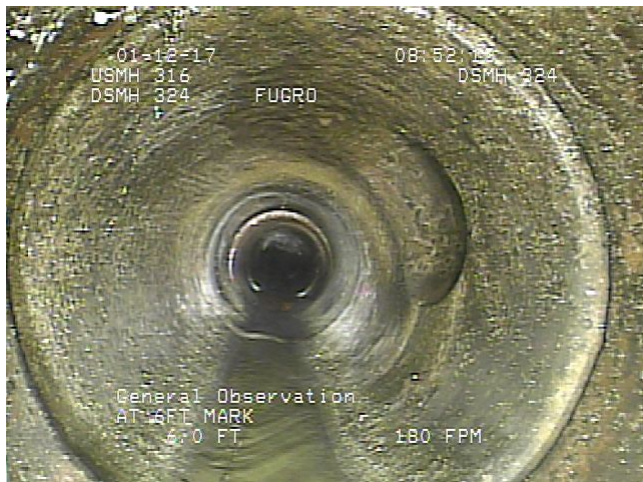
MGO - General Observation  
Distance: 6  
Severity: None

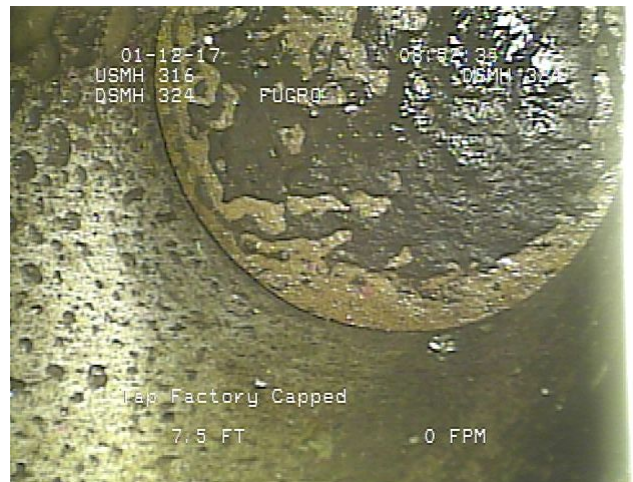
TFC - Tap Factory Capped  
Distance: 7.5 Position: 3  
Severity: None  
Size: 4

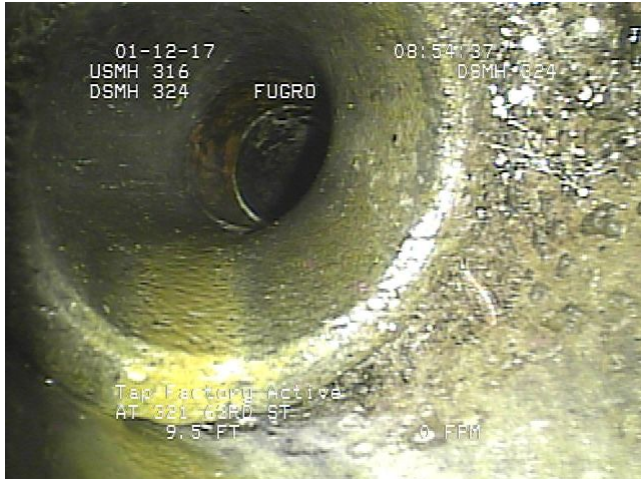
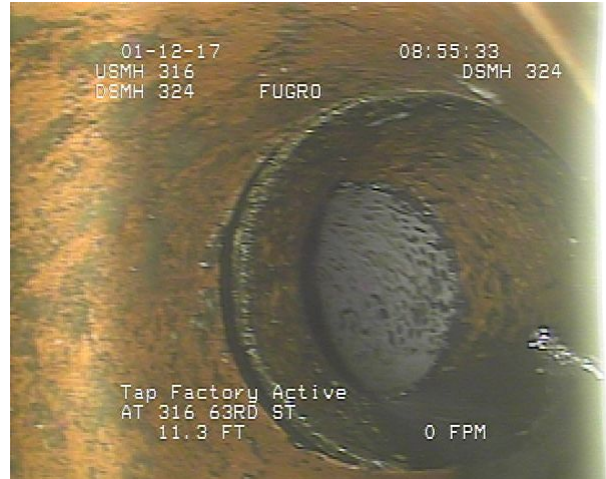
TFA - Tap Factory Active

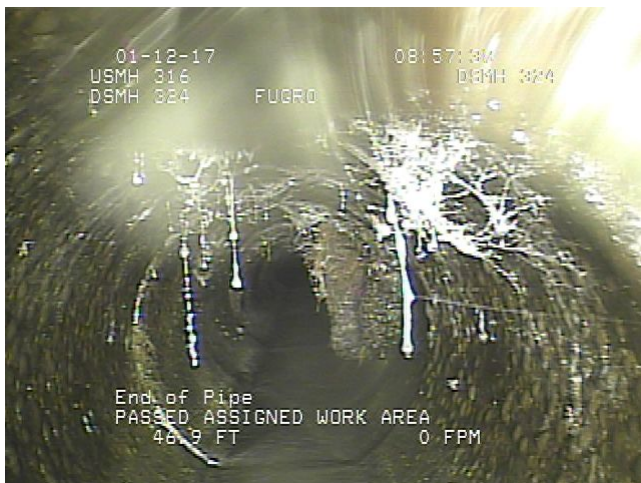
AEP - End of Pipe

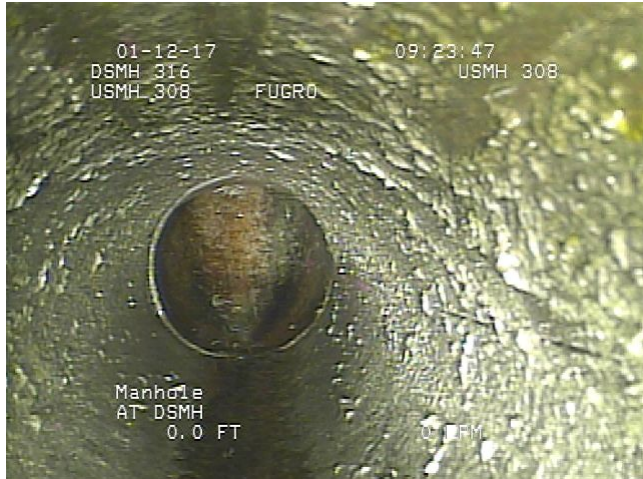
AMH - Manhole

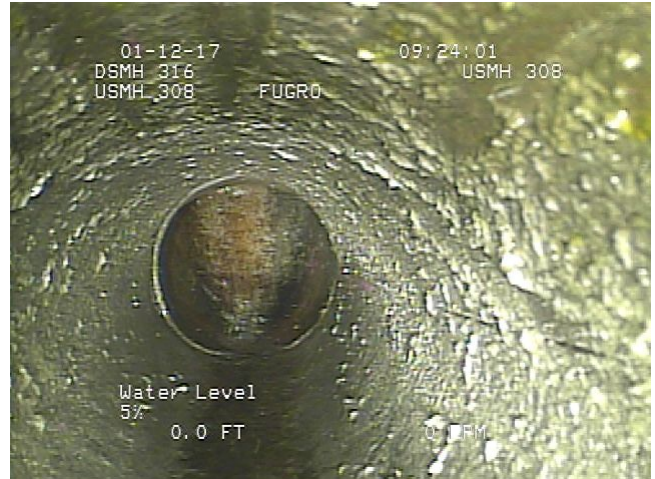
MWL - Water Level

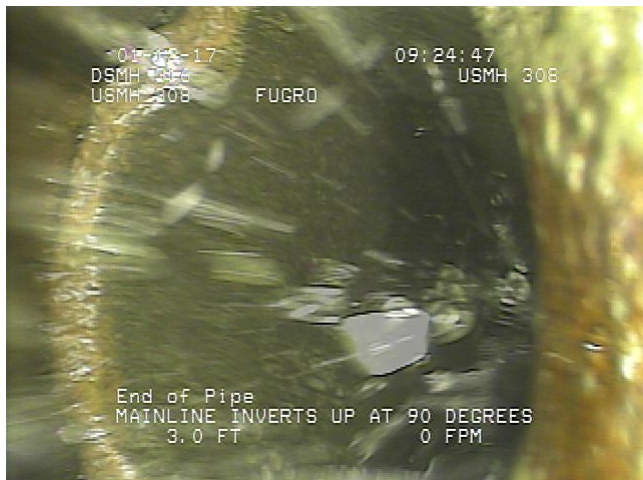
The camera was then removed and re-deployed upstream from the manhole (ss-2), or toward College Avenue. However, the camera could only travel 3 feet before the mainline made a 90 degree vertical bend upward. No lateral tie-ins were observed. No significant defects were observed. The mainline diameter was 8 inches.

AEP - End of Pipe

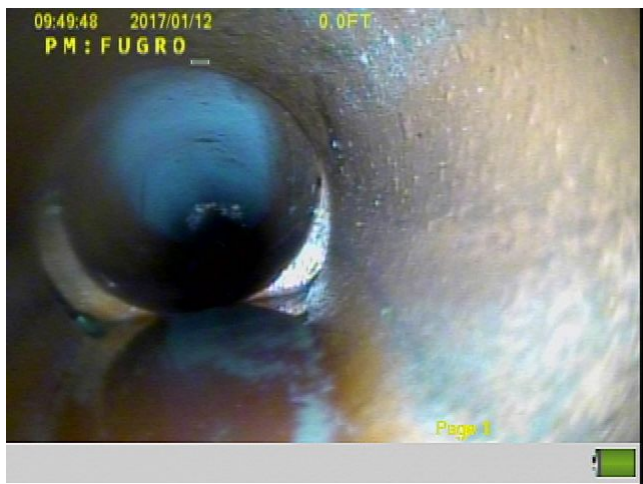
ACOH - Cleanout House  
Distance: 0  
Severity: None

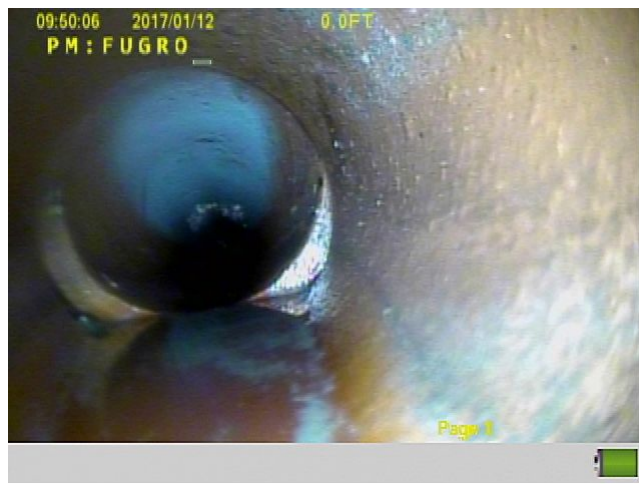
MWL - Water Level  
Distance: 0  
Severity: None

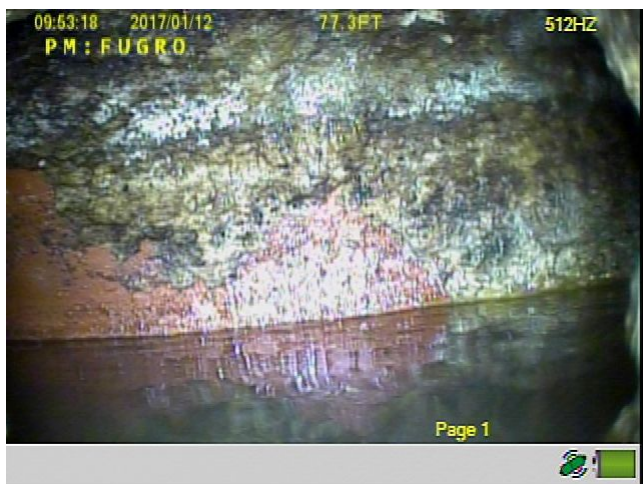
AML - Mainline  
Distance: 77.3  
Severity: None

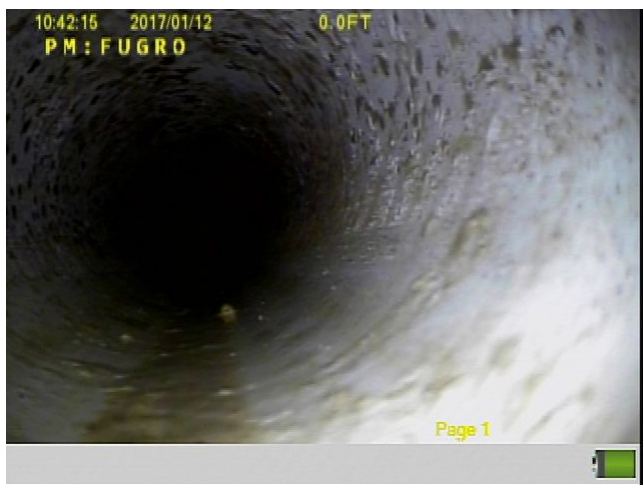
ACOP - Cleanout Propertyline

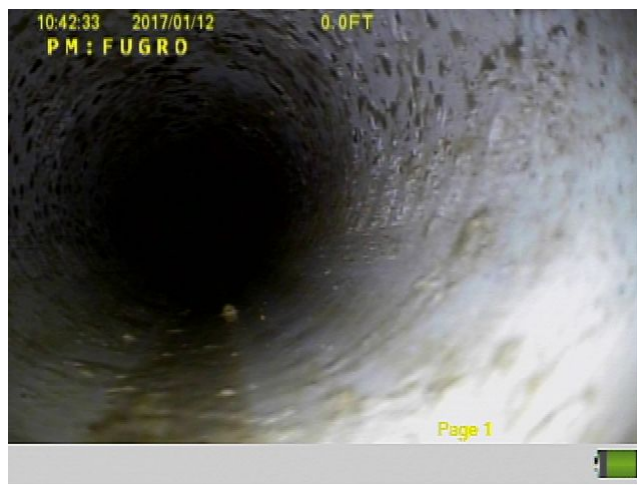
MWL - Water Level

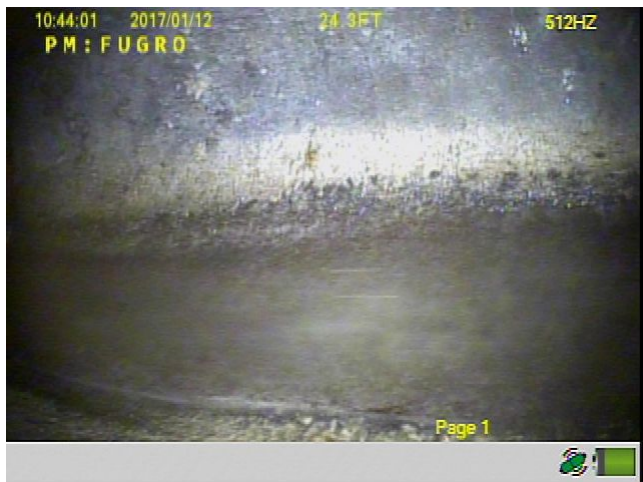
AML - Mainline

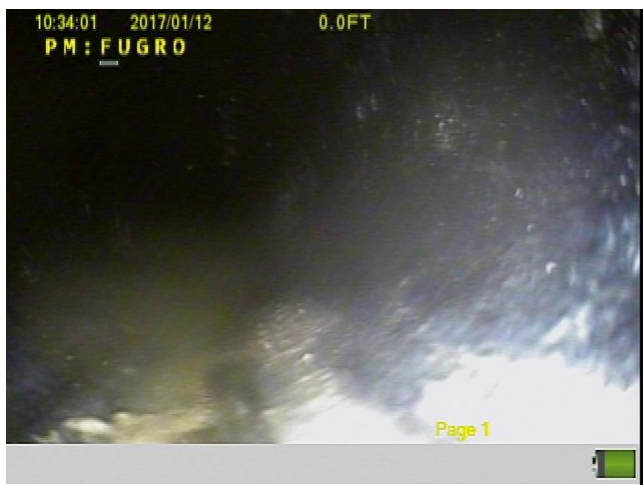
ACOP - Cleanout Propertyline

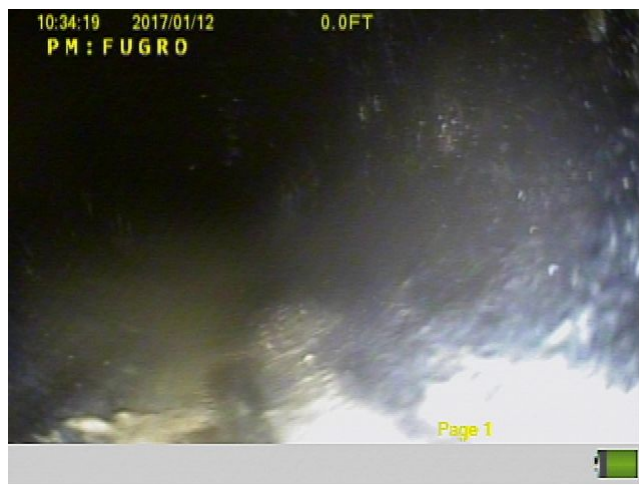
MWL - Water Level

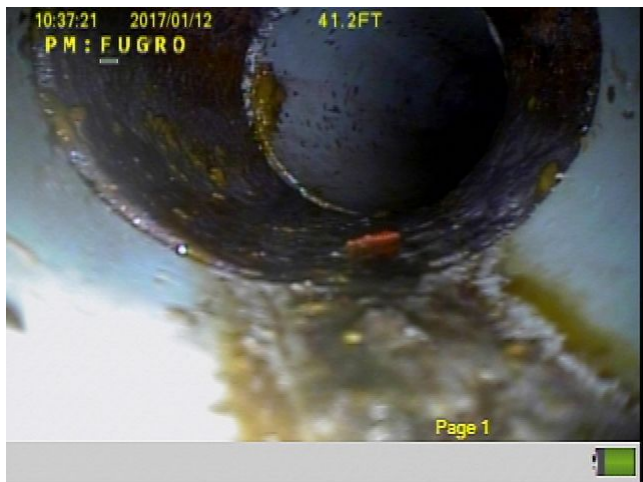
ACOH - Cleanout House

AT FOUNDATION

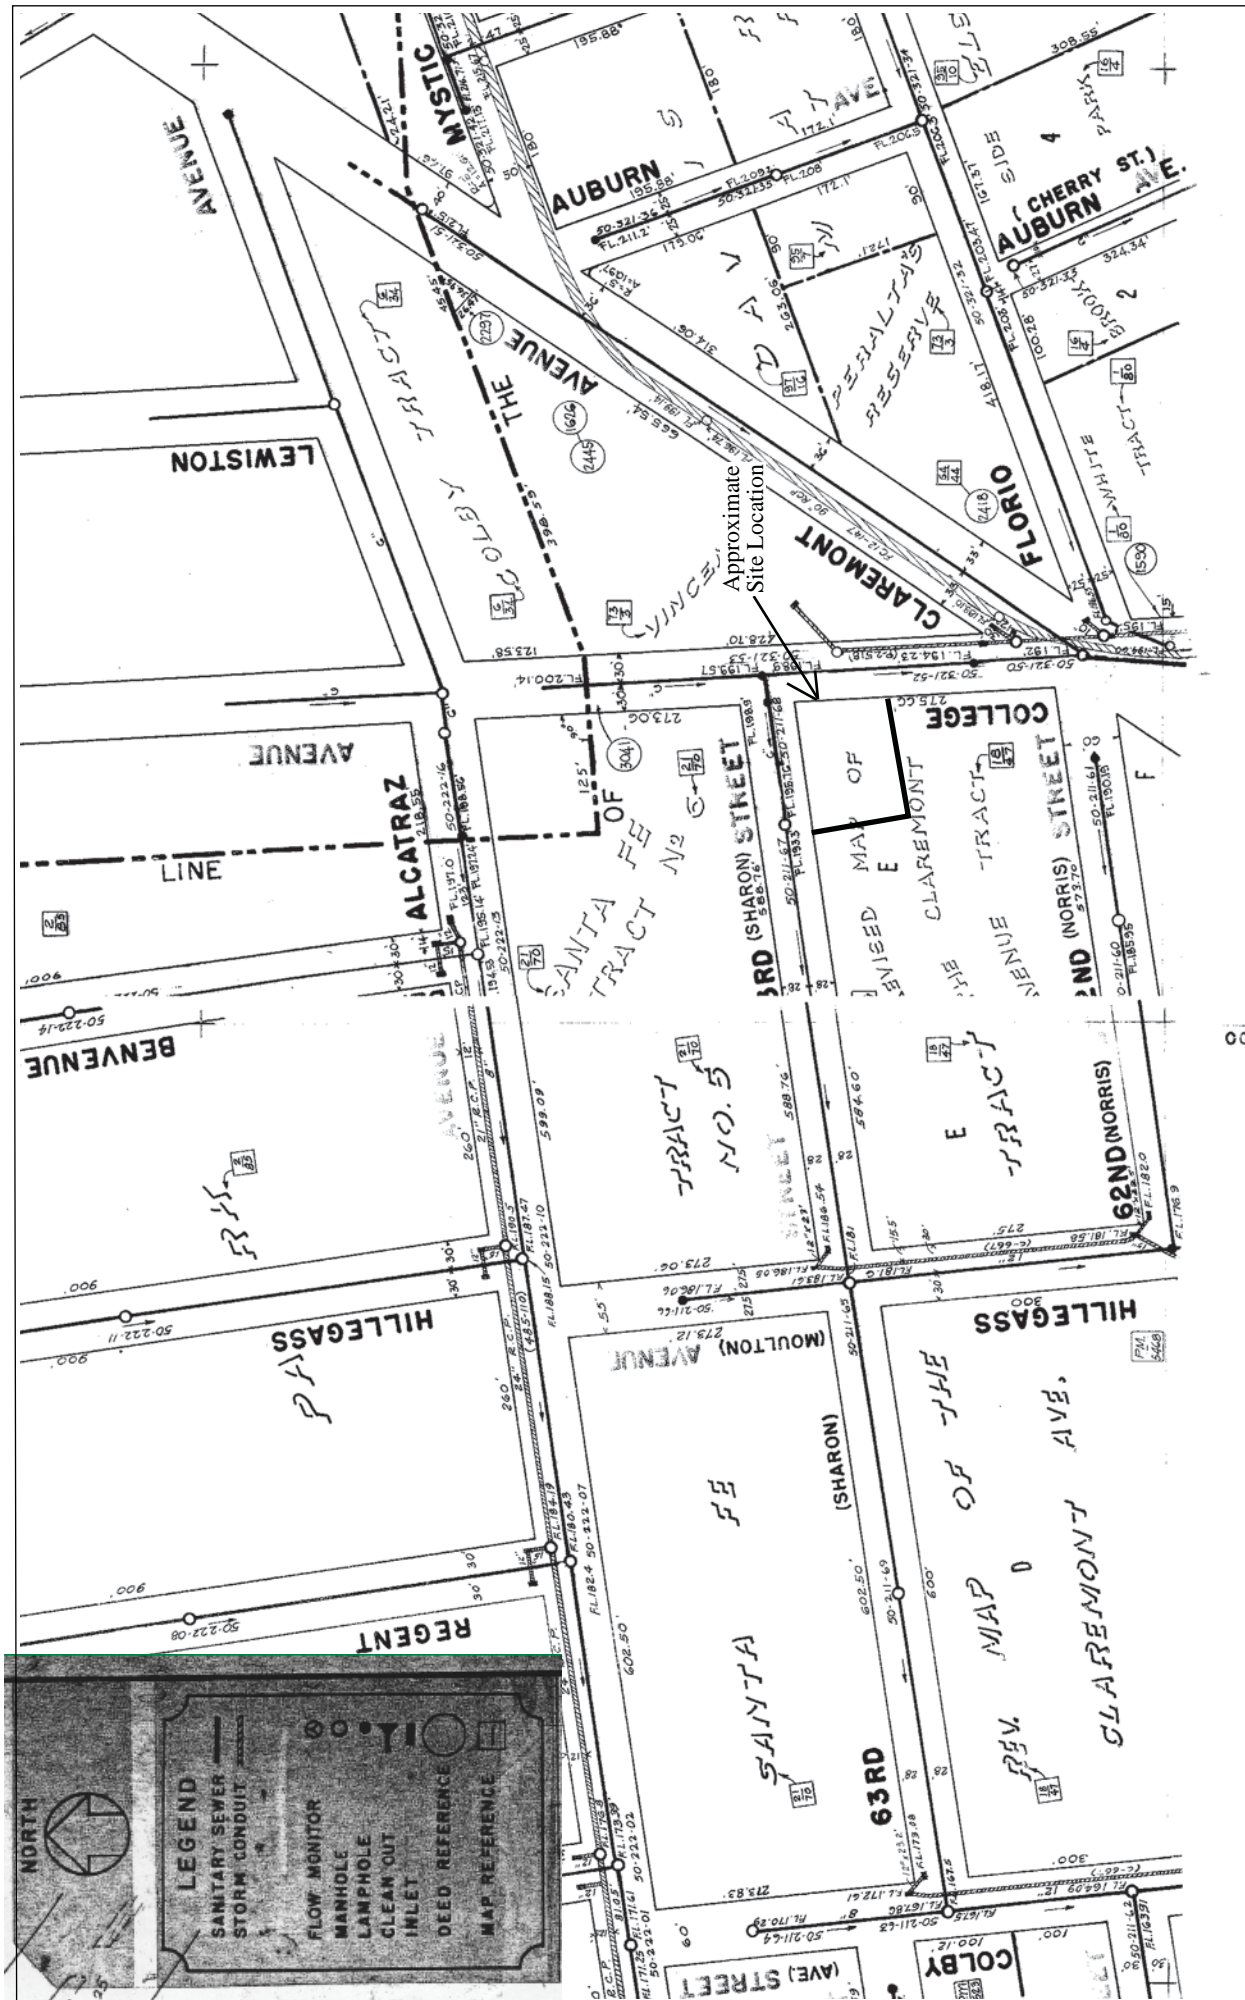
Figure 5  
 City of Oakland Sewer Map  
 Red Hanger Cleaners  
 6239 College Avenue  
 Oakland, California

City sewer maps are presented in Appendix B. The maps do suggest that sewer mainlines exist below both 63<sup>rd</sup> Street and College Avenue. The maps also indicate that the 63<sup>rd</sup> Street mainline is at two different flowlines and composed of both 6 and 8-inch diameter material. One of the maps also suggests that another mainline manhole was located near the College Avenue intersection, however the manhole has been paved over.
