Subject: Remediation Completion Report & Request for Case Closure
Magnolia Terrace at 4001 Adeline Street, Emeryville, California

**REMEDICATION COMPLETION
REPORT AND REQUEST
FOR CASE CLOSURE**

**MAGNOLIA TERRACE AT
4001 ADELINE STREET
EMERYVILLE, CALIFORNIA**

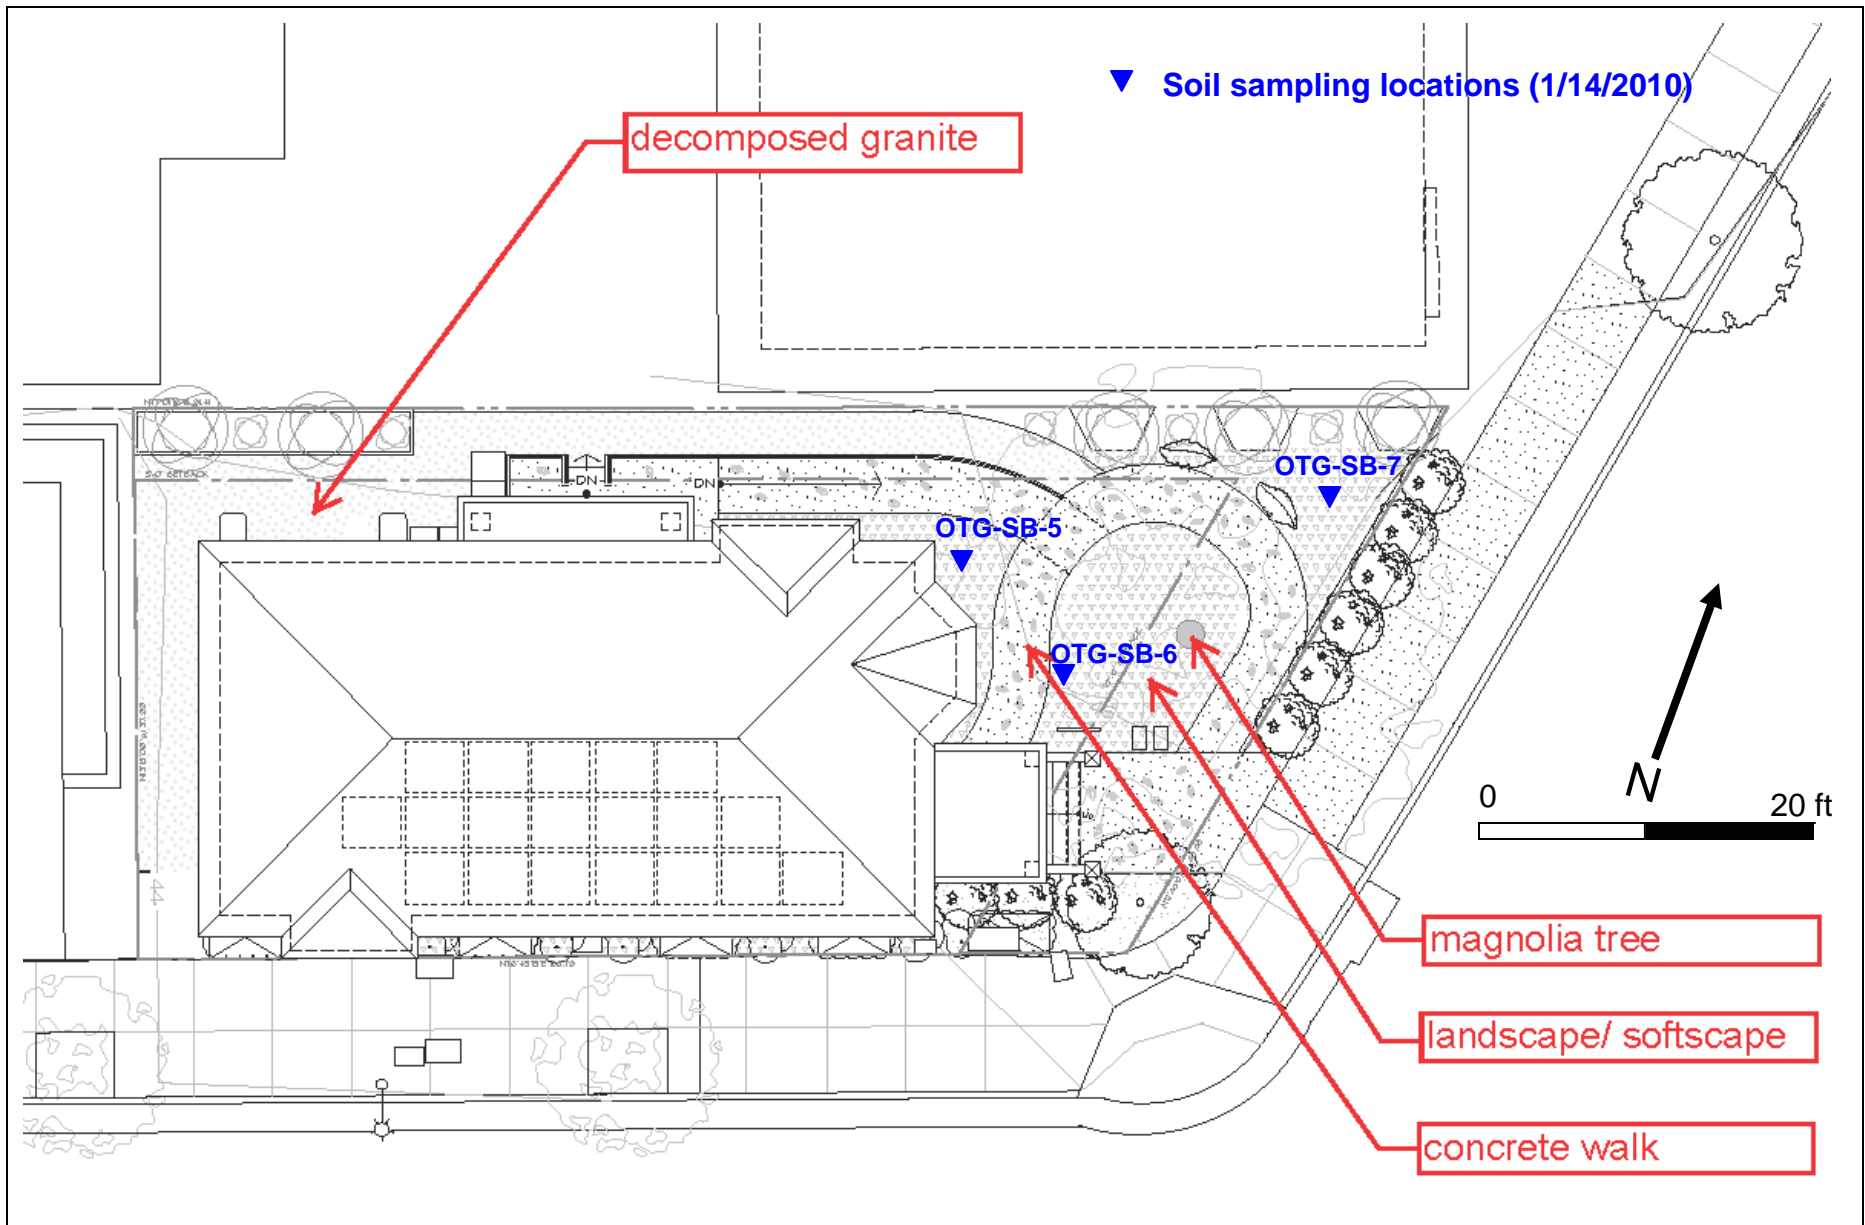
Figure 2. Site Plan with Identification of Soil Sampling Locations
4001 Adeline Street, Emeryville, California (Parcel APN 049-1025-26-05)

inches below grade, Sample ID OTG-SB-7-0) exceeded its Environmental Screening Level (370 mg/kg detected versus 200 mg/kg ESL). Therefore, the remedial action plan, as approved by ACEH, is as follows:

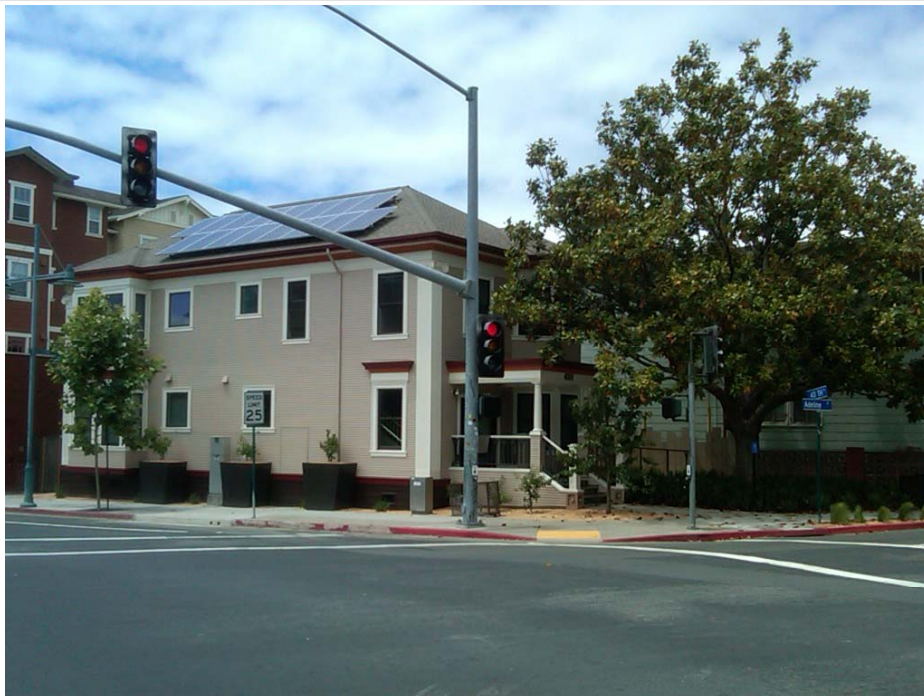
Photo showing the close proximity of the mature Magnolia tree to the building

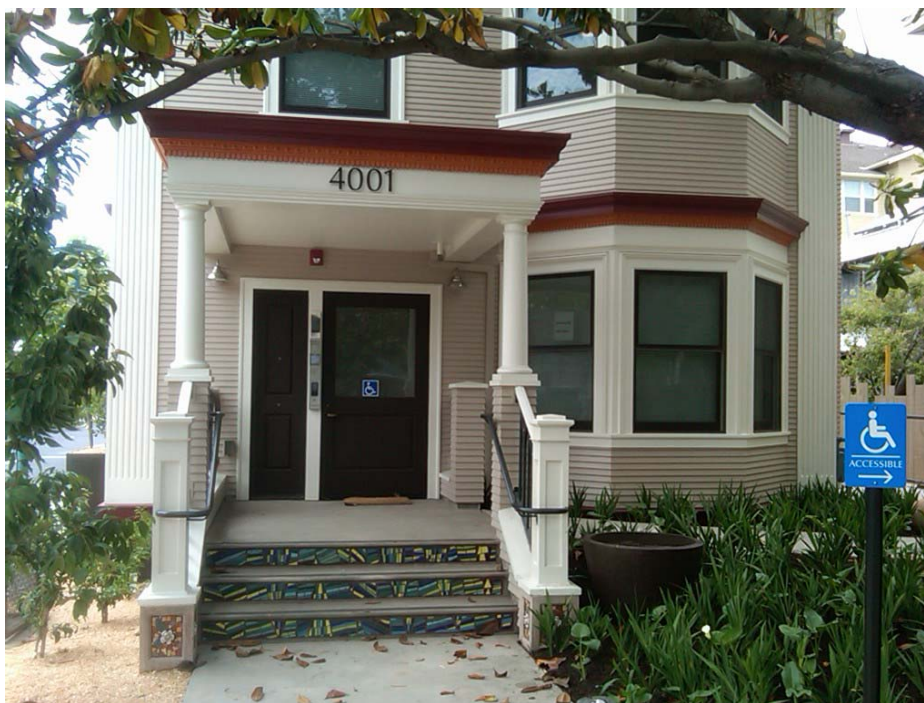
Photo showing the main entrance to the newly renovated building

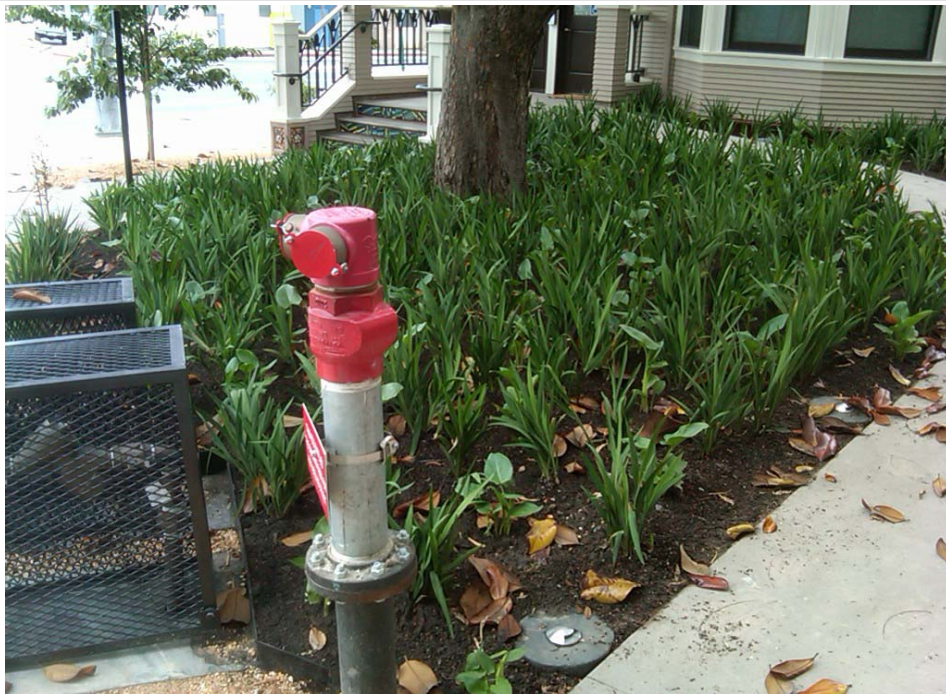
Photo identifying landscape area surrounding the tree

To accommodate the need of covering existing surface soil and minimize compaction to the tree's feeder roots, a six-inch thick top soil was placed in the vegetation area and followed by another approximately three inches of mulch. This was done in early May 2011 under the arborist's supervision (see photos in Plate 2).

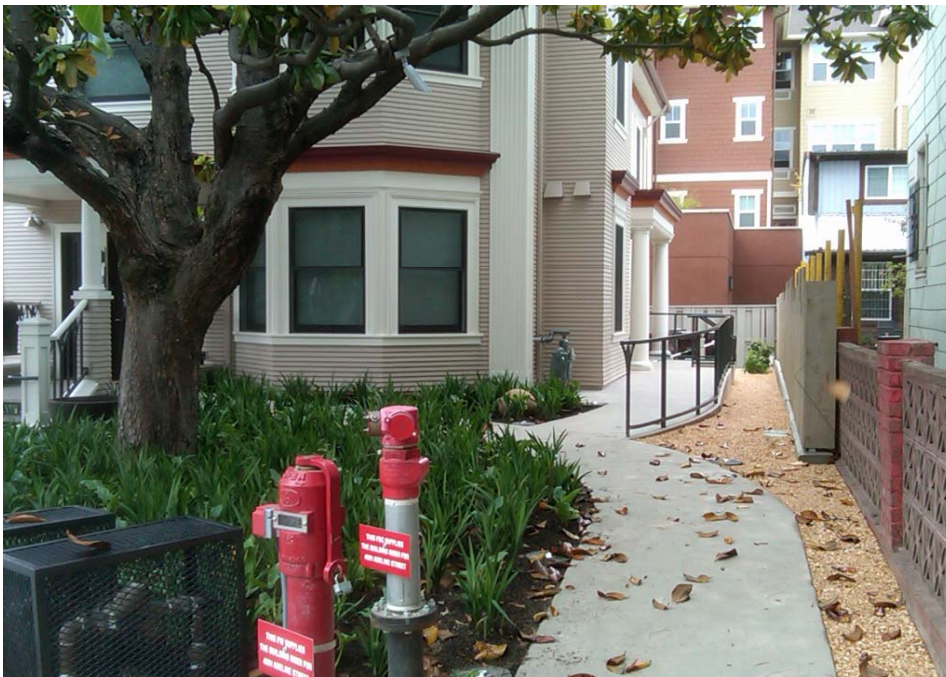
Photo showing landscape area and the wheelchair access path
