PHASE I
ENVIRONMENTAL
SITE ASSESSMENT

475 Lesser Street
Oakland
California

Subject: Phase I Environmental Site Assessment Report
475 Lesser Street
Oakland, California 94601

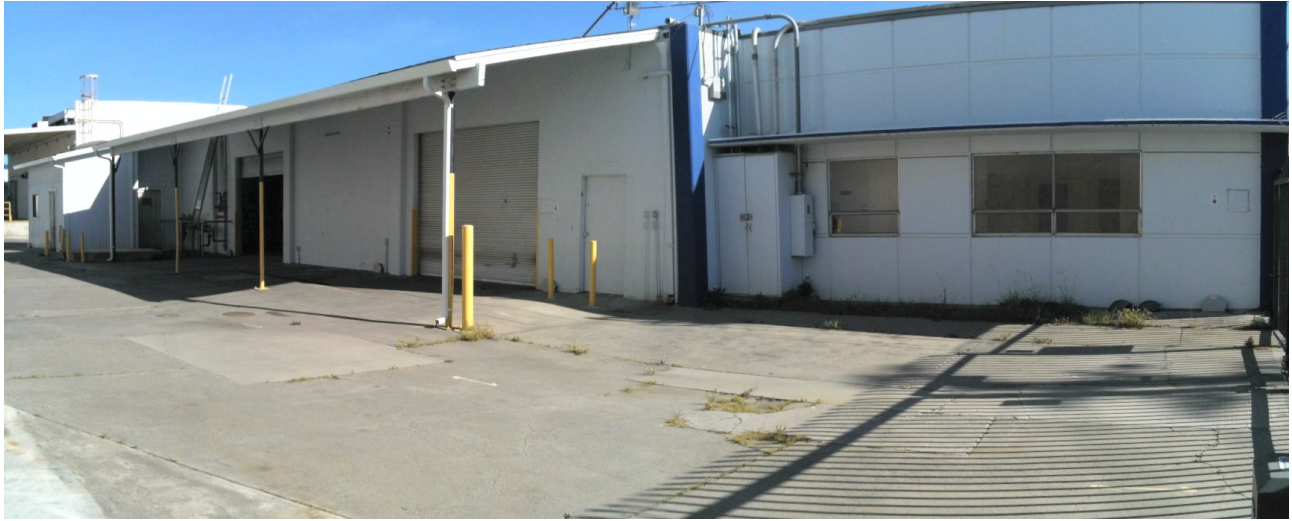
Located within the associated paved area is a covered canopy extending from the west side of the former processing area of Building 1 (See Photo 3). The covered canopy area is utilized as a grade-level shipping/receiving area for Building 1. Visual observations of the grade-level shipping/receiving area did not reveal any obvious evidence of hazardous materials, stains or spills. Located within the center portion of the grade-level shipping/receiving area is a trench floor drain. Visual observations of the floor drain did not reveal any obvious evidence of hazardous materials, stains or spills. Visual observations of the rest of the grade-level shipping/receiving area did not reveal any other obvious evidence of drains, sumps, major cracks or other conduits to the subsurface.

Photo 3: Subject Site (Facing Northeast)
Building 1 (Office/Processing Area) and Associated Paved Areas

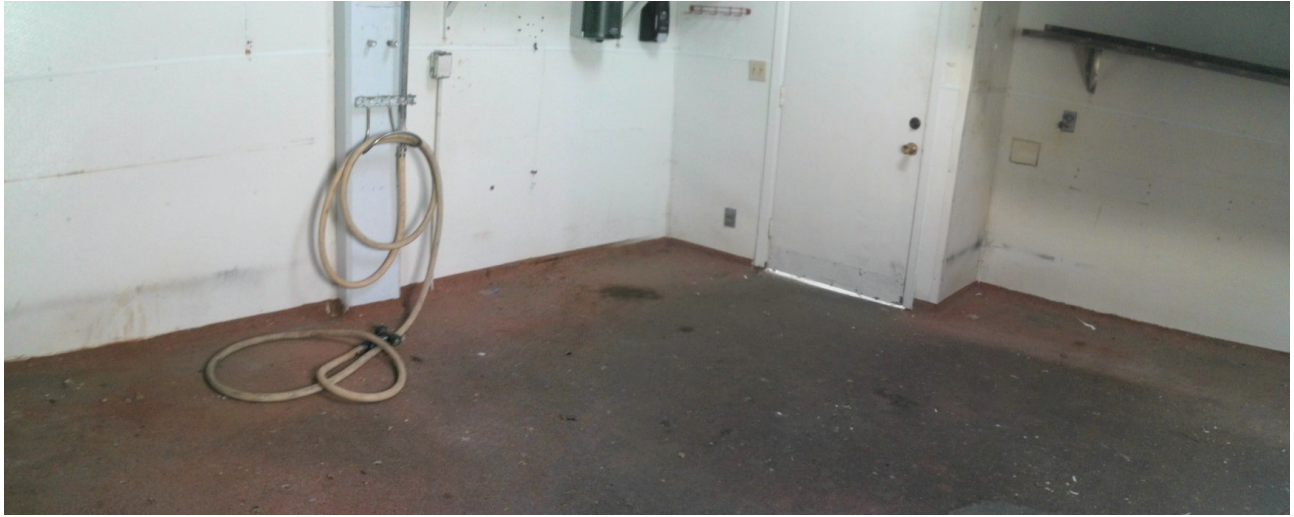
The former chemical storage room is located on the northwest portion of the warehouse/processing area and consists of a small room. This room was reported to store dry acids used as cleaning reagents for the food processing equipment. During the time of the site visit, the former chemical storage room was vacant and unoccupied (See Photo 7). Visual observations of the former chemical storage room did not reveal any obvious evidence of hazardous materials, stains or spills. Located within the center portion of the former chemical storage room is a small floor drain. Visual observations of the floor drain did not reveal any obvious evidence of hazardous materials, stains or spills. Visual observations of the rest of the former chemical storage room did not reveal any other obvious evidence of drains, sumps, major cracks or other conduits to the subsurface.

Photo 7: Subject Site (Facing Southeast)
Building 1 (Office/Processing Area)
Former Chemical Storage Room

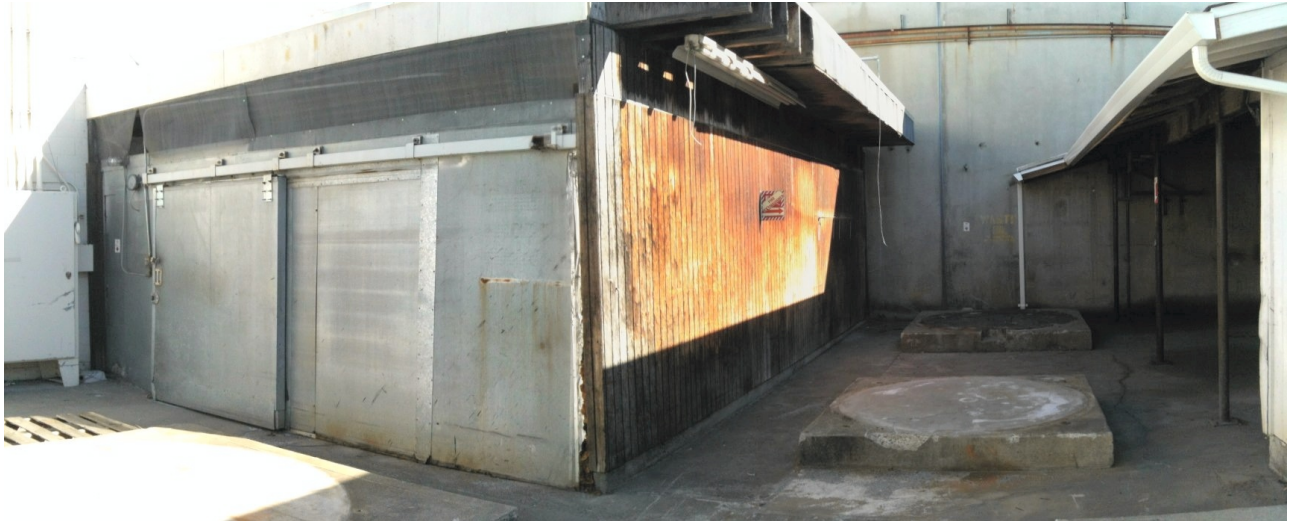
Located within the associated paved area is a covered canopy extending from the north side of the former processing area of Building 1 (See Photo 8). The covered canopy area was reported to have been utilized as a covered storage area for a former natural gas fueled hot water boiler unit and associated expansion tank along with air compressors. During the time of the site visit, the covered storage area was vacant and unoccupied, except for electrical and plumbing conduits noted along the wall of this area (See Photo 10). Visual observations of the covered storage area did not reveal any obvious evidence of hazardous materials, however minor oil stains were noted to the concrete. Visual observations of the concrete surface in this area did not reveal any other obvious evidence of drains, sumps, major cracks or other conduits to the subsurface.

Photo 8: Subject Site (Facing North)
Building 2 (Cold Storage Shed)

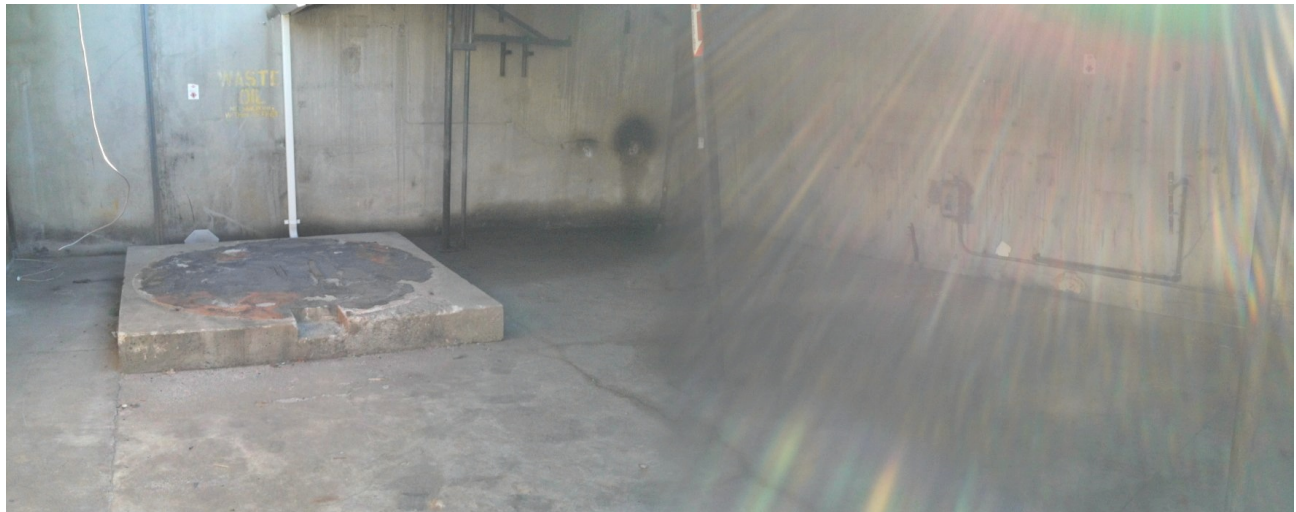
Photo 10: Subject Site (Facing East)
Former Service Area Between Building 1 and Building 2
Concrete Pads for Former Sugar/Syrup ASTs, Boiler and Air Compressor

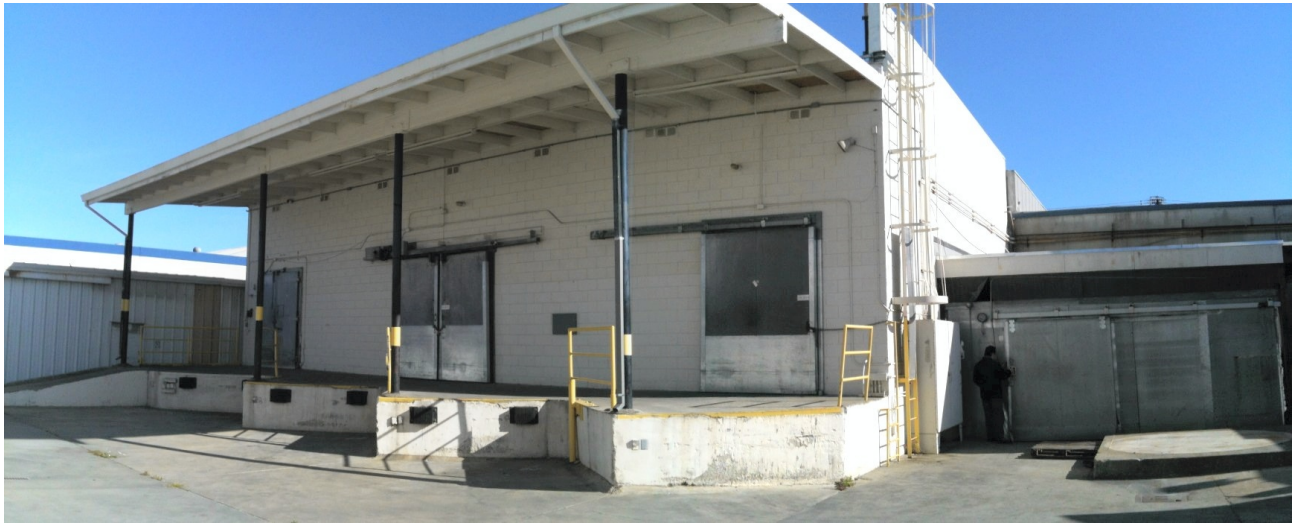
Located within the associated paved area is a covered canopy extending from the west side of Building 3 (See Photo 11). The covered canopy area is utilized as an elevated shipping/receiving dock area for Building 3. A ramp is located on the north side of the dock providing access from the associated paved area. Visual observations of the elevated shipping/receiving dock area did not reveal any obvious evidence of hazardous materials, stains or spills. Visual observations of the elevated shipping/receiving dock area did not reveal any other obvious evidence of drains, sumps, major cracks or other conduits to the subsurface.

Photo 11: Subject Site (Facing North)
Building 3 (Cold Storage Building)
Former Cold Storage Rooms
