**From:** Hoofard, Keith [Keith.Hoofard@tetrattech.com]  
**Sent:** Wednesday, August 26, 2015 1:52 PM  
**To:** Detterman, Mark, Env. Health  
**Cc:** Costello, Timothy; Rick Henderson (Rick.Henderson@safeway.com)  
**Subject:** 5100 Broadway, Oakland - DRAFT Soil-Soil Vapor Data Tables, Figures and Photo Log  
**Attachments:** Data Tables.pdf; DRAFT Soil-Soil Vapor Locations with Data Plotted\_082615.pdf; Photo Log.pdf

**DRAFT**  
**TABLE 1**  
**Analytical Results Summary - Soil**  
**Former Rockridge Cleaners Area**  
**5100 Broadway (Former 5114 tenant space)**  
**Oakland, California**

Analytical Results Summary - Soil Vapor  
Former Rockridge Cleaners Area  
5100 Broadway (Former 5114 tenant space)  
Oakland, California

**Photographic Documentation**  
**Soil Boring and Vapor Monitoring Probe Installation**  
**Former Rockridge Dry Cleaner – 5100 Broadway**  
**(5114 tenant space area)**  
**Oakland California**  
**Project No.: 117-7429001.06**

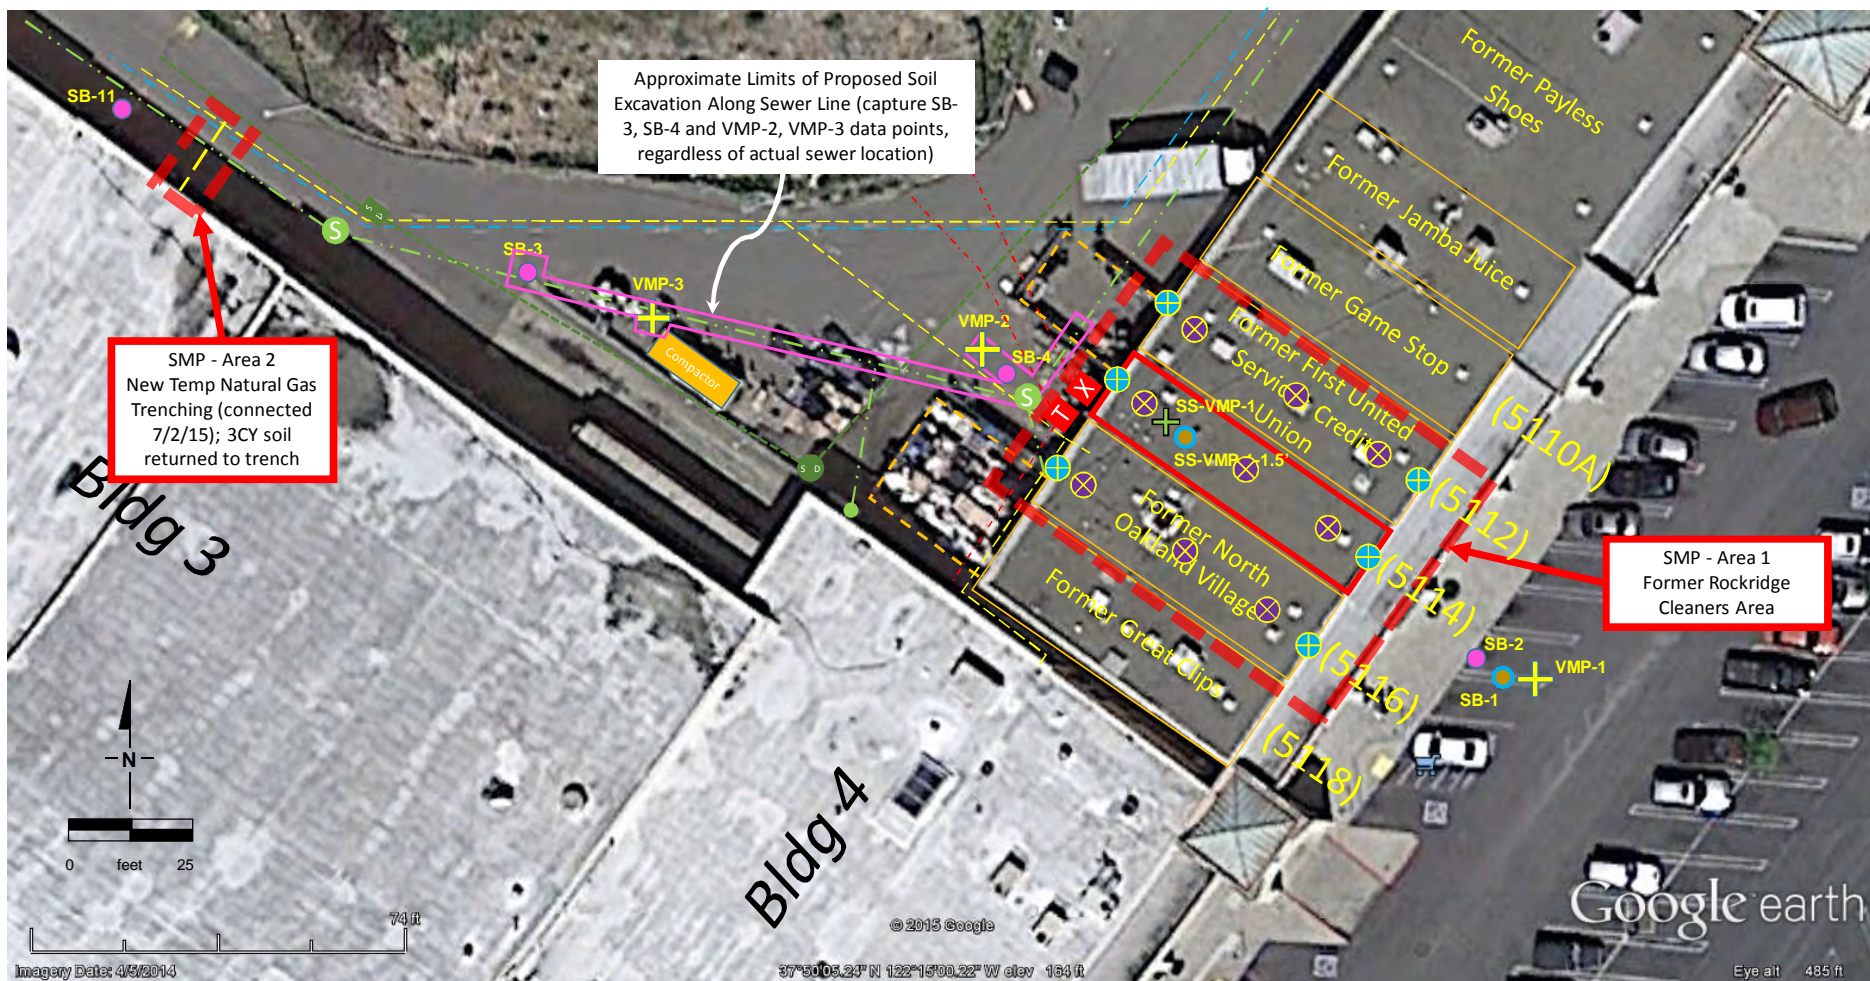
TITLE: <b>SMP Boundaries - Former Rockridge Cleaners</b>			
LOCATION: <b>5114 Broadway Oakland, California</b>			
	CHECKED:	TC	<b>FIGURE: 2</b>
	DRAFTED:	KDH/KBM KM	
	FILE:	117-7429001..	
	DATE:	08/12/15

Approximate Limits of Proposed Soil Excavation Along Sewer Line (capture SB-3, SB-4 and VMP-2, VMP-3 data points, regardless of actual sewer location)

SMP - Area 2  
New Temp Natural Gas Trenching (connected 7/2/15); 3CY soil returned to trench

SMP - Area 1  
Former Rockridge Cleaners Area

- ⊗ 0-6" (from bottom of slab)  
ALL 0.0 ppmv
- ⊕ 36" (beneath perimeter footing)  
ALL 0.0 ppmv

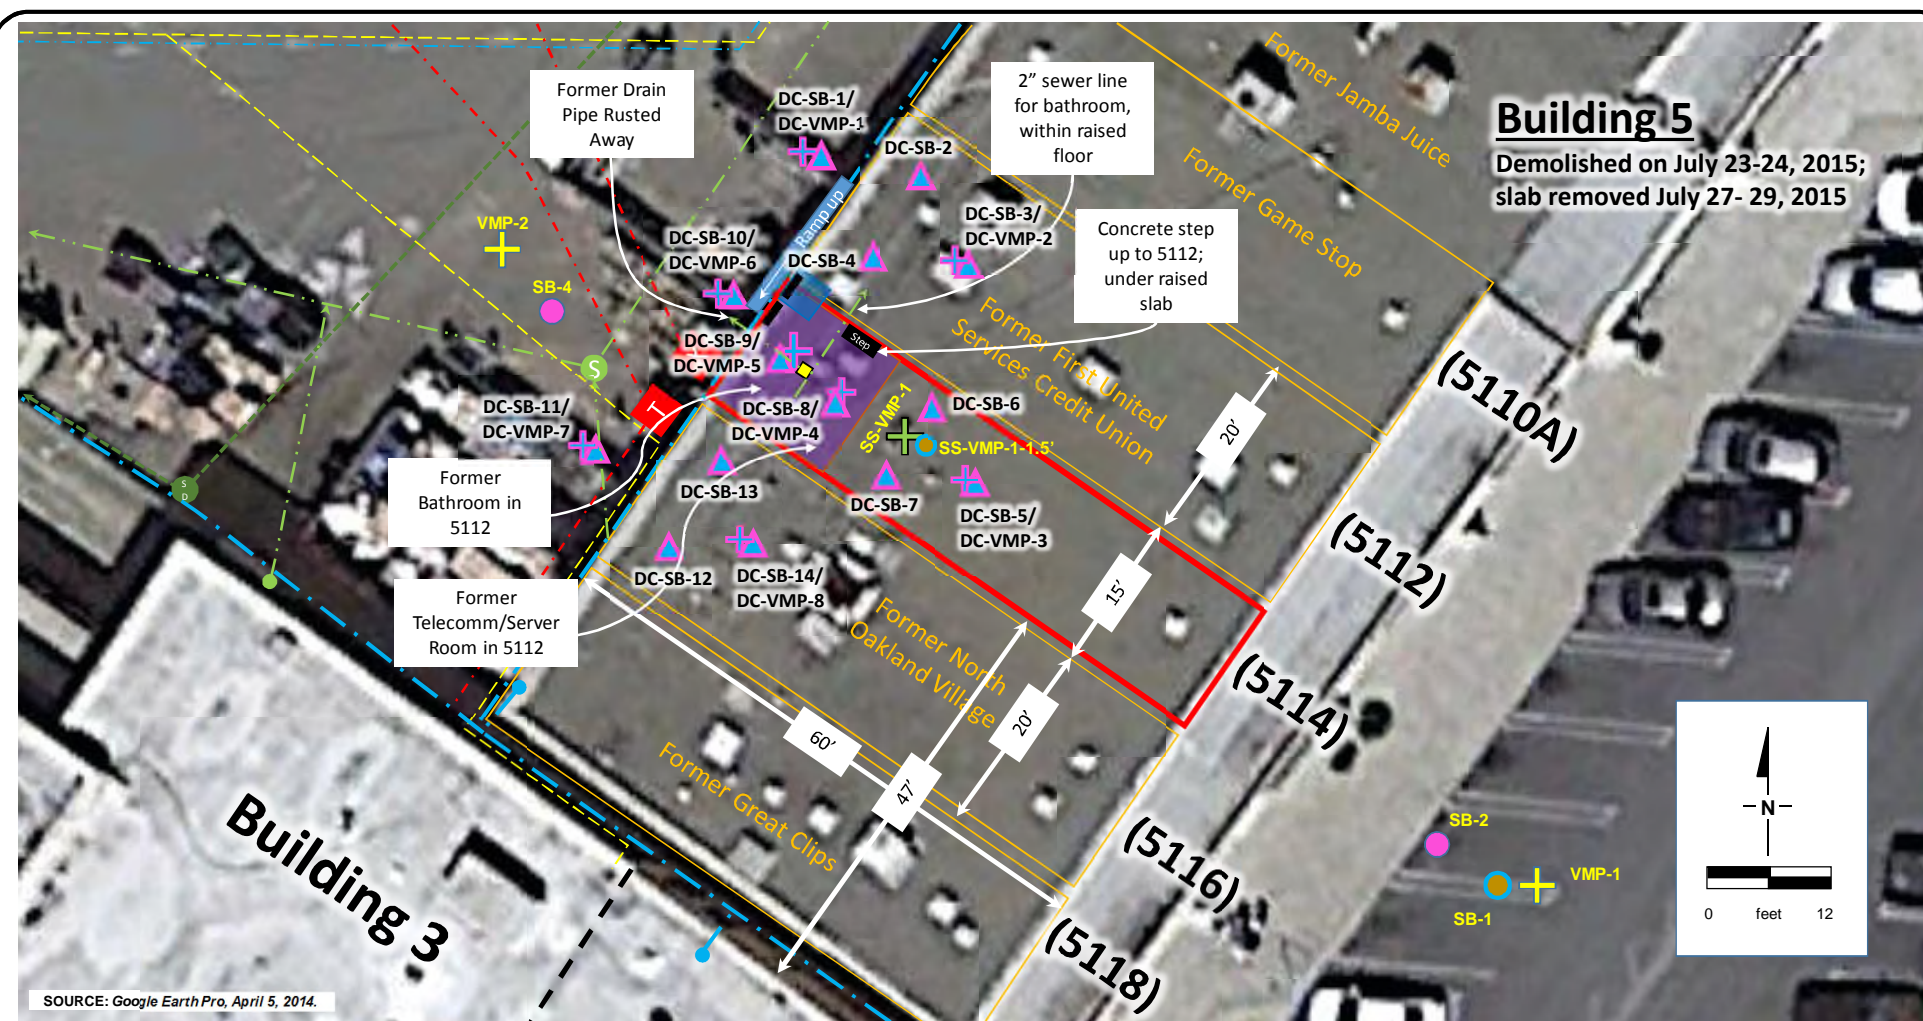
<b>TITLE: Additional Soil and Soil Vapor Sample Locations Former Rockridge Cleaners</b>			
<b>LOCATION: 5114 Broadway Oakland, California</b>			
<b>TETRA TECH</b>	CHECKED:	TC	<b>FIGURE: 3</b>
	DRAFTED:	KDK/KM	
	FILE:	117-7429001.	
	DATE:	08/12/15

- 12" x 12" floor drain at rear of former cleaner, beneath raised slab installed to expand 5112 tenant space
- Former doors – walled over and not used by recent tenant (Credit Union)
- 4' x 4' foyer, original to 5112 and 5114, with entry door at sidewalk grade. Ramp installed across front of door at later date.
- 14" raised slab to match elevation of 5112 slab, expanding 5112 space (not original to 5114). Concrete debris from wall-cut between tenant spaces used as fill before concrete pour, which excluded foyer area initially. Foyer filled in with ceramic toilet debris at a later date and concreted over (likely when ramp was constructed).

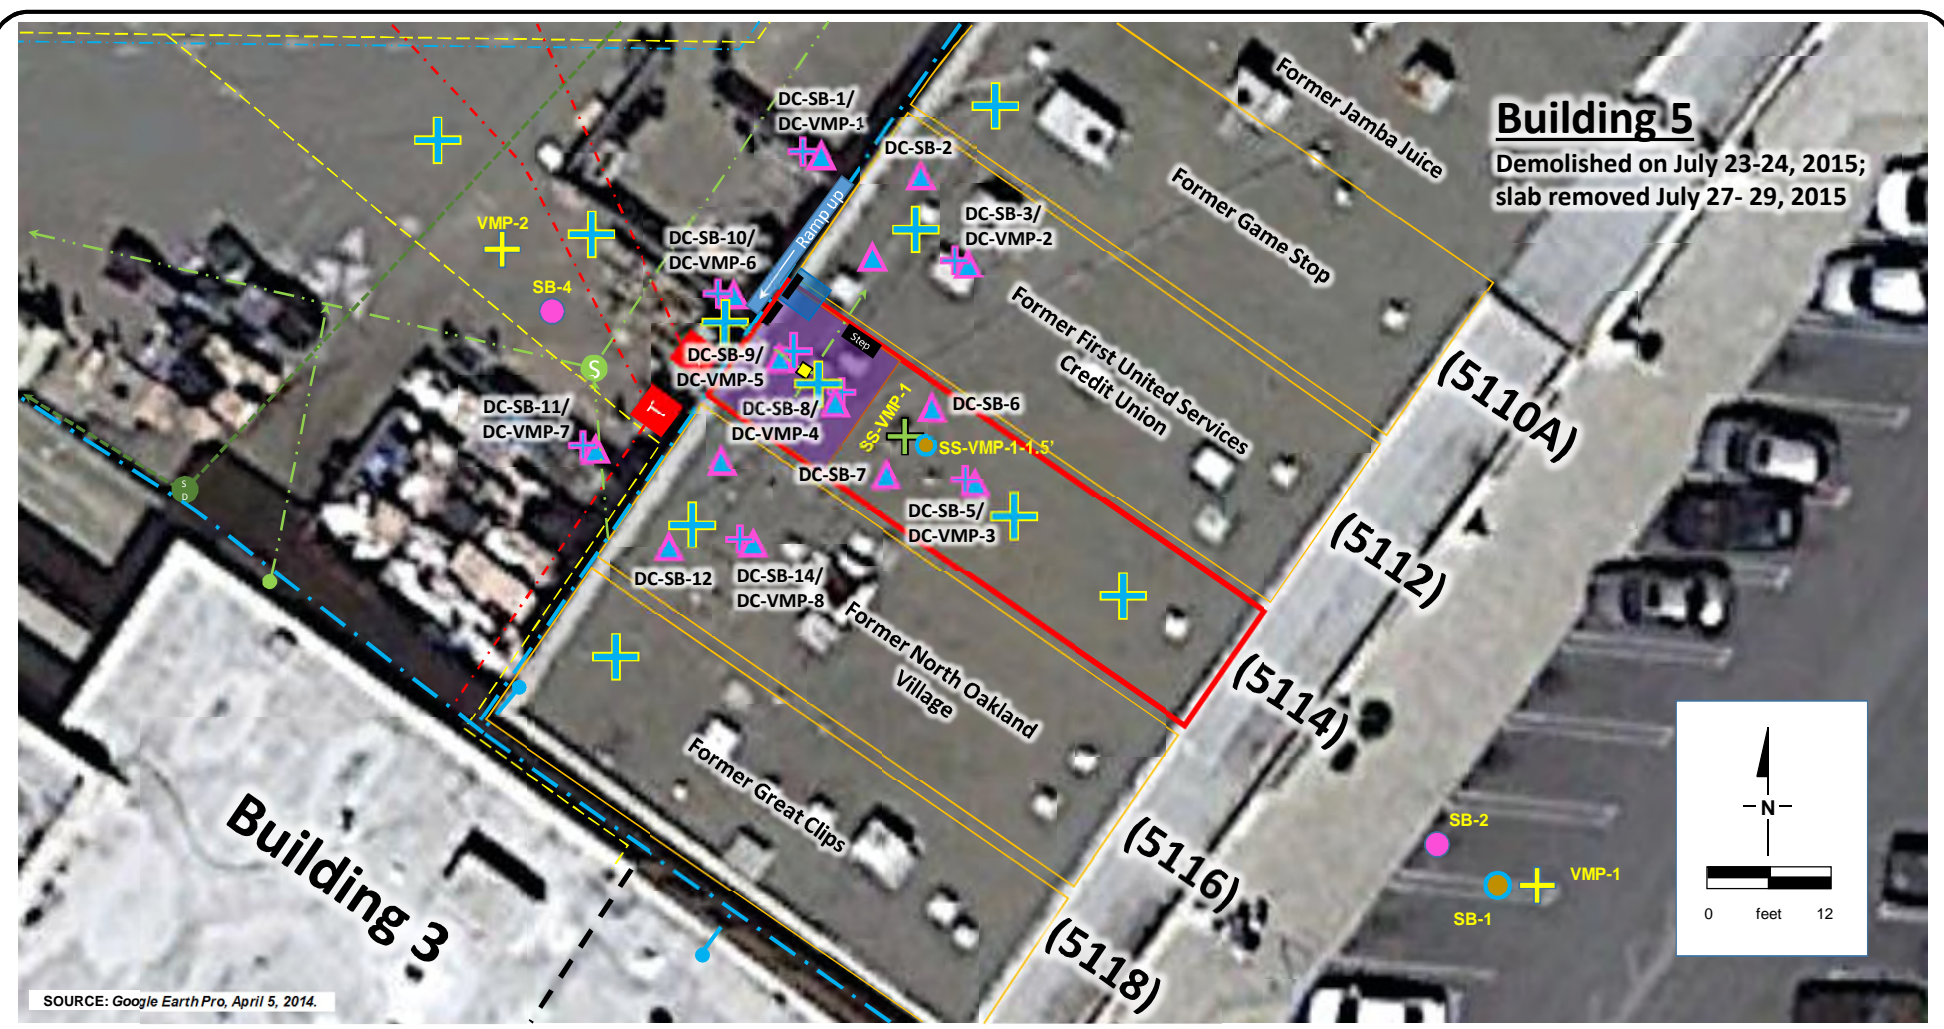
<b>TITLE: Proposed Step-Out Soil, Soil Vapor and GW Sample Locations Former Rockridge Cleaners</b>			
<b>LOCATION:</b>		5114 Broadway Oakland, California	
	CHECKED:	TC	<b>FIGURE: 5</b>
	DRAFTED:	KDH/KBM KM	
	FILE:	117-7429001.	
	DATE:	08/12/15

+ Proposed Soil, Soil Vapor and GW Sample Location  
 Soil – sample 10', 15' and 20', bgs  
 Soil Vapor – sample 5' and 15', bgs  
 GW – 1 sample, if encountered (GW encountered at 22 feet bgs in boring SB-1 in 2014, but generally absent)

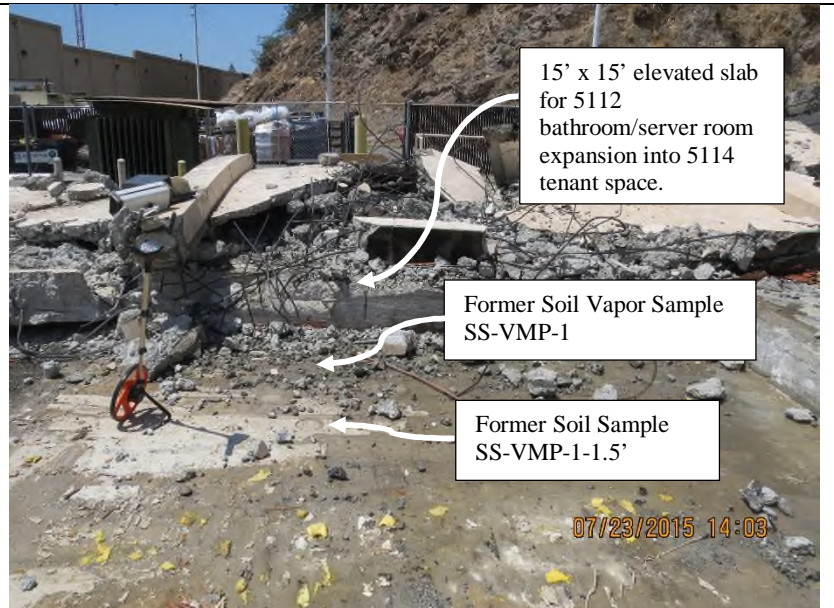
**Photo: 1**

**Description:** During building demolition, it was discovered that the bathroom/server room at the rear of 5112 was actually the rear 15-feet of the 5114 dry cleaner tenant space, constructed atop a concrete pad installed to match the 5112 tenant space floor elevation.

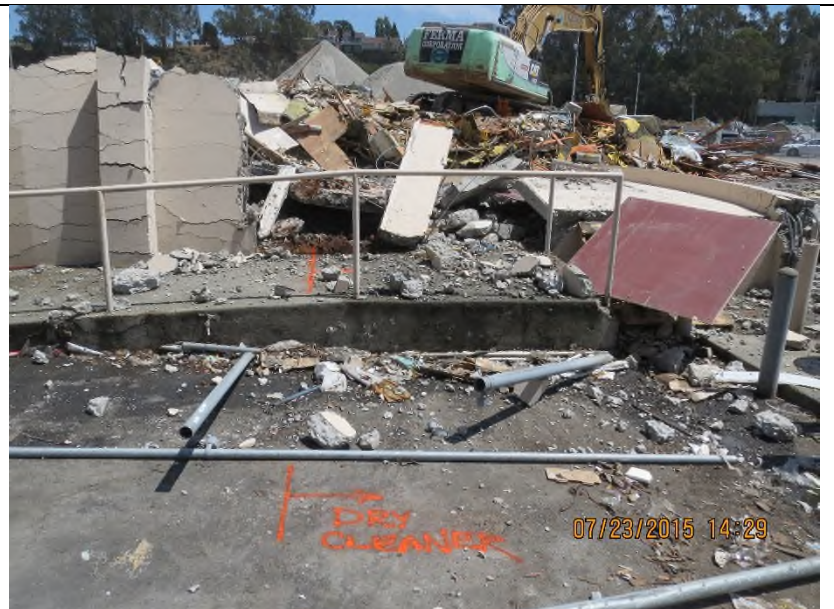
**Photo: 2**

**Description:** Rear of dry cleaner tenant space. Demolition revealed a rusted steel door concealed in the wall, split across the 5112/5114 tenant spaces, with bottom of door behind the concrete ramp, at sidewalk grade. Sidewalk is beneath the ramp.

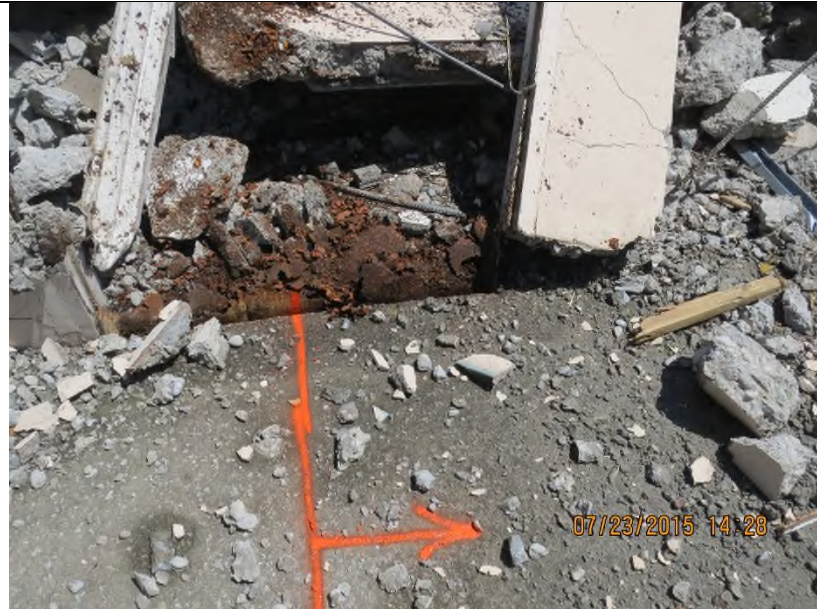
**Photo: 3**

**Description:** Rusted out steel door. Formerly served both 5112/5114 tenant spaces.

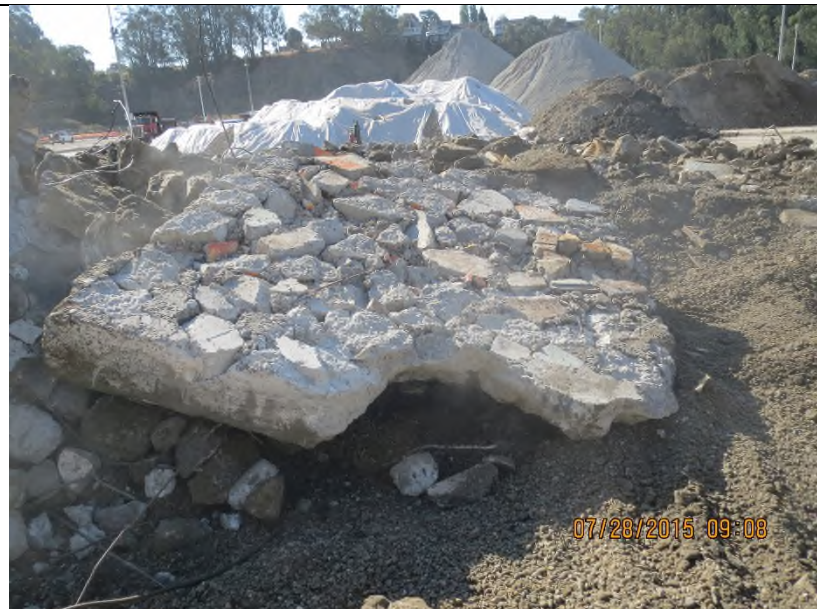
**Photo: 4**

**Description:** Elevated slab removed from rear of 5114. Consists of concrete wall debris created when 5112 expanded into 5114 space. The notch in the slab represents the 4'x4' foyer entry for the original steel door that served both 5112 and 5114 spaces. Foyer was not initially filled in when elevated slab was installed in 5114.

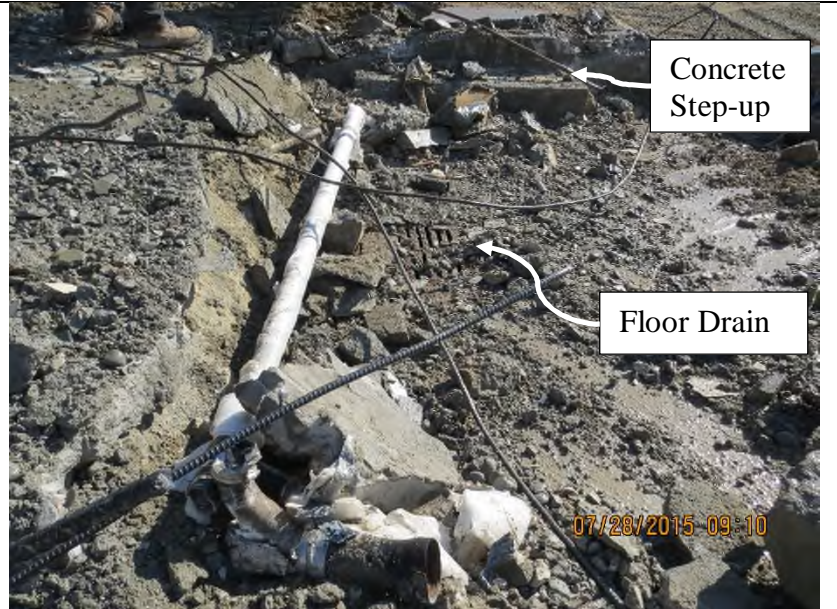
**Photo: 5**

**Description:** 12" x 12" steel floor drain in the original concrete slab of 5114, beneath the elevated slab used to expand 5112 into 5114. White wrapped piping is more recent sewer line for bathroom in 5112 space. Concrete step up from 5114 to 5112 visible in background, used prior to 5112 expansion into 5114.

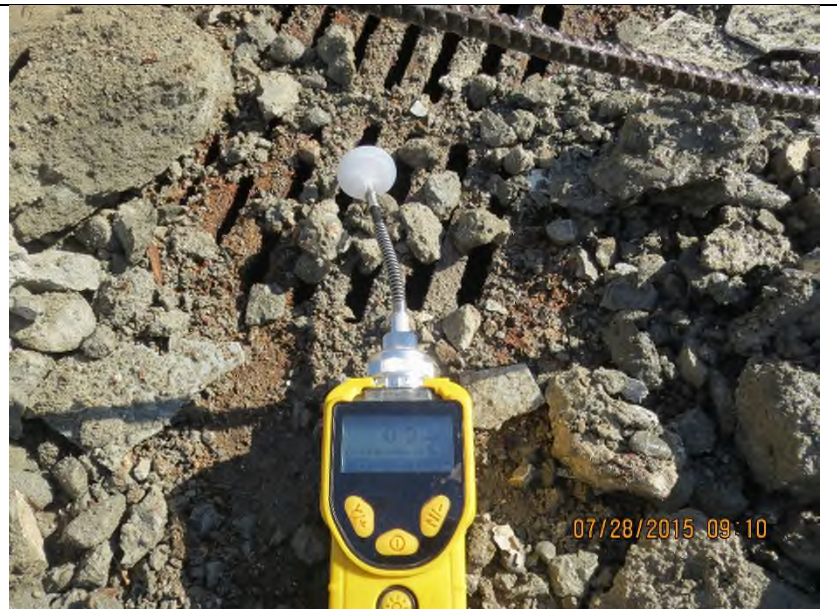
**Photo: 6**

**Description:** PID reading of floor drain immediately after uncovering (0.0 ppmv). Associated drain piping headed to rear of tenant space, but was only identified by a rust stain in the soil.

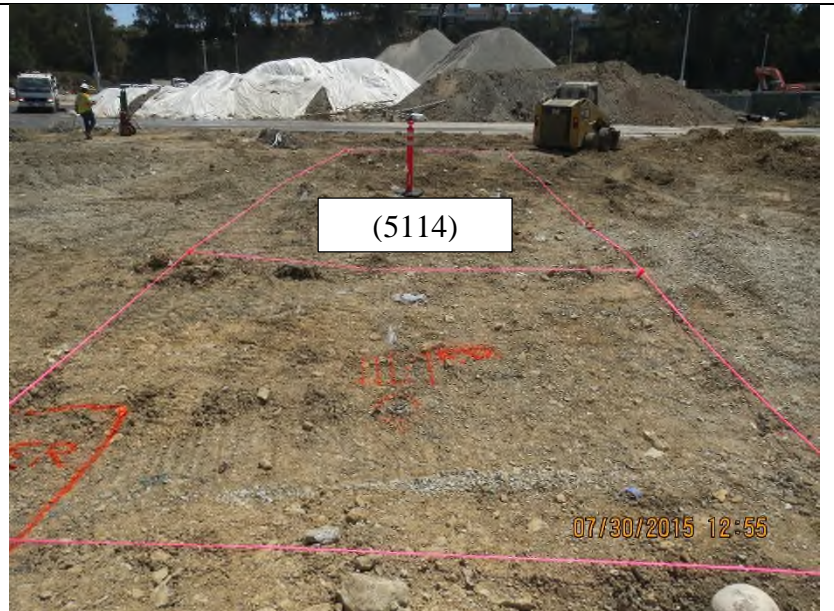
**Photo: 7**

**Description:** Looking southeast along the length of the former 5114 tenant space in Building 5; former Rockridge Cleaners. Near, square area, represents bathroom/server room raised floor area, most recently associated with the 5112 tenant space (to left).

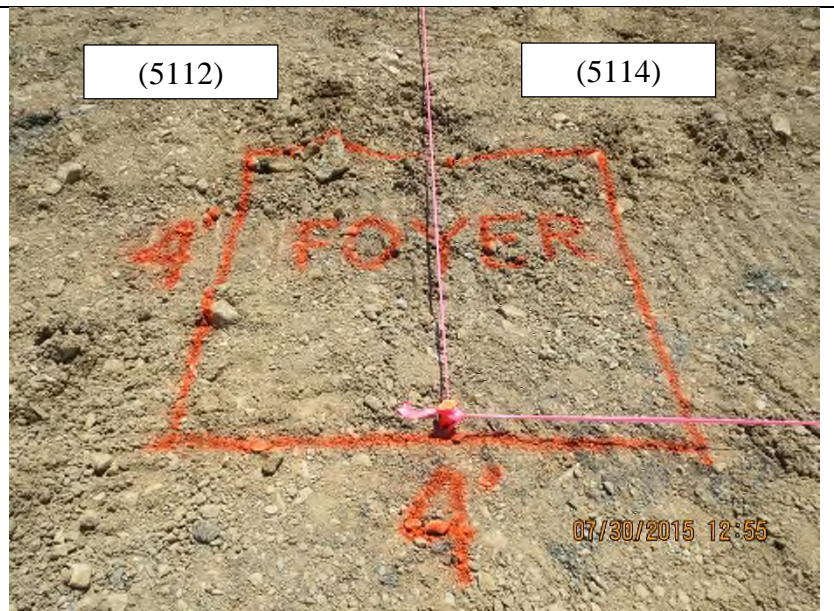
**Photo: 8**

**Description:** Former entrance foyer to both 5112 and 5114 tenant spaces. The 5112 floor slab was elevated 14” compared to the 5114 floor slab.

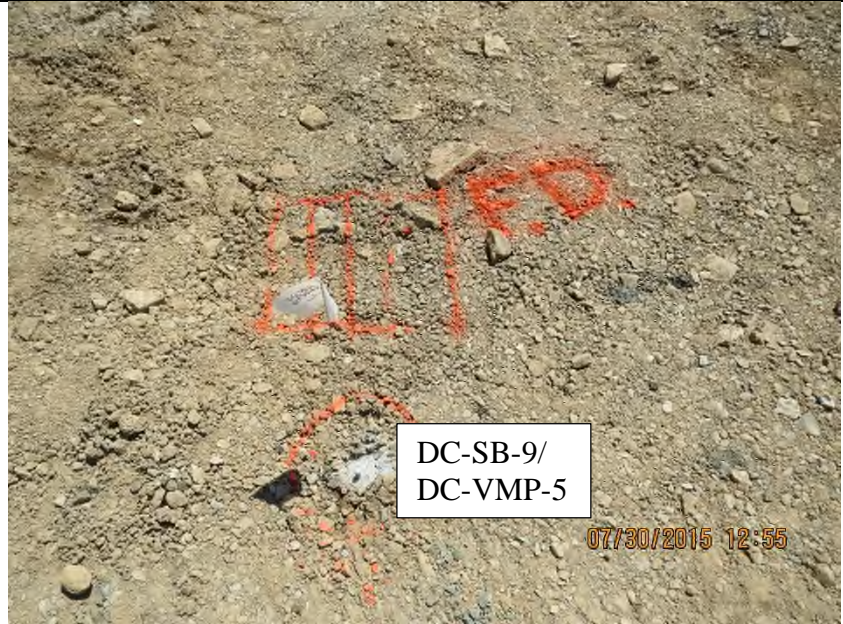
**Photo: 9**

**Description:** Former 12” x 12” floor drain located in 5114 floor slab, subsequently covered by raised floor slab during expansion of 5112 tenant space into the 5114 tenant space (15’ x 15’ area to back).

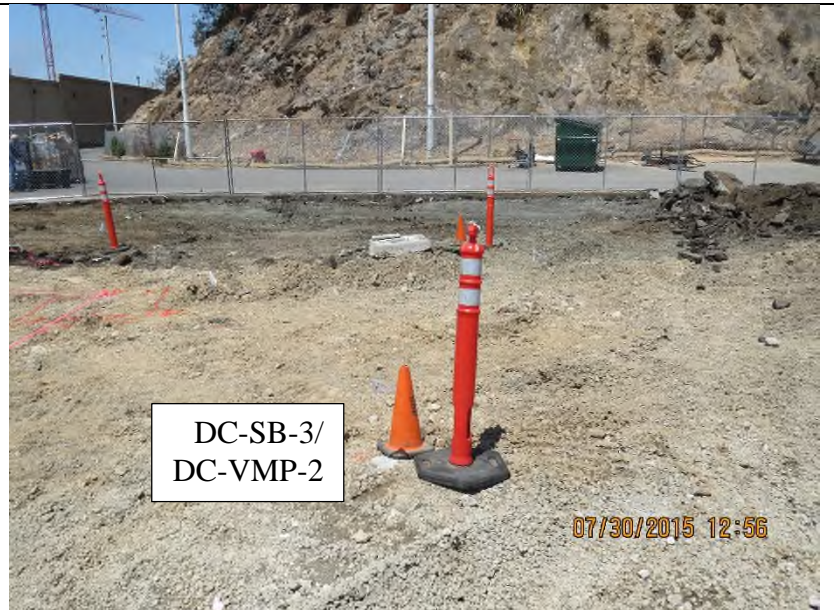
**Photo: 13**

**Description:** Sample point DC-SB-3/DC-VMP-2. Water valve box and DC-SB-1/DC-VMP-1 (next to orange delineator) visible in background. Water line is live.

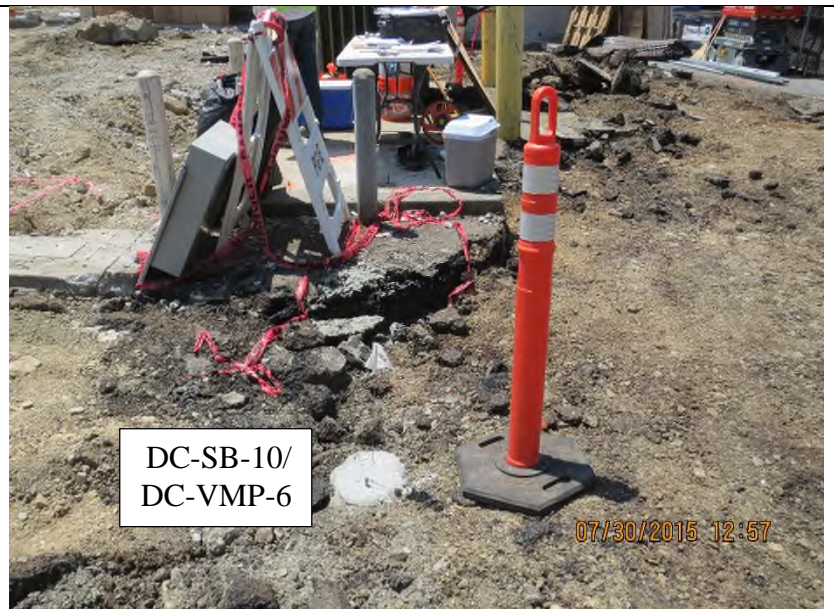
**Photo: 14**

**Description:** Sample point DC-SB-10/DC-VMP-6. Remnant slab of 8- to 10-inch thick asphalt is visible next to bollard. Water valve box visible left of frame.
