MEMORANDUM

Subject: Source of VOCs in Soil Vapor
39155 and 39183 State Street, Fremont, California

Project No.: 1098.007.01.012

PCE Concentrations in Soil Vapor
39155 and 39183 State Street
Fremont, California

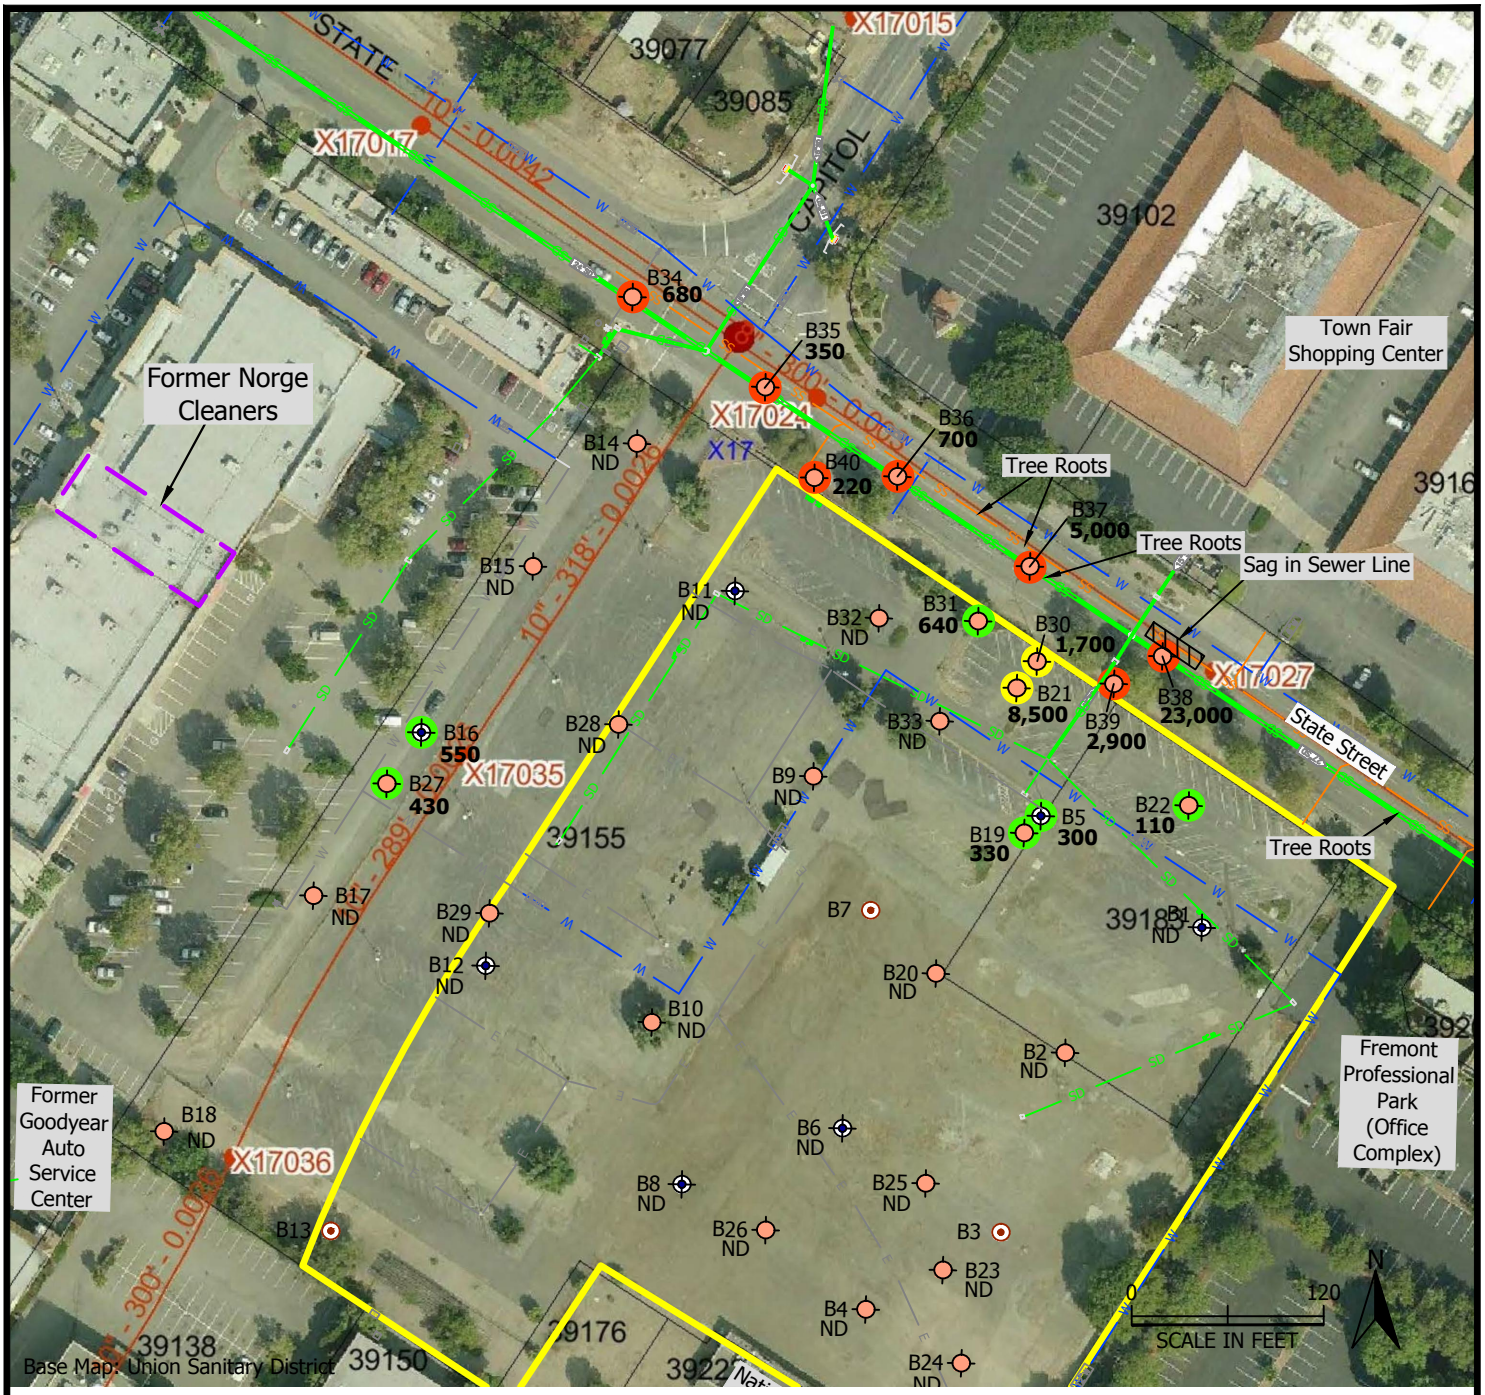
- The storm drain is depicted as a green line on the attached Plate 3.

- At between approximately 10 to 48 feet upstream (northwest) of Manhole 17027 an apparent sag is present in the main trunk line as evidenced by a higher water level in the pipe (indicative of water accumulation). Up and downstream of this interval the water level is lower. Tree roots are present on the upper portion of pipe joints located approximately 142 and 177 feet northwest of Manhole 17027. Manhole 17027 and the

approximate location of the sag and the tree roots have been added to Plate 3 (attached) from our February 12, 2015 memorandum.

THE LOCATION OF THE SAG AND THE TREE ROOTS COINCIDE WITH THE LOCATION OF THE ELEVATED PCE CONCENTRATIONS DETECTED IN SOIL VAPOR SAMPLES COLLECTED WITHIN STATE STREET AND THE ADJACENT PROPERTY. PCE RELEASES FROM THESE DEFECTS IS CONSISTENT WITH PUBLISHED METHODS BY WHICH PCE CAN LEAK FROM SEWER LINES

The sewer line within State Street has tree roots in pipe joints and an apparent sag at the location where elevated PCE concentrations were found in soil vapor samples collected within State Street. These defects represent preferential pathways for PCE laden wastewaters to have migrated from the sewer pipe at some point in the past into the sewer backfill and surrounding native soils. Disposal of PCE wastewater at Norge Cleaners and leakage from the sewer represents the best explanation for the presence of elevated PCE concentrations in soil vapor samples collected within State Street and on the subject property. Past releases from the storm drain may also have contributed, particularly the detection of PCE near the storm drain lateral that serviced the rear parking lot of the former Norge Cleaners.
