**Transmittal
Vapor Mitigation System
Construction Completion Report
Building A
State Street Center
Fremont, California**

**VAPOR MITIGATION SYSTEM
CONSTRUCTION COMPLETION REPORT
BUILDING A
STATE STREET CENTER
FREMONT, CALIFORNIA**

JULY 25, 2017

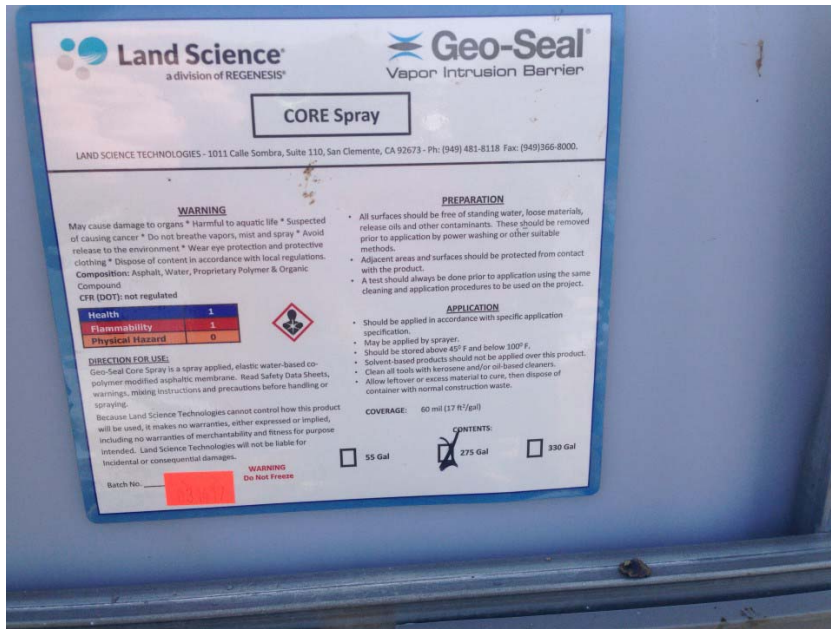
Photo 1.
Land Science Geo-Seal CORE Spray product label. Photograph taken on April 10, 2017.

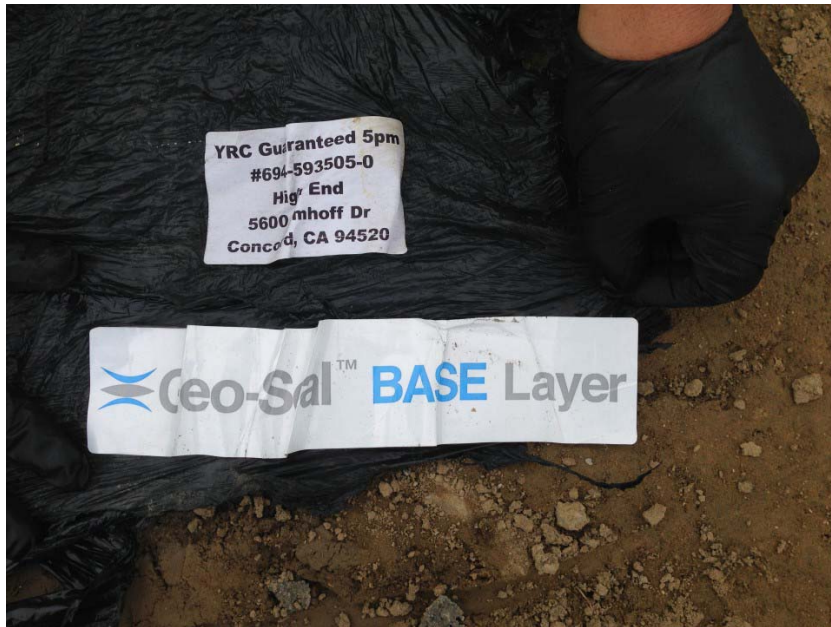
Photo 2.
Land Science Geo-Seal BASE Layer product label. Photograph taken on April 11, 2017.

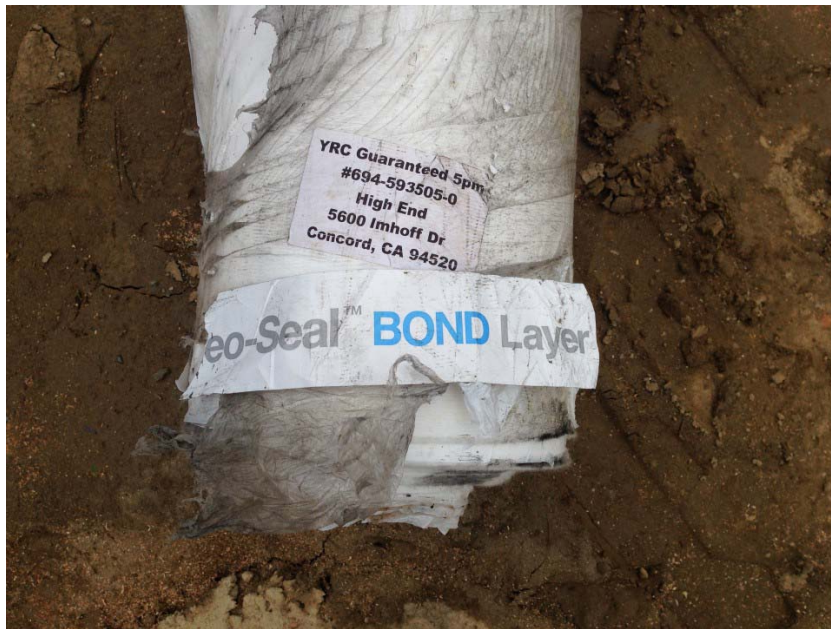
Photo 1.
Land Science Geo-Seal BOND Layer product label. Photograph taken on April 11, 2017.

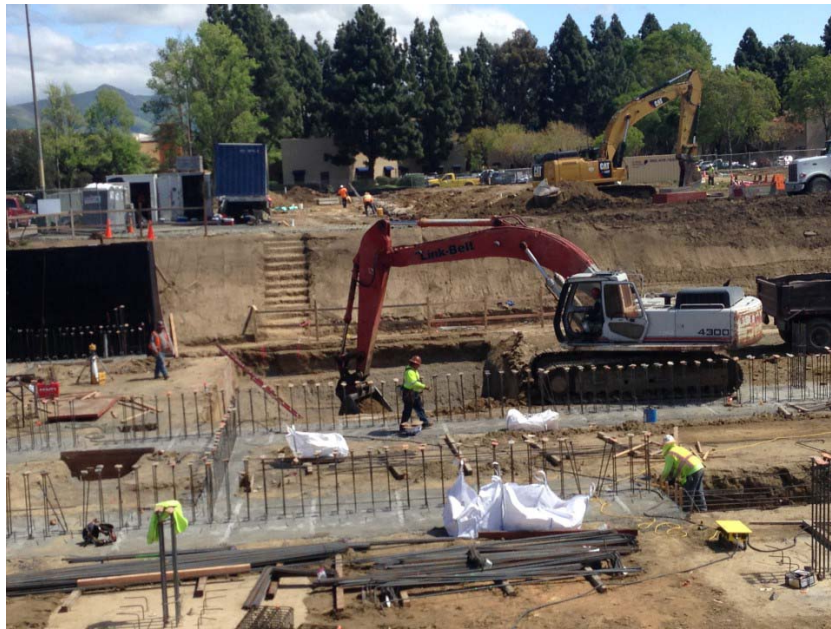
Photo 2.
Excavation of the northeastern elevator pit footing area of Building A prior to the placement of the Geo-Seal BASE Layer fabric. Photograph taken on April 12, 2017.

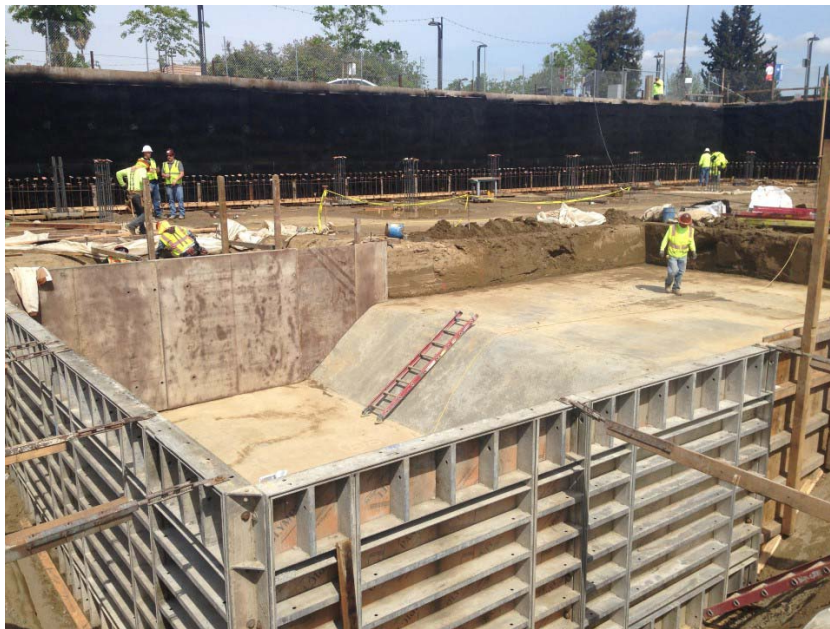
Photo 1.
Preparation of the subsurface area prior to the placement of the Geo-Seal BASE Layer fabric at the southwestern elevator pit footing of Building A. Photograph taken on April 10, 2017.

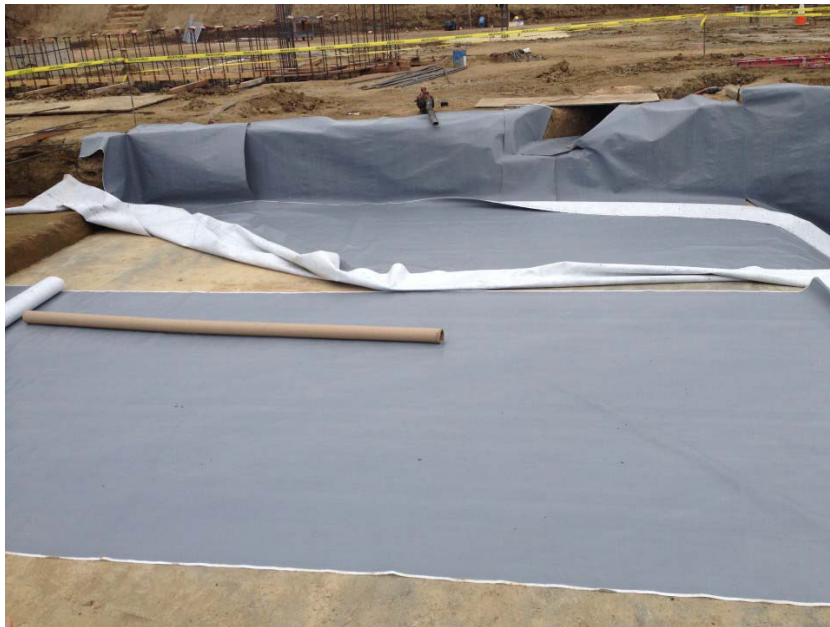
Photo 2.
Beginning of the installation of the Geo-Seal BASE Layer fabric at the southwestern elevator pit footing of Building A. Photograph taken on April 11, 2017

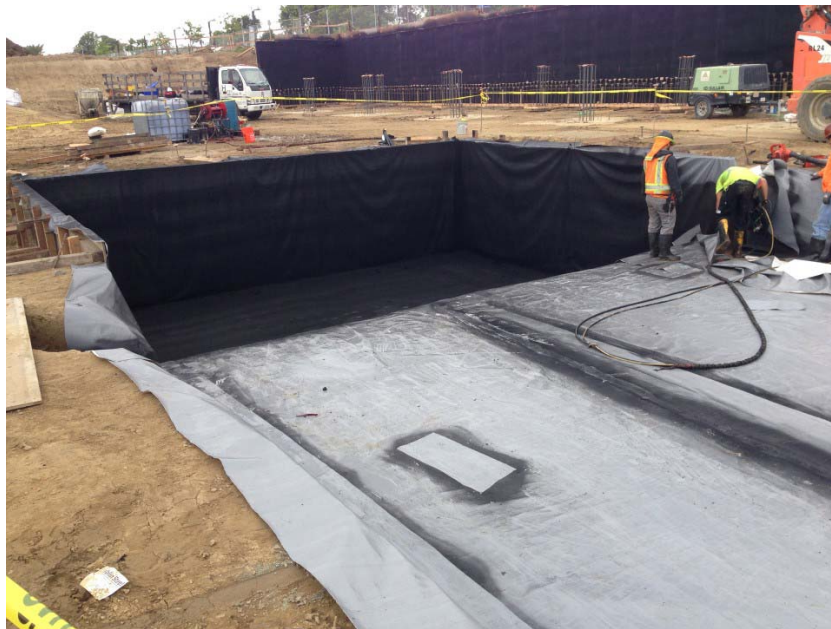
Photo 1.
Installation of the Geo-Seal BASE Layer fabric and spray application of the Geo-Seal CORE Spray at the southwestern elevator pit footing of Building A. Photograph taken on April 12, 2017.

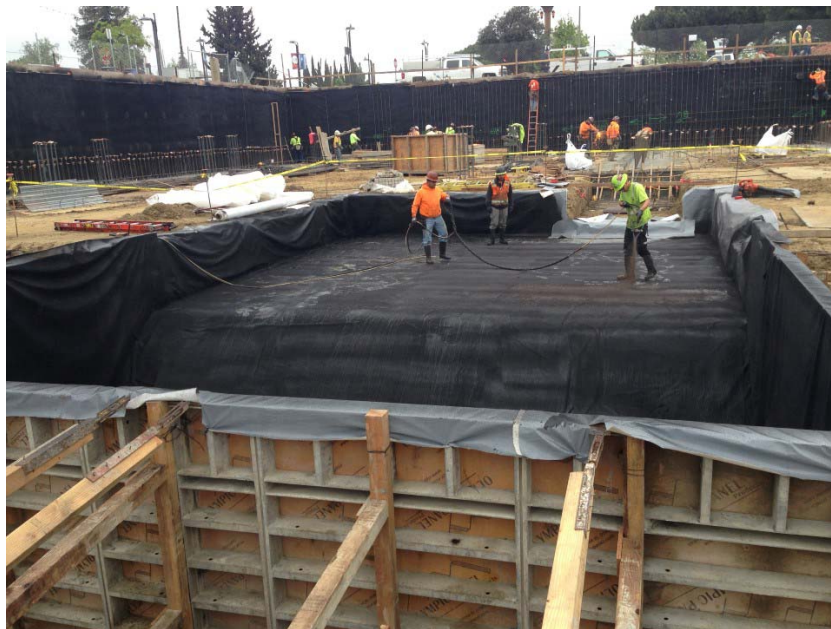
Photo 2.
Spray application of the Geo-Seal CORE Spray at the southwestern elevator pit footing of Building A. Photograph taken on April 10, 2017.
Photograph taken on April 12, 2017.

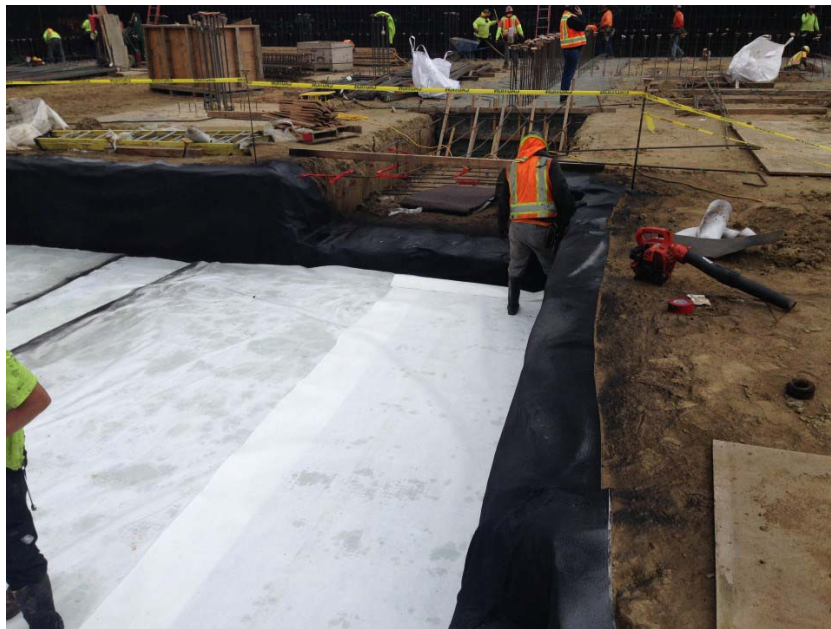
Photo 1.
Typical termination of the vapor barrier fabric, extending one foot or more beyond the edge of the elevator pit footing. Installation of the Geo-Seal BOND Layer fabric on top of the cured Geo-Seal CORE Spray at the southwestern elevator pit footing of Building A. Photograph taken on April 12, 2017.

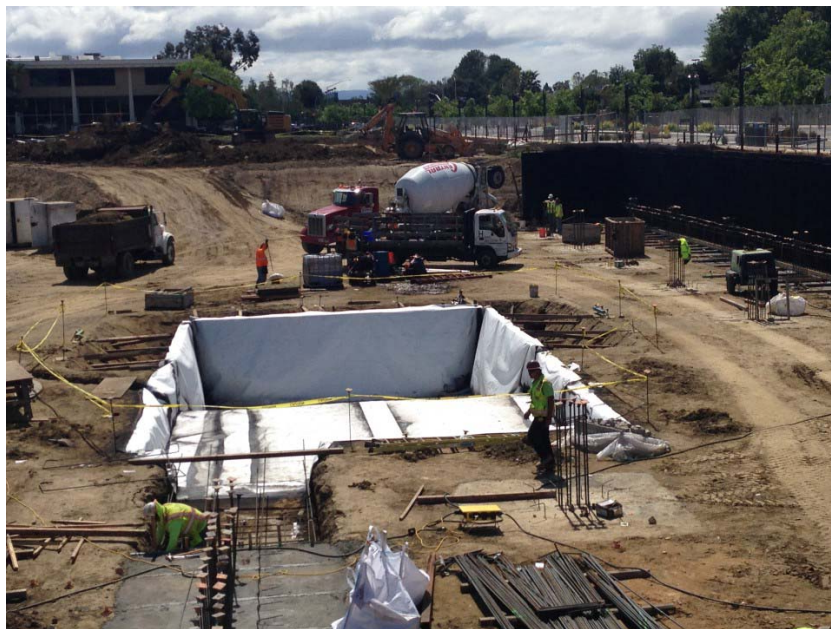
Photo 2.
Installation of the Geo-Seal BOND Layer fabric on top of the cured Geo-Seal CORE Spray at the southwestern elevator pit footing of Building A. Photograph taken on April 12, 2017.

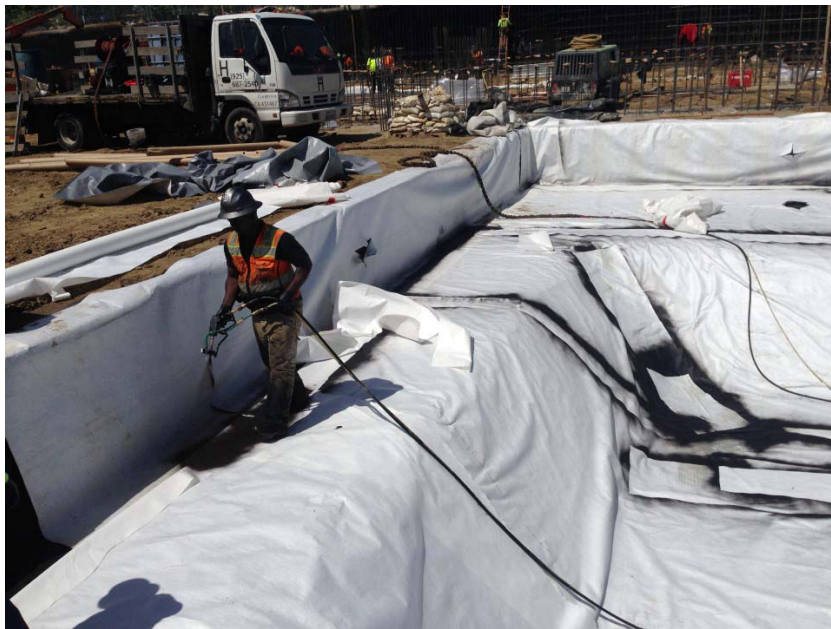
Photo 1.
Installation of the Geo-Seal BOND Layer fabric on top of the cured Geo-Seal CORE Spray at the northeastern elevator pit footing of Building A. Photograph taken on April 14, 2017.

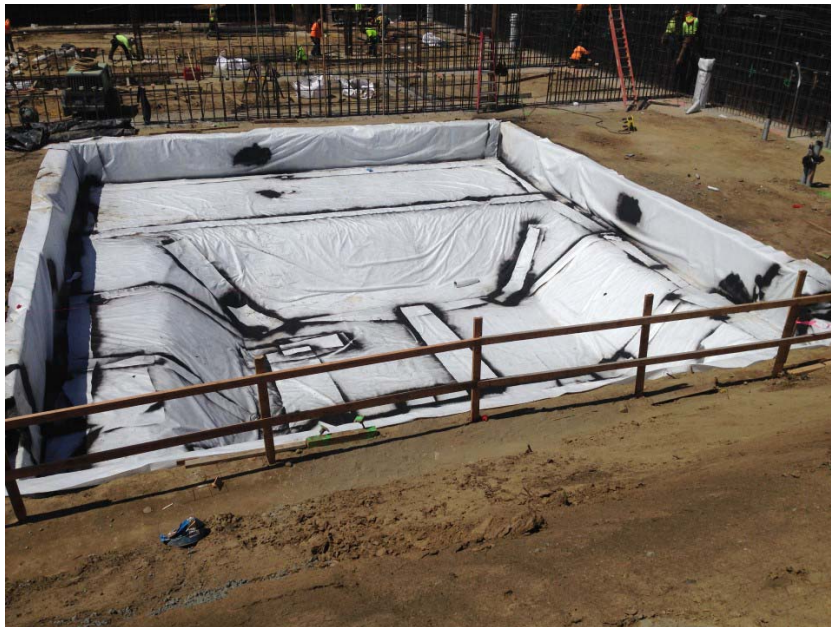
Photo 2.
Installation of the Geo-Seal BOND Layer fabric on top of the cured Geo-Seal CORE Spray at the northeastern elevator pit footing of Building A. Photograph taken on April 14, 2017.

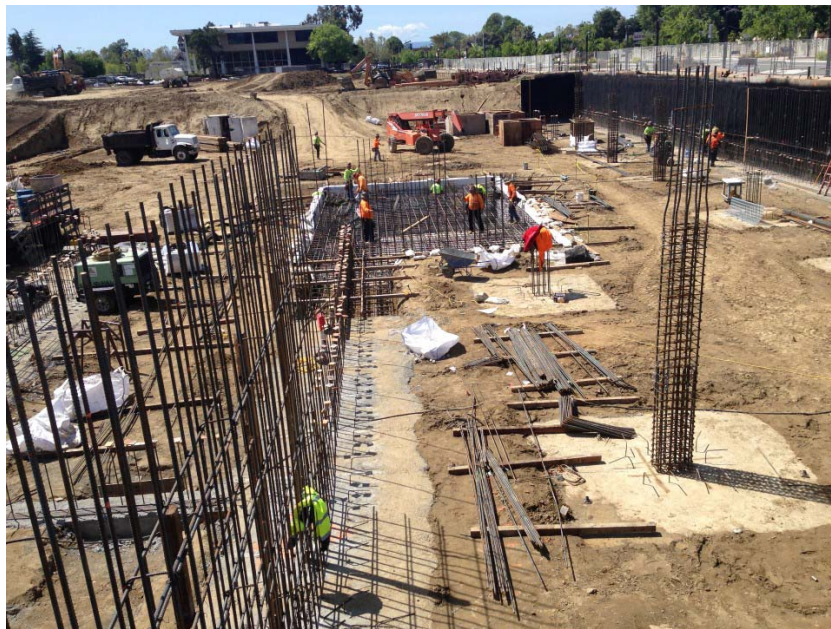
PES conducted spot checks of the vapor barrier during rebar placement and following removal of concrete footing formwork between April 14 and 21, 2017. No damage to the vapor barrier was identified.

Photo 1.
Installation of rebar at the southwestern elevator pit footing of Building A during follow up inspection to check for any penetrations. Photograph taken on April 14, 2017.

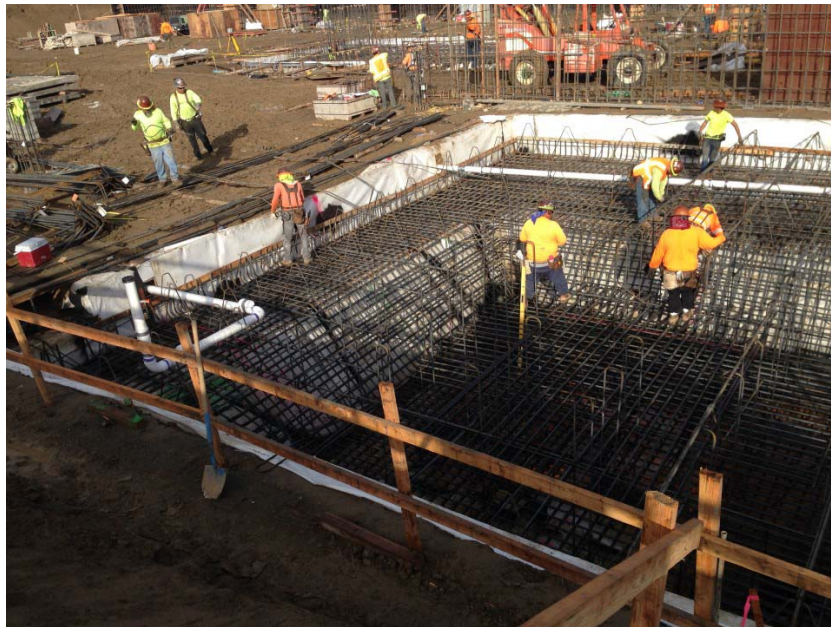
Photo 2.
Installation of rebar at the northeastern elevator pit footing of Building A during follow up inspection to check for any penetrations. Two plumbing penetrations can be seen at the upper left of the photograph. Photograph taken on April 20, 2017.

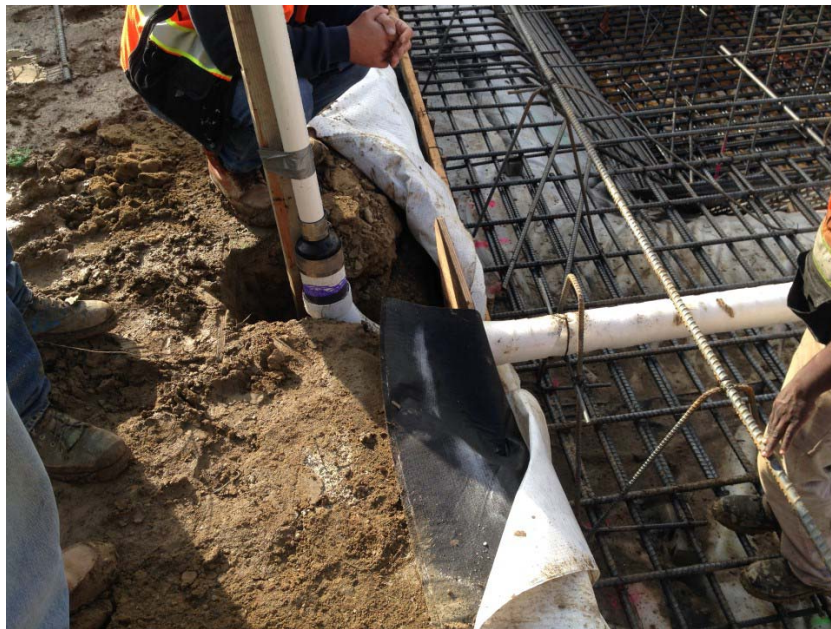
Photo 1.
A plumbing penetration of the vapor barrier at the northeastern elevator pit footing of Building A. Photograph taken on April 20, 2017.
