## Phase I Environmental Site Assessment

1550 Park Avenue  
Emeryville, California

Prepared for  
1550 Park LLC  
June 9, 2015  
Adanta, Inc. Project A1293-1

Project: A1293-1  
Date: June 9, 2015

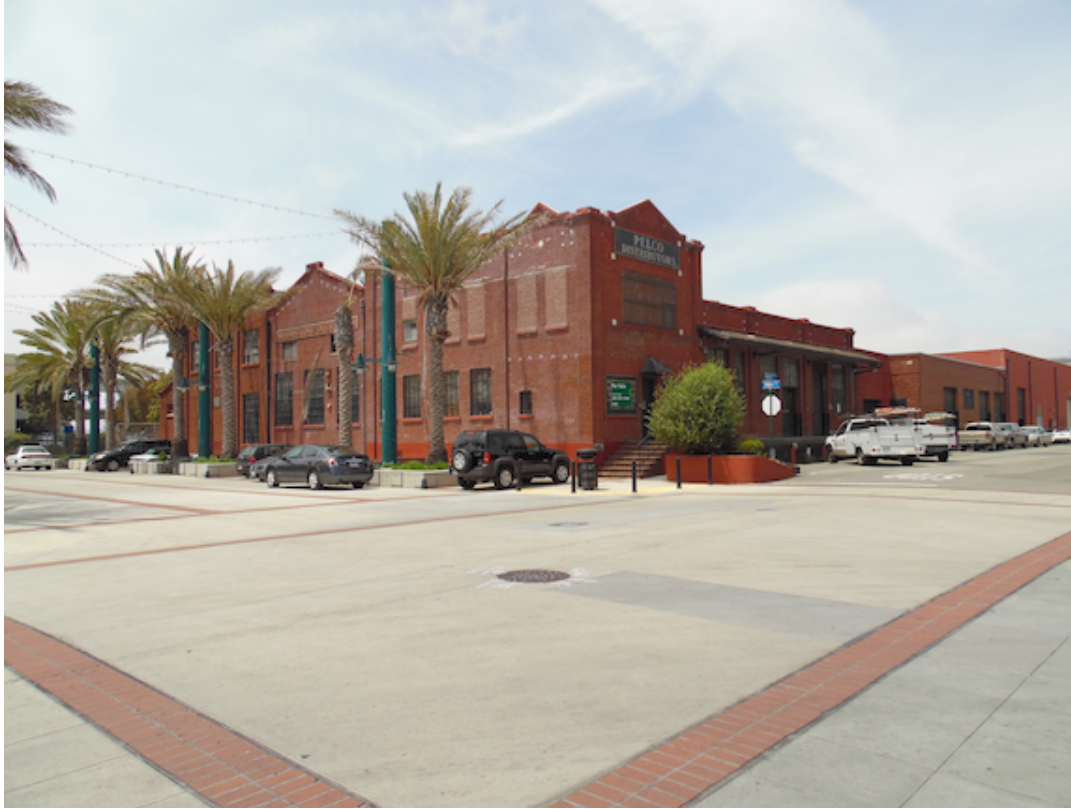
Photograph 1 - Looking northwest from across Halleck Street.

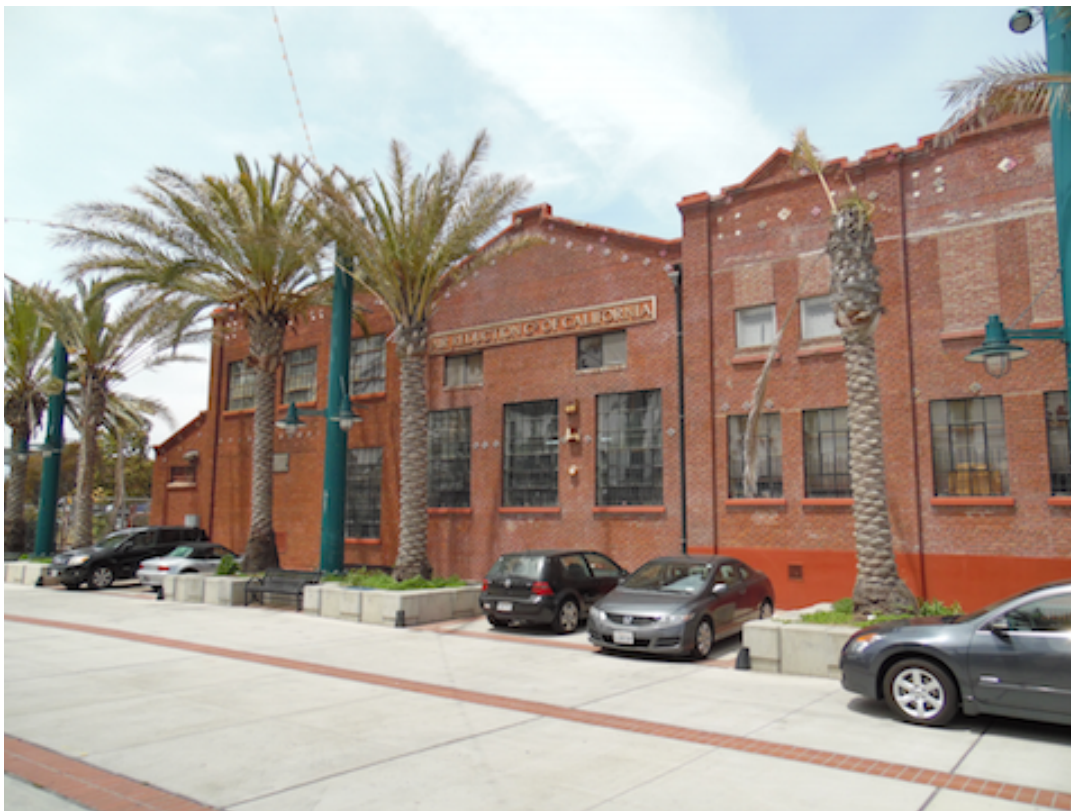
Photograph 2 - Southern wall of Property building.

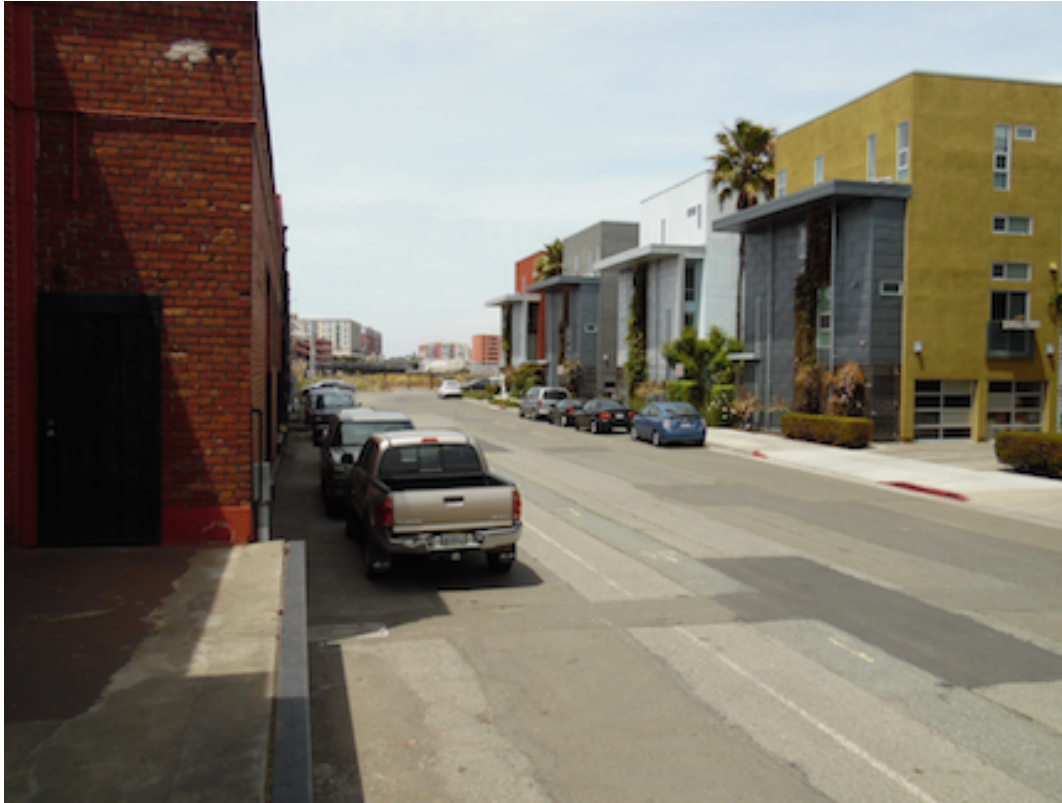
Photograph 3 – Halleck Street looking north, loading dock for Property building is on left.

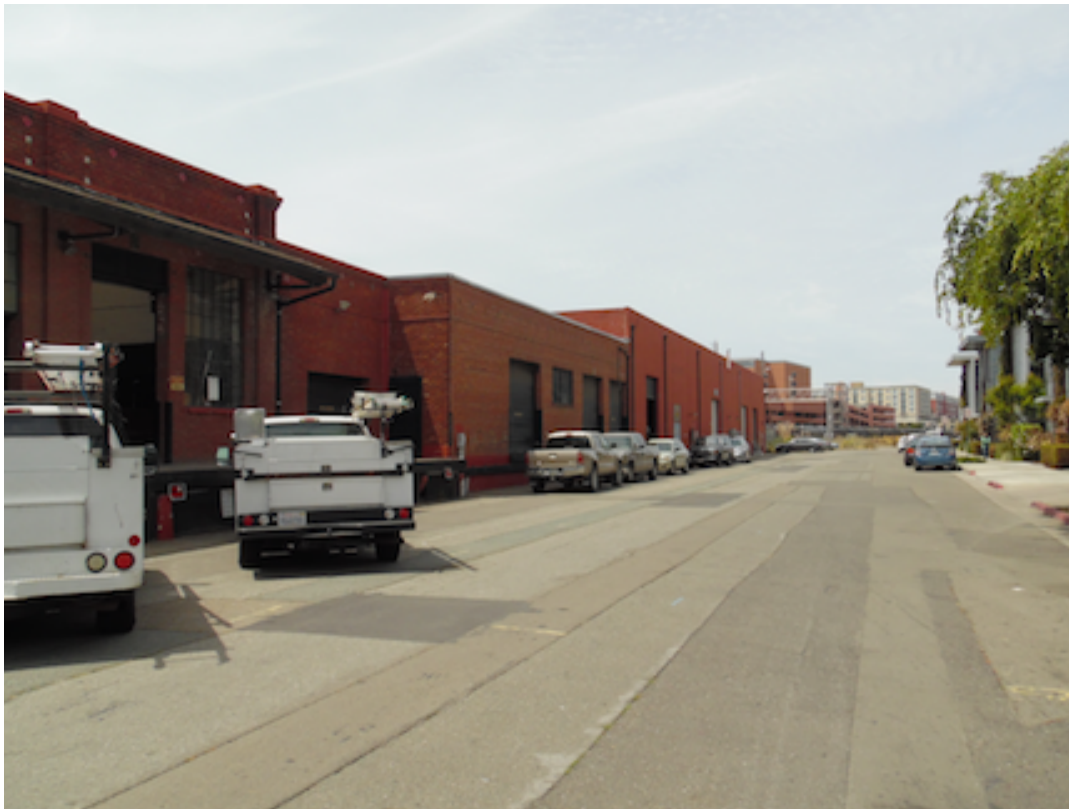
Photograph 4 – Looking north on Halleck Street at east side of Property building.

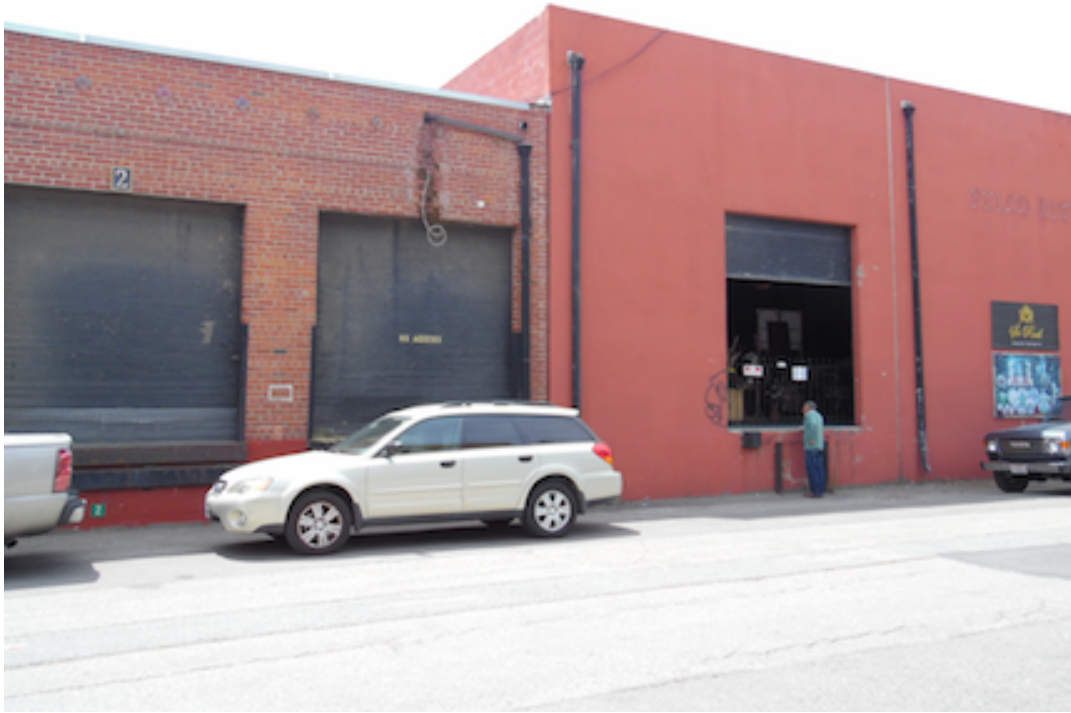
Photograph 5 – Property boundary with site to the north.

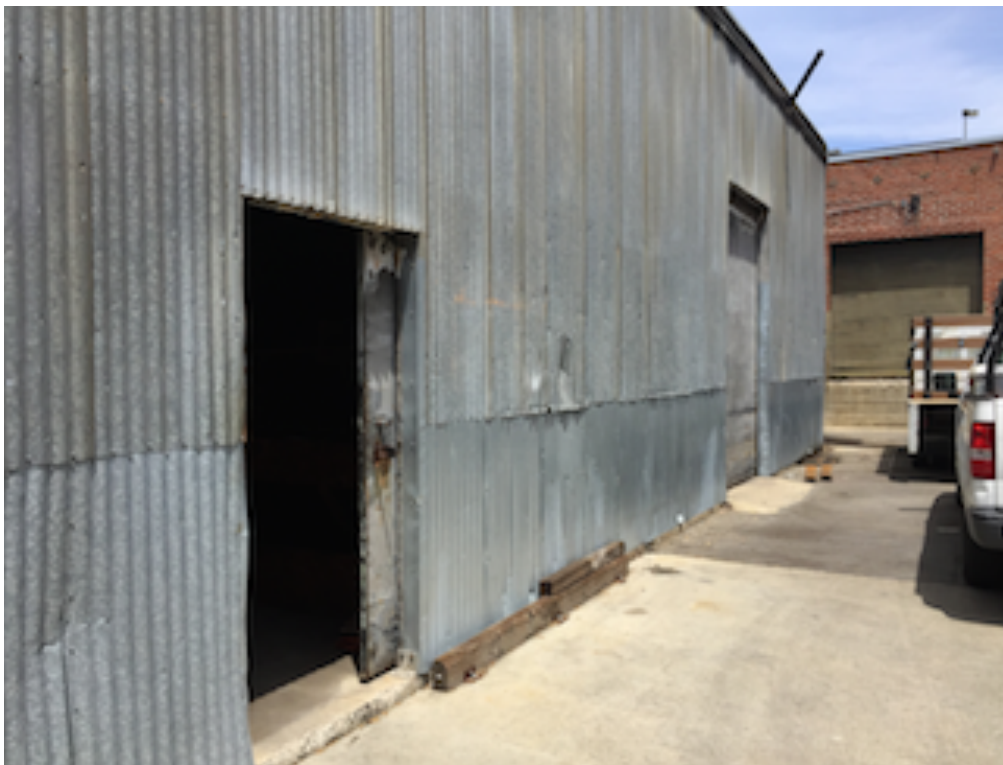
In the approximate center of the Property is a corrugated metal building that is apparently used for storage only, at this time. Inside the building are some lubricating chemicals, waste oil, and propane canisters. The surface of the building is concrete. Staining was noted on the concrete floor through out the building. One roll-up door allows vehicles inside. The yard to the north and south of the corrugated metal building is concrete. To the north of the building is an additional concrete pad, on top of the yard concrete pad, that is octagonal and may have been a base for a large oxygen tank, based on information obtained from Sanborn Fire Insurance Maps.

Photograph 6 – Corrugated metal maintenance shed in central portion of Property.

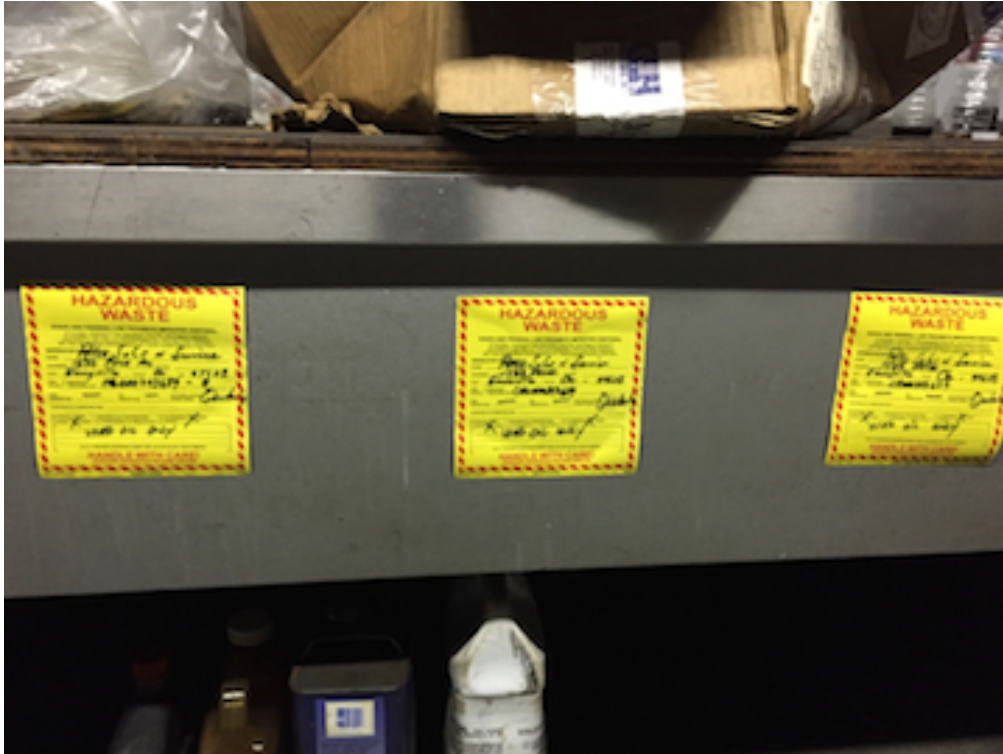
Photograph 7 – Used oil storage tank in corrugate metal building.

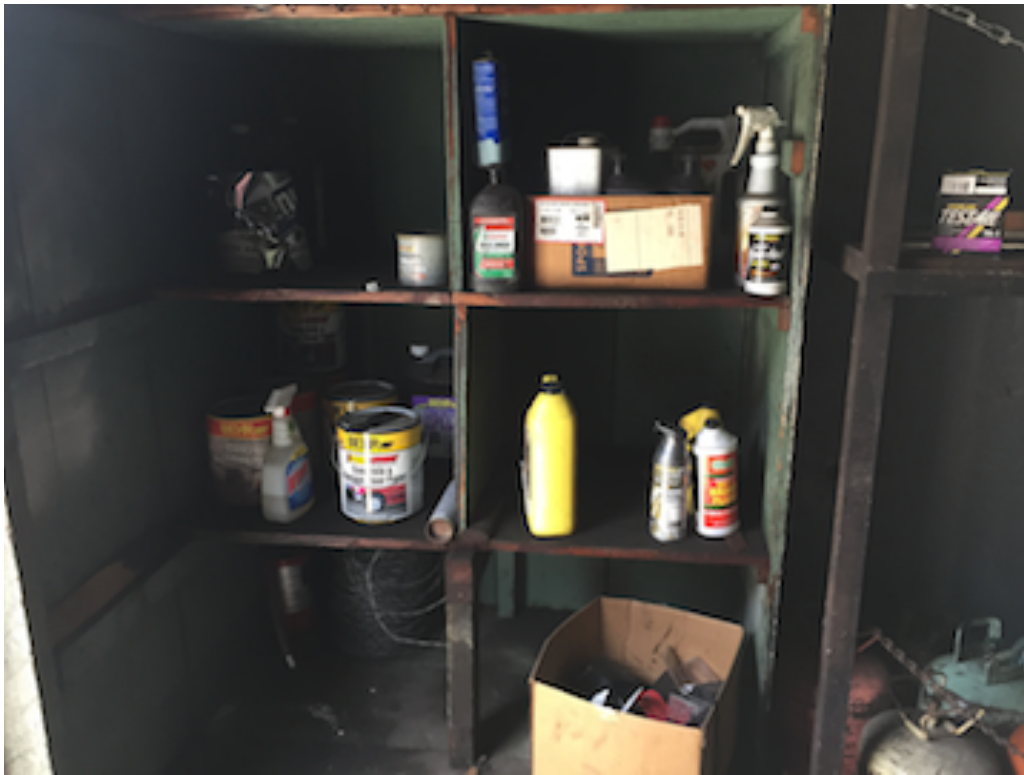
Photograph 8 – Maintenance chemicals and lubricants with propane canisters in bottom right.

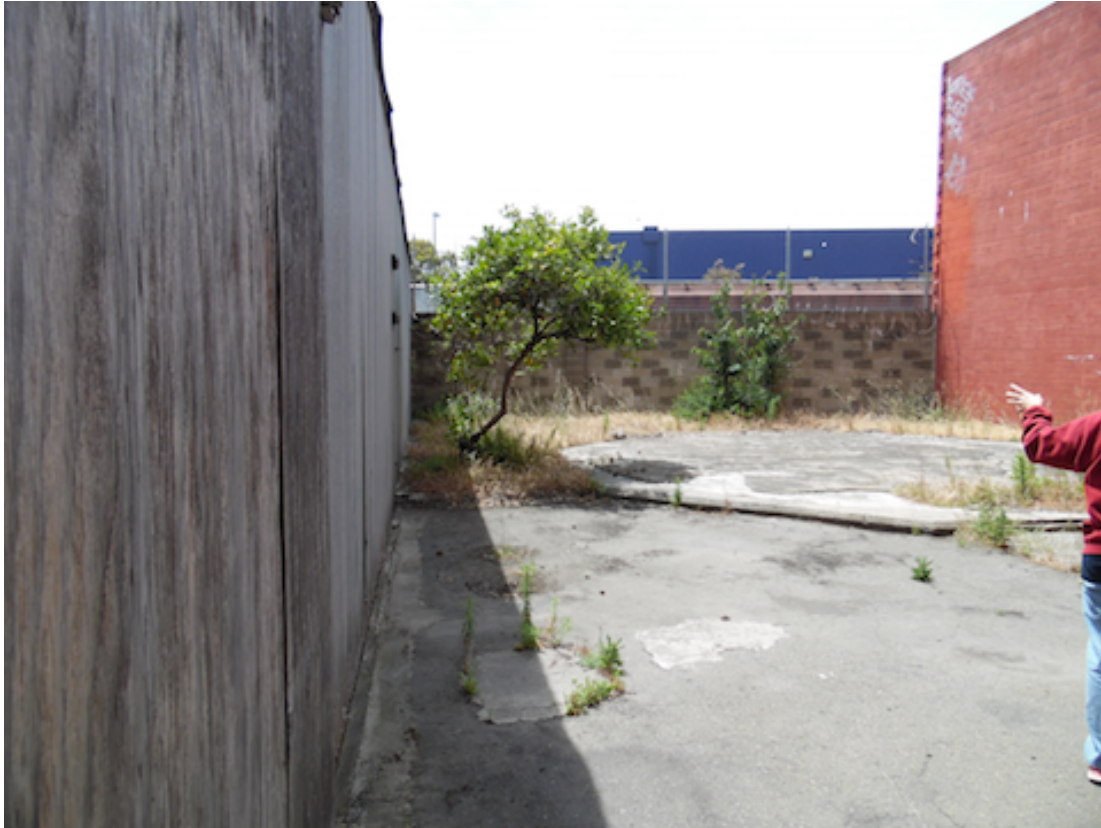
Photograph 9 – Former location of elevated oxygen tank.

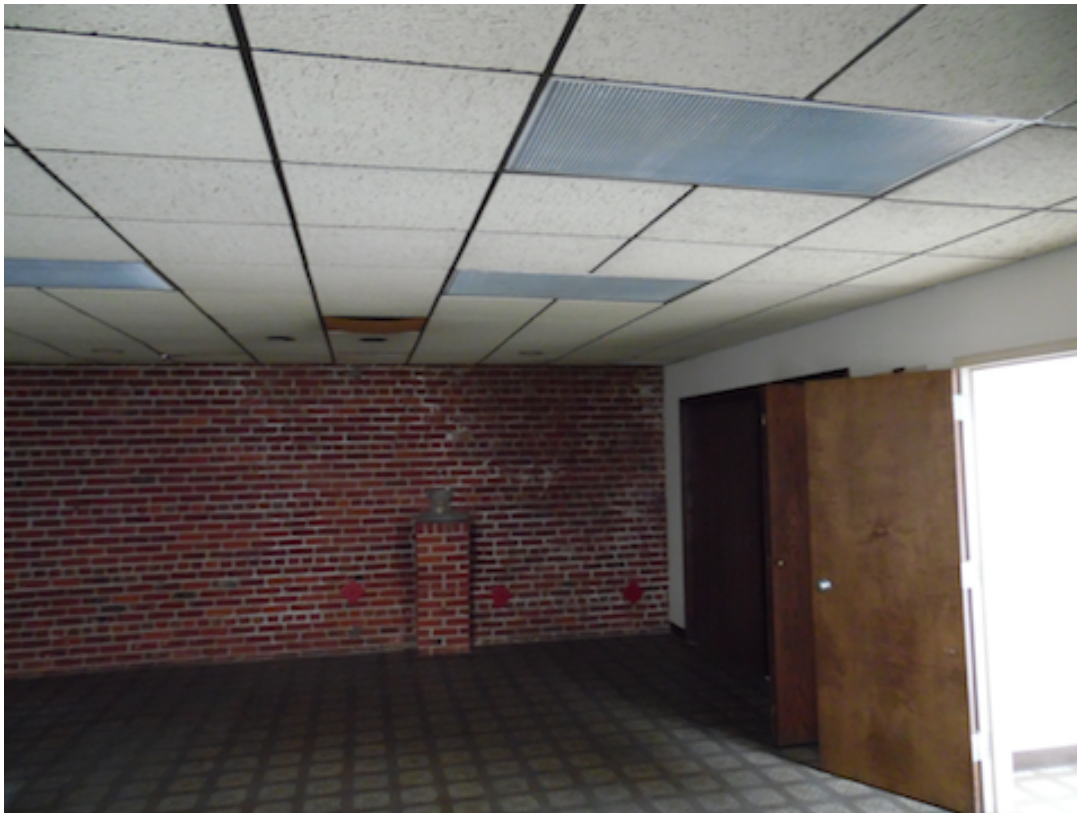
Photograph 10 – Second floor conference area.

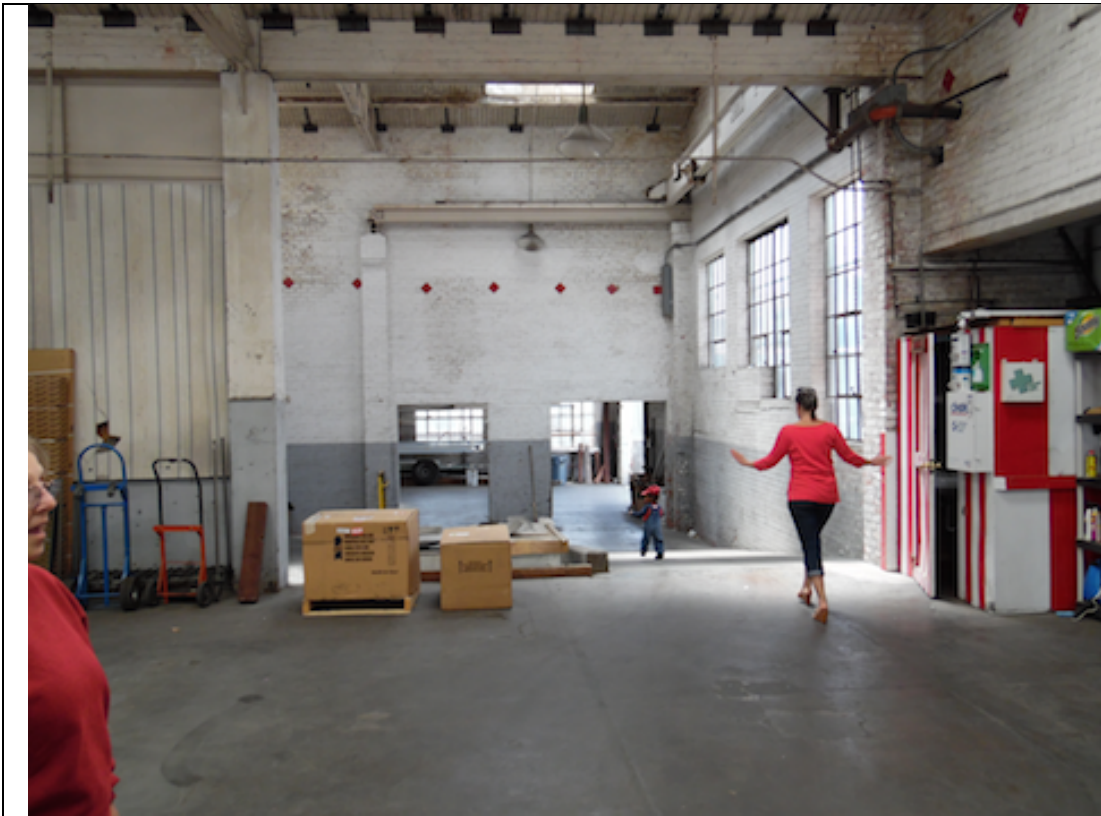
Photograph 11 - Interior of main building.

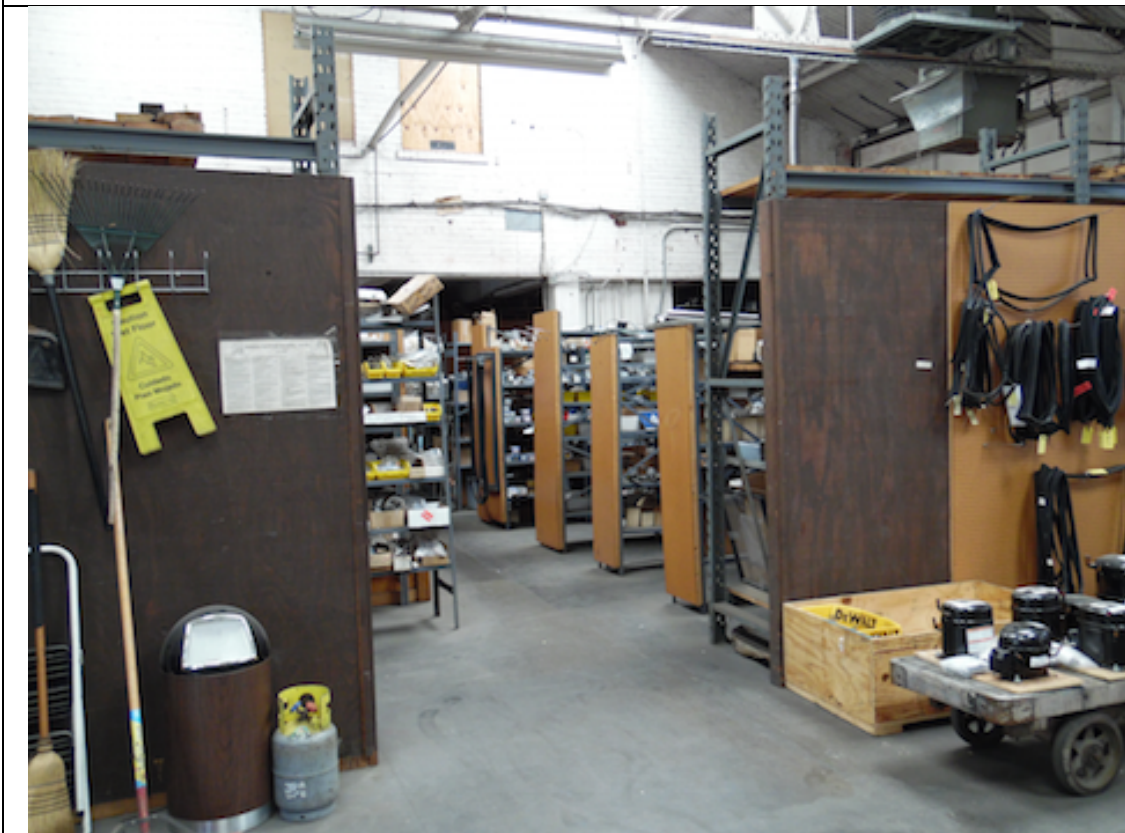
Photograph 12 - Storage area for Pelco Services.

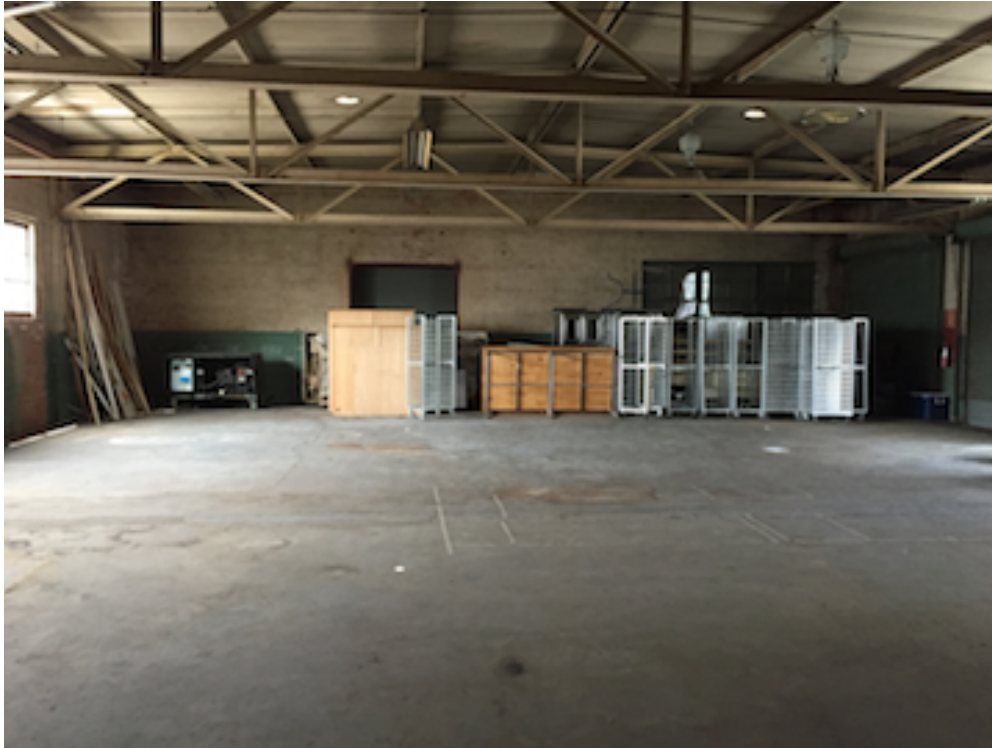
Photograph 13 – Warehouse of main building.

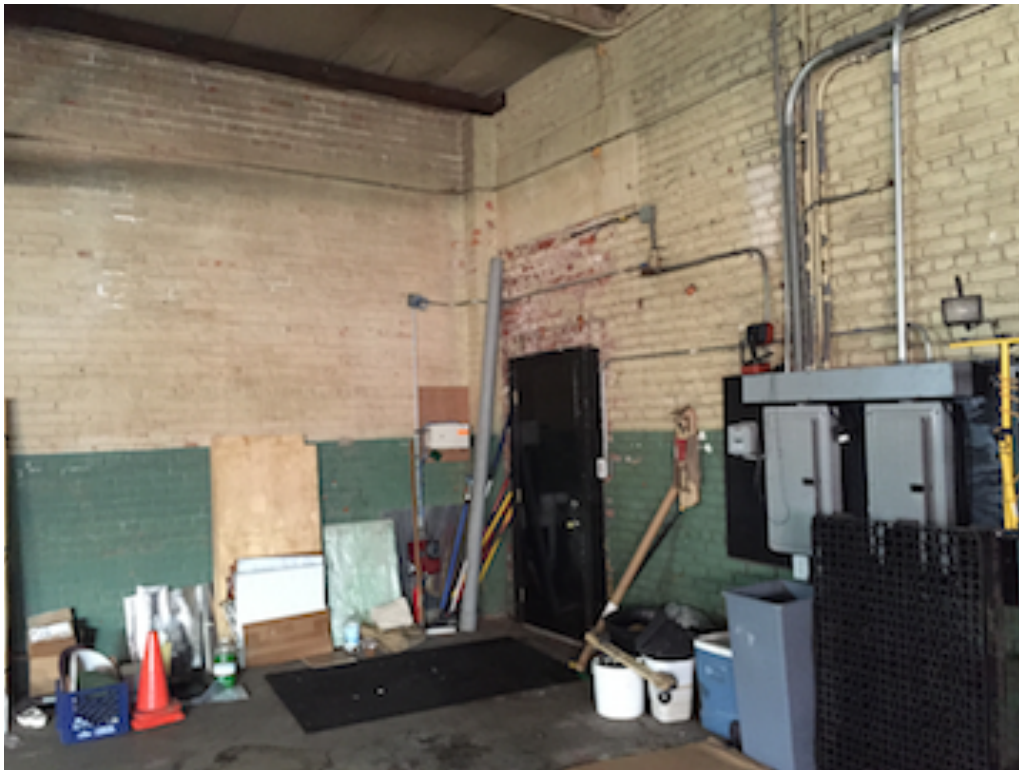
Photograph 14 – Northeast corner of main building with 5-gallon buckets of cleaners.

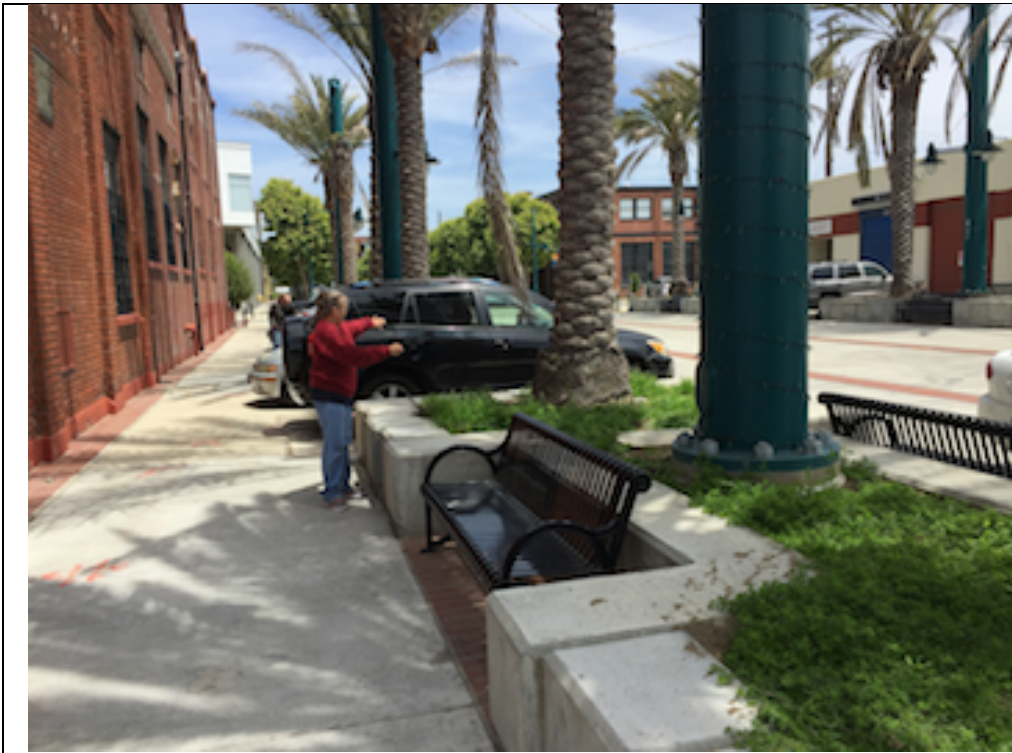
There is known soil and groundwater contamination adjacent to the south of the Property due to a leaking underground storage tank that was apparently used as a heating oil tank for the Property building. It is not known, if the soil and groundwater contamination originating from leaks in this tank has migrated to the Property.

Photograph 15 – Pennie Barger is pointing to former location of UST responsible for current open regulatory case.

- An environmental assessment should be conducted to determine if soil or groundwater has been affected beneath the Property building. Soil and groundwater sampling should be conducted inside the building, near the southern wall to find if contamination from the former UST beneath the sidewalk of Park Street has affected environmental conditions beneath the Property building. In addition, soil borings should be advanced in the northern portion of the Property collecting grab groundwater samples to assess the potential that the PCE contamination at the adjacent site has affected environmental conditions at the Property.

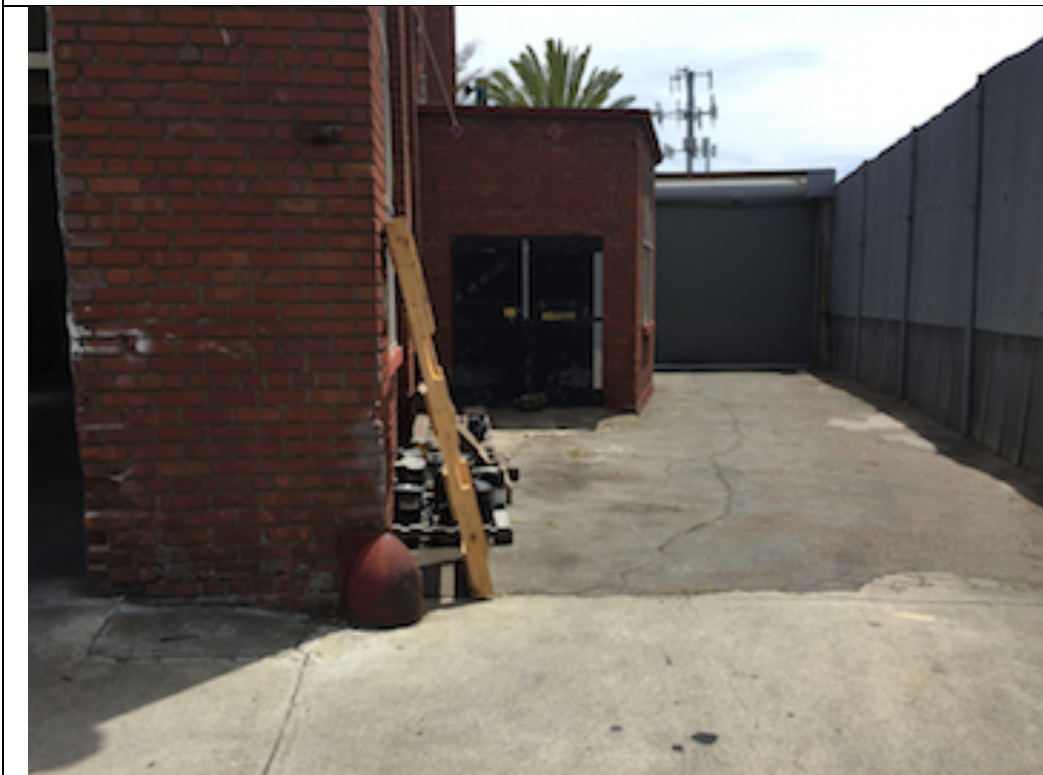
The Property has a leaking underground storage tank case that was closed in 1994. The UST was removed, and a small amount of soil was disposed offsite. Excavation sampling and soil sampling for an installed groundwater monitoring well did not detect soil or groundwater contamination.

Photograph 16 – Adjacent to the wall on the left is the former pump and in the center is the former location of the closed UST.
