Subject: Draft Phase I Environmental Site Assessment Report

DRAFT PHASE I ENVIRONMENTAL SITE ASSESSMENT

Children's Hospital and Research Center of Oakland

747 52nd Street Oakland, California

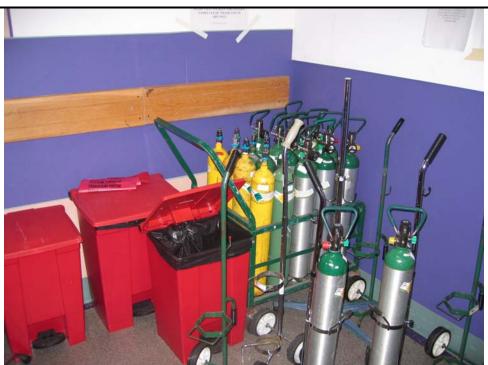
Photograph 10: View of oxygen cylinders located in a biohazard waste storage room located in the main hospital building.

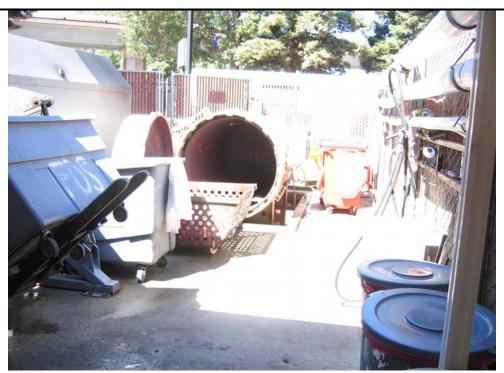
Photograph 12: View of the biohazard waste disposal area. Note autoclave oven in the background and dumpster in the left foreground.

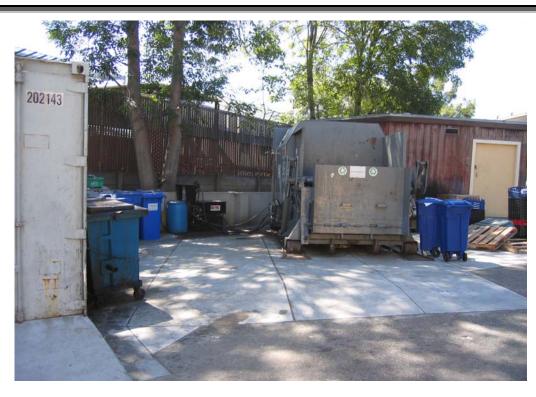
Photograph 13: View of recycling dumpster. Note paint shed in the background and petroleum storage van in left foreground.

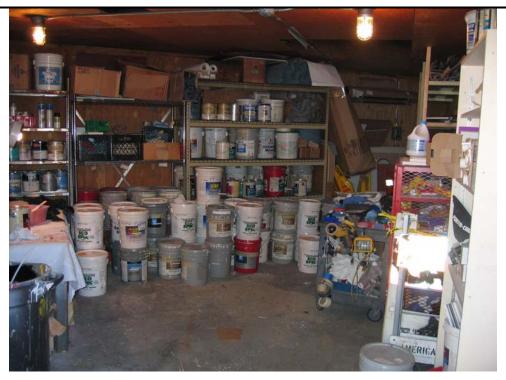
Photograph 14: View of paints located in the paint shed.

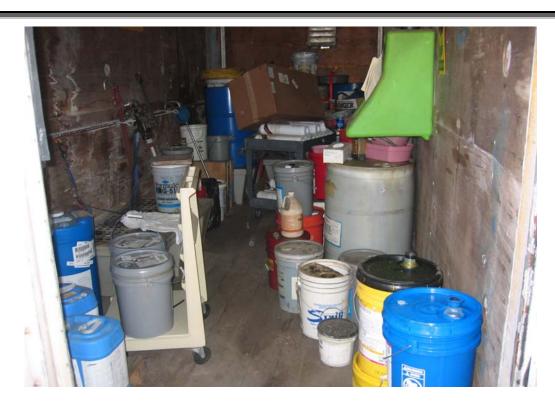
area, various storage vans and a paint shed were observed. According to Mr. Carlson, the storage vans are used for storing small quantities of hydraulic fluid and oil for the onsite generators. No staining was observed.

Photograph 15: View of the hydraulic oil containers located in the storage van depicted in photograph 13.

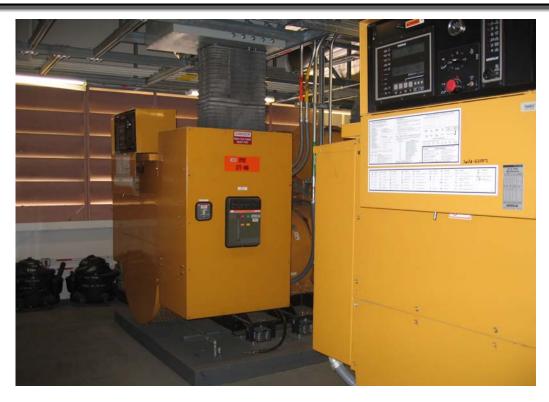
Photograph 17: View of the back-up generators located in the steam plant.

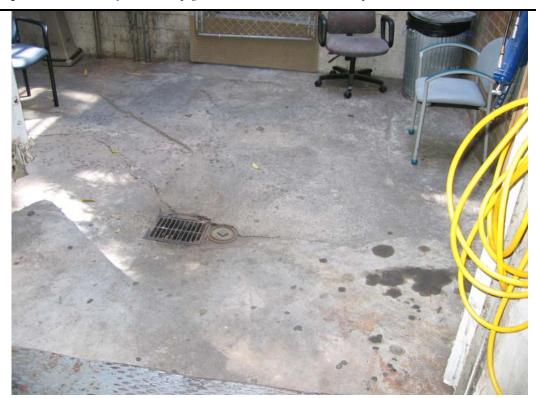
Based on interviews with CHRCO engineers we understand that an underground storage tank (UST) was previously located and removed near the southwest corner of wing B. No further information regarding the contents of the UST or whether any contamination was present upon removal was available.

Photograph 18: View of the location of the former UST.

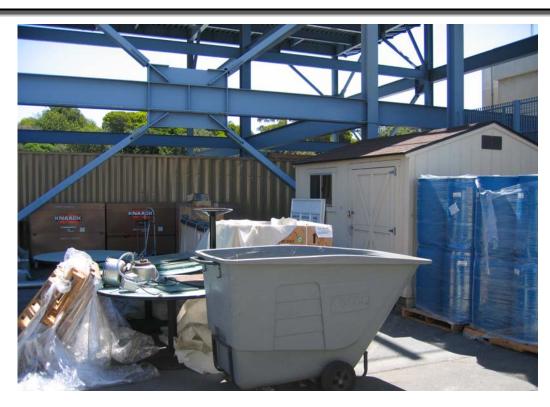
Photograph 19: View construction supplies stored beneath the helipad.

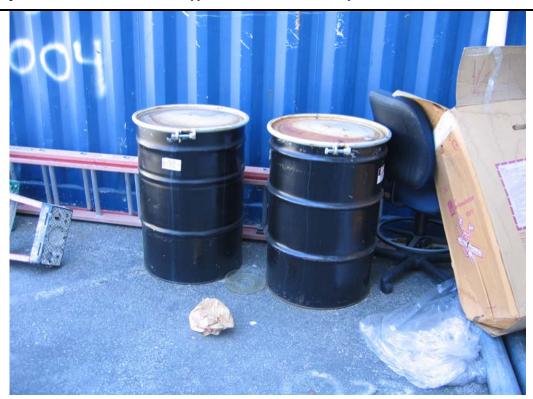
Photograph 20: View of the two 55-gallons drums labeled as hazardous located in the construction materials storage area.

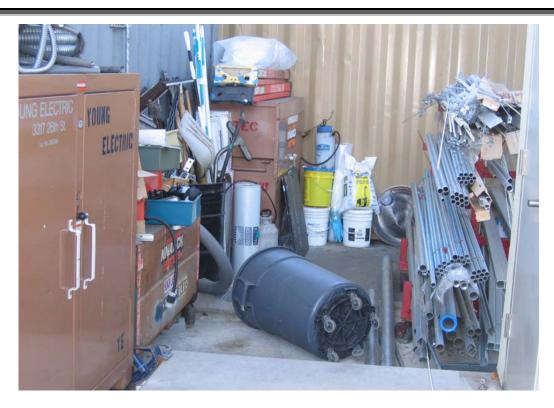
Photograph 21: View of pipe-fittings and construction materials stored beneath the helipad.
