PRELIMINARY REPORT AND WORK PLAN
KAMUR INDUSTRIES
PLAZA CAR WASH
400 SAN PABLO AVENUE
ALBANY, CALIFORNIA

IT Environmental Services Inc. 4585 Pacheco Boulevard
Martinez, California 94553
12 January 1990
ITES Job # 148031 - Phase 03

EXECUTIVE SUMMARY

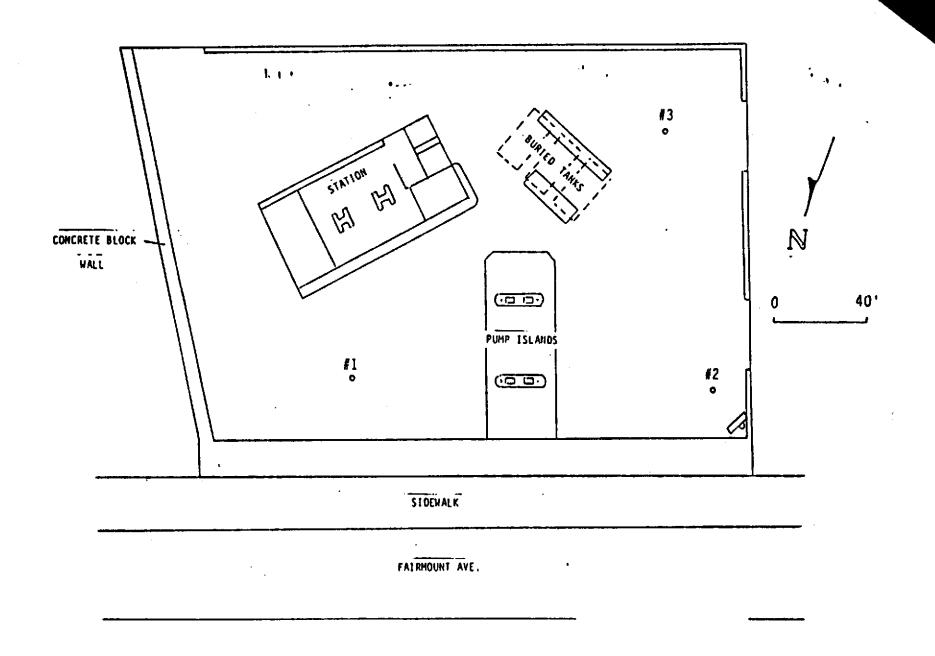
Figure 1. Location of monitoring wells on project site.

On July 8th, three monitoring wells were installed on the property (see Figure 1 for locations). During the drilling of these wells, split-spoon samples were taken to ascertain subsurface soil conditions and detectable hydrocarbon contamination. Geologic logs of these wells are given on Appendix A of this letter.
