SOIL TECH ENGINEERING

PRESULTS OF PHASE II
PRELIMINARY SITE CHARACTERIZATION
AT 2951 HIGH STREET IN
OAKLAND, CALIFORNIA

March 9, 1990

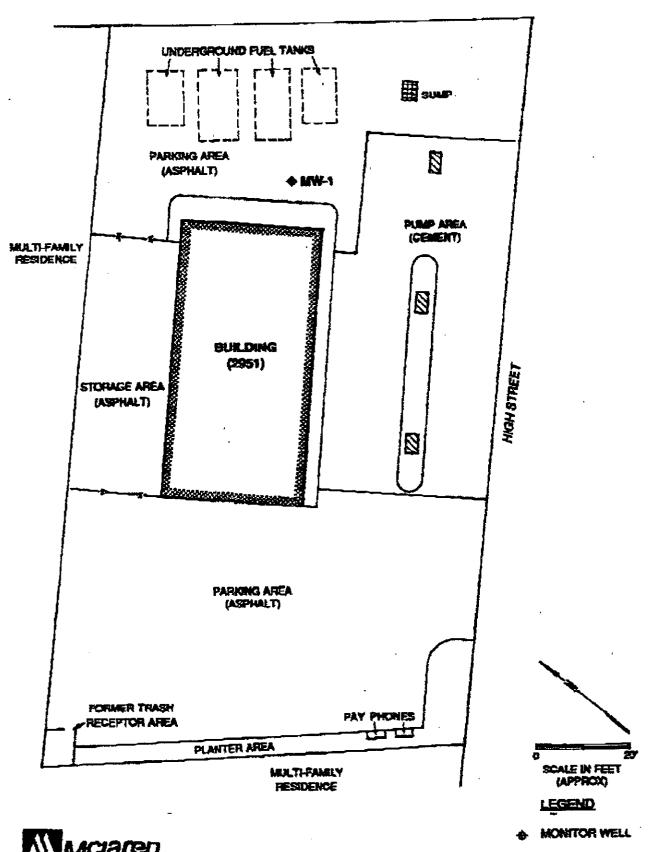
FIGURE 2 SITE PLAN AND MONITOR WELL LOCATION

The property is currently occupied by Lee's ARCO Service Station and is pending sale. The site location is shown in Figure 1. Phase II work was performed to determine if petroleum contamination problems exist at the site due to on-site activities. Four underground fuel tanks exist at the site: two 4,000 gallon unleaded gasoline tanks; one 6,000 gallon super unleaded gasoline tank; and one 6,000 gallon regular gasoline tank. Tank testing results from August 2, 1988 indicate that the two 6,000 gallon tanks tested tight. The two 4,000 gallon tanks were not certified tight, however, the leak rates measured were within the legal limits. The four tanks are located immediately adjacent to one another as a tank farm as shown on Figure 2.

Soil samples were collected for possible analysis from one soil boring located approximately ten feet downgradient from the tank farm area. A four-inch diameter monitoring well (MV-1) was constructed in the boring. The monitoring well location is shown on Figure 2.
