GROUNDWATER MONITORING REPORT

August 13, 1997

Peralta Maintenance Yard 501 5th Avenue Oakland, California

ACC Project No. 6045-014.00

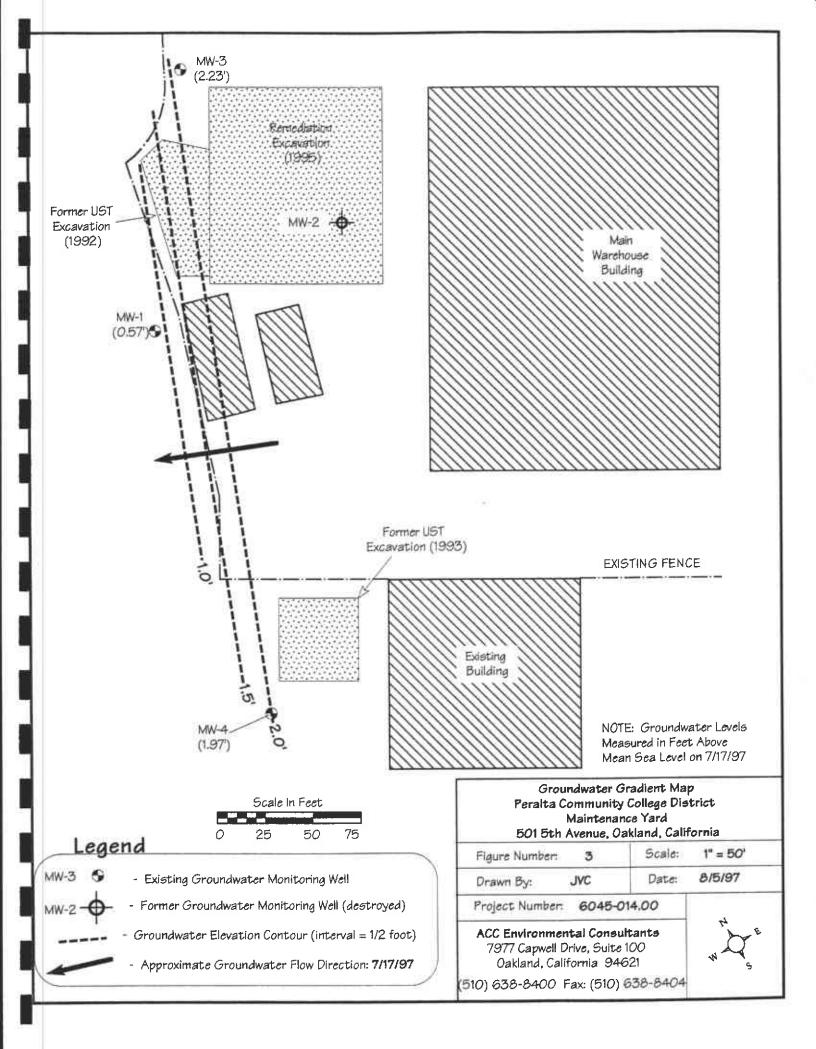
Groundwater elevations were calculated from water level measurements collected in the wells on July 17, 1997. Groundwater gradient and flow direction were calculated using this data by triangulation using the elevation of the potentiometric surface measured with respect to MSL datum. As shown in Figure 3, general direction of groundwater flow is west at a gradient of 0.05 foot/foot. Historic groundwater flow direction on site is summarized in Table 2. The groundwater gradient is slightly steeper and flow direction is toward the west, which is similar to previous sampling events.
