State Water Resources Control Board

REVISED THIRD 5-YEAR REVIEW SUMMARY REPORT FOR CLAIM NUMBER: 10290: SITE ADDRESS: 2301 E 12th STREET, OAKLAND, CA

USTCF 5-YEAR REVIEW SUMMARY REVISED THIRD REVIEW - APRIL 2012

Case No. RO0000387	Global ID: T0600101212
Site Name: Mel Senna Brake Service	Site Address: 2301 East 12 th Street, Oakland, CA 94601
Responsible Party: J.W. Silveira c/o Virginia Tracey	Address: 499 Embarcadero, Oakland, CA 94606
USTCF Clajm No.: 10290	Number of Years Case Open: 22
-USTCF Expenditures to Date: \$70,981

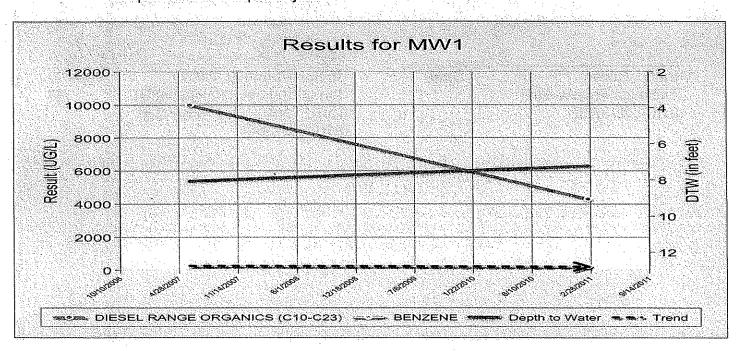
- Geology and Hydrogeology: The Site is underlain by clay, silty clay, and sandy clay, with intermittent layers of clayey sand. The depth to groundwater varies seasonally between five and nine feet bgs and the groundwater gradient is west-northwest at approximately 0.0035 feet per foot.
- Estimate of Hydrocarbon Mass in Soil: None reported.
- Groundwater Trends: There are more than 19 years of infrequent groundwater monitoring data for this Site. The graph below presents groundwater concentrations of TPHg, TPHd and benzene for Site well MW-1. Please note that the Site has been sampled twice in the past 5 years.

Water Quality Objectives: Water Quality Objectives have not been achieved.
