RE: Site Investigation Summary

Berkeley Land Company

51st Street & Telegraph Avenue

Oakland, California

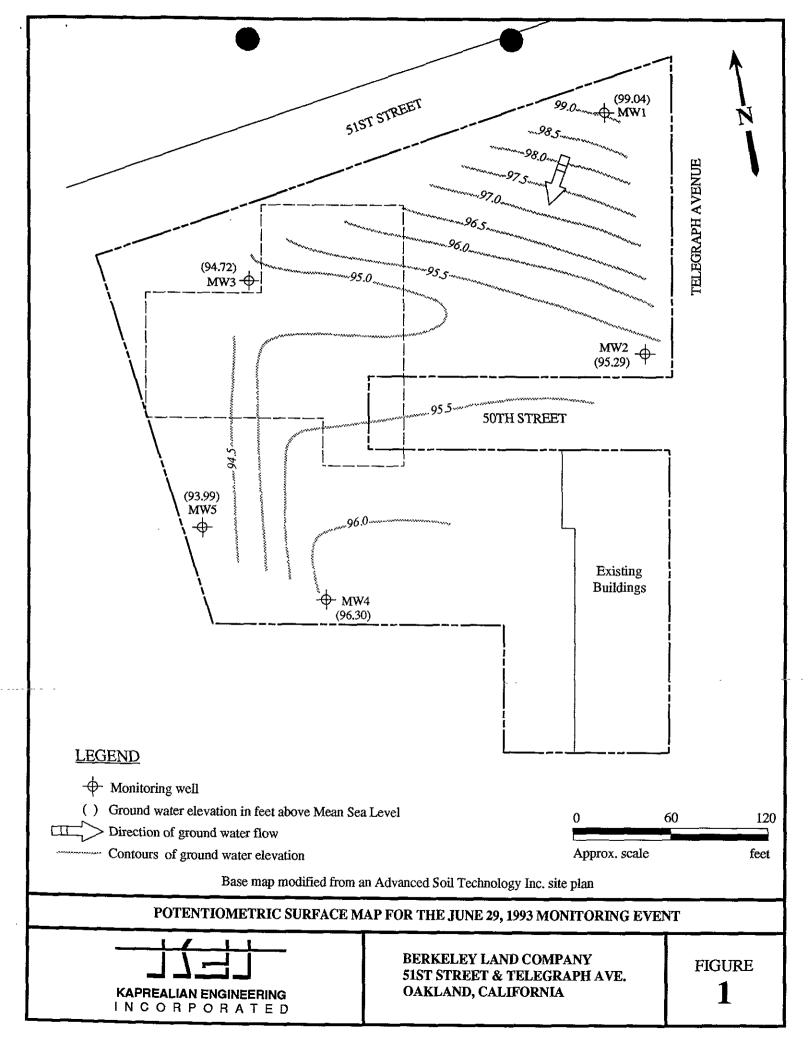
On June 29, 1993, the measured depth to ground water in the existing monitoring wells ranged from 12.15 to 17.72 feet below grade. The ground water flow direction appeared to be predominantly to the southwest, as shown on the attached Figure 1. The hydraulic gradient at the site on June 29, 1993, varied between approximately 0.03 and 0.008, based on the water level data collected from the monitoring wells prior to purging. The ground water monitoring data is presented in Table 1.

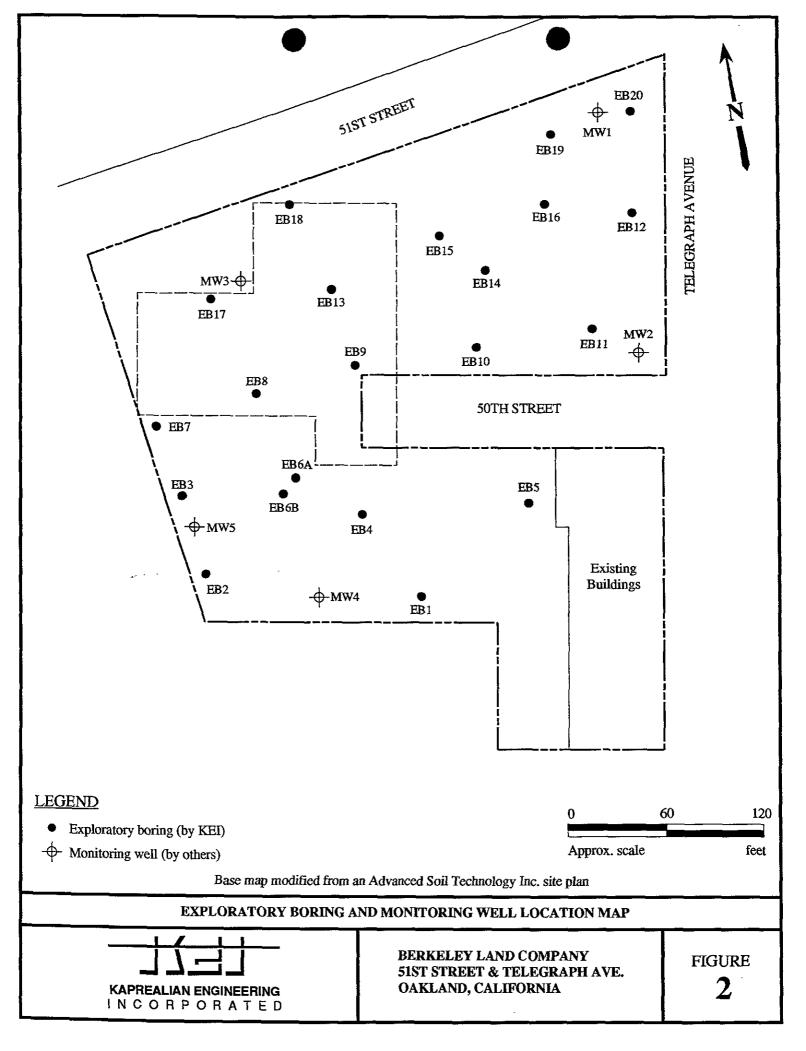
The attached Tables 2 through 7 present the analytical results of all of the soil and ground water samples collected by KEI at the subject property to date. As requested, accepted regulatory limits have been included in the tables. Soil sample point locations are shown on the attached Figure 3, and the existing monitoring wells are shown on the attached Figures 1 and 2.

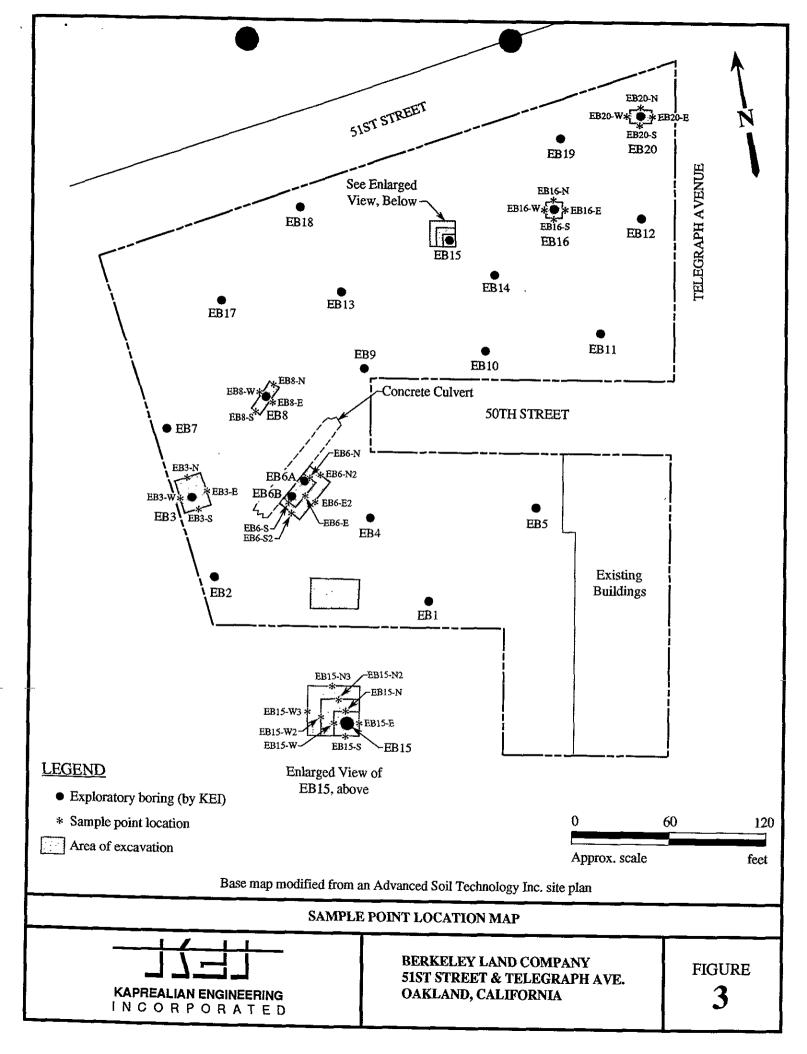
In summary, the analytical results of all of the "final" verification soil samples collected at the subject property indicate concentrations of all analytes below the indicated regulatory limits. Based on the analytical results of all of the soil samples collected and evaluated to date, it appears that the majority of the hydrocarbon contaminated soil in the vicinity of the areas investigated has been removed from the subject property. Therefore, no further soil excavation appears to be warranted at the subject property.

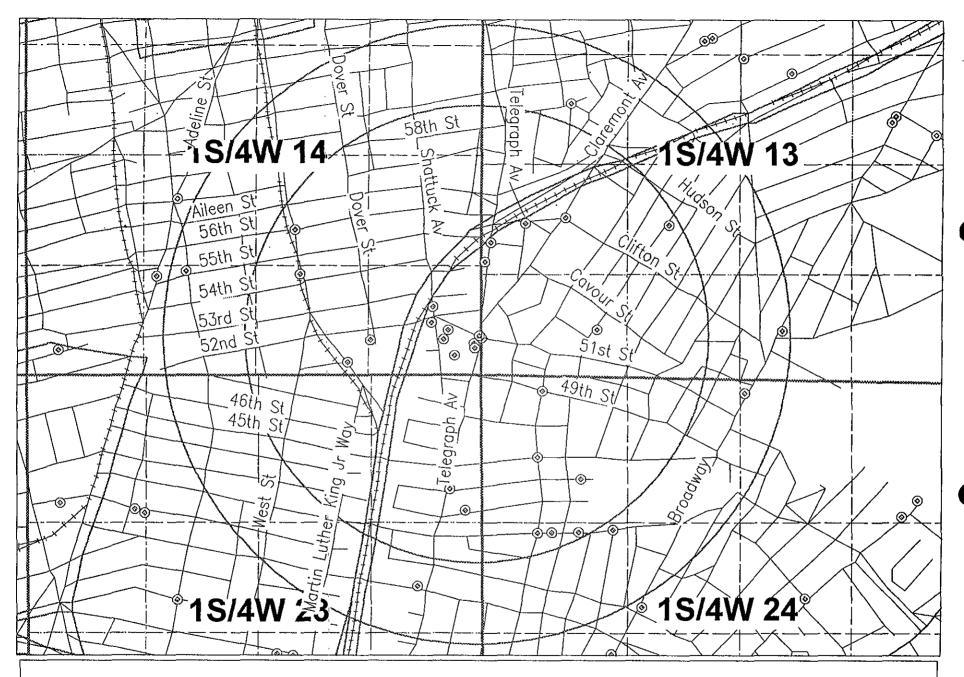
.5 mile radius from 51st St. and Telegraph Ave. 01/26/1994

KEI recently contacted the Alameda County Public Works Agency (ACPWA), Water Resources Section, to conduct a survey of all wells within a 1/2-mile radius of the site. The survey indicated the existence of five water wells within a 1/2-mile radius of the site. The water wells identified in the study area, along with well information, survey numbers, owners, and locations are listed in Table 8. The approximate locations of the water wells are shown on the attached Well Location Map. The ACPWD listing of all wells including monitoring wells, cathodic protection wells, abandoned wells, and exploratory borings, is included in Appendix B.

Domestic wells are located at sites #1 and #5, an industrial well is located at site #2, and irrigation wells are located at sites #3 and #4. Based on the previously reported southwest gradient at the subject property, sites #1 and #2 are located in the apparent upgradient direction from the subject property, and sites #3, #4, and #5 are located cross-gradient of the subject property. Based on a southwest direction of ground water flow and the locations of the identified water wells, it does not appear likely that any residual contamination that may exist at the subject property could impact the identified wells.
