October 3, 1988 KE812-3, 12056

RE: PRELIMINARY ENVIRONMENTAL
ASSESSMENT

PROPOSED FOOTHILL SQUARE OAKLAND, CALIFORNIA

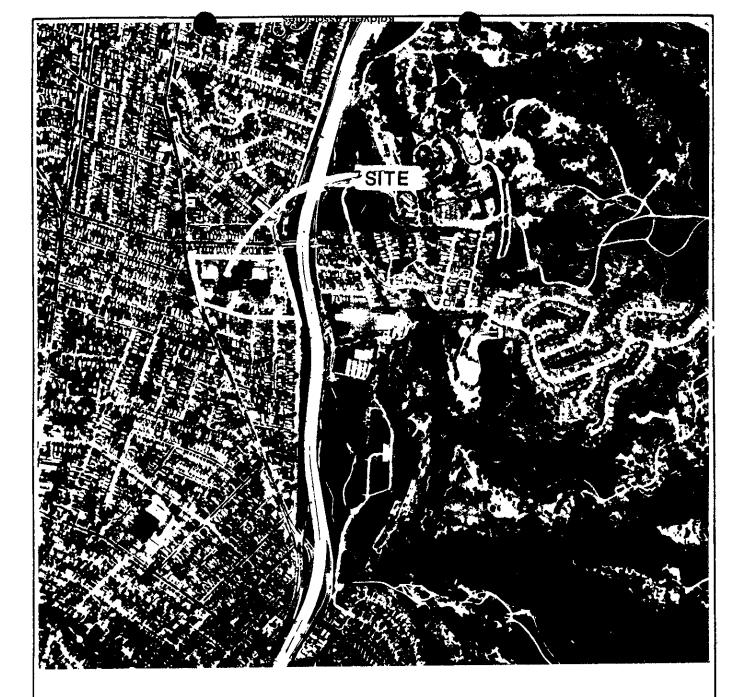
1988 AERIAL PHOTOGRAPH FOOTHILL SQUARE Oakland, California								
KE812-3	October 1988	Figure '3

Information on the site prior to 1916 was not available. In 1916, the Fageol Brothers built Fageol Motors Company at 107th Avenue and Hollywood Boulevard. Hollywood Boulevard was later re-named MacArthur Boulevard. Fageol Motors Company manufactured tractors, trucks and motor buses. Our review of aerial photographs (ranging from 1947 to the present) identified the various land uses beginning in the late 1940's. Our observations indicated that the Fageol Motor Company structure stood until early 1960. A March, 1988 aerial photo of the site and near-vicinity area is shown on Figure 3.
