May 21, 2003 Project 62400117

Pump Island Modification and Testing Report

Earthgrains Baking Companies, Inc.

955 Kennedy Street

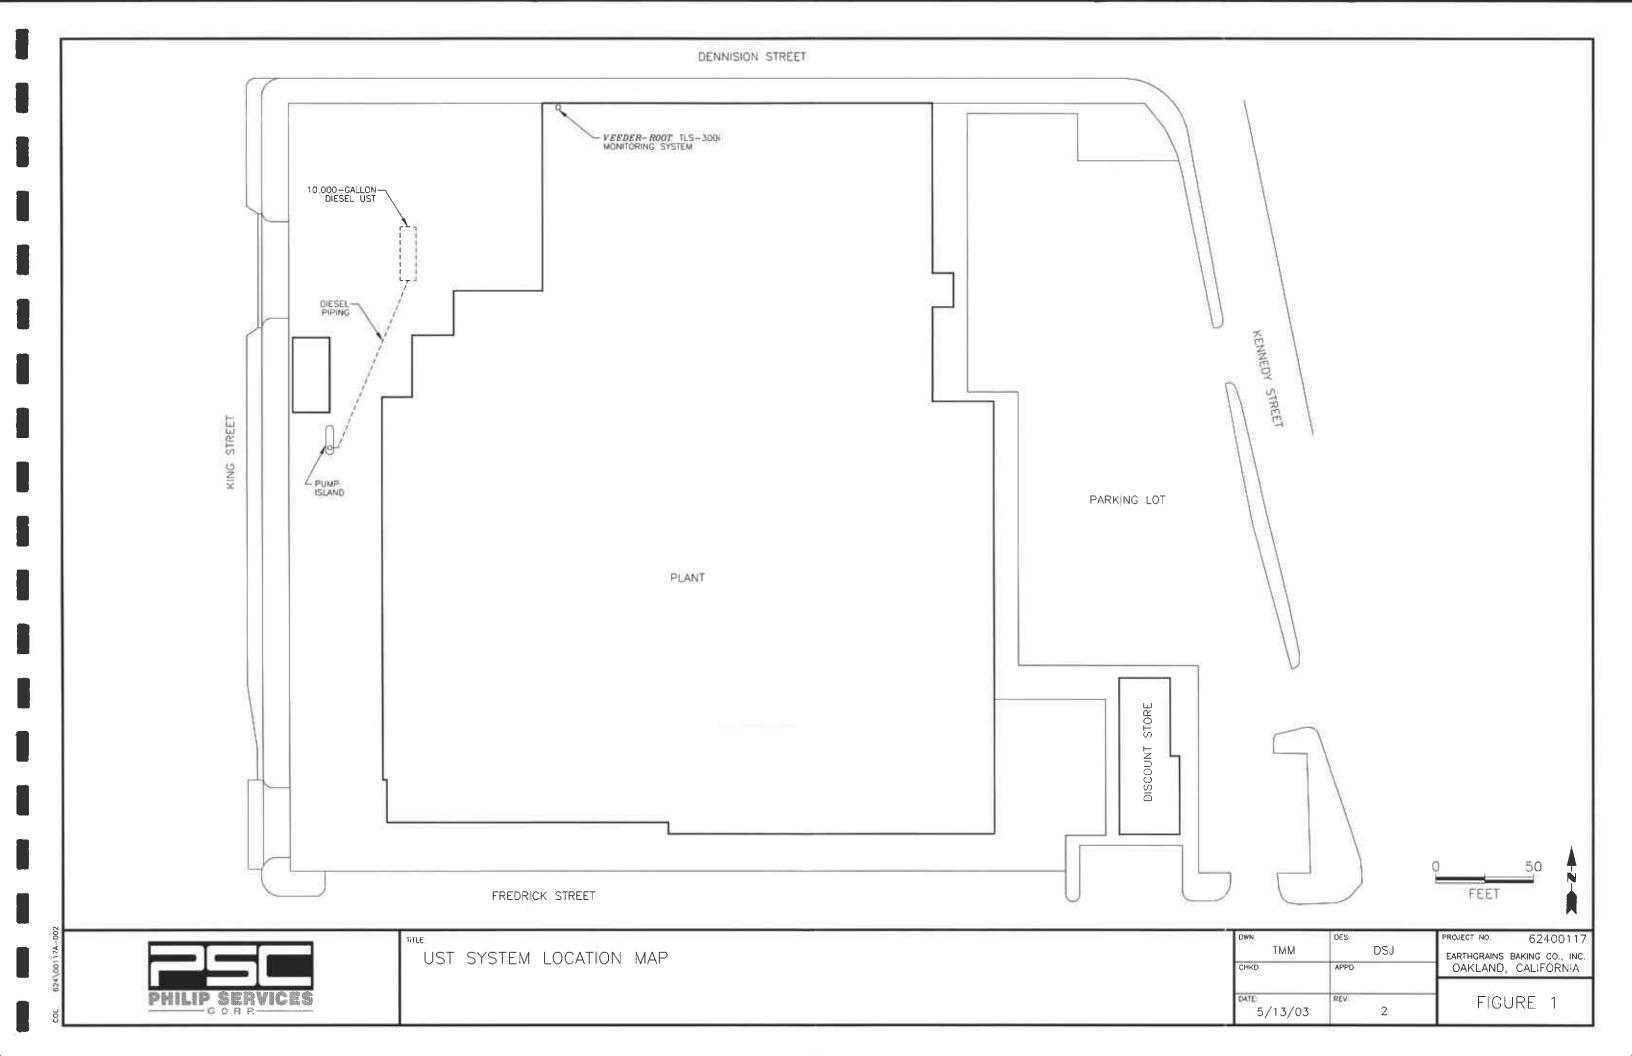
Figure 1 - UST System Location Map

On behalf of Earthgrains Baking Companies, Inc. (Earthgrains), Philip Services Corporation (PSC) is submitting a Pump Island Modification and Testing Report for the above-referenced facility. This report summarizes the pump island modifications and secondary containment testing performed on the 10,000-gallon diesel UST system during April 2003. A UST system location map is shown on Figure 1 (Attachment 1).

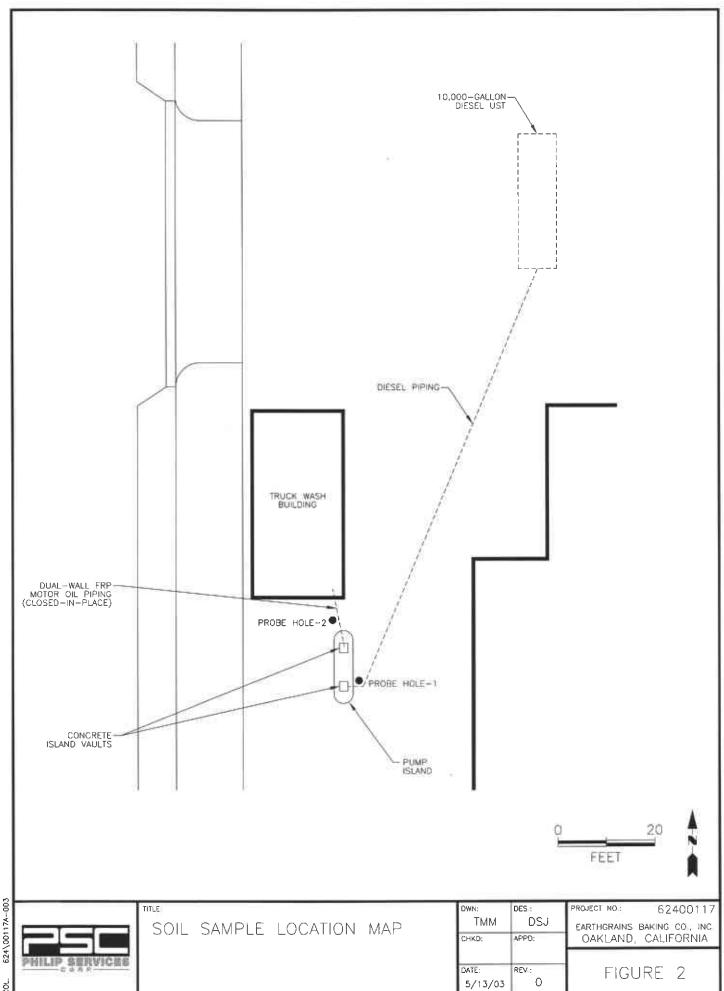
Figure 2 - Soil Sample Location Map

Vironex drilled two probe holes in the vicinity of the pump island to assess subsurface soils on April 9, 2003. PSC collected one native soil sample from each probe hole to determine potential petroleum-hydrocarbon impact from the diesel and new motor oil underground product piping (Attachment 6). Probe Hole - 1 was collected adjacent to the diesel product piping chase at a depth of 4.5 feet below pavement surface. Probe Hole - 2 was collected adjacent to the motor oil product piping chase at a depth 3.5 feet below pavement surface. A soil sample location map is shown on Figure 2 (Attachment 1).

STL analytical data report indicates that benzene, toluene, ethyl benzene, and total xylenes were not detected at the reporting limits in Probe Hole - 1. Total extractable petroleum hydrocarbons (TEPH) calculated as diesel were detected at a concentration of 3,300 milligrams-per-kilogram (mg/Kg) in Probe Hole - 1. TEPH calculated as motor oil were not detected at the reporting limits in Probe Hole - 2 (Attachment 7).
