GEOTECHNICAL ENGINEERING INSPECTION REPORT

Oak Walk Redevelopment Site
Emeryville, California

Bay Rock Oaks, LLC

February 2009

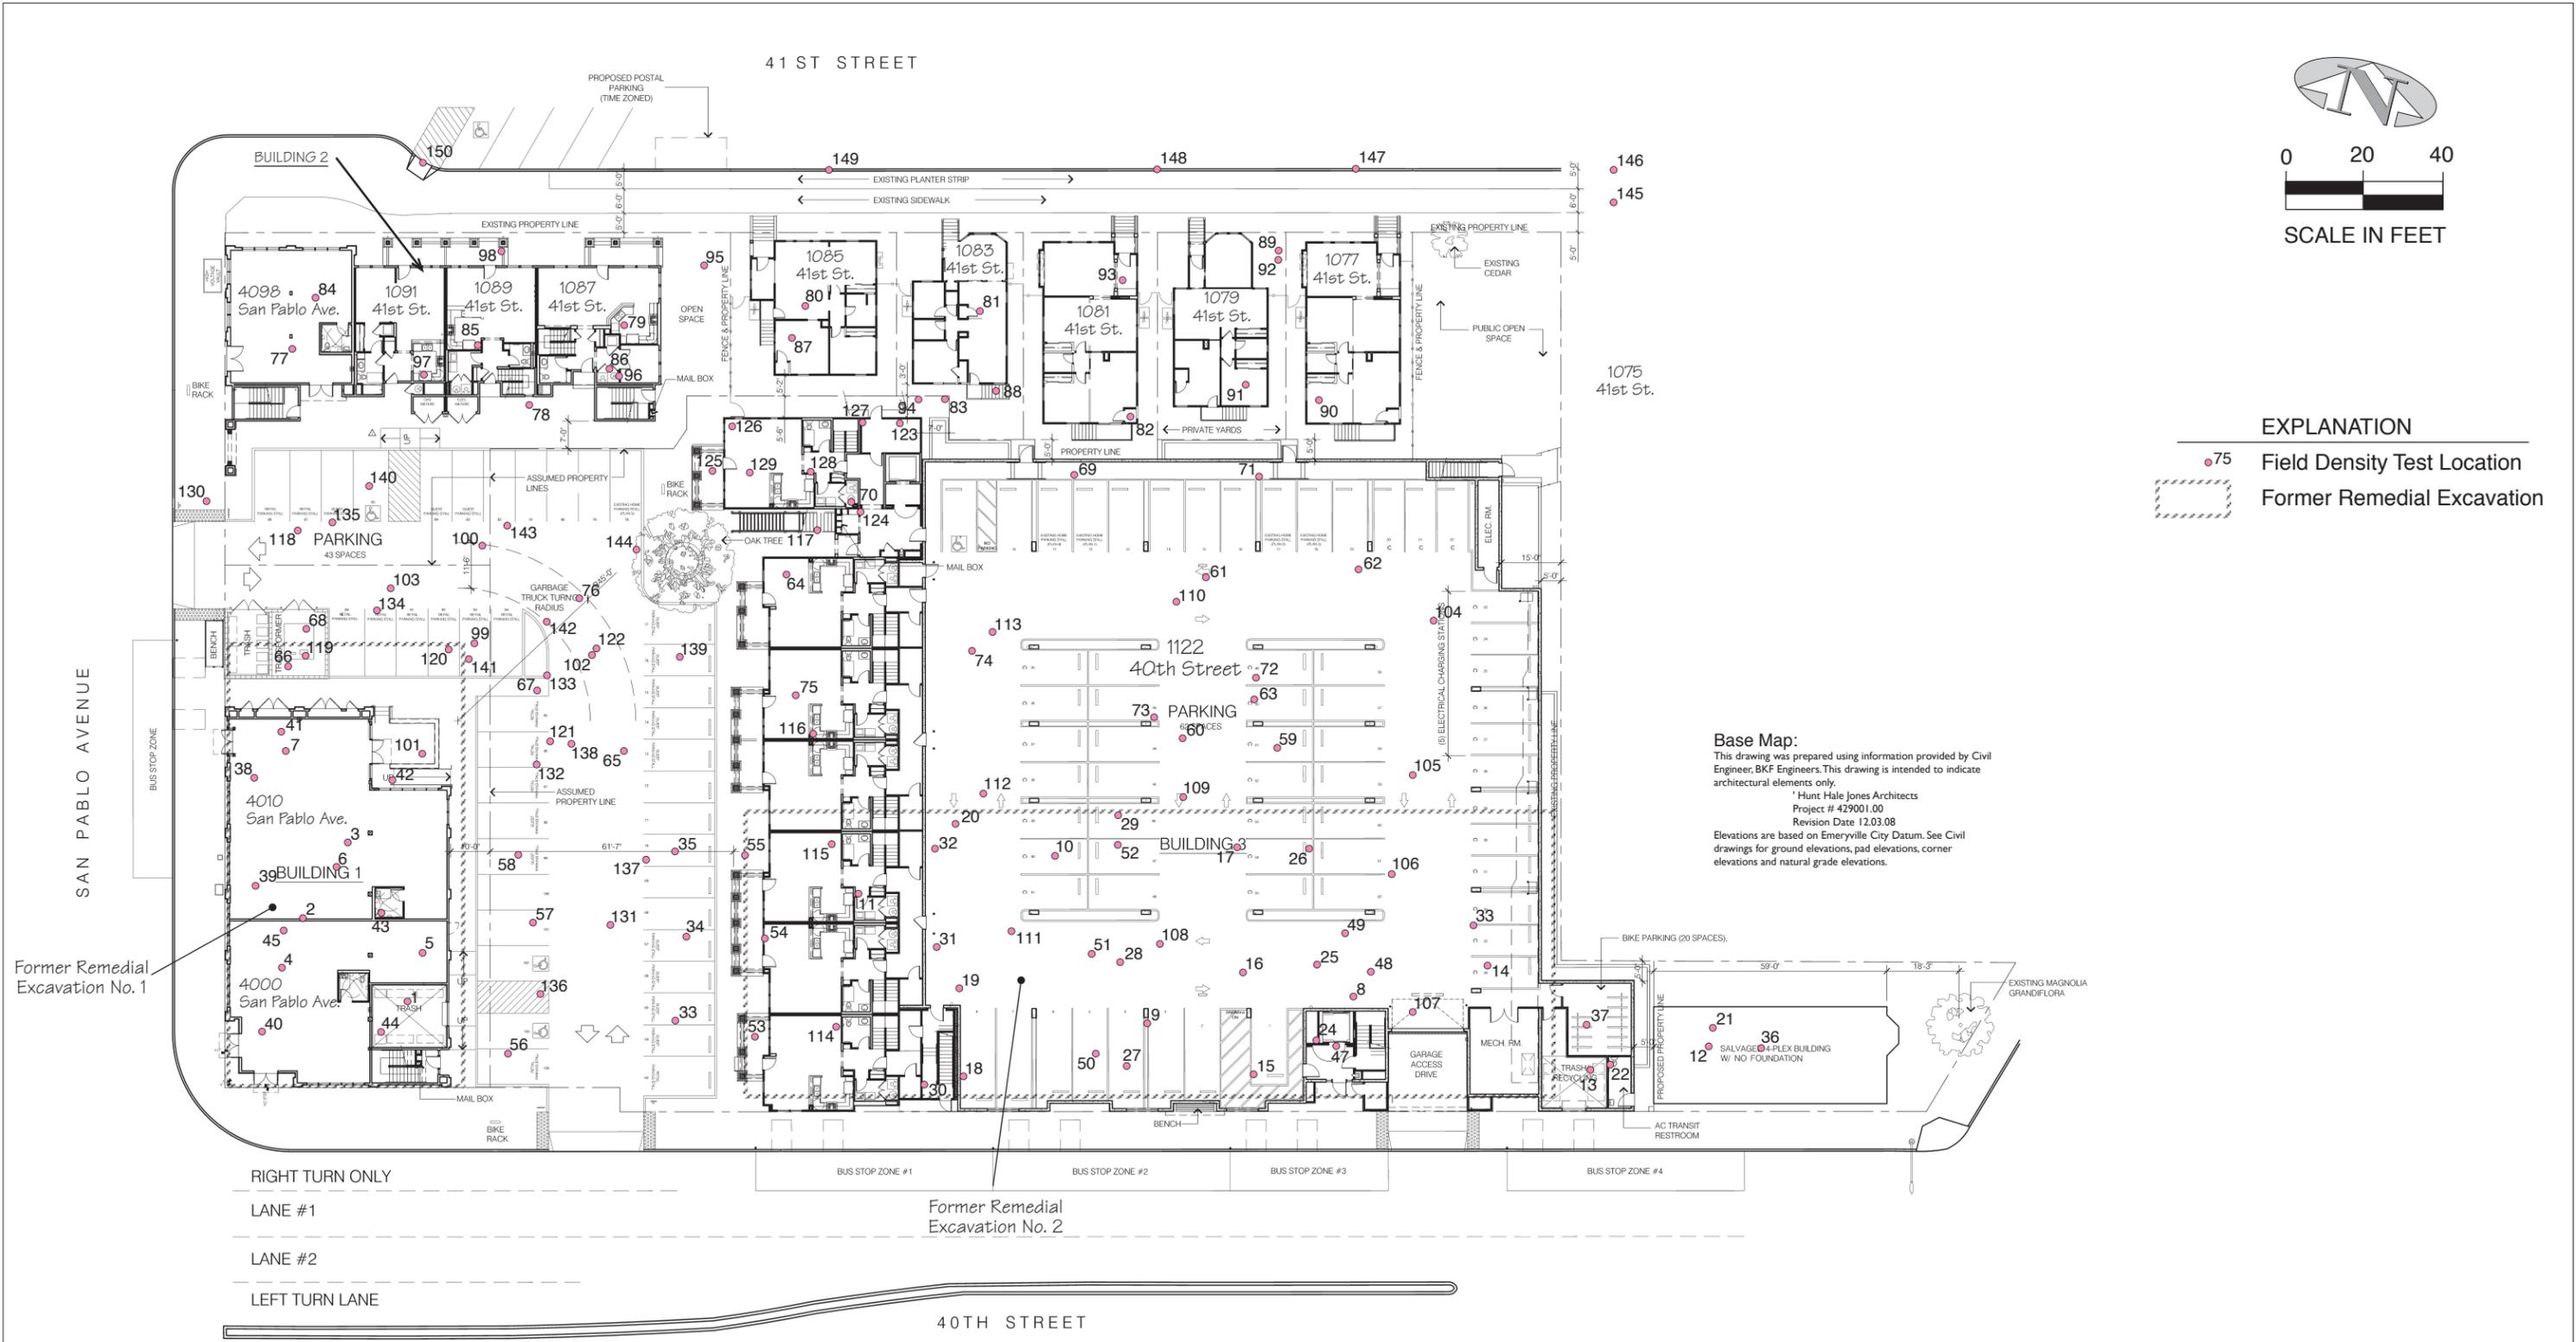
Figure 1: Soil Compaction Test Locations

Fill placement and compaction were observed intermittently by SJC's field technician. Our technician performed field density tests using a nuclear gauge to evaluate the in-place density and moisture content of compacted fill and pavement sub-grade and base-rock materials. The nuclear gauge tests were conducted in compliance with American Society for Testing and Materials Test Method D2992-01 (American Society for Testing and Materials 2001). Field density test locations are shown on the Figure 1. Table 1 presents the results of the field density tests.
