Project: 8710018A/B

ENVIRONMENTAL ASSESSMENT
FORMER NIELSEN FREIGHT LINE SITE AND ADJACENT PARCEL
Emeryville, California

ENVIRONMENTAL ASSESSMENT
FORMER NIELSEN FREIGHT LINE SITE AND ADJACENT PARCEL
EMERYVILLE, CALIFORNIA

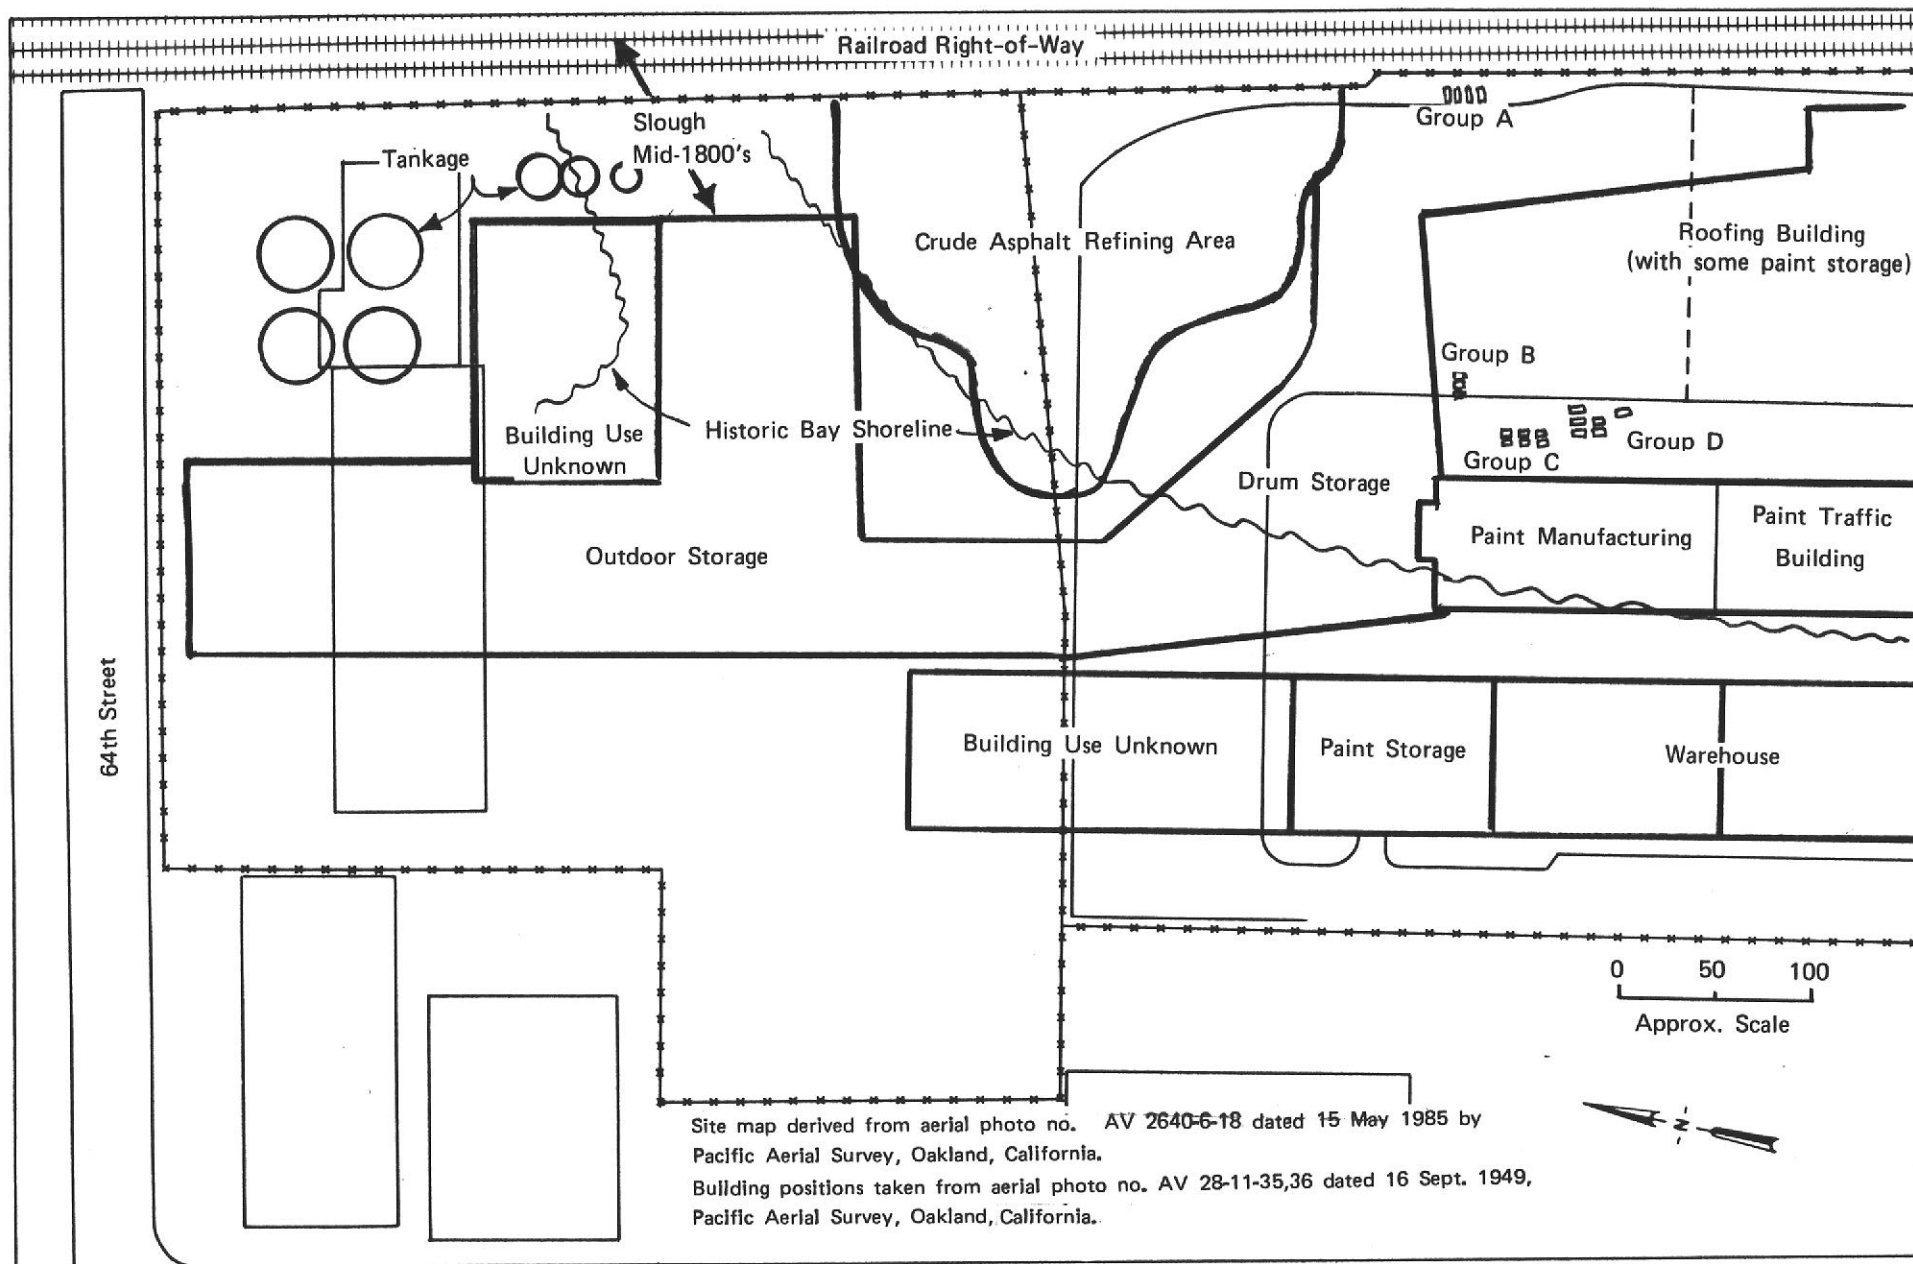
Figure 2a

Boring B3 was placed through a tar seep on the north side of the Nielsen repair garage and within the bounds of an earlier storage tank area (see Figure 2A). Some visible tar and a wood slab or block were seen in this boring. Below the wood obstacle, the soil was found to have a pungent tarry odor. A further investigation of the area consisting of six to eight shallow borings and one groundwater monitoring well is recommended. The predominant soil test for this study will be fuel hydrocarbons. If the odoriferous contaminants are fuel-weight petroleum hydrocarbons, state and local guidelines for the remediation of fuel tank spills will likely be applied by the agencies.

In a 1947 aerial photo, the eastern part of the present Nielsen parcel is seen to be under development. The construction activities include the construction of four large above ground tanks (Figure 2A). A small black area just south of the four large tanks is evident in the photo, but its cause is not known with certainty. By 1949, a single large building and outdoor storage areas are evident. The building tanks and storage area are shown on Figure 2A. The remaining portion of the area between this development and the current Eastshore freeway had not yet been developed.

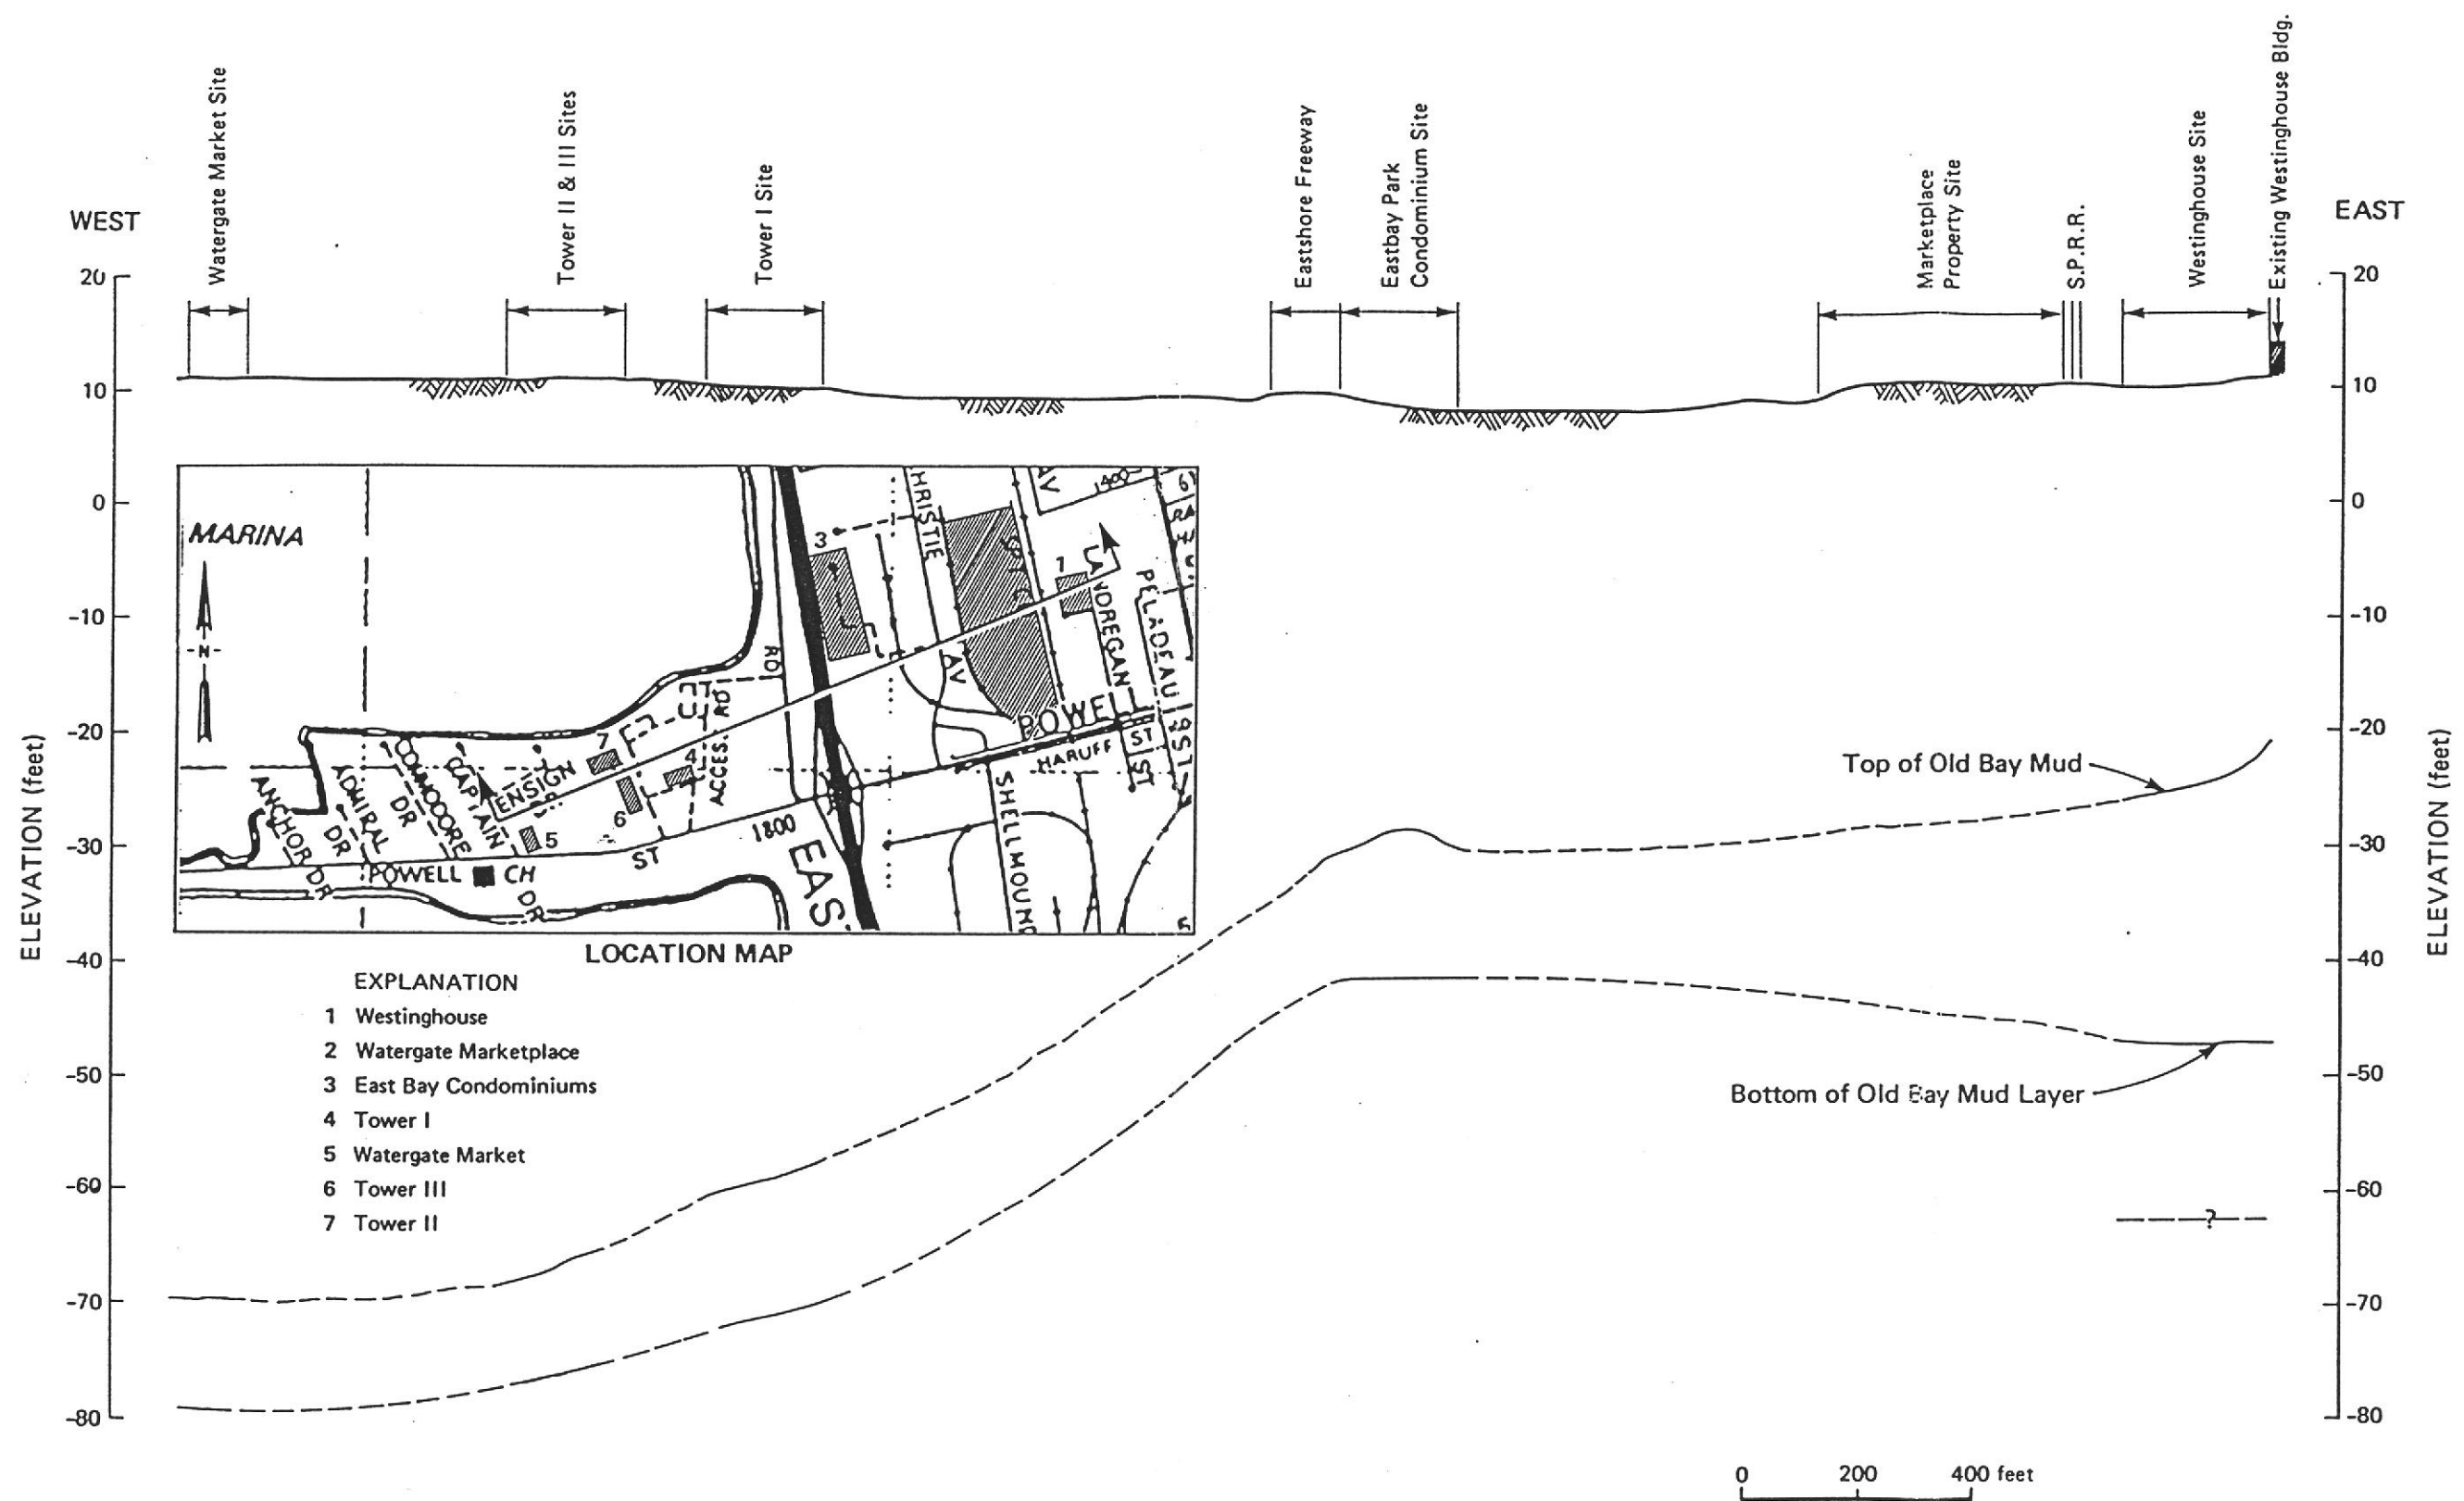
| Project No. 8710018A | The Martin Company Nielsen Freightline Site | Figure 5 |

A typical geologic cross section extending from the adjacent Westinghouse site through the Watergate Peninsula in Emeryville is shown in Figure 5. This figure, presented in WCC's 1985 Westinghouse study, shows a thick and laterally continuous layer of "Old Bay Mud," a substantially regional clay aquitard, to be present from at least the Southern Pacific Railroad right-of-way to San Francisco Bay. It is expected that this layer exists beneath the Nielsen parcel and the North Marketplace parcel. The top of the layer was found in Geomatrix boring 1.
