**4901, 4915 & 4921 Broadway Avenue
Oakland, CA**

KELLCO JOB #0706-07 & 1507-15

**Pre-Demolition Asbestos and Lead Inspection Report
Waste Profiling and Asbestos 1000 Point Count Final Report**

**SRM Construction, Inc.
111 North Post Street
Suite #200
Spokane, WA 99201**

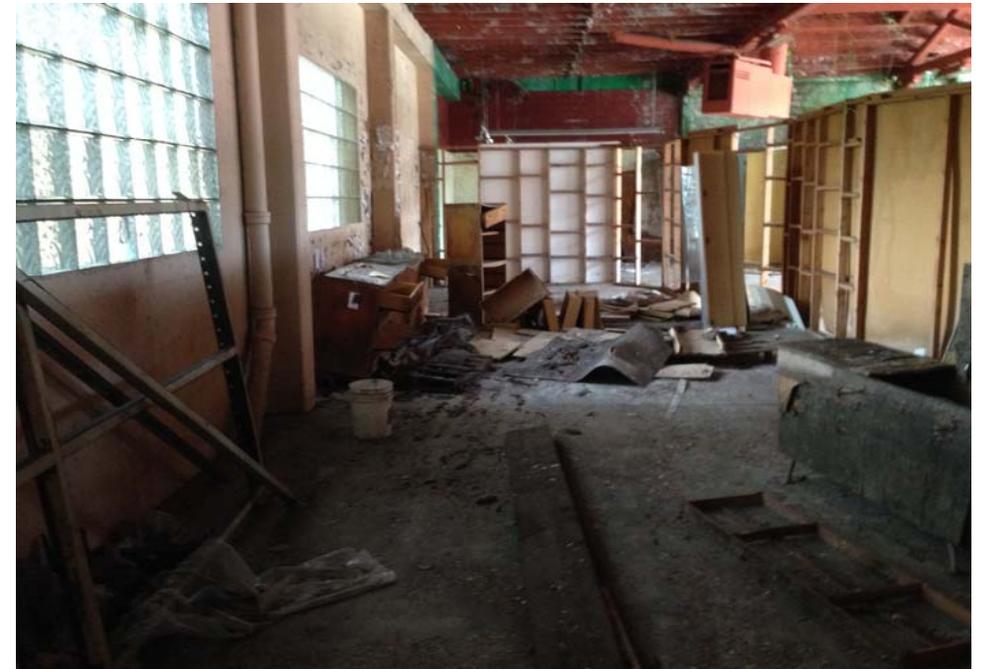
Please Note: This address was noted wrong during the first inspection. Please see the attached photographs. In that photograph the City of Oakland posted signage that called this building 4921 Broadway Avenue not 4929 Broadway Avenue, Oakland, CA.
