PHASE I  
ENVIRONMENTAL  
SITE ASSESSMENT

3820 Penniman Avenue  
Oakland  
California

**Subject:** Phase I Environmental Site Assessment Report  
3820 Penniman Avenue  
Oakland, California 94619

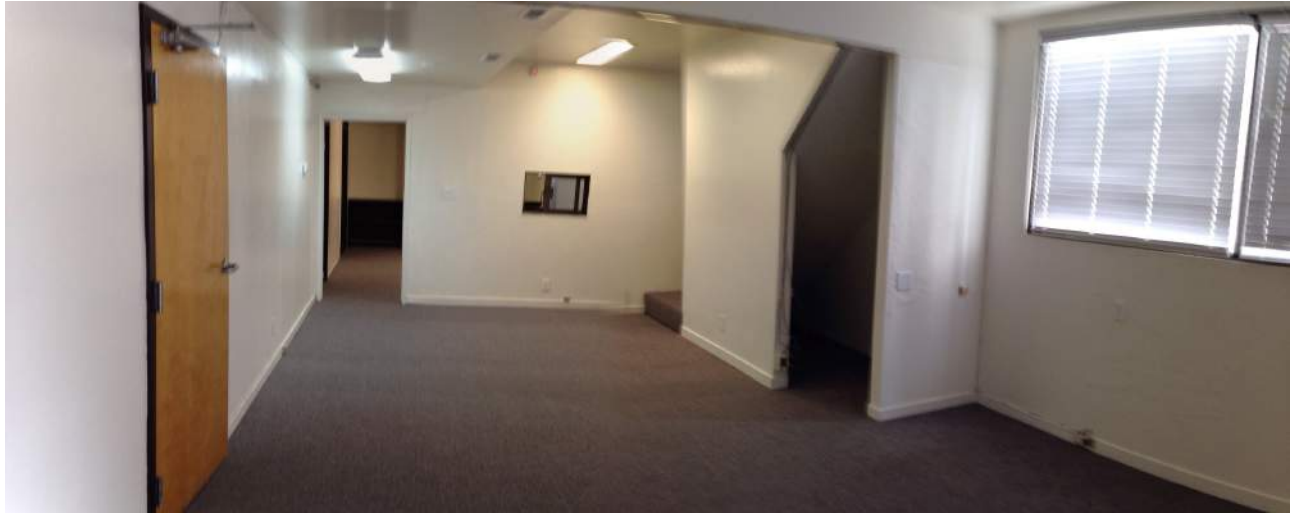
The empty lobby is located at the southwest portion of the building and consists of an empty room (See Photo 5). The lobby is empty. Visual observations of the empty lobby did not reveal any obvious evidence of hazardous materials, stains, or spills. Visual observations of the carpet-covered floor of the empty lobby did not reveal any obvious evidence of collection drains, sumps, or other conduits to the subsurface.

Photo 5: Subject Site (Facing Southeast)  
3820 Penniman Avenue Interior  
Empty Lobby

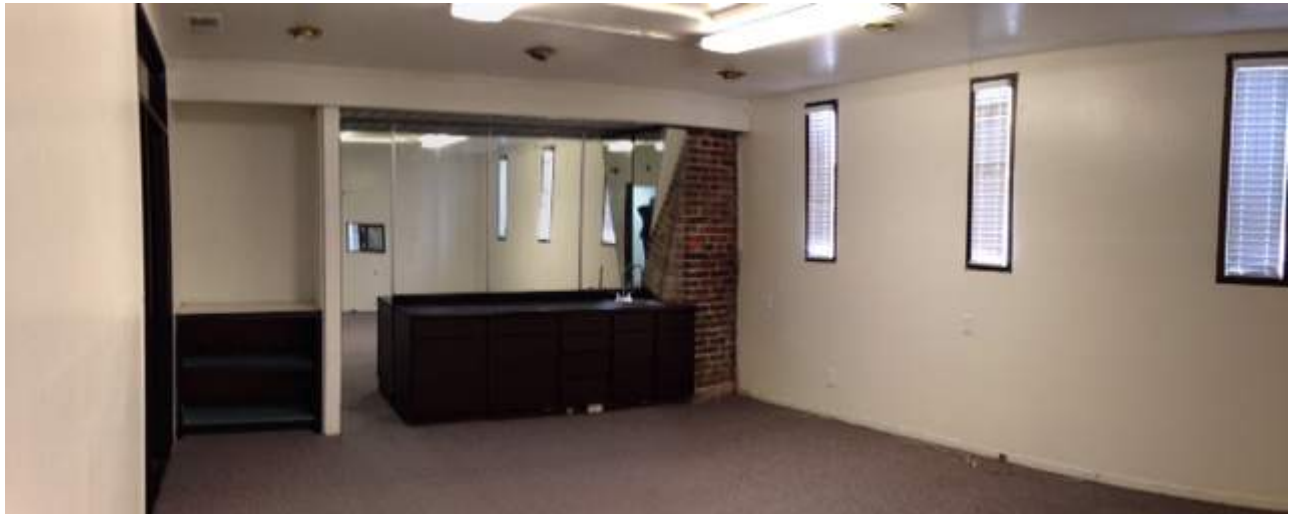
The empty office area is located at the southeast portion of the building and consists of an empty room, a small empty individual office, and a restroom facility (See Photos 6-8). Located within the empty office area are a counter with a sink basin, a shelf, and a mirror. Located within the restroom facility are typical restroom furnishings and supplies. Visual observations of the empty office area did not reveal any obvious evidence of hazardous materials, stains, or spills. Visual observations of the carpet-covered and tile floor of the empty office area did not reveal any obvious evidence of collection drains, sumps, or other conduits to the subsurface.

Photo 6: Subject Site (Facing Southeast)  
3820 Penniman Avenue Interior  
Empty Office

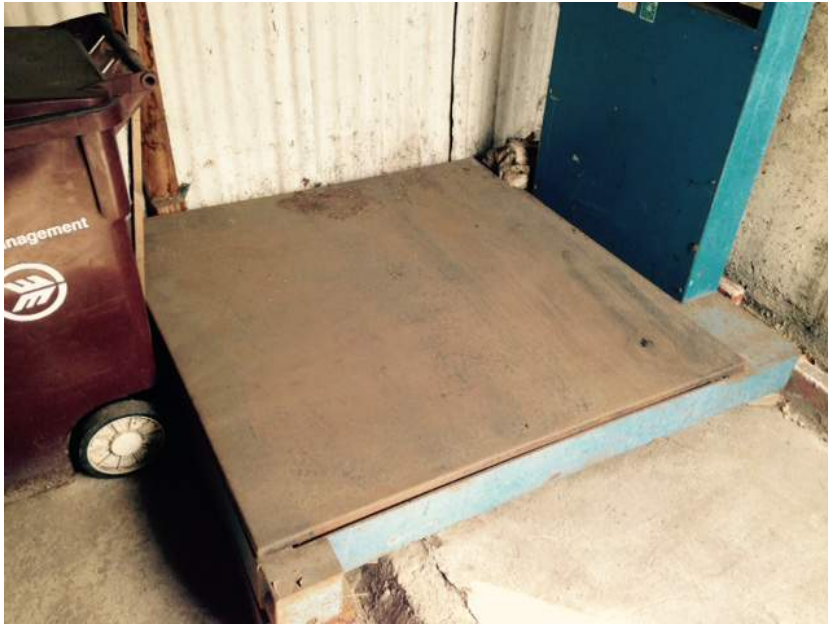
*Storage Canopy* – The storage canopy is located at the southeast side of the subject site. The storage canopies are empty. A weighing scale and debris bin are located at the northeast side of the storage canopy (See Photos 21-22). Visual observations of the storage canopy did not reveal any obvious evidence of hazardous materials, stains, or spills.

Photo 21: Subject Site (Facing North)  
3820 Penniman Avenue Exterior  
Associated Paved area and Storage Shed - Scale

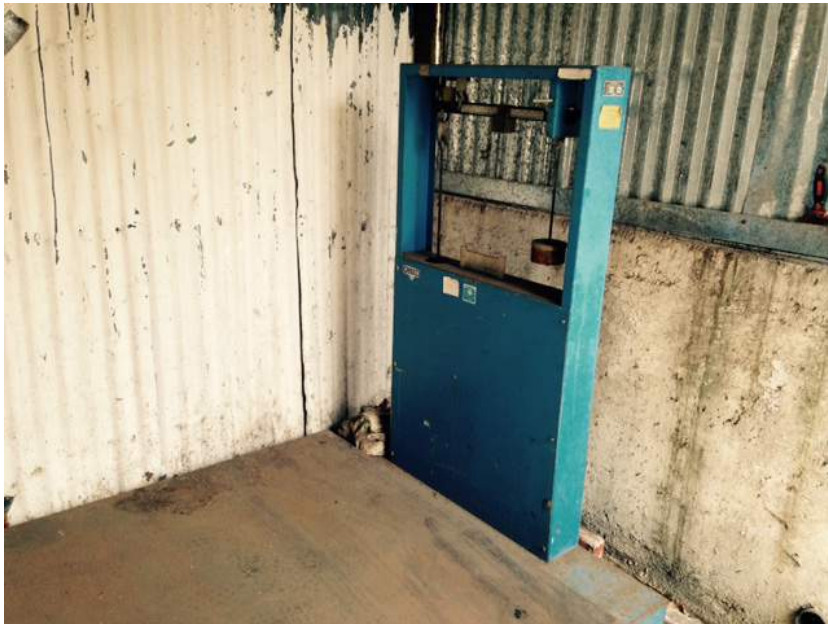
Photo 22: Subject Site (Facing North)  
3820 Penniman Avenue Exterior  
Associated Paved Area and Storage Shed - Scale

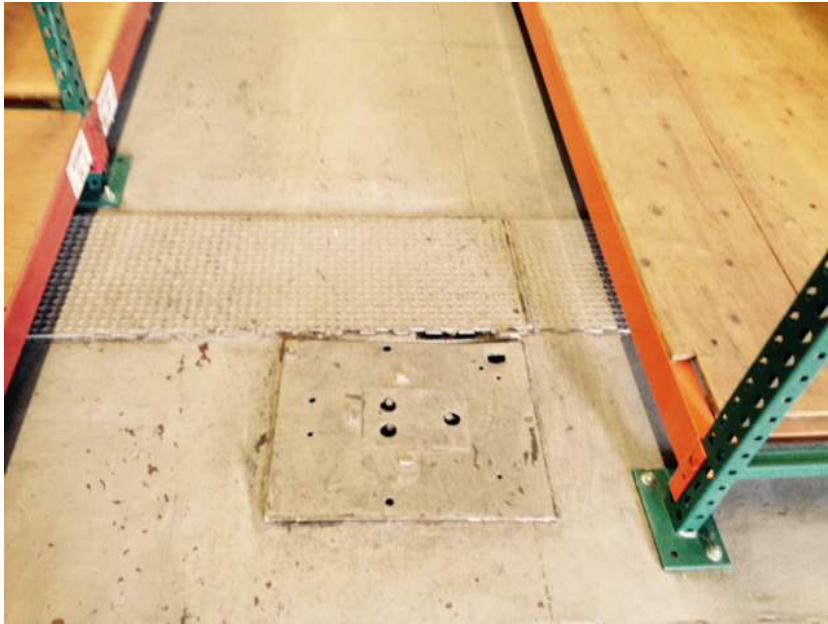
warehouse area. A sump is located at the southeast side of the warehouse area (See Photo 23). A small collection drain and a cement-filled conduit are located at the north corner of the warehouse area (See Photos 24 and 25). Located within the kitchen are empty cabinets and a sink basin. Visual observations of the warehouse area and kitchen did not reveal any obvious evidence of hazardous materials, stains, or spills. Visual observations of the concrete floor of the warehouse did not reveal any obvious evidence of other conduits to the subsurface.

Photo 23: Subject Site (Facing Northeast)  
3820 Penniman Avenue Interior  
Storage Warehouse - Sump

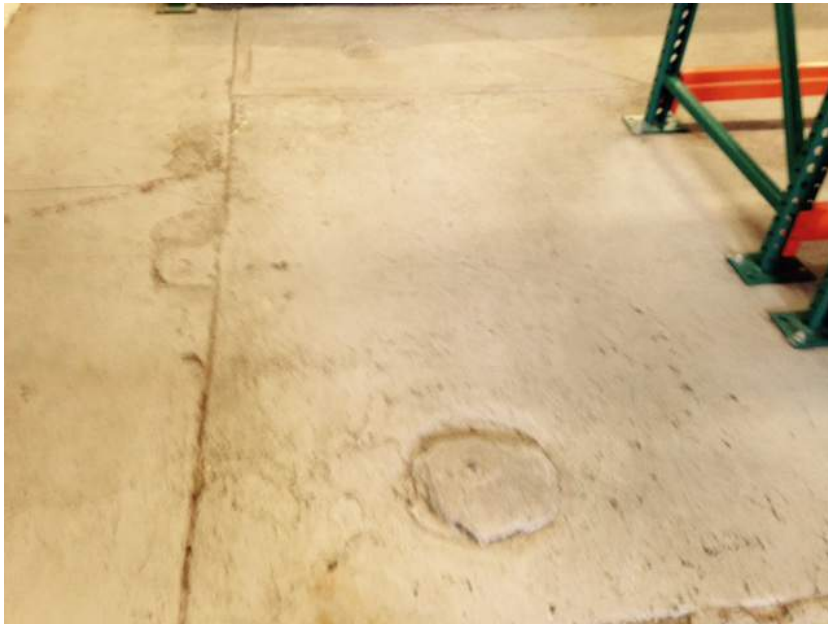
Photo 24: Subject Site (Facing Southeast)  
3820 Penniman Avenue Interior  
Storage Warehouse - Former Underground Lift

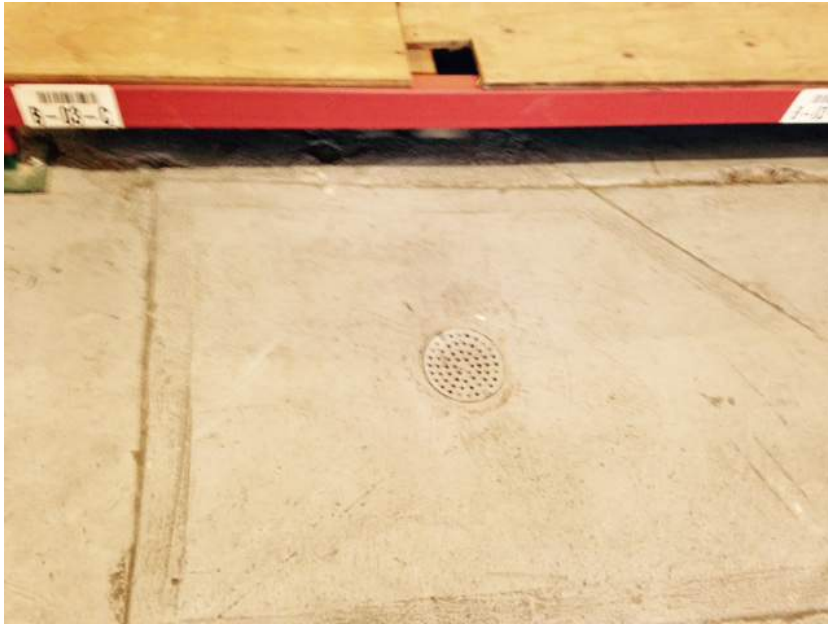
Photo 25: Subject Site (Facing Southeast)  
3820 Penniman Avenue Interior  
Storage Warehouse - Drain

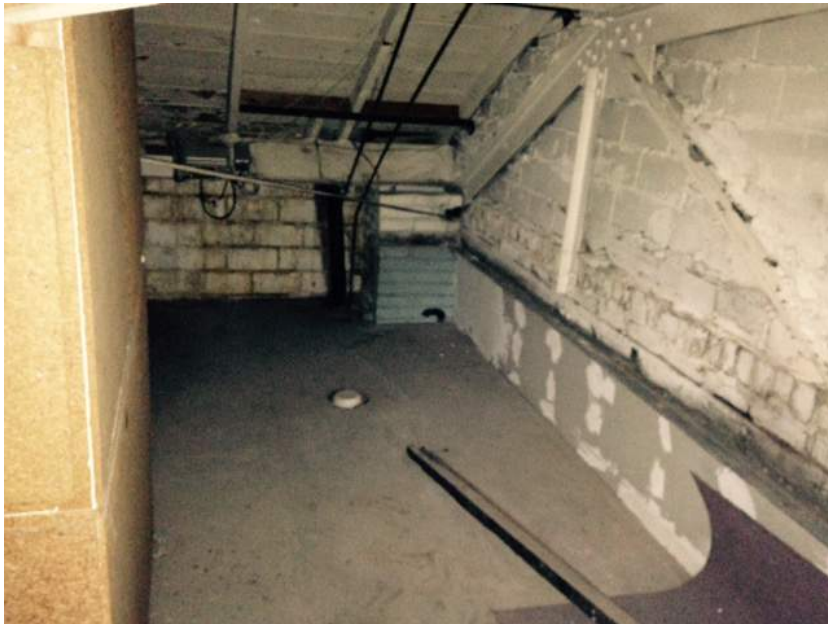
The office area encompasses the whole of the second floor and consists of an empty room (See Photos 26-28). The office area is empty. Visual observations of the office area did not reveal any obvious evidence of hazardous materials, stains, or spills. Visual observations of the carpet-covered floor of the office area did not reveal any obvious evidence of collection drains, sumps, or other conduits to the subsurface.

Photo 26: Subject Site (Facing Northeast)  
3820 Penniman Avenue Interior  
Mezzanine Office Area
