CORRECTIVE ACTION REPORT

208 JACKSON STREET, OAKLAND, CALIFORNIA

SNK DEVELOPMENT INC

November 1999

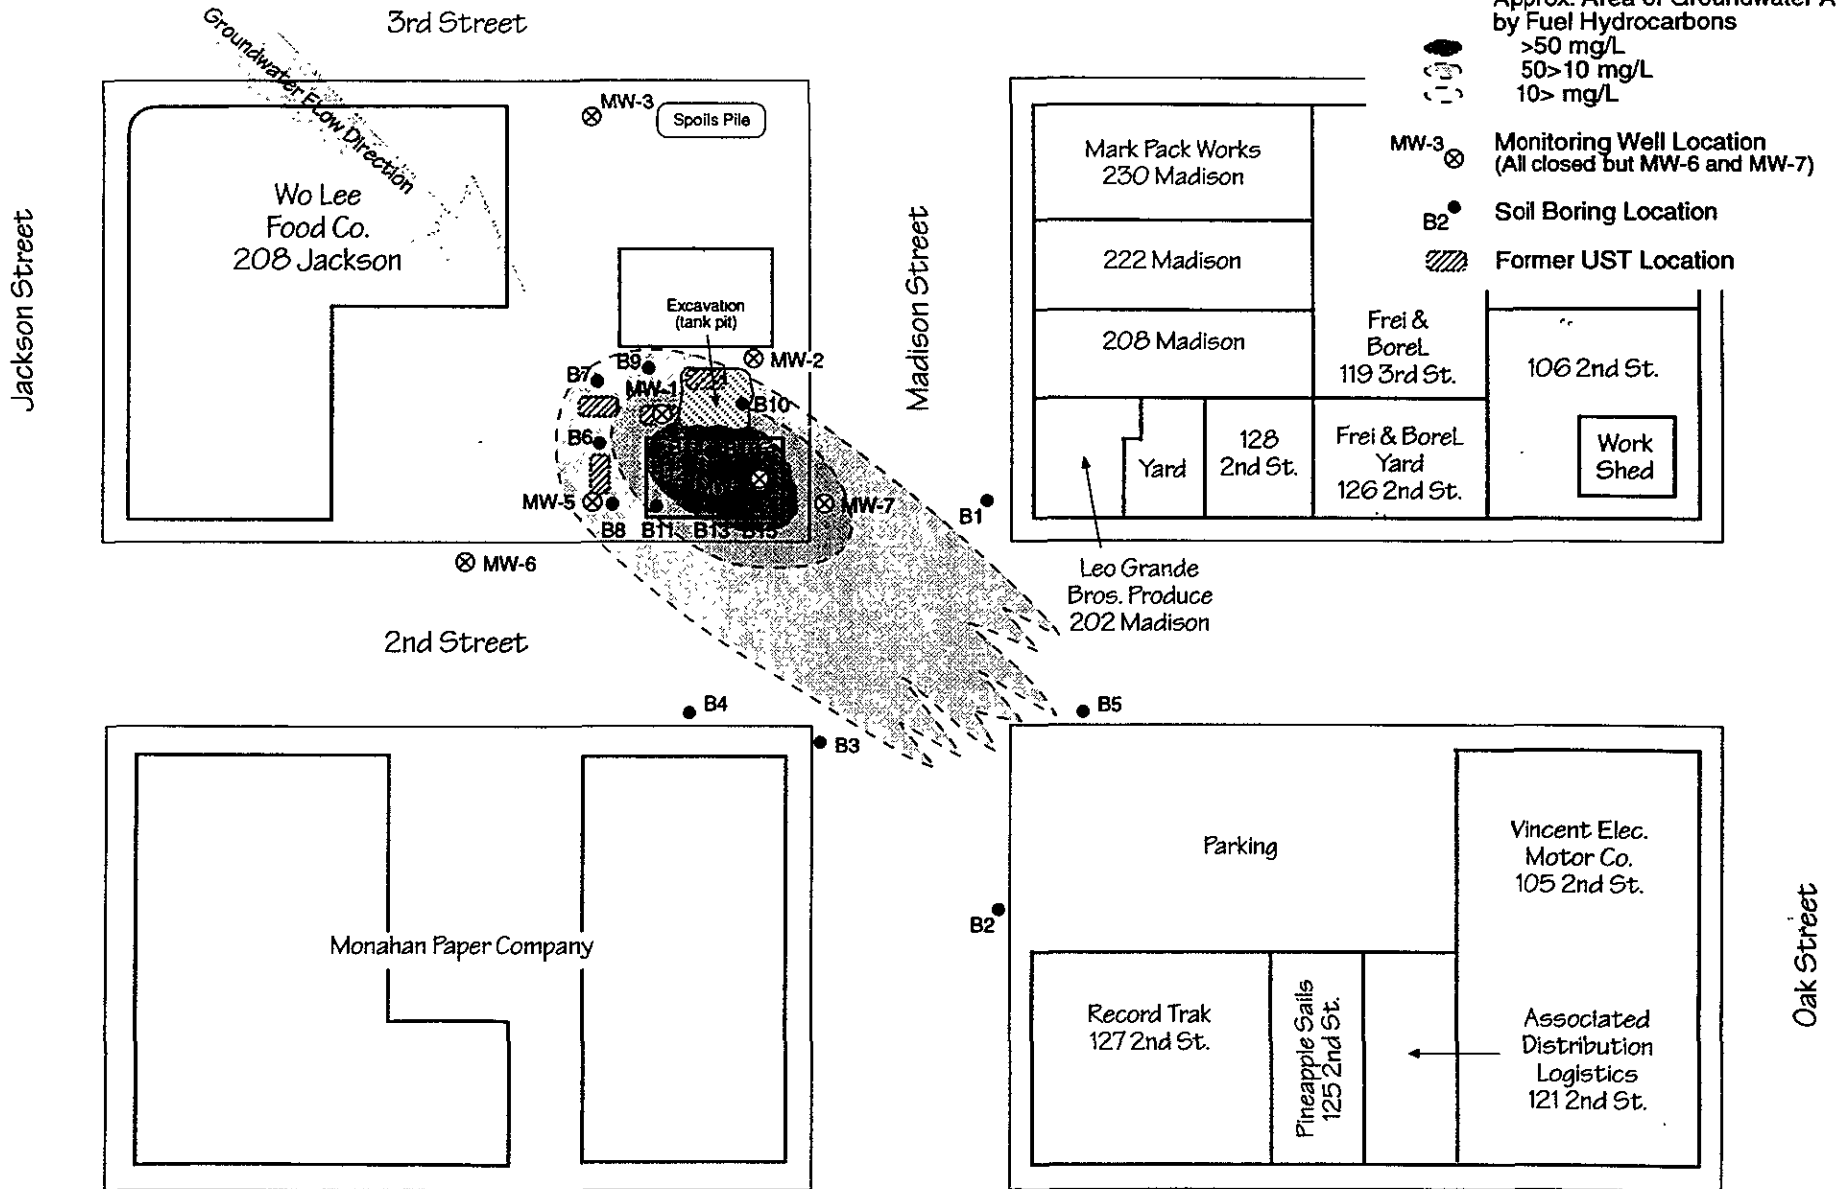
FUEL HYDROCARBON PLUME PRIOR TO REMEDIATION

significant loss of fuels from the underground storage tanks in the southern corner of the 208 Jackson Street property, but that the down-gradient migration of the leaked fuels was relatively limited

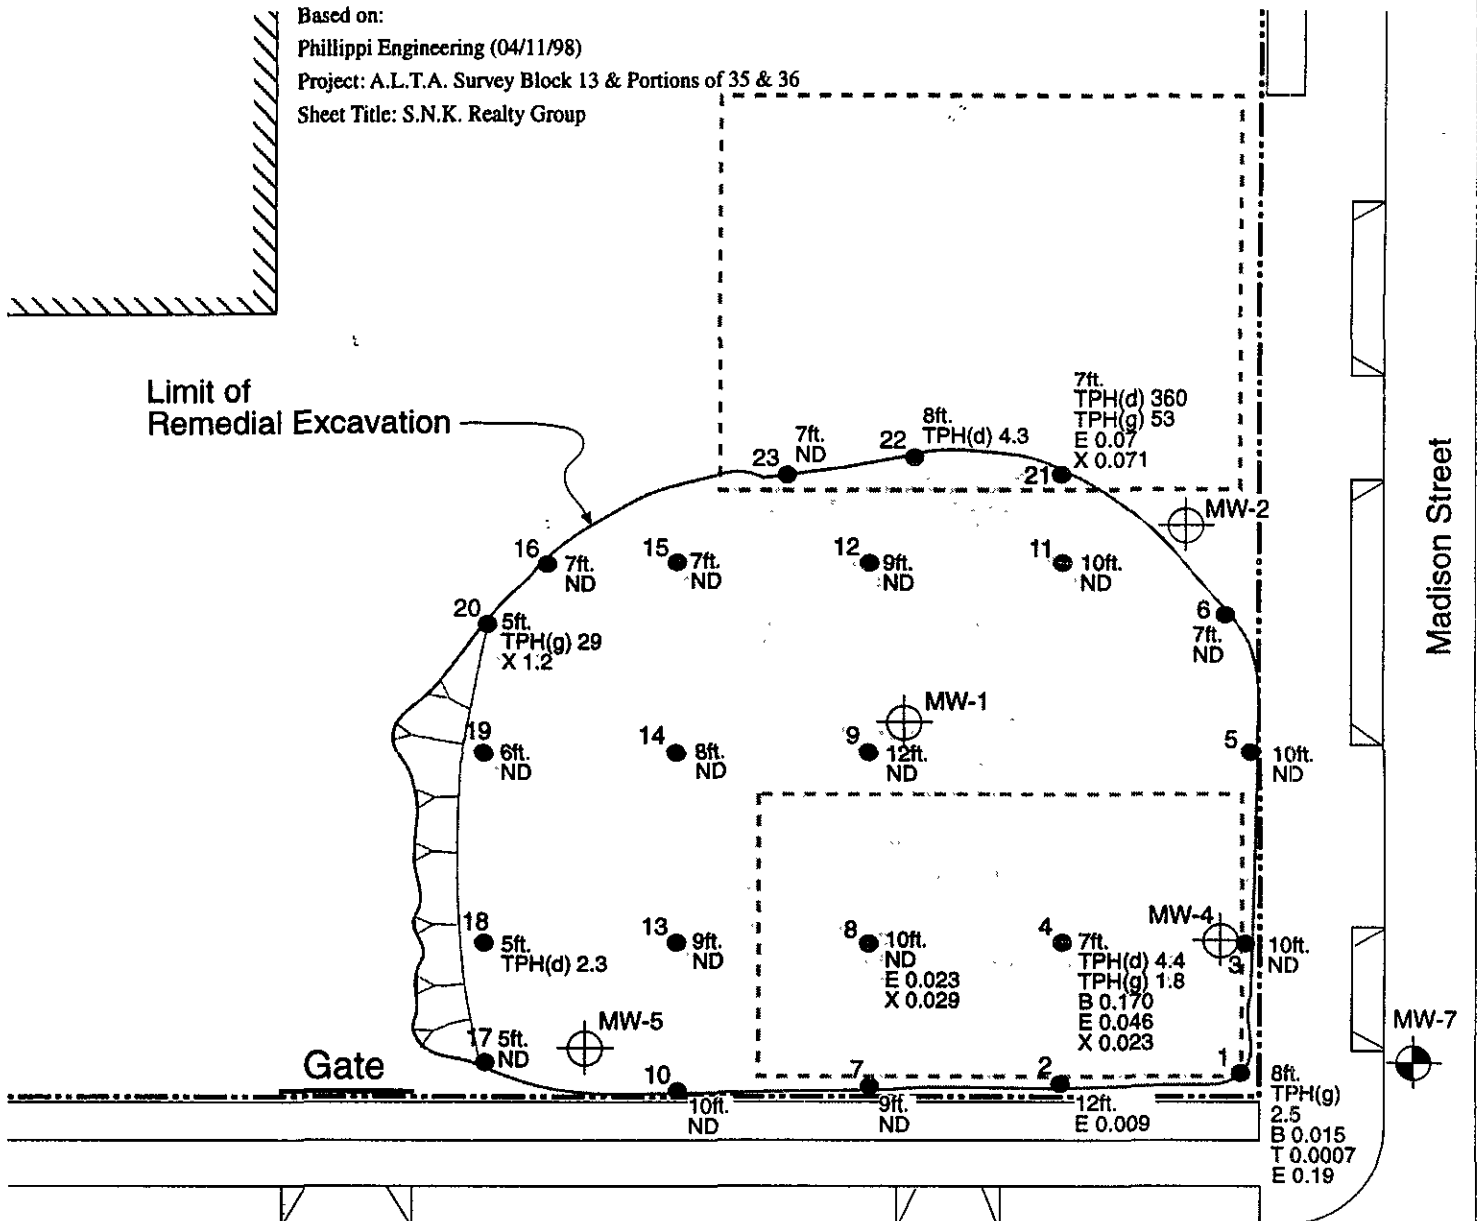
SAMPLING LOCATIONS IN REMEDIAL EXCAVATION

A total of 23 soil samples were recovered from the bottom of the remedial excavation. The sampling locations are shown on Figure 6. The depths from which they were recovered are also noted on that Figure.

The data in Table 9 show that the remedial excavation was successful in removing essentially all hydrocarbon-affected soil from beneath the 208 Jackson Street property, except for trace concentrations of hydrocarbons at a few isolated locations where the flowing sand caused the local remediation cell to collapse before the desired depth of the excavation could be achieved.

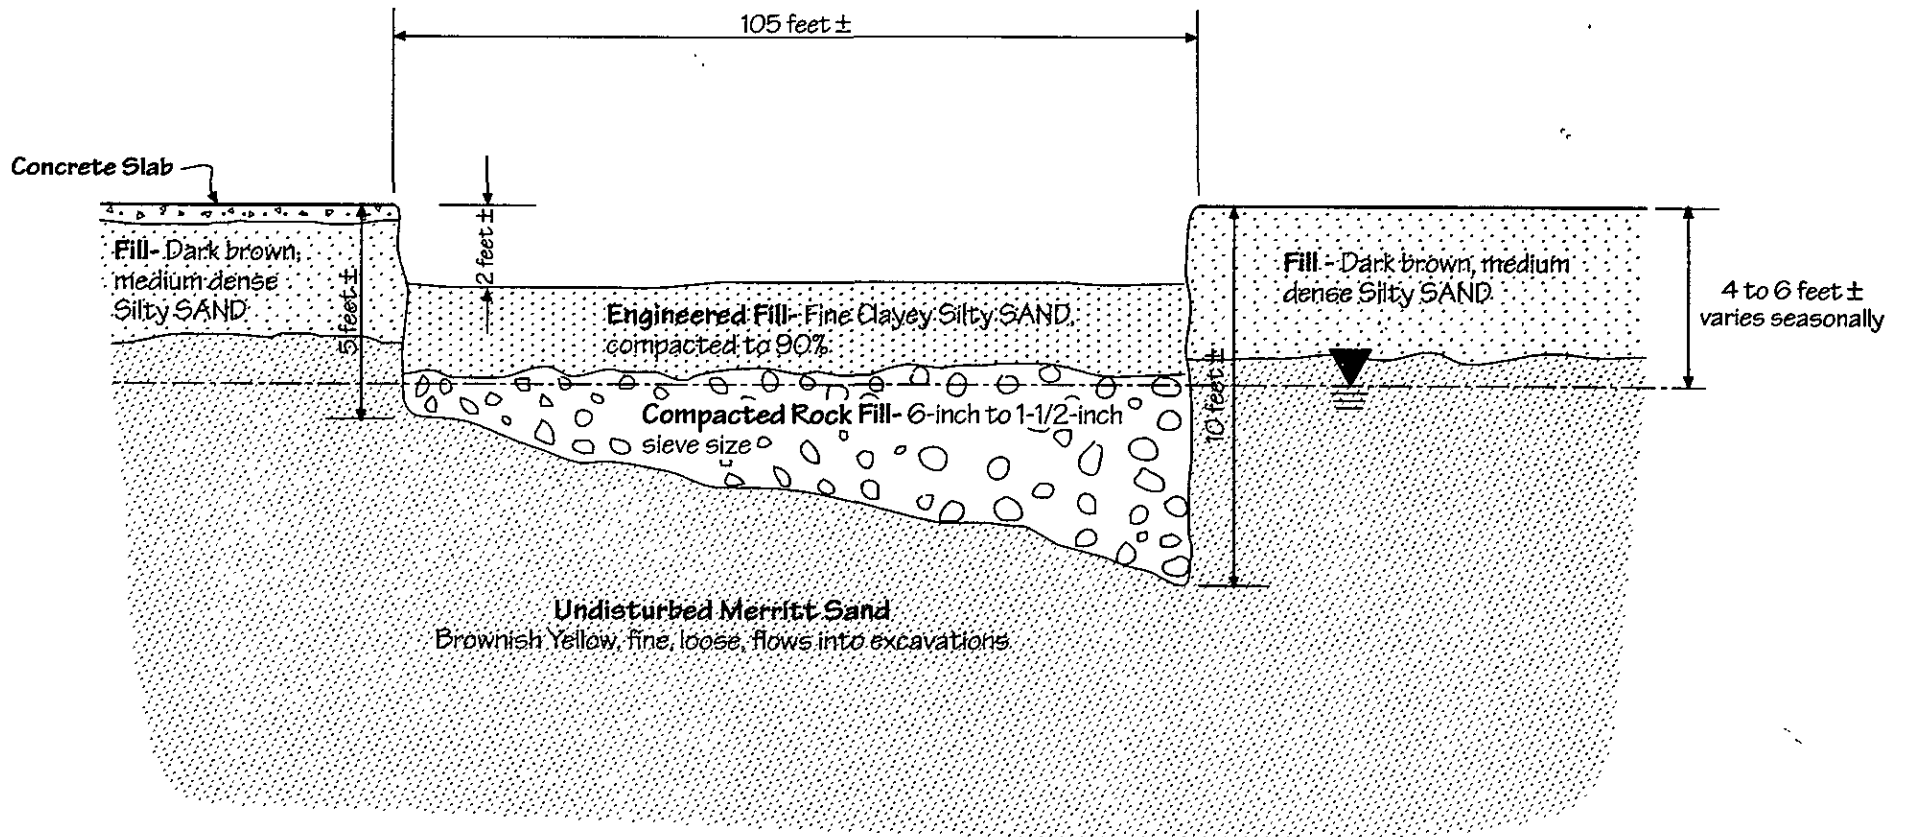
RESTORED REMEDIAL EXCAVATION

North-South Section Through Backfilled Excavation

Following its placement in the excavation, the clean, 6-in. to 1-1/2 in. sieve-size, no-fines rock was thoroughly compacted using a heavy, vibratory compactor. Due to the large voids between the rocks, this material, when so compacted, can serve as support for heavy foundations and, because it has a very high permeability, it is not susceptible to liquefaction during a seismic event.

Material from the temporary stockpile of treated soil was used to backfill the remedial excavation. As noted previously, to permit safe excavation, clean rock backfill had been placed in the excavation from the bottom of the excavation to the depth of the water table at the time soil affected by fuel hydrocarbons was removed from that zone of the subsurface. To prepare the rock already placed in the excavation for placement of this additional backfill, the front-end loader and excavator were used to carefully level its surface. It was then thoroughly compacted using a 66-in. pad-footed, vibratory compactor.
