SUBJECT Quarterly Status Report – 208 Jackson Street, Oakland, California

QUARTERLY STATUS
REPORT

DECEMBER 1, 1999 to FEBRUARY 29, 1999

208 Jackson Street, Oakland, California

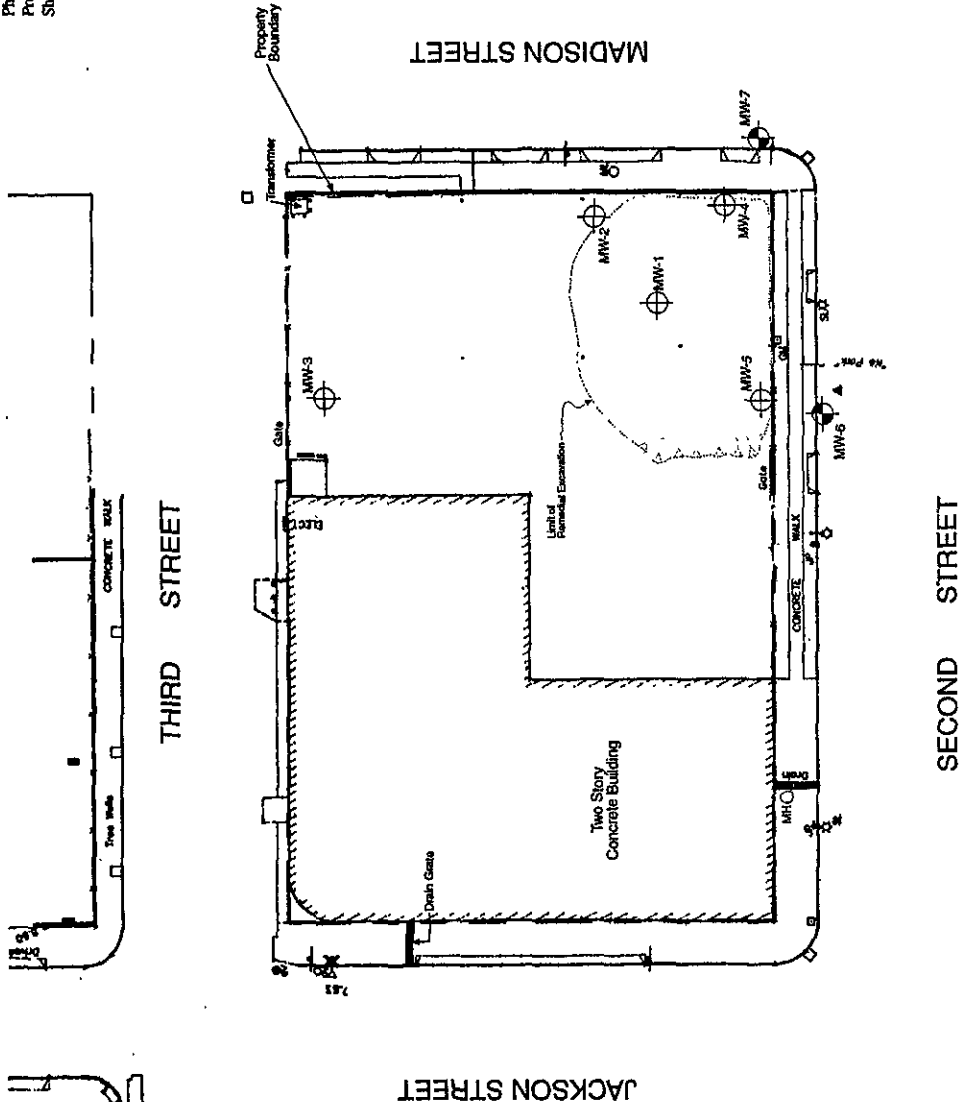
FIG. 2 **The San Joaquin Company Inc.**

All previously existing groundwater-quality monitoring wells present on the site were closed when the hydrocarbon-affected soil was remediated. As called for by the remediation work plan, two new off-site monitoring wells - Nos. MW-6 and MW-7 - were installed on December 30, 1998 at the locations shown on Figure 2. A first round of groundwater-quality monitoring using these wells was completed on January 9, 1999 (The San Joaquin Company Inc 1999a); a second round followed on April 25, 1999 (The San Joaquin Company Inc 1999b); a third round was completed on July 24, 1999 (The San Joaquin Company Inc 1999c) and a fourth round on October 24, 1999 (The San Joaquin Company Inc 1999d).

Re-paving is complete around MW-6. Debris has been cleared from the MW-7 well cover, but that cover is found broken and loose in the paving of Madison Street, which has not been re-paved. On removal of the dedicated bailer hung in the well casing, it was found that the upper 6 inches of the casing above the top of the bailer was blocked by bituminous macadam debris and there was evidence that some of that material had fallen further down the well to the groundwater table.

At some time between April 25 and July 25, the MW-7 well cover was damaged and displaced by the bucket of heavy equipment used to load the paving debris that had been temporarily stored over it. This activity caused debris to fall into the well casing before the paving contractor reset the cover over the well. The material introduced into the well at that time caused the concentration of petroleum hydrocarbons in the groundwater in the gasoline range to rise significantly, thus accounting for the results obtained by the analysis of the sample recovered from MW-7 on July 25. By October 24, the effect of this perturbation had passed, so that the results of the analyses of the sample recovered on that date showed that the trend of steadily decreasing concentrations of analytes of concern with time had resumed.
