On behalf of Ingersoll-Rand Equipment Sales, Capsule Environmental Engineering (Capsule) is submitting the enclosed report, Geophysical Subsurface Investigation, (Geophysical Investigation) for the facility at 1944 Marina Boulevard, San Leandro, California. Additionally, this letter includes information that expands on the Geophysical Investigation findings.

GEOPHYSICAL SUBSURFACE INVESTIGATION
for
INGERSOL RAND EQUIPMENT SALES
at
1944 Marina Boulevard
San Leandro, California

Geophysical subsurface investigation for underground storage tanks (USTs).

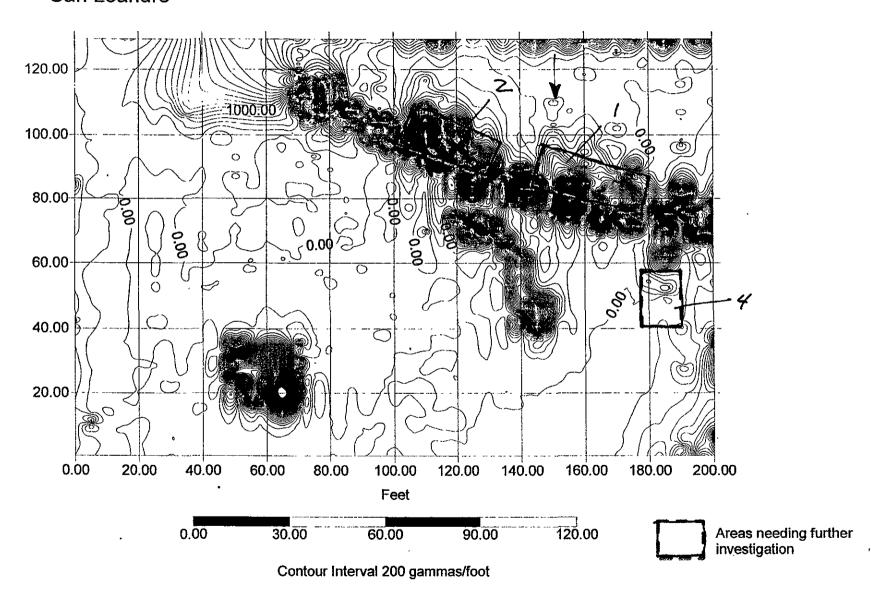
Vertical Gradient of Total Field Magnetometer Data -- Mininum Curvature Contouring Site -- Northwest Portion of Property Located at 1944 Marina Boulevard in the City of San Leandro

The results from the magnetometer (858G) show anomalies either caused by objects known to be buried (i.e. railroad tracks) or objects visible at the surface (i.e. above ground tanks). Three areas are highlighted on the magnetometer contour map which warrant further investigation.

There are some buried metallic objects that deserve a closer look, we recommend excavating in those areas indicated on the drawings.

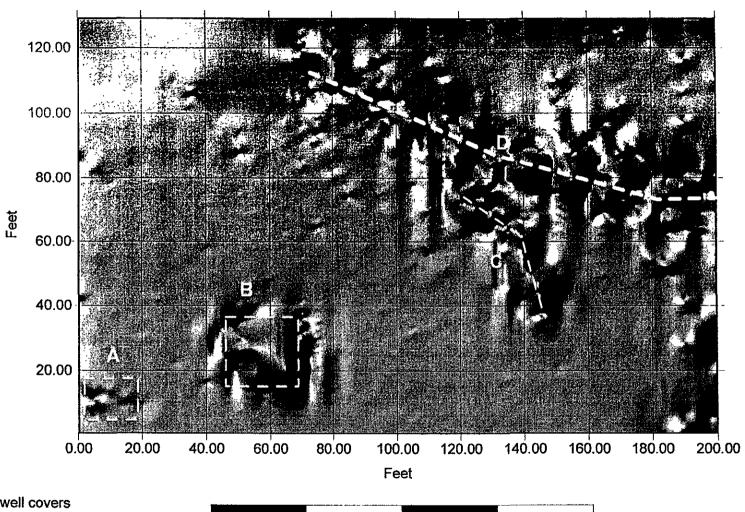
Vertical Gradient of the Total Field Magnetometer Data

While not readily apparent from the site map, the trapezoidal area is in the same location as the rectangular feature centered at coordinates x = 120 ft., y = 100 ft. on the vertical gradient of total field magnetometer data.

The rectangular area on the vertical gradient map at whose southwest corner is at coordinates x = 180 ft. and y = 40 ft.

Anomaly 4 is directly south of the storm drain identified on the site map. The Subtronic geophysicist posited that the anomaly could likely be related to a pipe tying the storm drain into the municipal system under Marina Blvd.

A -- steel monitoring well covers

B -- above ground storage tanks

C - steel structure for loading dock
D - anomaly from buried railroad tracks.

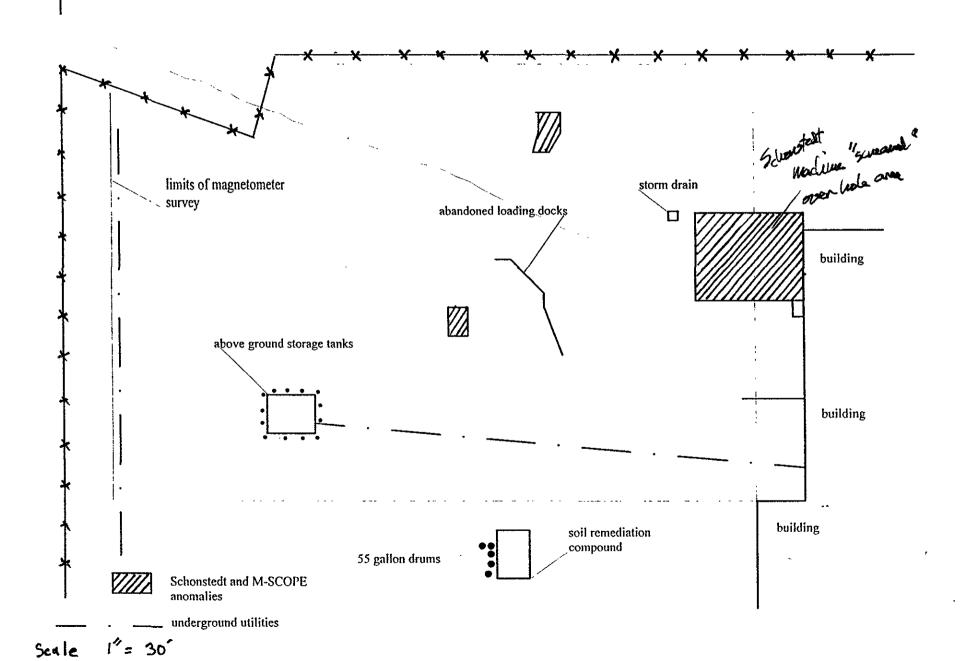
Site Map for Northwest Portion of Property 1944 Marina Boulevard, San Leandro California

This trapezoidal area appeared as an anomaly with the M-scope and locator.

The M-Scope, but not the magnetometer identified the rectangular area southwest of the "abandoned loading docks".

According to Subtronic, this anomaly likely represents a shallow buried piece of metal, such as sheet metal (from verbal discussion with Subtronic geophysicist).

The visual inspection for USTs did not reveal any indications of UST type features on the ground. The magnetic locator and the M-SCOPE detected two anomalies with approximate dimensions of 10 feet by 4 feet (see site sketch). Using the M-SCOPE, a pipe trending north south ending approximately 10 feet from the northwest corner of the property was also detected. High readings were detected in a square shaped area at the northwest corner of the main service building. The cause of some of the high readings could be attributed to some steel piping and railroad tracks, however due to the large amounts of buried steel in the area it is not known if all of the anomalies in this square area are accounted for. Two areas highlighted on the site sketch warrant further investigation.
