**ENVIRONMENTAL REPORT**  
**6601 and 6603 BAY STREET**  
Emeryville, California

Project No. PE90.005.02

July 1990

Subject: **ENVIRONMENTAL REPORT**  
Underground Storage Tank Removals  
6601 and 6603 Bay Street  
Emeryville, California.

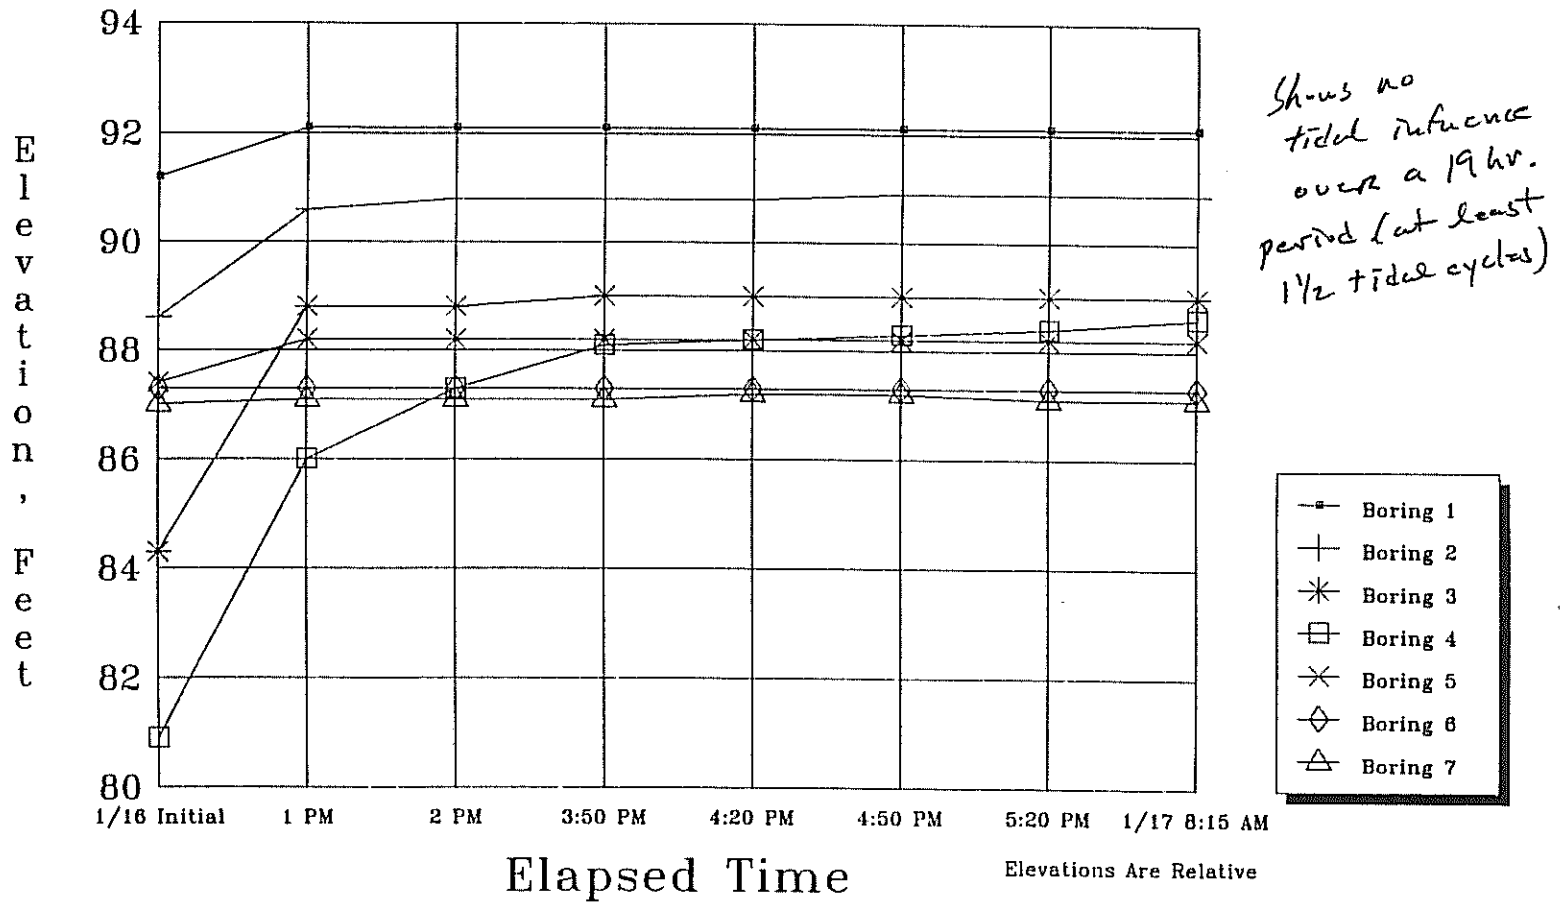
# Water Table Elevation Stabilization Curve

Boring No. 4 exhibited the greatest change in water level, almost 8 feet, during the period of observation. On the other hand, Boring No. 6 did not change from its initial level at the time of drilling. This dramatic difference underscores the highly variable soil and debris conditions encountered in the municipal and

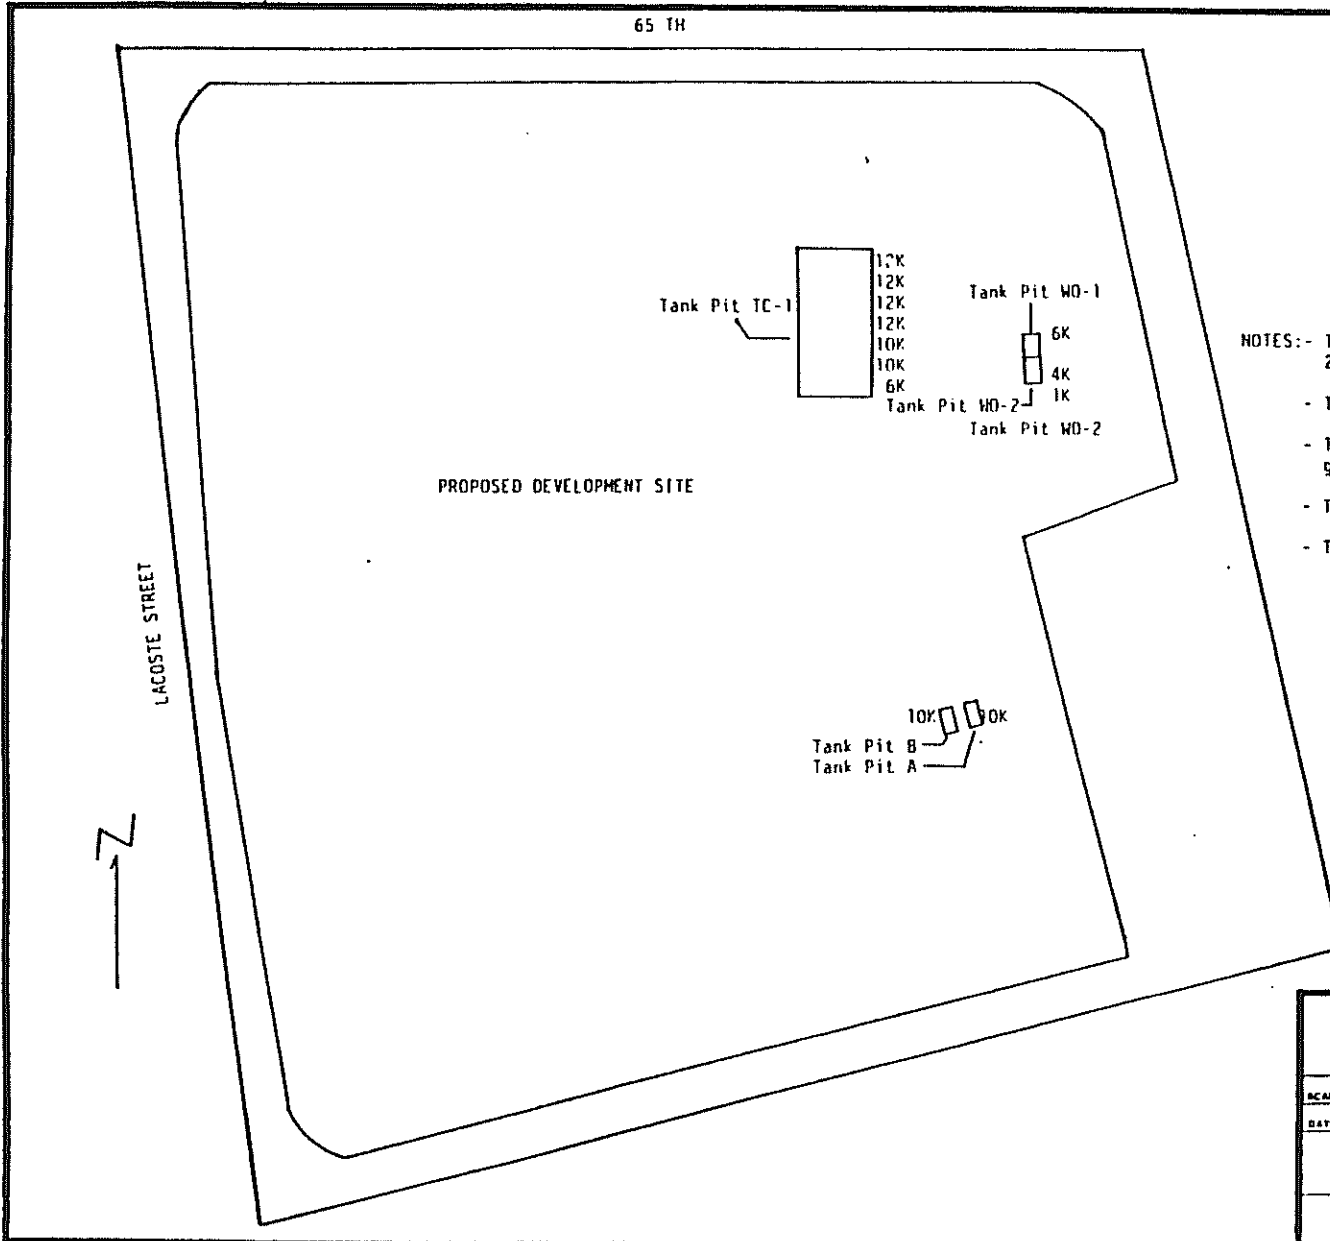
BAY CENTER - EMERYVILLE, CA.		
SCALE 1" = 40'	APPROVED BY TEC	DRAWN BY QH
DATE 5-8-86		REVISED
AQUA SCIENCE ENGINEERS, INC.		
Figure 1.		DRAWING NUMBER

*COMMENT:* Figure Nos. 1 and 2 are included. The highest value of soil contamination is 5,250 ppm Total Hydrocarbons (northeast corner of TC-1). This sample location is located the closest to the 6601 and 6603 Bay Street properties. Note that the groundwater contamination is 240 ppm Total Hydrocarbons. The validity of these values for expressing the actual values of the most likely contamination of diesel, oil and grease are suspect because a headspace (EPA 5020) method was used that will not detect the middle and higher boiling point diesel constituents unless special procedures are used. Also, the headspace method is prone to interference from other mechanisms that effectively bind the hydrocarbons resulting in lower reported concentrations. This method will not detect oil or grease.

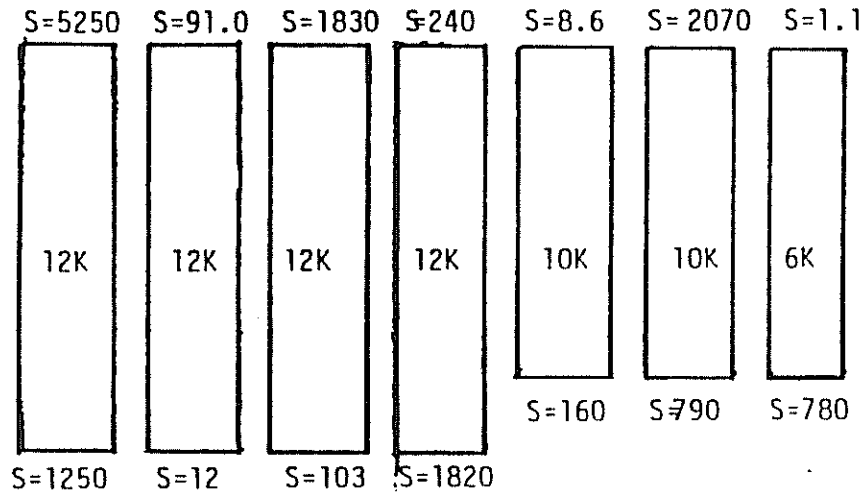
BAY CENTER _ EMERYVILLE, CA.		
SCALE:	APPROVED BY:	DRAWN BY D.H.
DATE: 5-6-86		REVISED
AQUA SCIENCE ENGINEERS, INC.		
		DRAWING NUMBER Figure 2.

"Figure 2 presents the results of the soil and groundwater analysis for motor fuel {fuel} hydrocarbons. The results indicate that motor fuel contamination in the soil and groundwater is above acceptable limits set by the Regional Water Quality Control Board and that a program of decontamination is necessary."

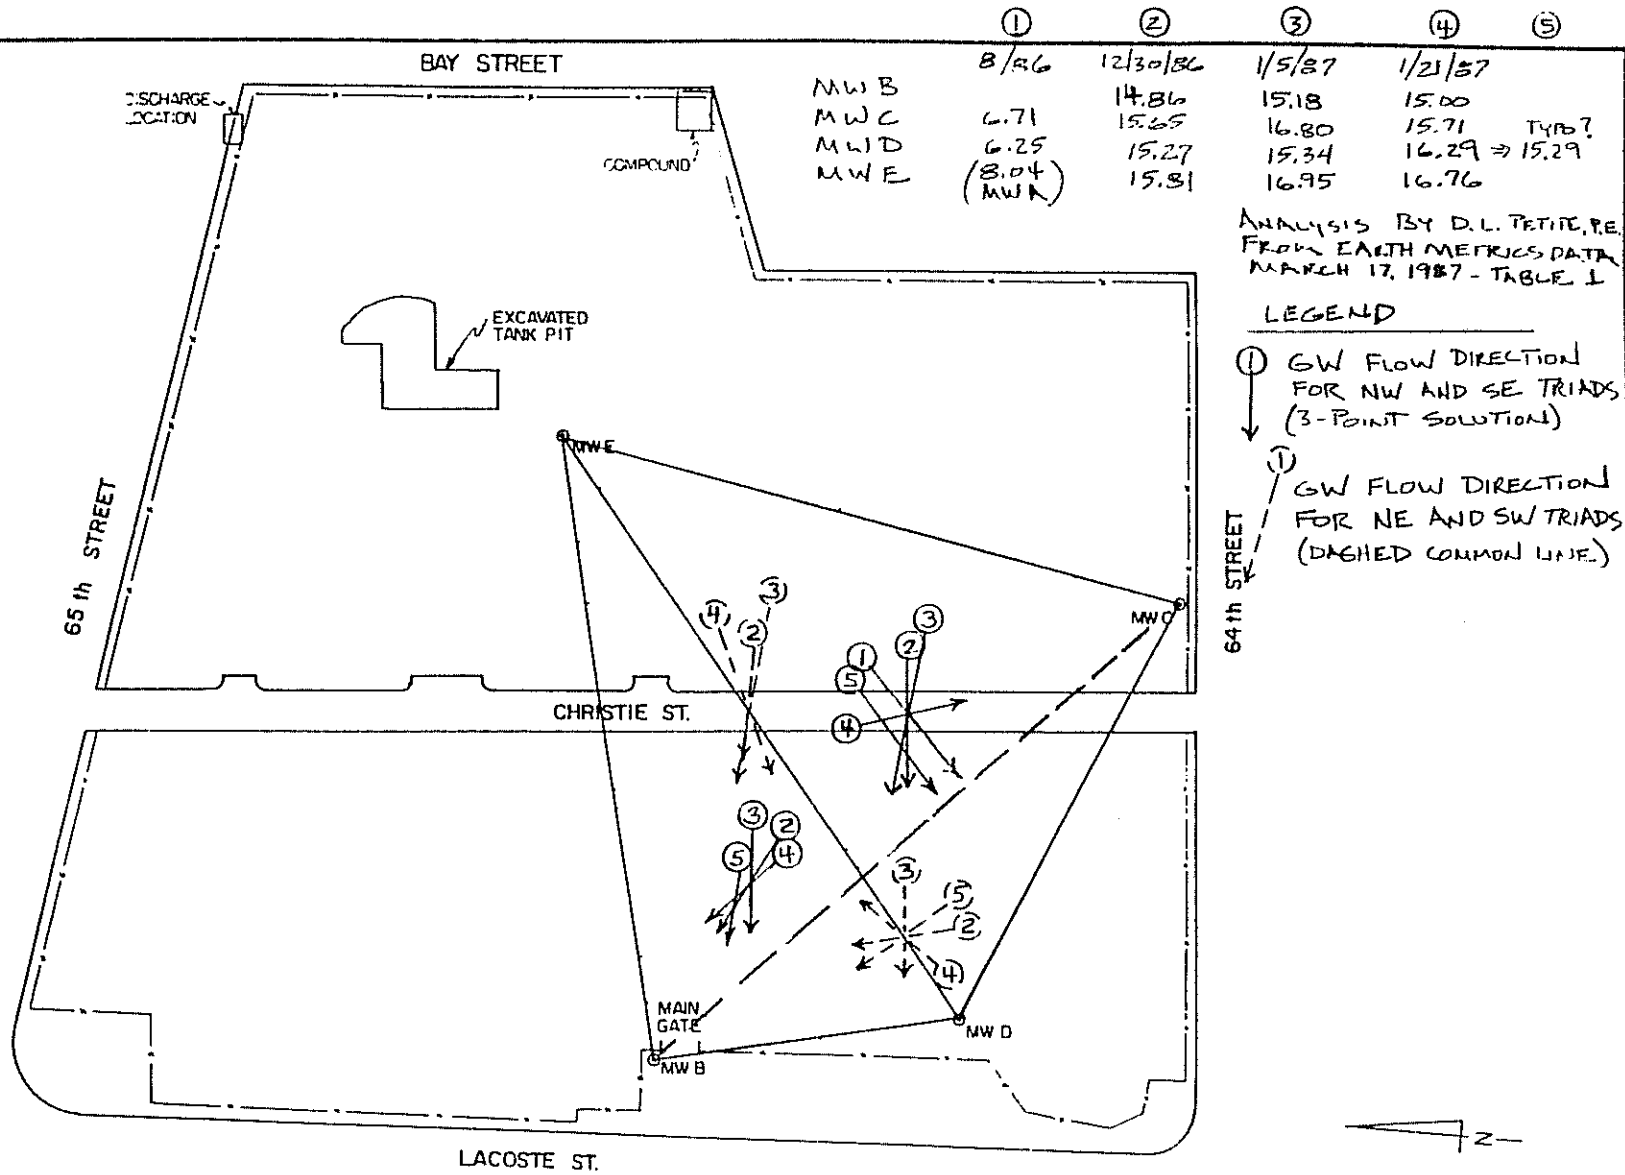
ANALYSIS BY D.L. TETITE, P.E.  
FROM EARTH METRICS DATA  
MARCH 17, 1987 - TABLE 1

*COMMENT: The groundwater table is very flat in this area and will respond to relatively small water extraction or infiltration rates. Due to the natural seasonal fluctuations in the groundwater level, differing flow directions will occur as noted in Figure 1. This situation allows for a very complex flow of the floating hydrocarbon product that may be significantly directed by variable permeabilities in the heterogenous fill and construction debris.*

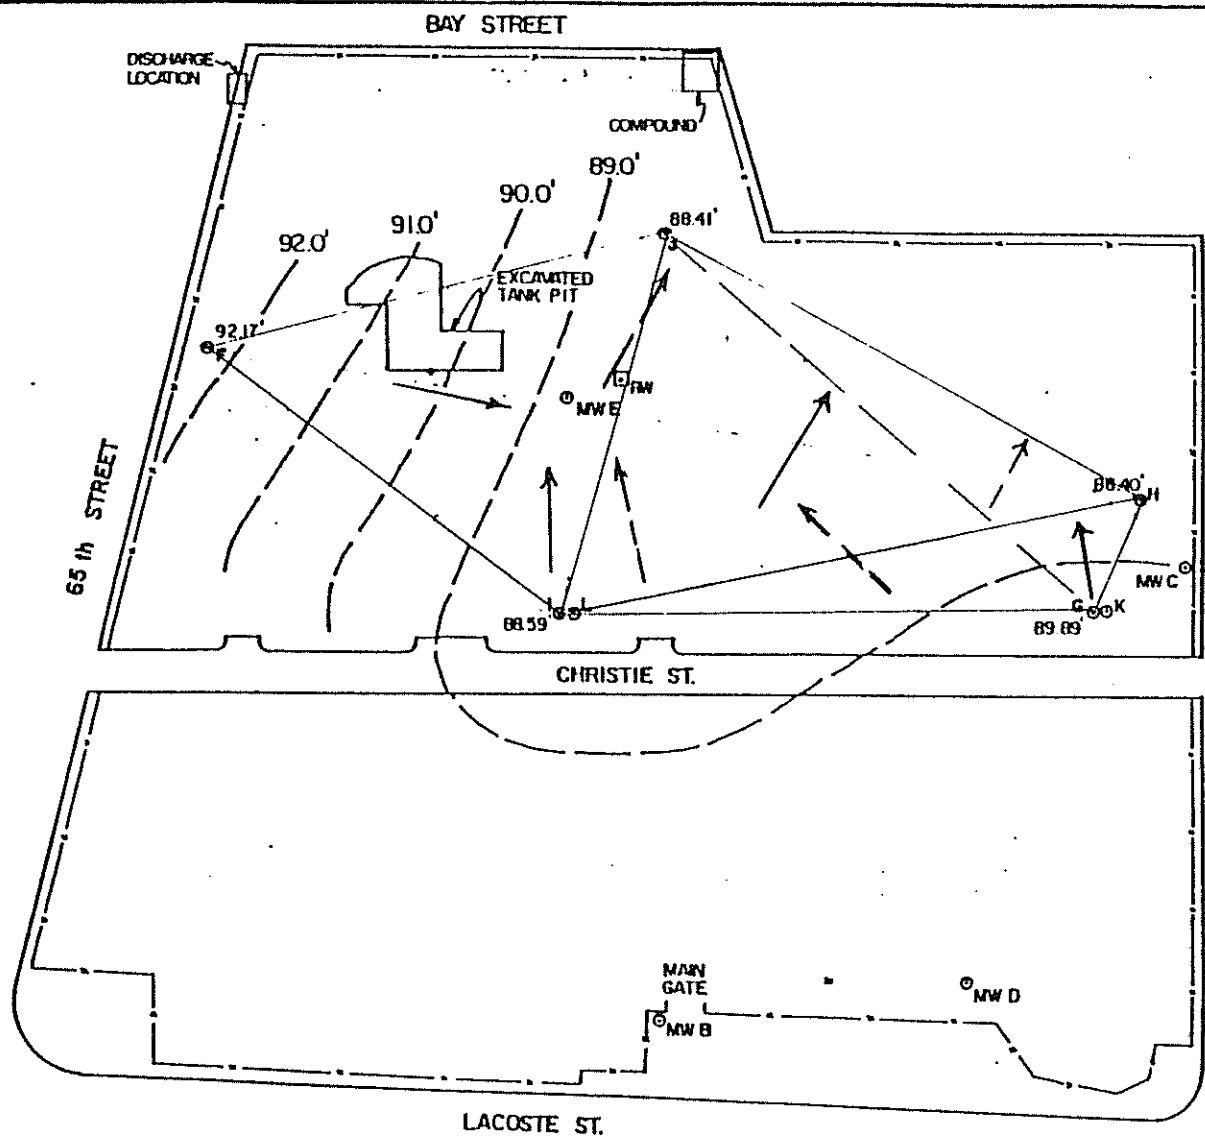
GROUNDWATER GRADIENT MAP  
SEPTEMBER 2, 1987

recovery well. Total Volatile Hydrocarbons (primarily gasoline hydrocarbons) of 93,724 ppb were sampled on September 2, 1987. The Total Petroleum Hydrocarbons concentration including the heavier gasoline fractions and the diesel, oil and grease for this sample was 355,000 ppb.
