November 11, 1987

RE: Proposal for In-place Closure of an Underground Storage Tank Located at the Former Grow Group Facility, Emeryville, California

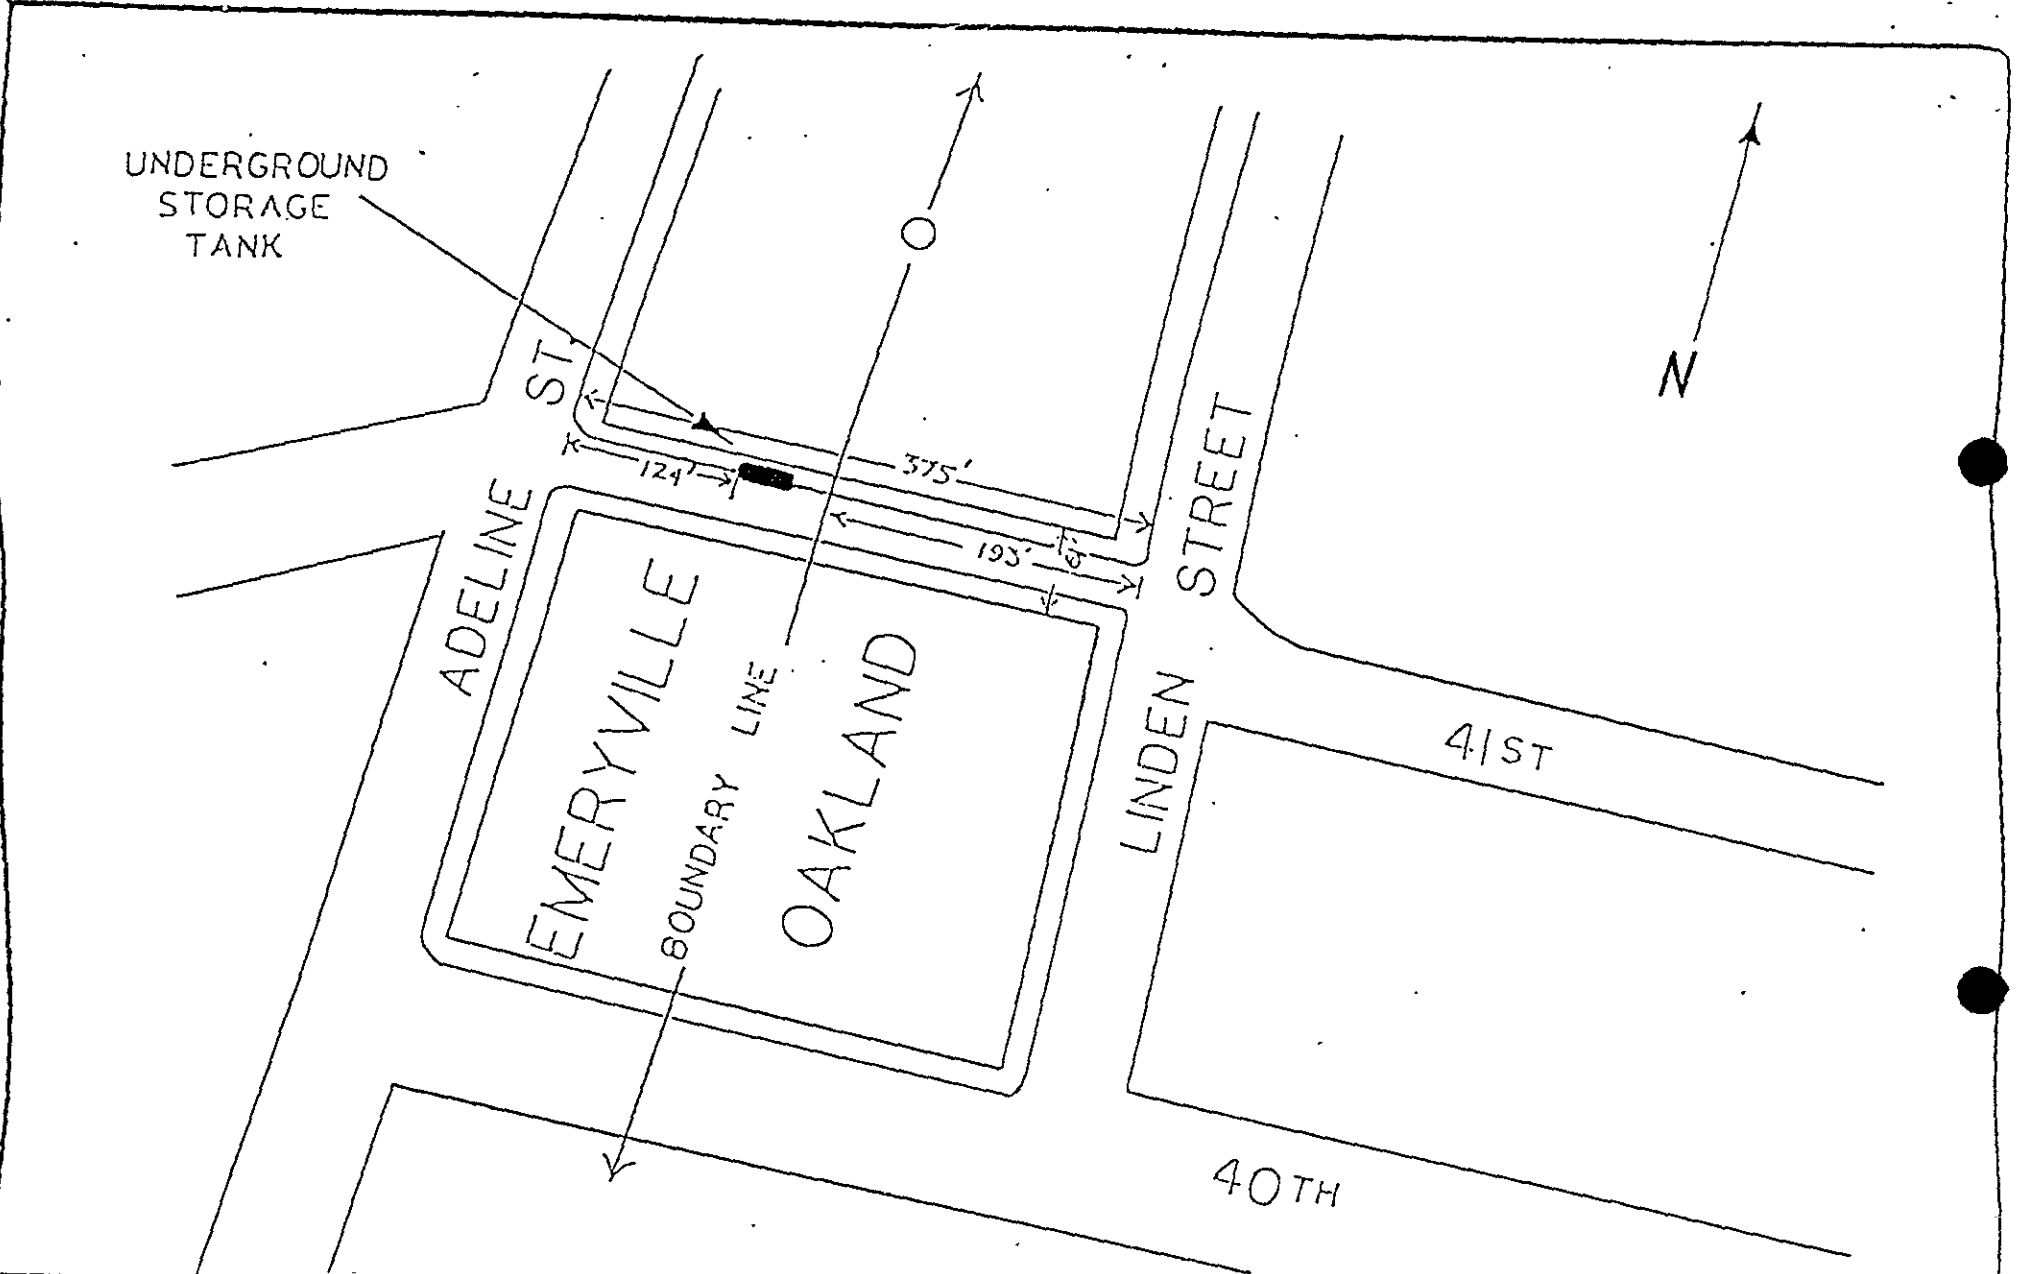
FIGURE 1.
UNDERGROUND STORAGE
TANK LOCATION

On September 1, 1987, OHM personnel conducted a site investigation to determine the capacity, orientation and structural soundness of the underground storage tank. Figure 1 shows the underground storage tank location.

- o The underground storage tank lies in close proximity to adjacent buildings. The tank is oriented in an west to east direction, running parallel to the Oakland National Engravers Building. The tank is 7.3 feet in diameter and is within 3.5 feet from the building. Excavation may cause structural damage to the adjacent facility and disruption or inconvenience of nearby business operations. In addition, excavation will cause disruption to traffic along 41st Street.

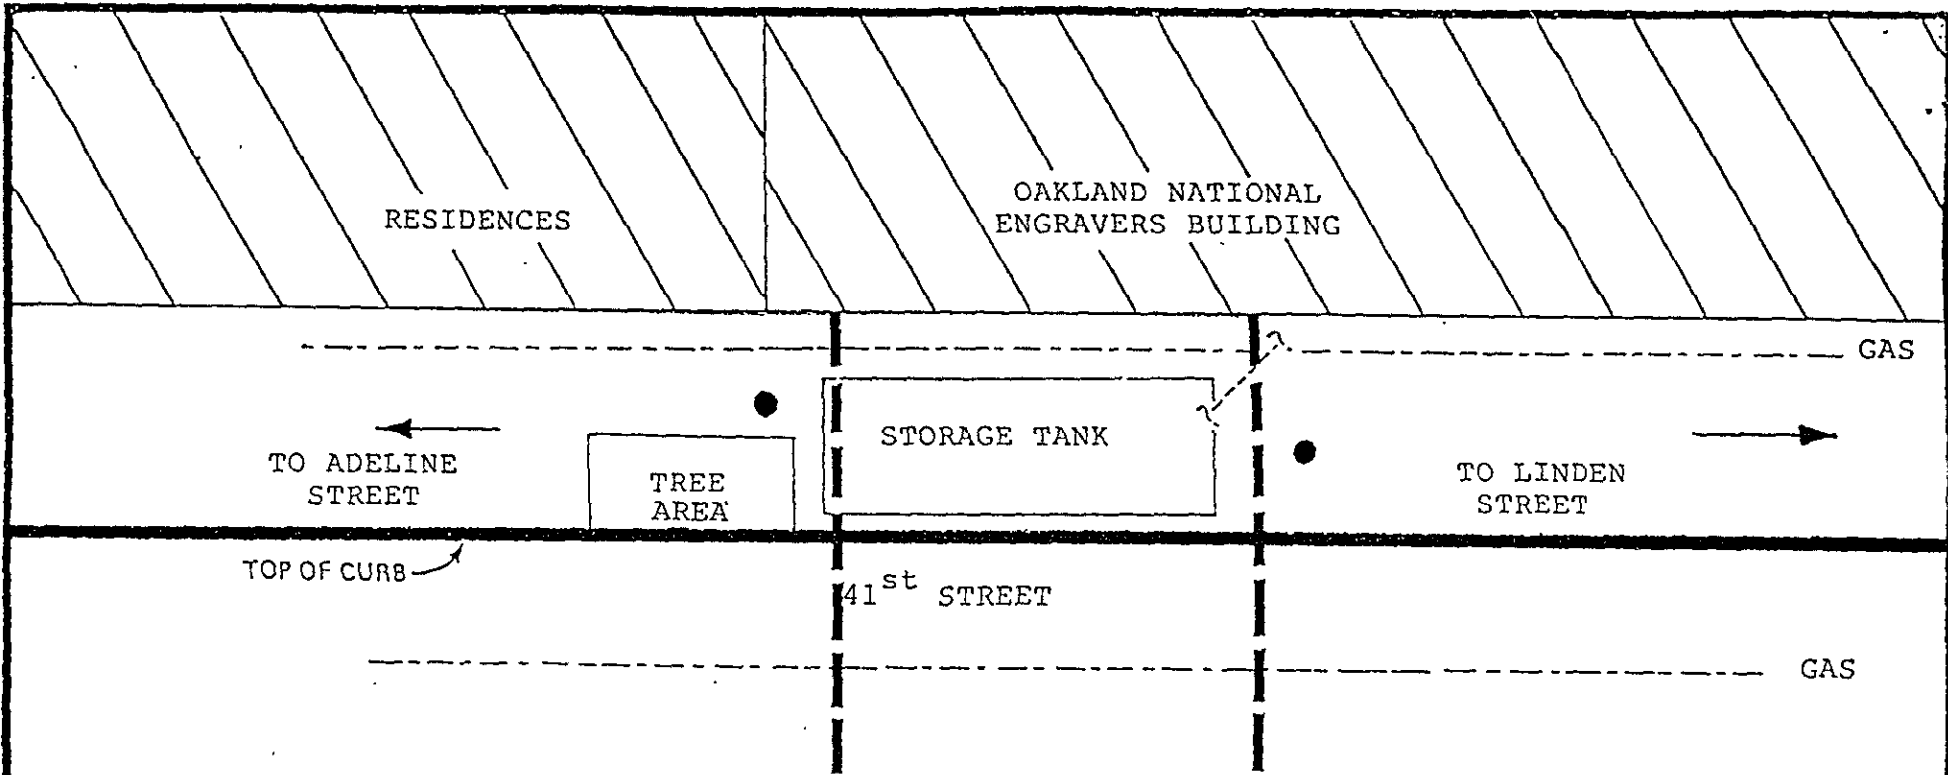
FIGURE 2.
UTILITY AND PROPOSED
BORING LOCATIONS

underground utility lines. Figure 2 shows the locations of the utility lines identified. One Pacific Gas and Electric natural gas line is located approximately one foot north of the tank oriented in an east-west direction, while another lies 8 feet to the south of the tank underneath 41st Street. An unknown utility line, located just east of the tank, runs at an angle to the building at approximately 1.5 feet below the base of the sidewalk. It is possible that additional utility lines exist but could not be identified with the GPR.

- o Two soil borings will be advanced and terminated at approximately two feet below the water table.
- o Because of the tank location with respect to adjacent structures and the known or suspected utility lines, the borings will be placed directly east and west of the tank as shown in Figure 2.
- o Temporary PVC well screens will be installed, and water samples will be taken from each boring.
- o The water samples will be analyzed according to the San Francisco Regional Water Quality Control Board method for addressing underground tank leaks. (TPHC - total petroleum hydrocarbons) and EPA method 624 (volatile constituents).
