# AMERICAN BRASS & IRON FOUNDRY

September 8, 1992

**Subject: Report on Removal of 12,000 Gallon Capacity  
Underground Diesel Fuel Storage Tank,  
American Brass & Iron Foundry,  
Oakland, California**

REMOVAL OF 12,000 GALLON CAPACITY  
UNDERGROUND DIESEL FUEL STORAGE TANK  
AMERICAN BRASS & IRON FACILITY  
OAKLAND, CALIFORNIA

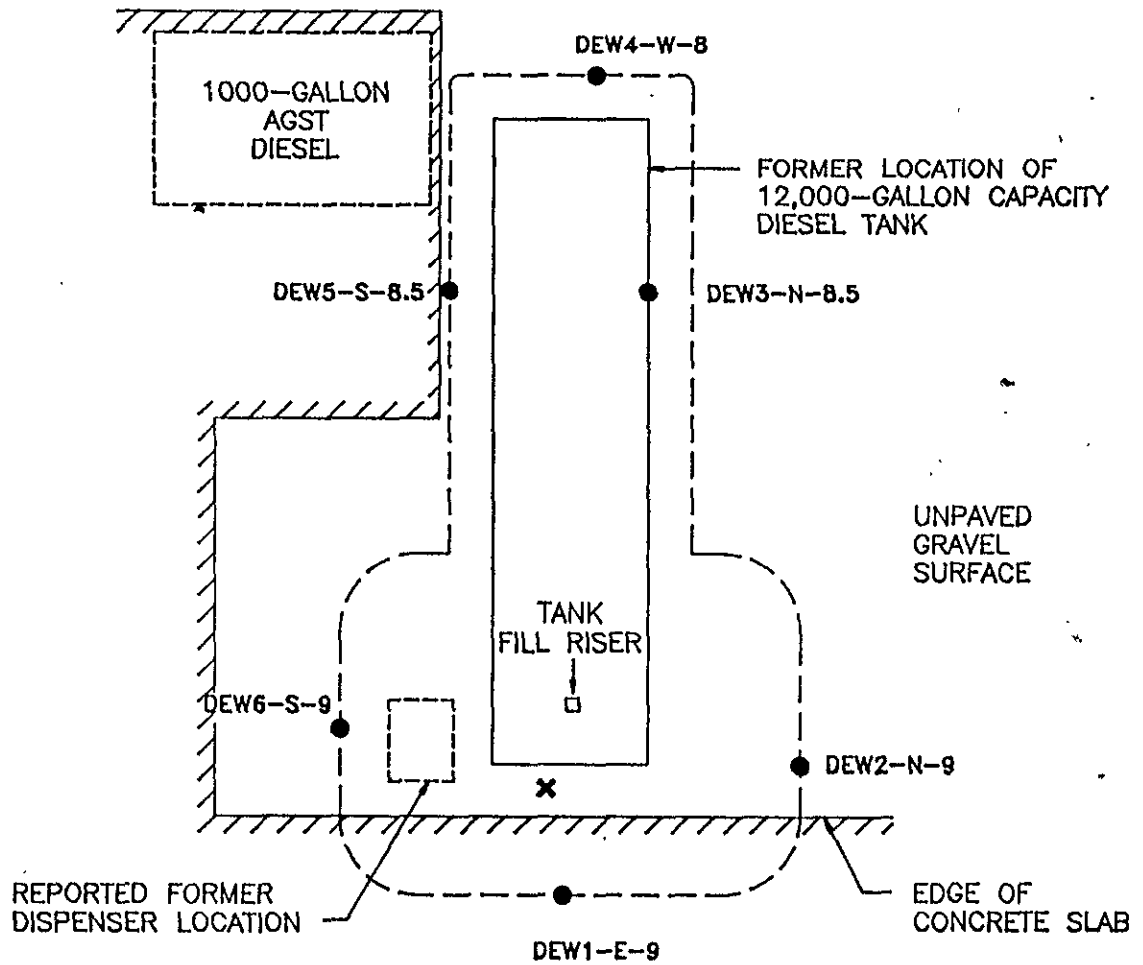
**FIGURE 3**  
**SAMPLING LOCATION MAP**

All sampling was performed by Michael Stoll, Senior Geologist, with Levine\*Fricke Consultants, using the same methodology as stated previously in a prior section. A series of six soil samples were taken to best represent the investigation. Each sample was tested for extractable hydrocarbons as diesel using EPA 3550(GCFID) and BTXE using method EPA 8020(50~~60~~<sup>30</sup>). Soil samples collected during the excavation were labelled DEW1-E-9, DEW2-N-9, DEW3-N-8.5, DEW4-W-8, DEW5-S-8.5 and DEW6-S-9.

The soil analysis results demonstrating the soil was unaffected by diesel fuel contamination caused from leakage of the storage tank and piping connections. The southeast corner was the only indication of soil contamination with a level of 2 milligrams per kilogram. As depicted by the sampling layout map, sufficient samples were taken to determine both the lateral and vertical contamination level surrounding the UST excavation. Among other parameters the down gradient direction for this area was considered in choosing sampling locations.

Figure 2 : PLAN SHOWING FORMER TANK AND SOIL SAMPLE LOCATIONS
