**SUMMARY REPORT OF
PREVIOUS SITE ACTIVITY**

**DI SALVO TRUCKING
4919 TIDEWATER AVENUE
OAKLAND, CALIFORNIA**

March 24, 1994
Project No. 9407

Re: **Summary Report of Previous Site Activity**
Di Salvo Trucking, 4919 Tidewater Avenue, Oakland, CA
RWQCB File: 01-0495 & 2198.17

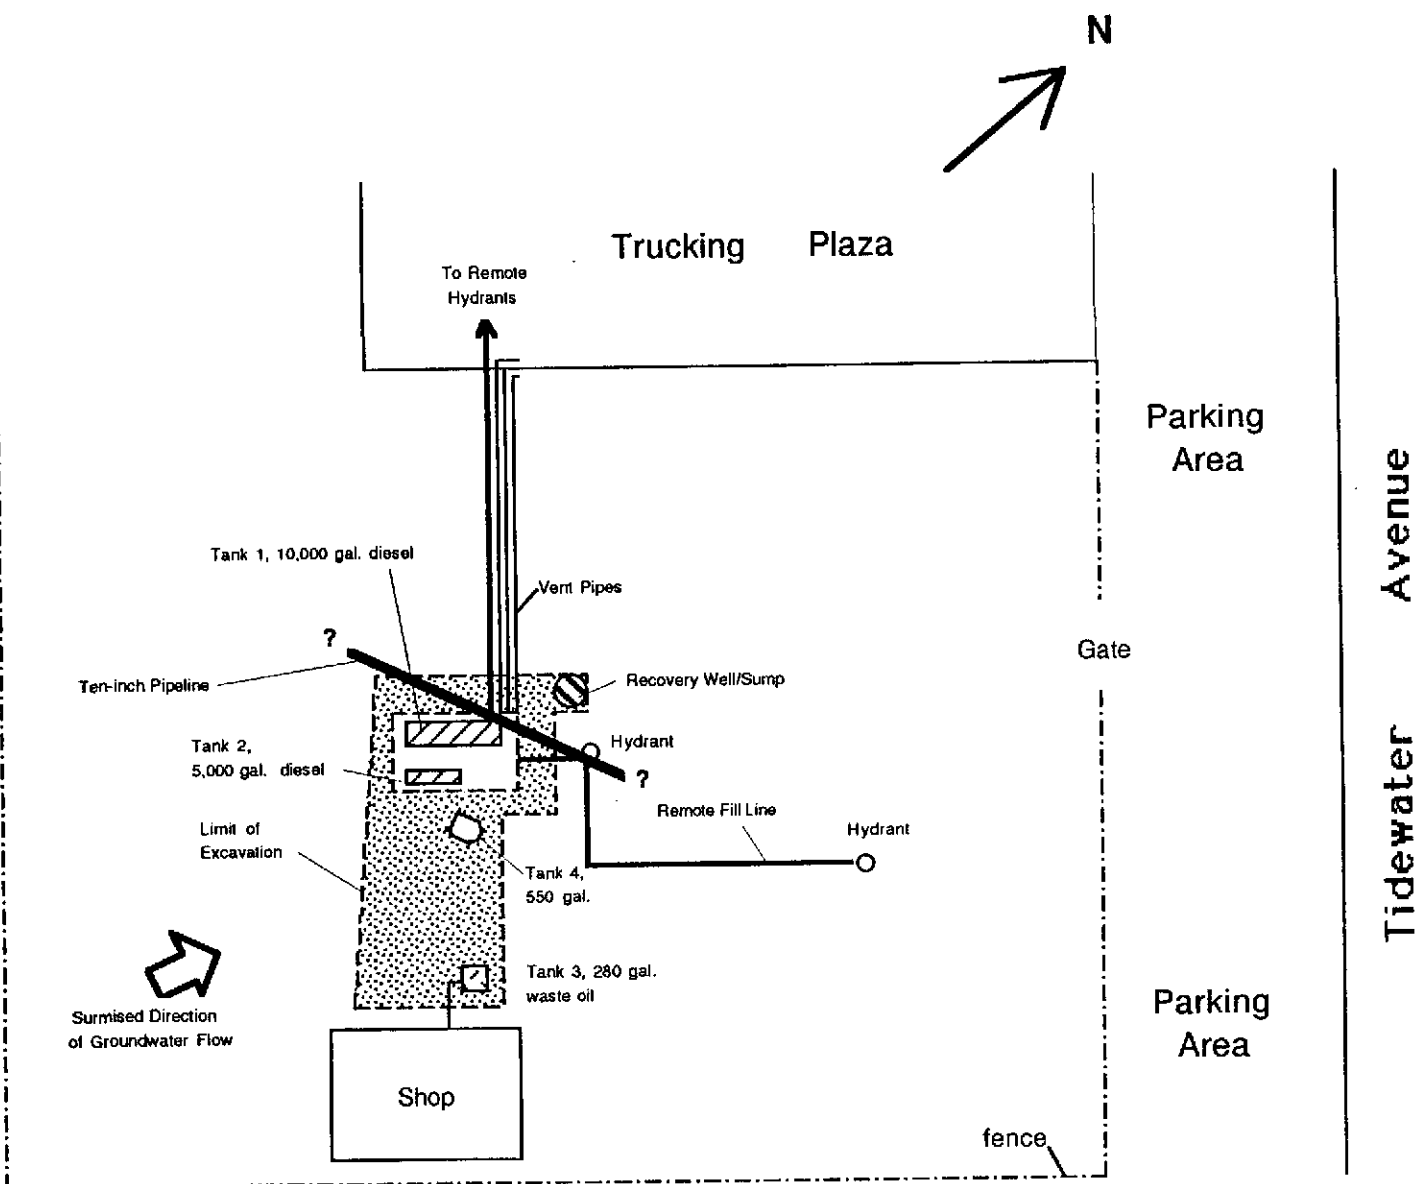
| Tank Location and Excavation Map DiSalvo Trucking 4919 Tidewater Avenue Oakland, CA | Project No. 9344 Scale: 1" = 50' Date: Mar., 1994 Figure 2 |

Notes: Information presented taken from Geo-Environmental Technology, Inc. June, 1989.
 Tank No. 4 discovered during excavation, apparently used for petroleum storage. Ten-inch Pipeline may be related to oil refinery use.

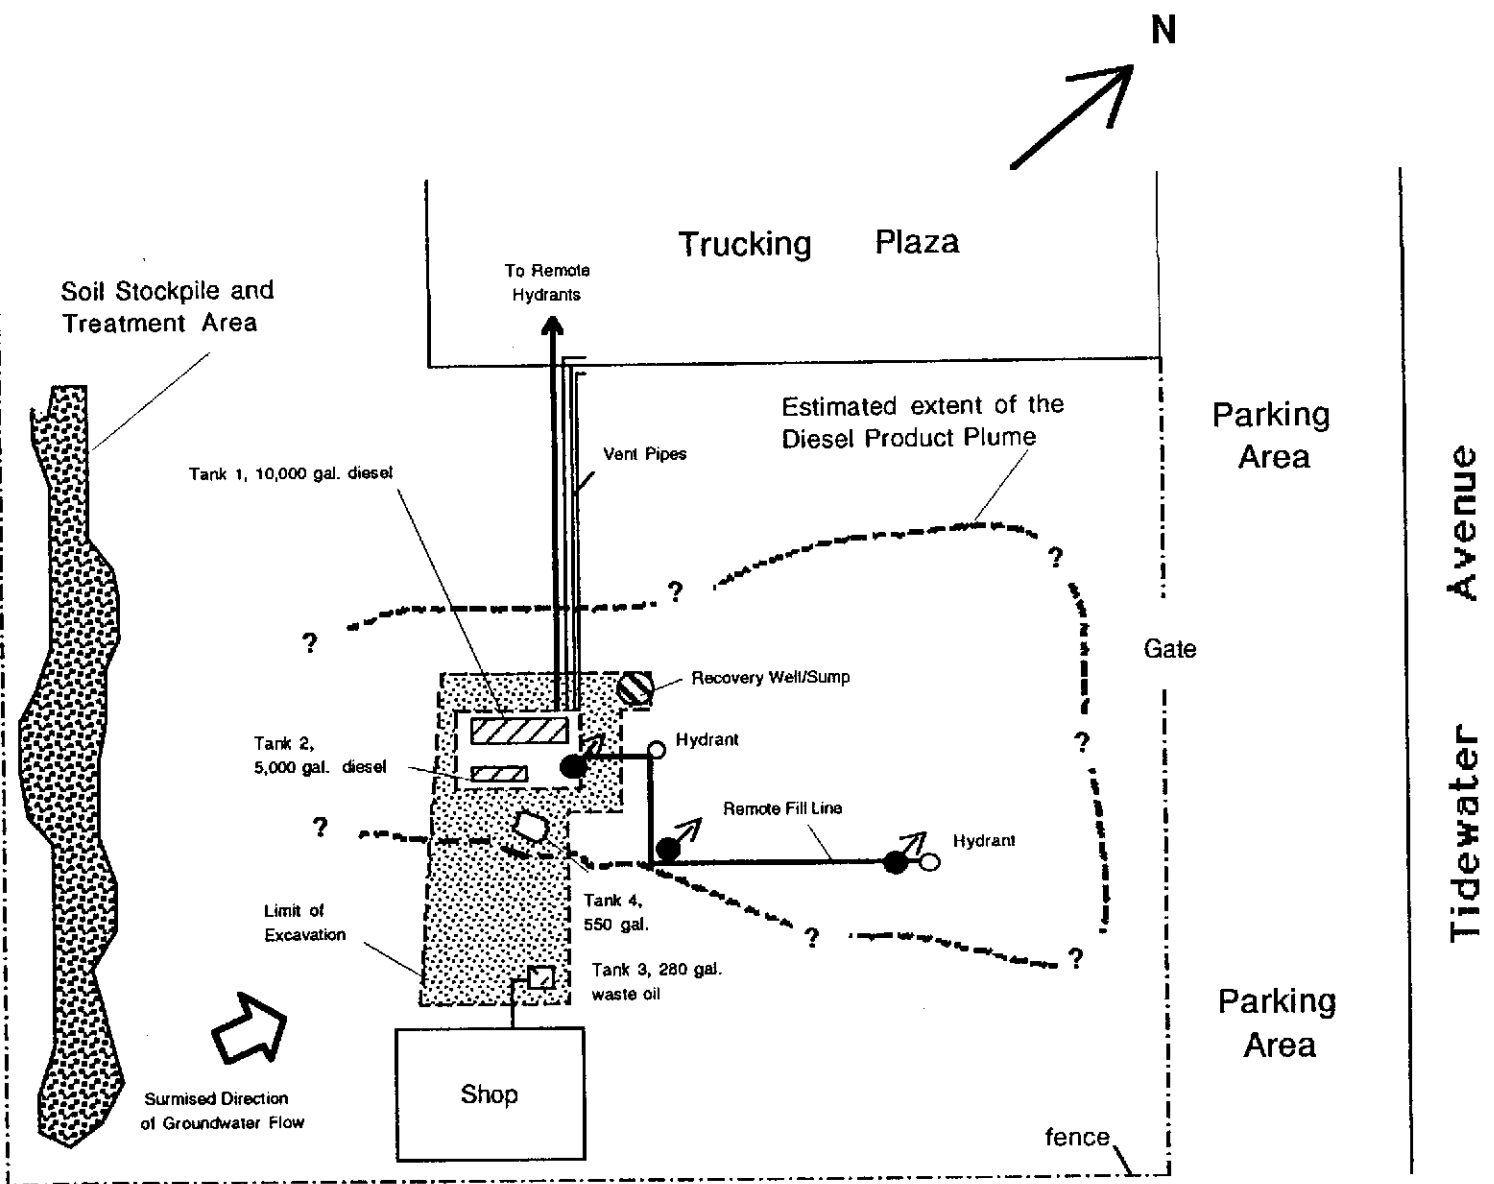
Figure 5

A large quantity of diesel fuel has leaked at this site. The main leak sources were apparently the tanks and pipeline leaks shown on Figure 5. Possible other sources could have been the ten-inch pipeline, and fourth tank used by a prior site occupant. Large quantities of fuel were observed to leak during the excavation and the hydrant metal pipeline appeared to be seriously corroded. An area of vadose zone soil and saturated soil was affected in the vicinity of the underground storage tanks. The storage tanks and the section of pipeline were disposed properly off-site.

Estimated extent of the separate phase Diesel plume plotted using sample locations shown on Figures 3 and 4.

Corroded Pipeline and/or Pipeline Leak

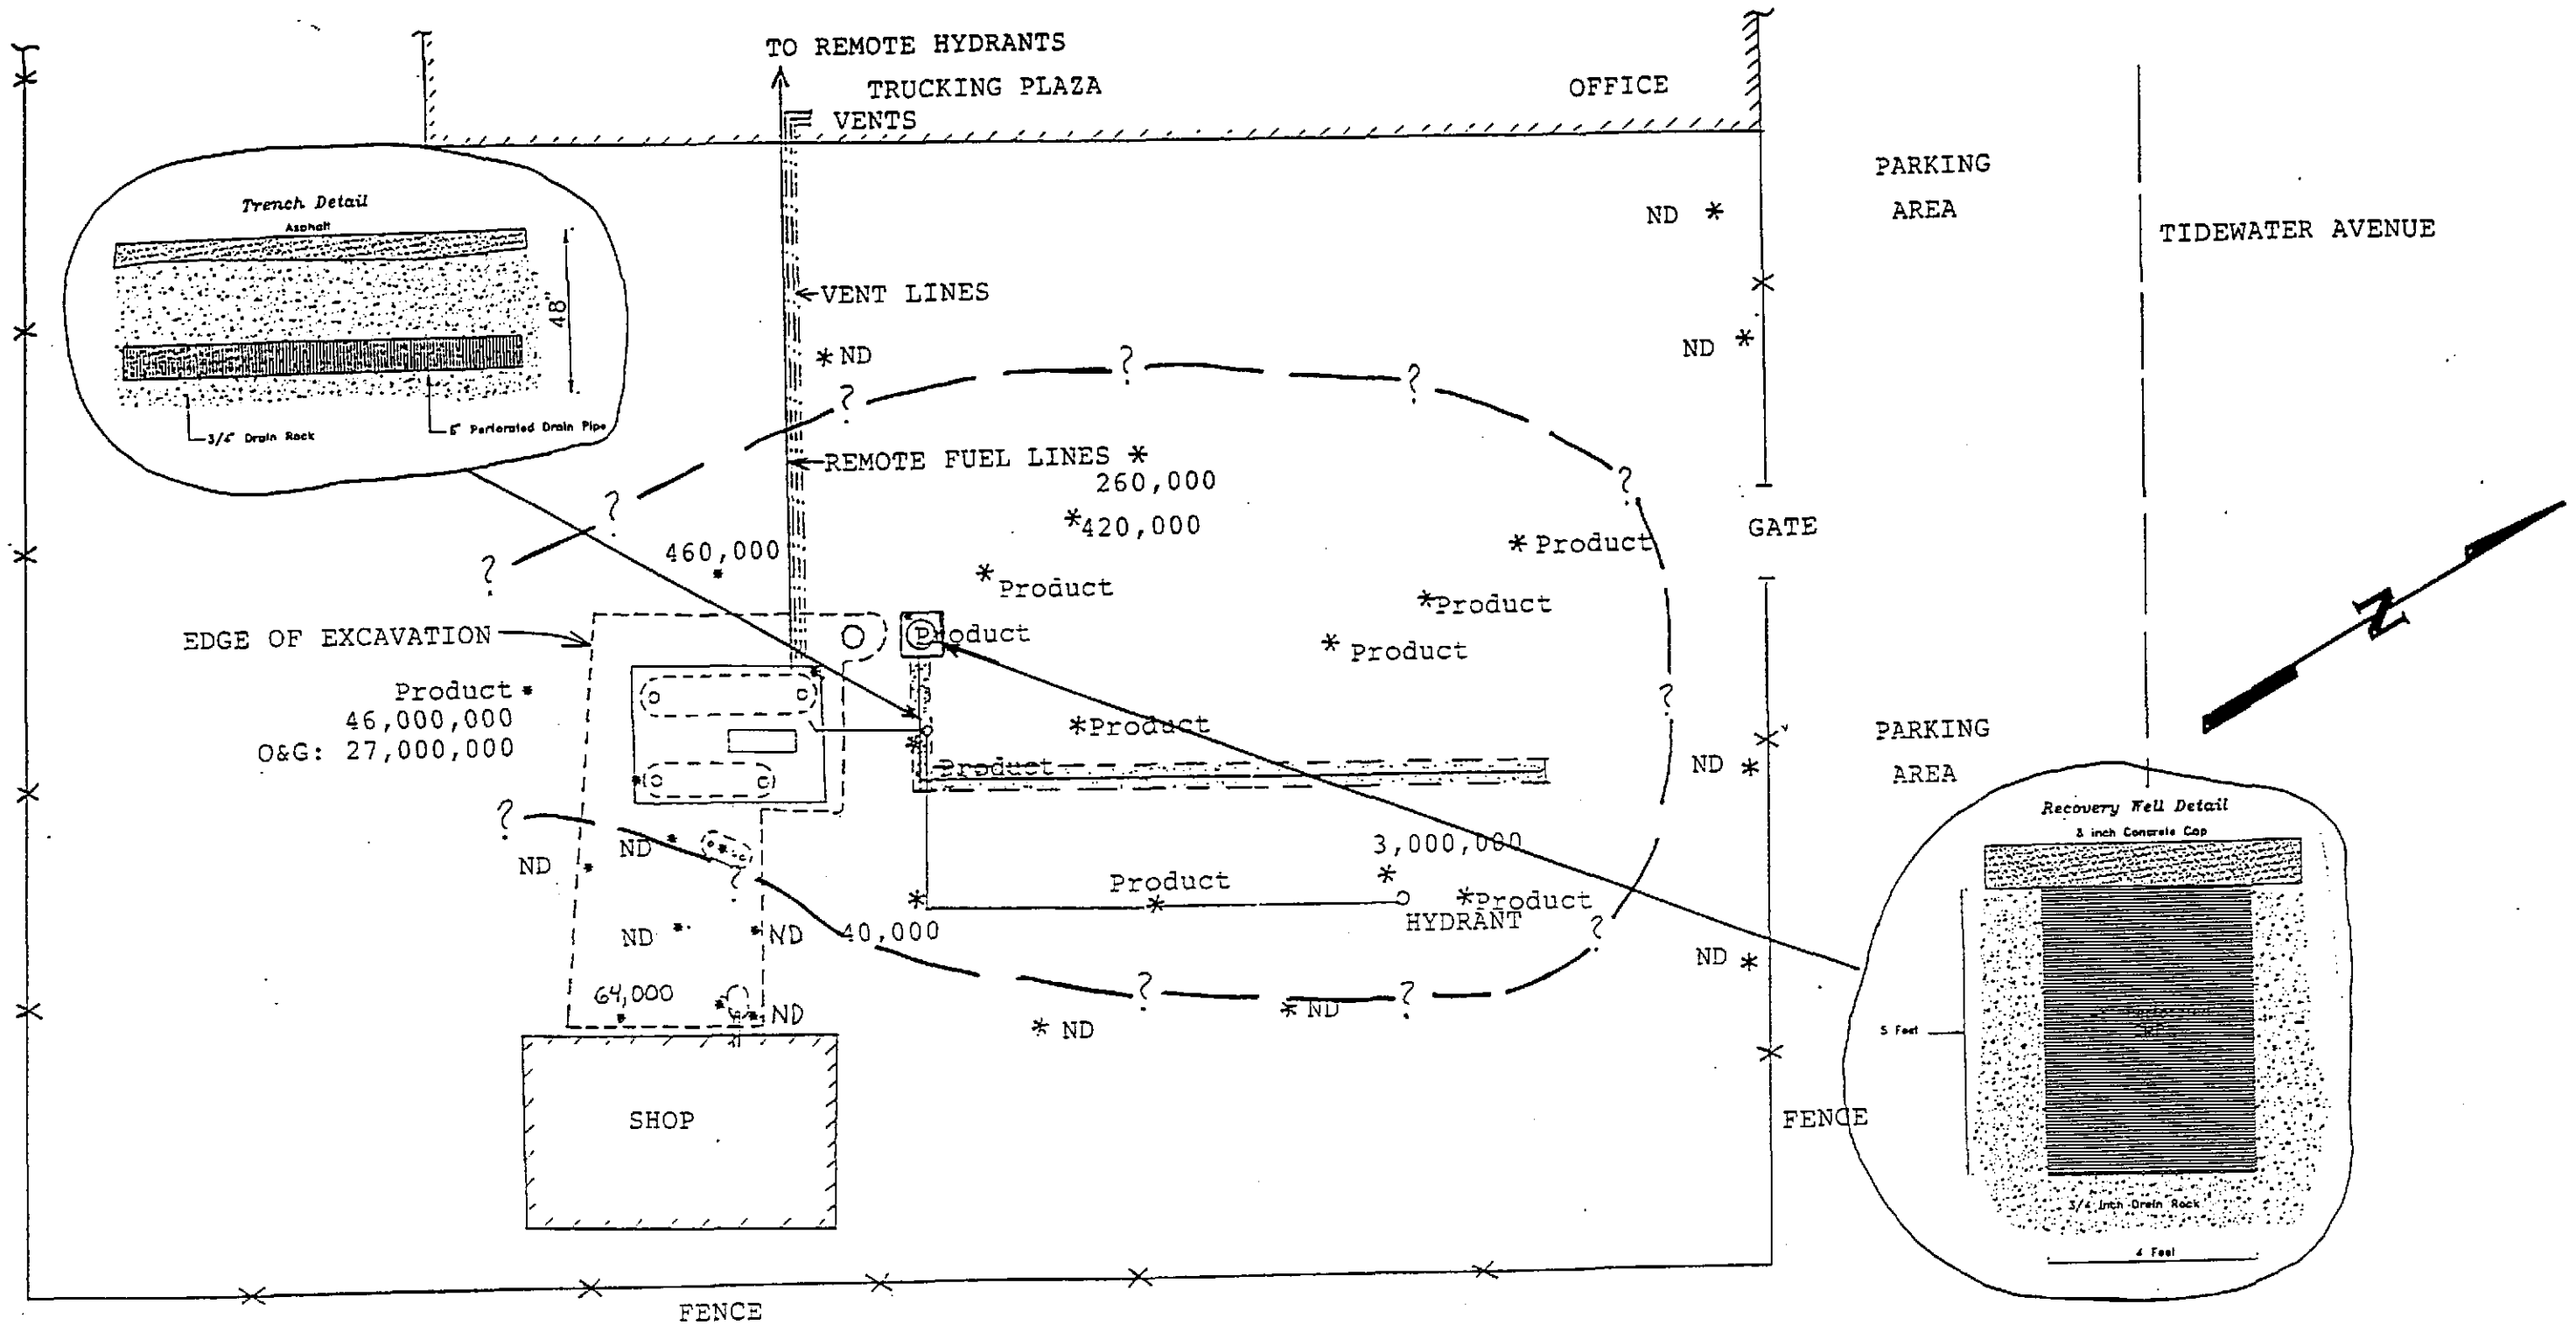
Figure 6

The excavation and recovery well/sump were used to collect the separate phase fuel "floating" on the groundwater surface. The well/sump is a 48-inch diameter pipe drilled to a depth of about 6 feet. A recovery trench was added to the system and connected to the well/sump. The trench is 4-feet deep and backfilled with a perforated drain pipe at the trench base, and backfilled with drain rock (see Figures 2 and 6). The trench follows the course of the pipeline which connected the hydrants in the yard area near the former tank locations. Most of the fuel was pumped out of the initial excavation pit, and about 2,400 gallons of separate phase were removed. Groundwater which recharged the excavation were pumped out and disposed off-site. Once the fluids were removed, the excavation was backfilled.

Product Recovery Sump and Trench

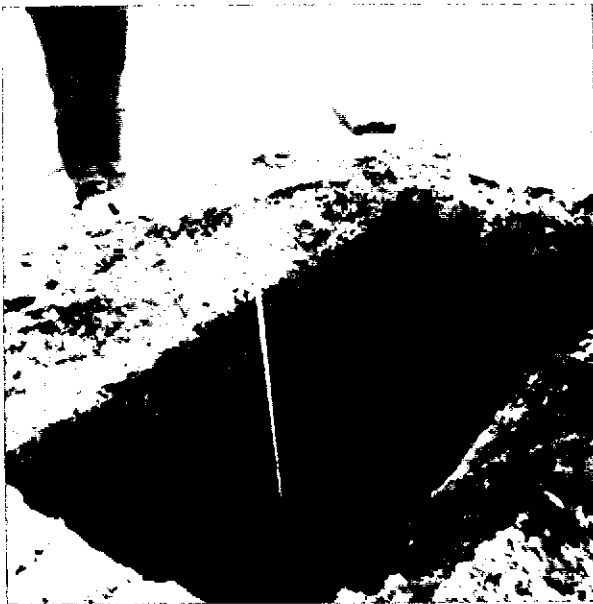
Di Salvo 3/21
Tidewater Site

WASTE OIL TANK PIT

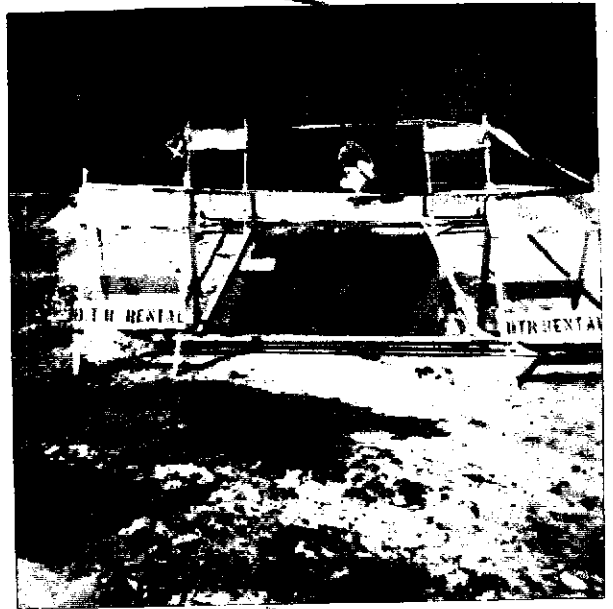
AREA SECURED AT 534 6A
STORAGE TANK

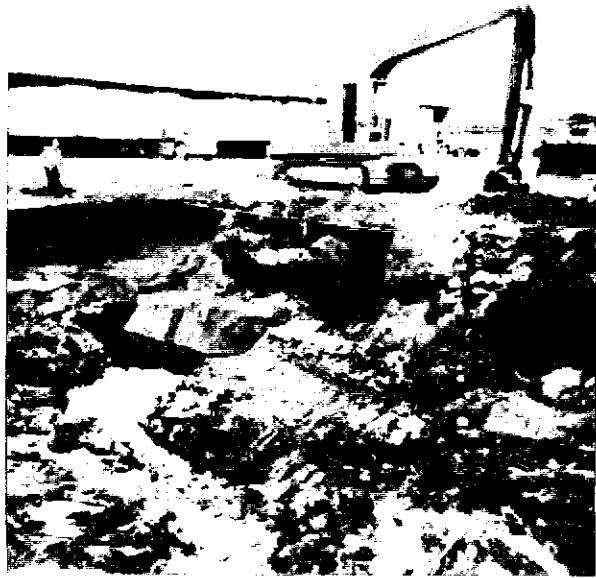
→
dust

Sampling limits
↓
